VEHICLE INSPECTION REPORT

KR58AFO

Toyota Land Cruiser 3.0 D-4D Invincible 5dr Auto [173]

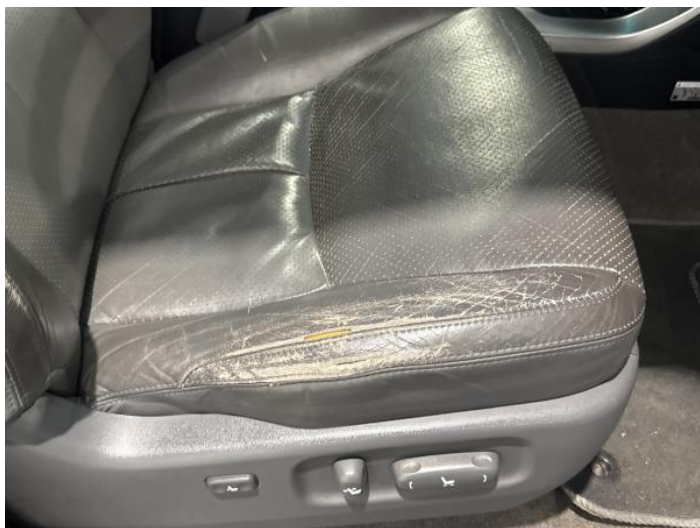
1: Seat Base Cover osf
Torn
Over 3mm

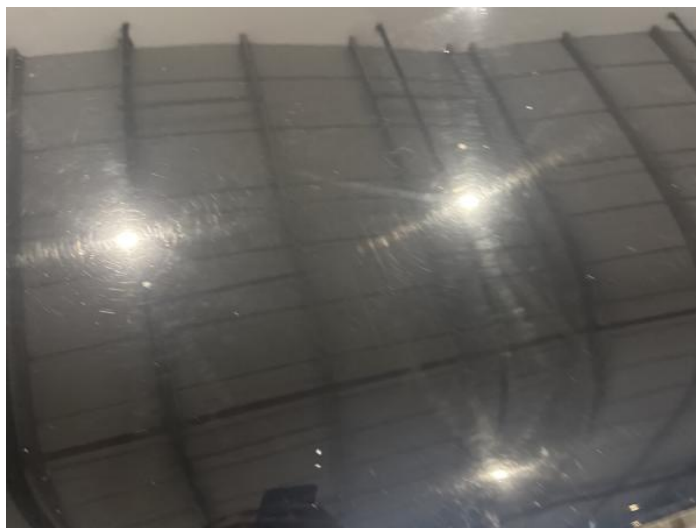
2: Bonnet
Chipped
Multiple Chips

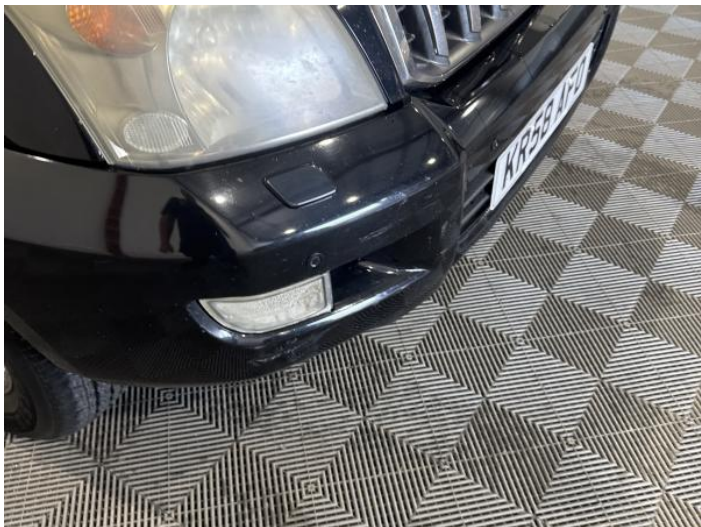
3: Bumper Front
Scratched
Over 100mm Thru Paint

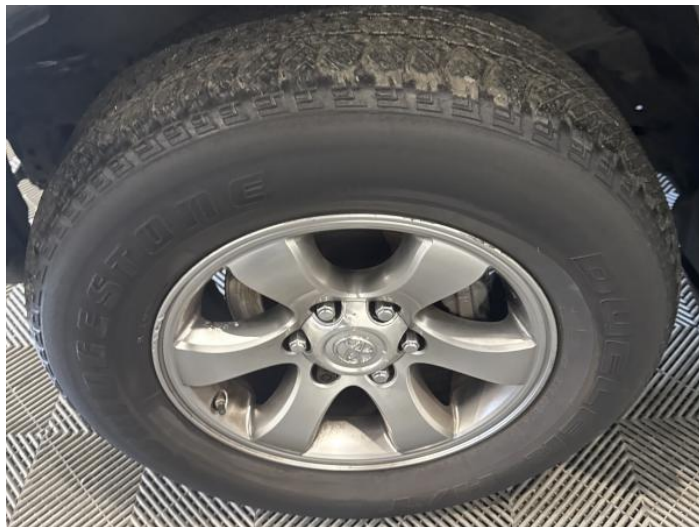
4: Wheel nsf
Scratched
Over 50mm

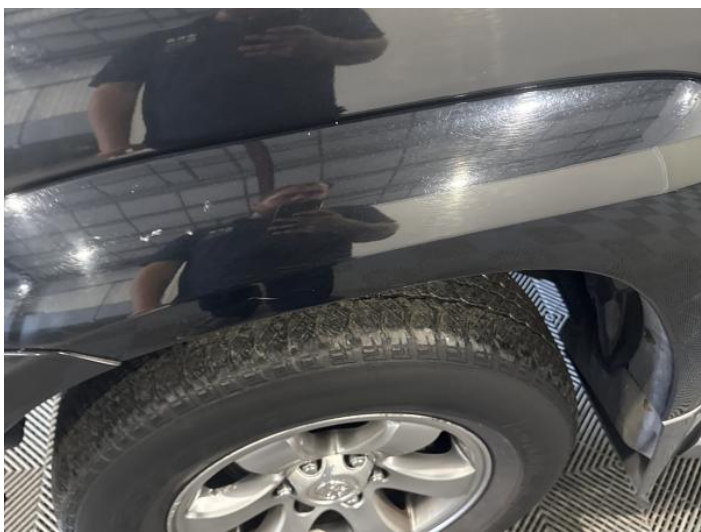
5: Wing nsf
Chipped
1 To 5

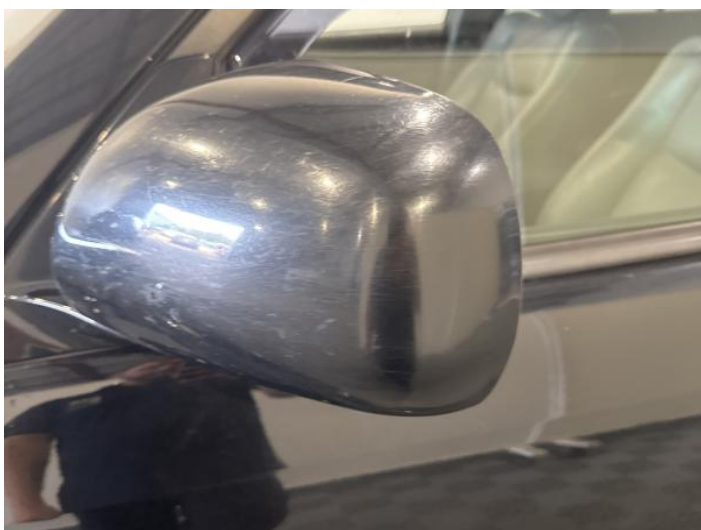
7: Door Mirror Assy nsf
Scratched (Painted)
Over 25mm Not Thru Paint

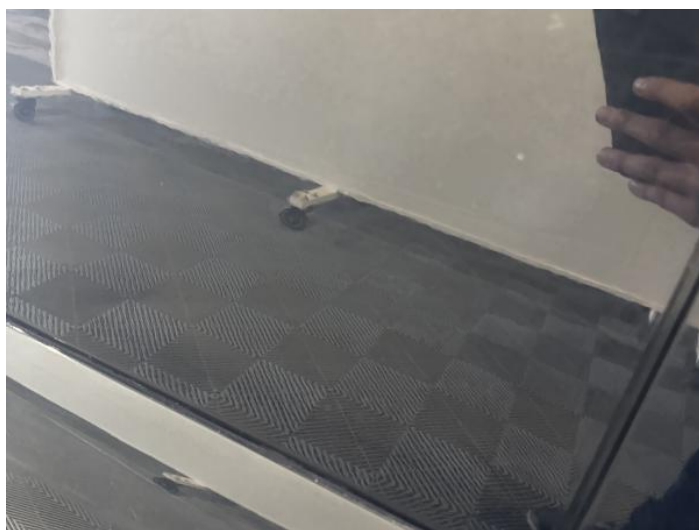
8: Door nsf
Chipped
1 To 5

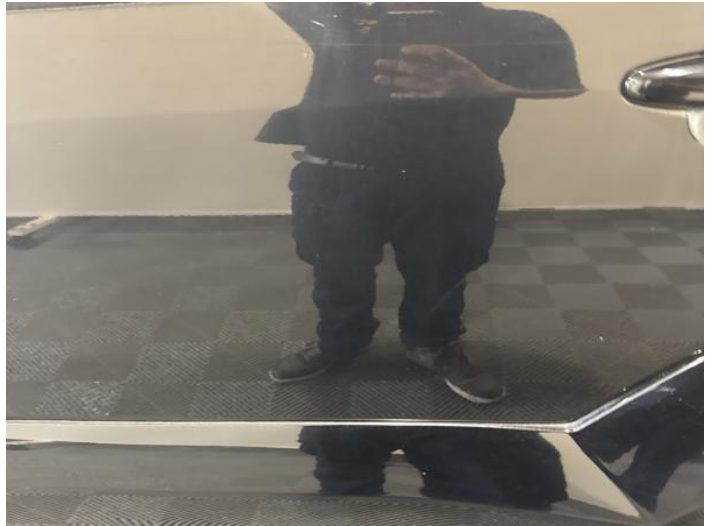
10: Door nsr
Chipped
1 To 5

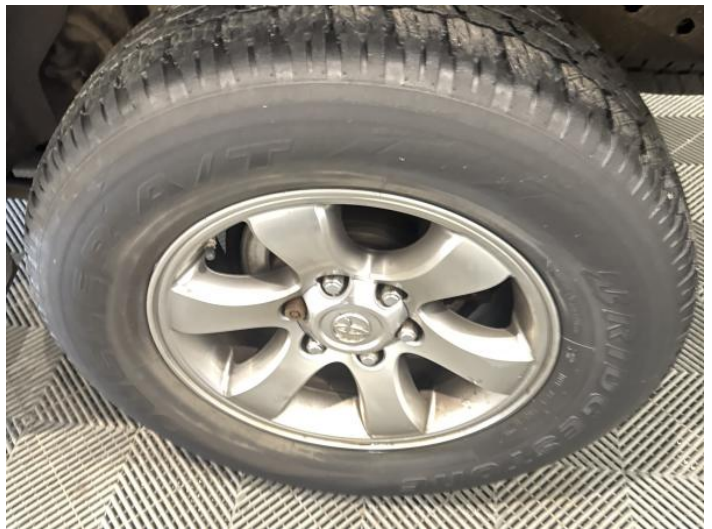
12: Wheel nsf
Scratched
Over 50mm

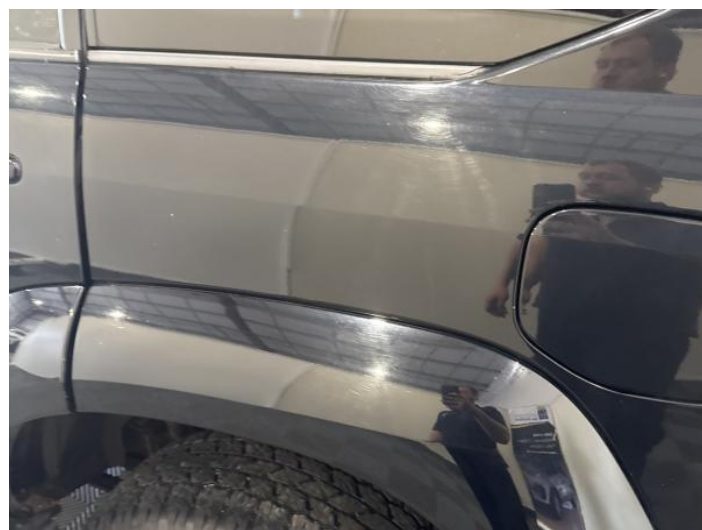
13: Qtr Panel nsr
Chipped
1 To 5

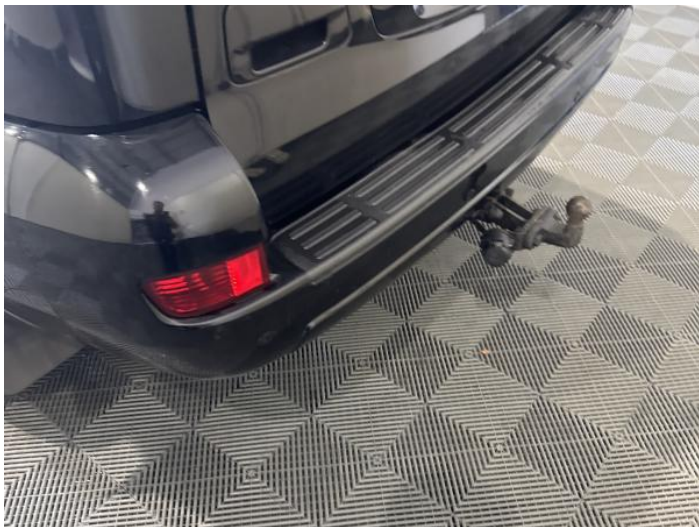
15: Bumper Rear
Scratched
Over 100mm Thru Paint

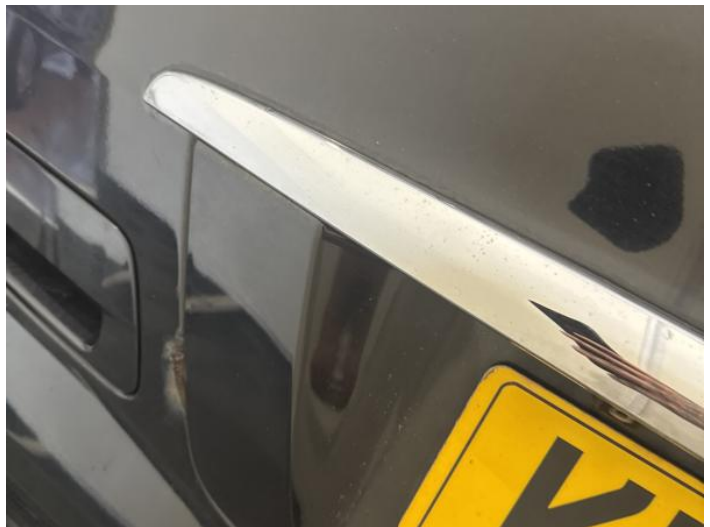
16: Boot Lid
Rusted
Over 5mm

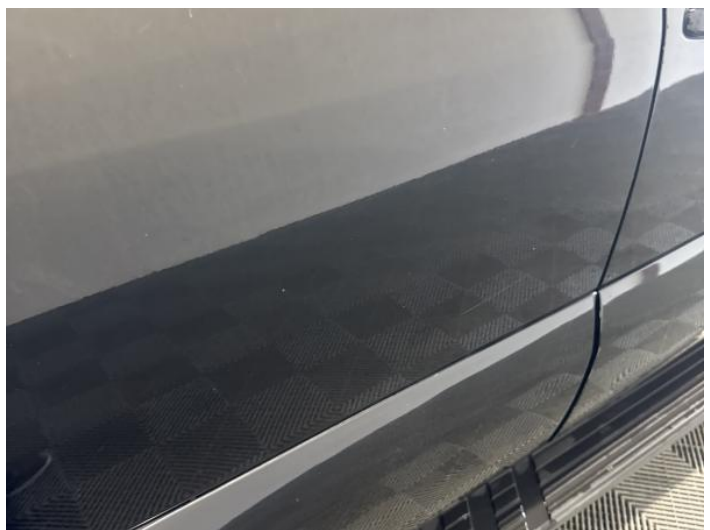
18: Door osr
Scratched
Over 25mm Thru Paint

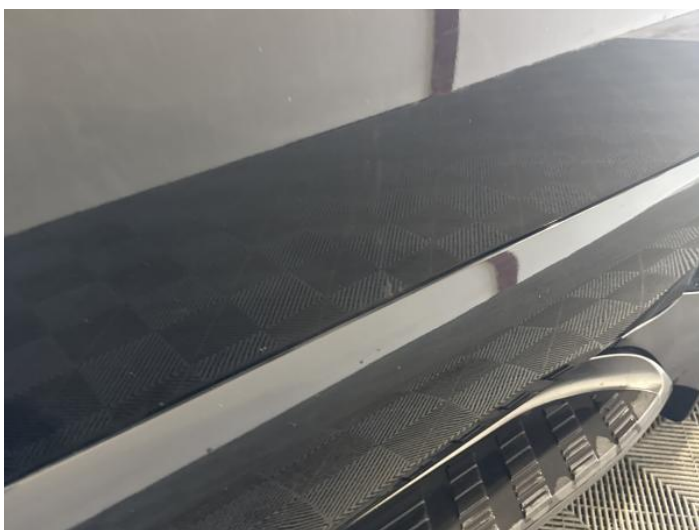
19: Door osf
Chipped
1 To 5

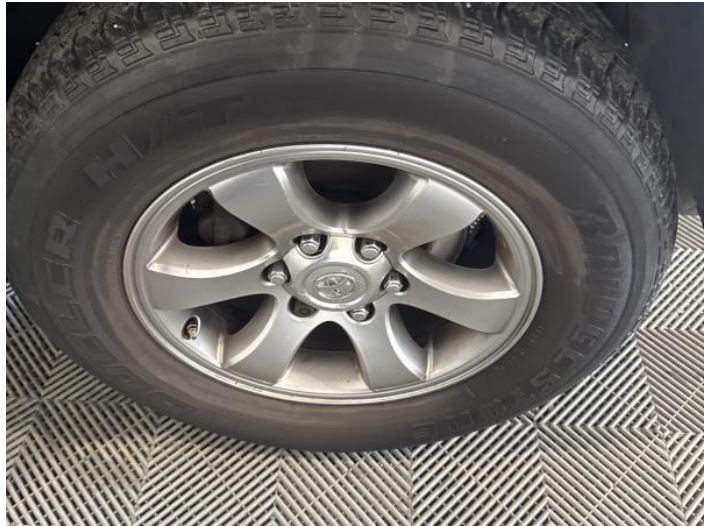
21: Wing osf
Scratched
Over 25mm Not Thru Paint
