# VEHICLE INSPECTION REPORT

**HV11SOU**

## Vauxhall Meriva 1.4i 16V SE 5dr

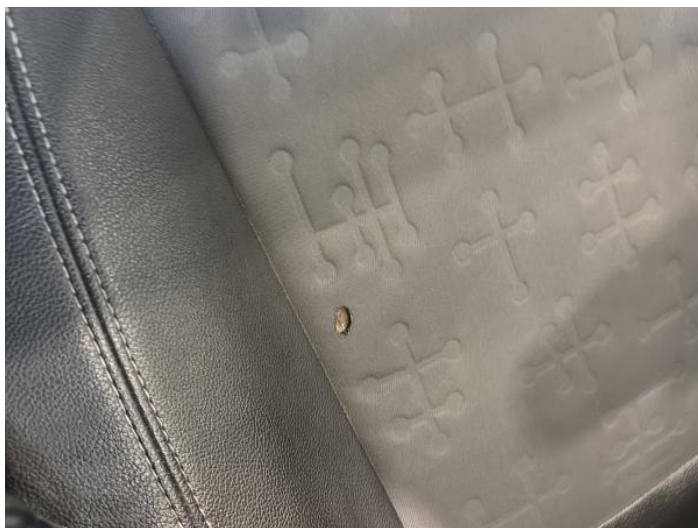
1: Seat Back Cover osf  
Burn  
Over 3mm

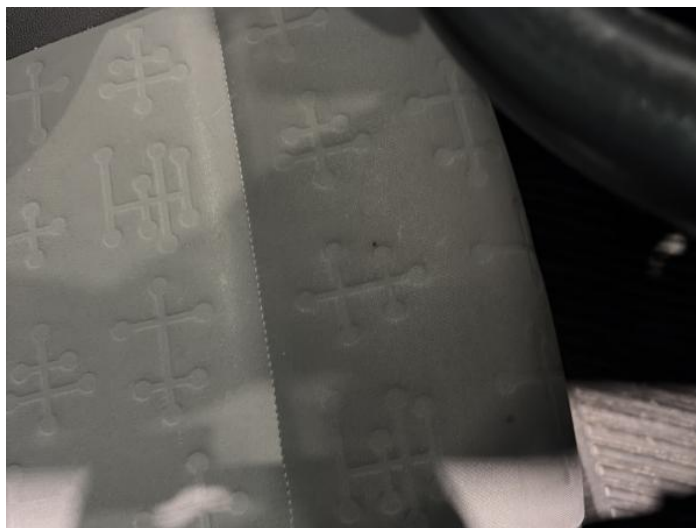
2: Seat Base Cover osf  
Burn  
UpTo 3mm

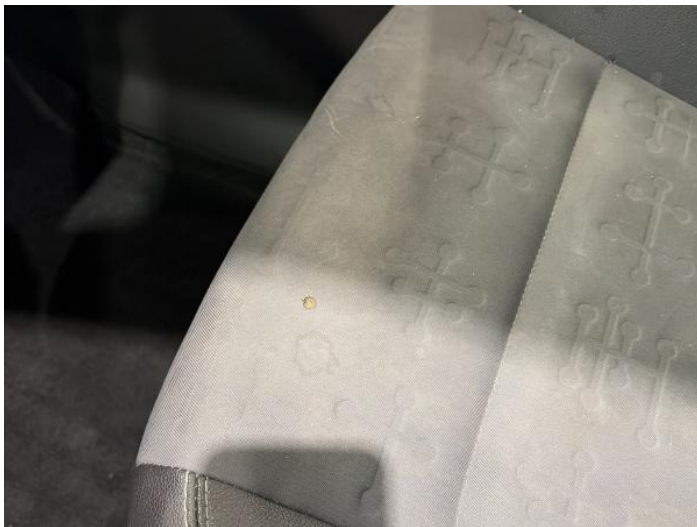
3: Seat Base Cover nsf  
Burn  
Over 3mm

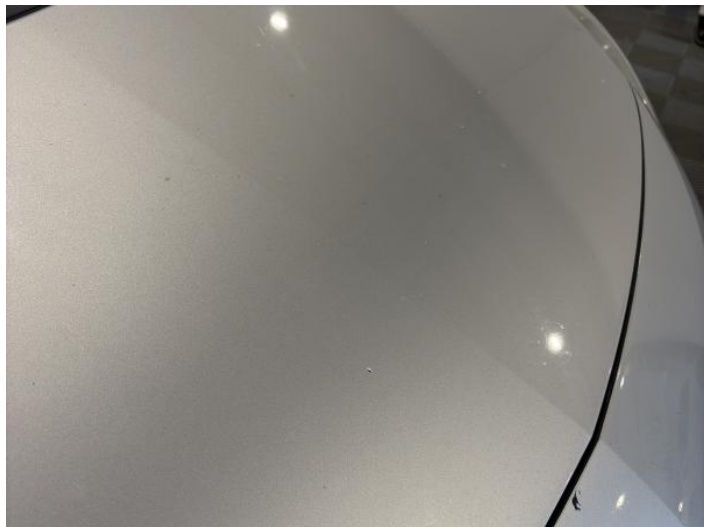
4: Bonnet  
Chipped  
Multiple Chips

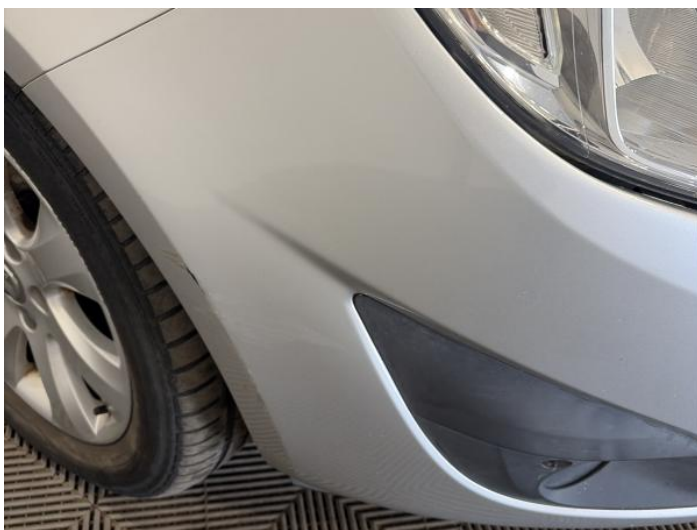
5: Bumper Front  
Scratched  
Over 100mm Thru Paint

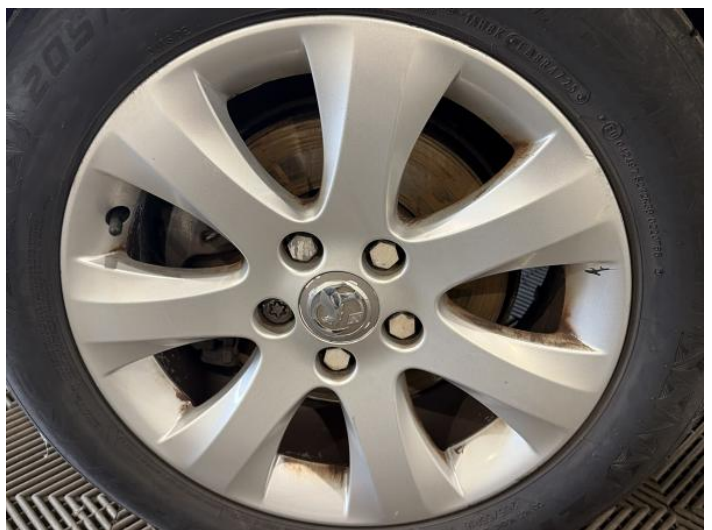
6: Wheel nsf  
Scratched  
Over 50mm

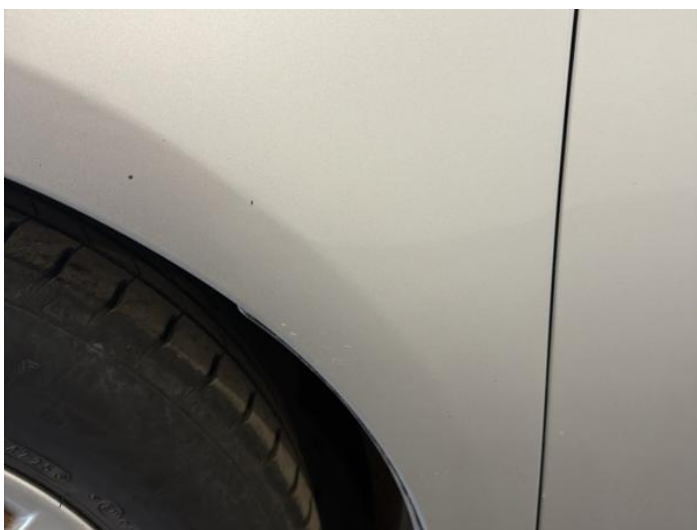
7: Wing nsf  
Chipped  
1 To 5

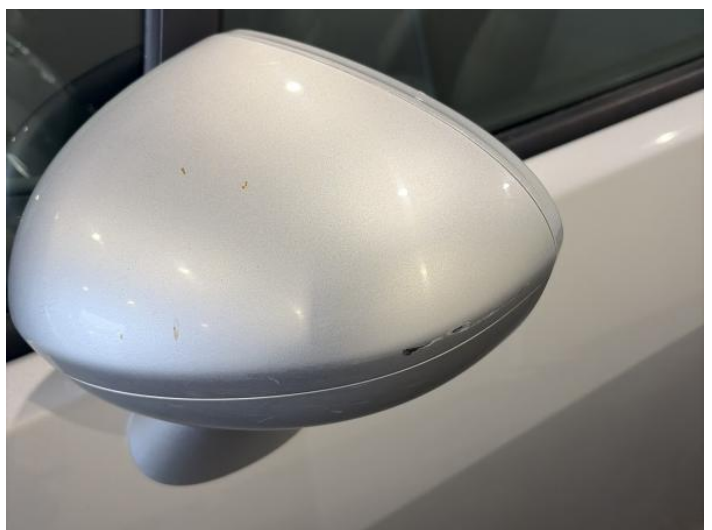
8: Door Mirror Assy nsf  
Scratched (Painted)  
Over 25mm Thru Paint

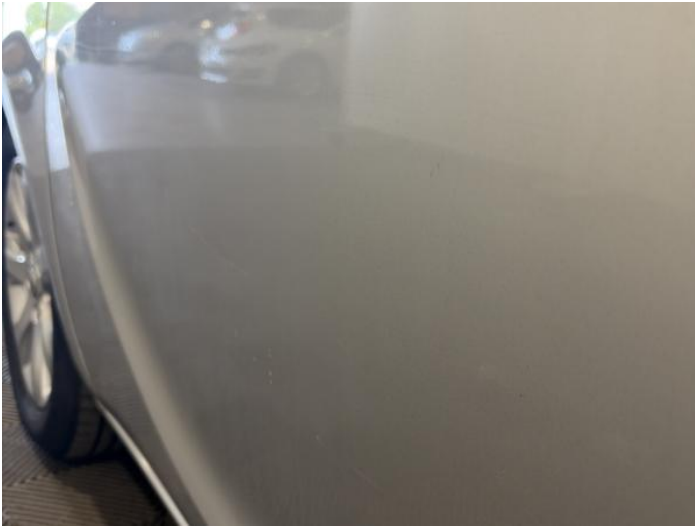
9: Door nsf  
Dented  
With Paint Damage

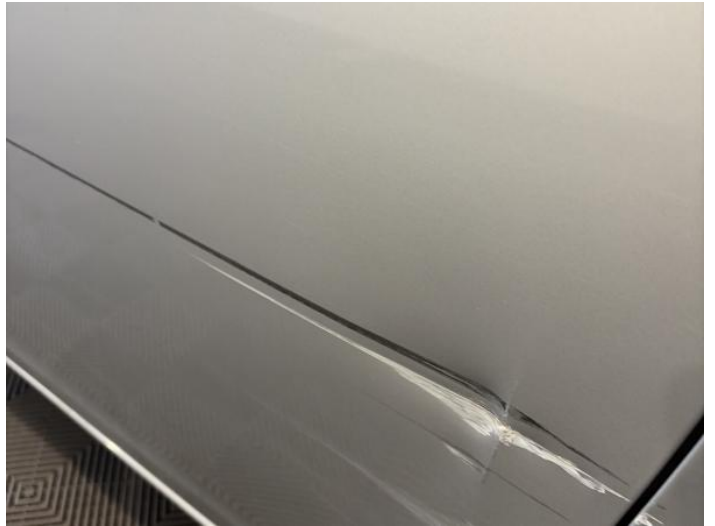
10: Door nsr  
Dented  
With Paint Damage

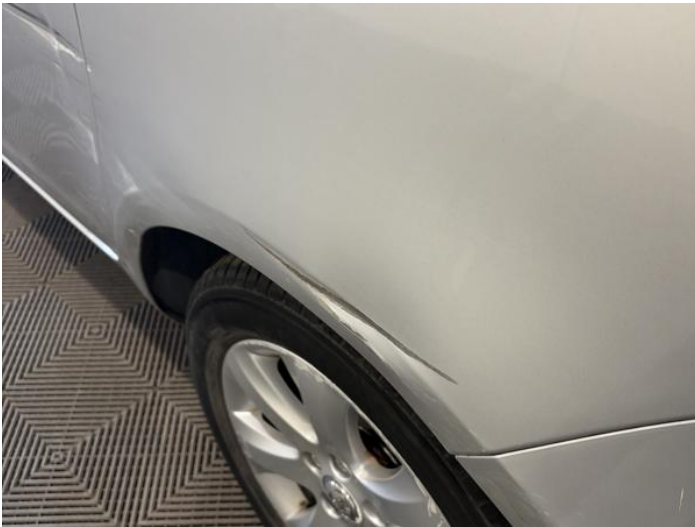
11: Qtr Panel nsr  
Dented  
With Paint Damage

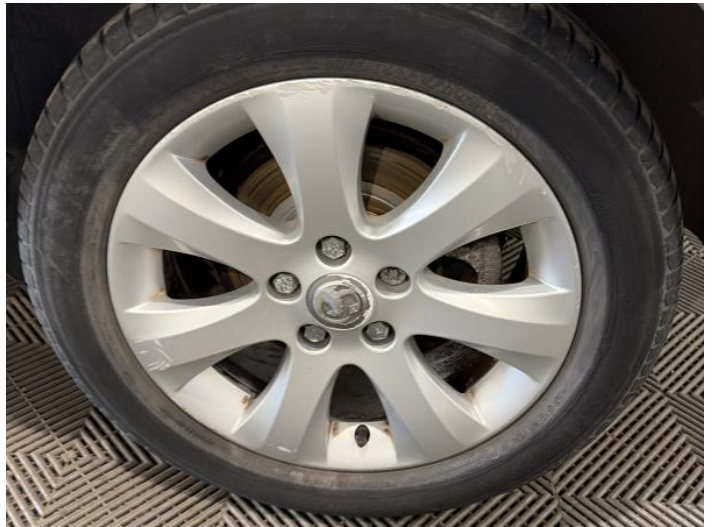
12: Wheel nsr  
Scratched  
Over 50mm

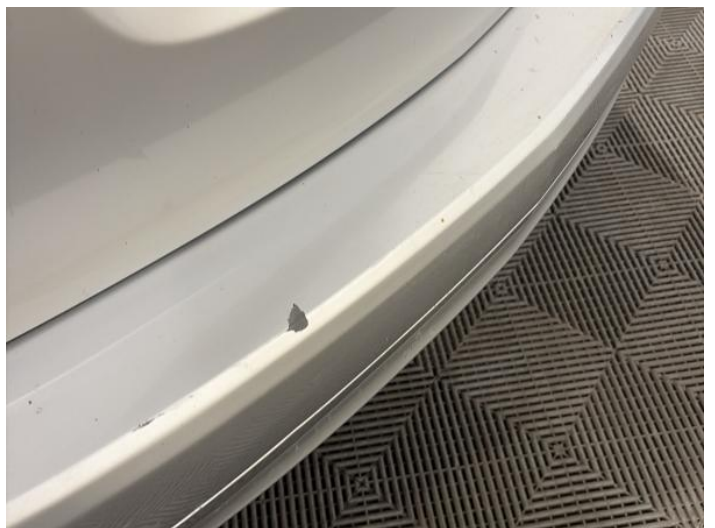
14: Bumper Rear  
Poor Previous Repair  
Paint Flake

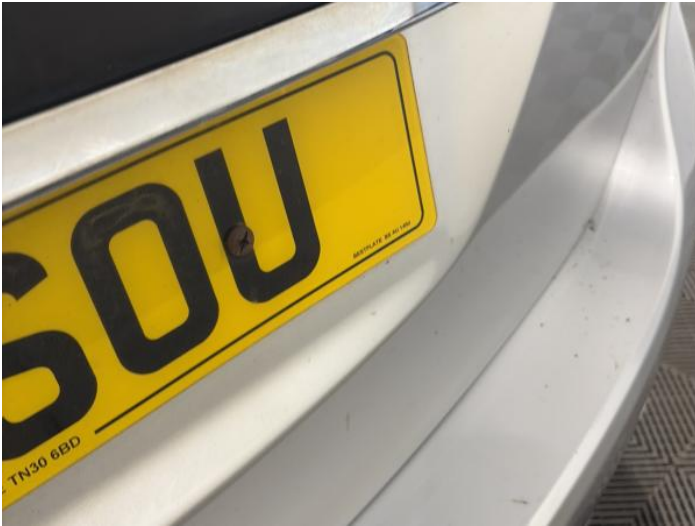
15: Tailgate  
Dented  
Between 10mm + 30mm

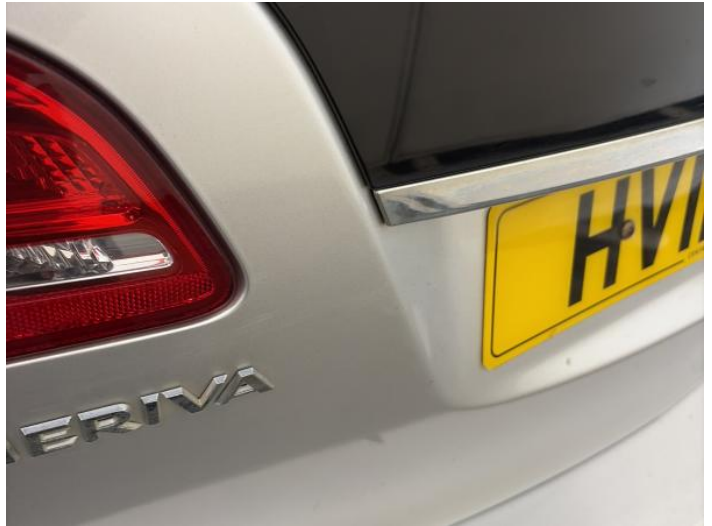
16: Tailgate  
Scratched  
Over 25mm Thru Paint

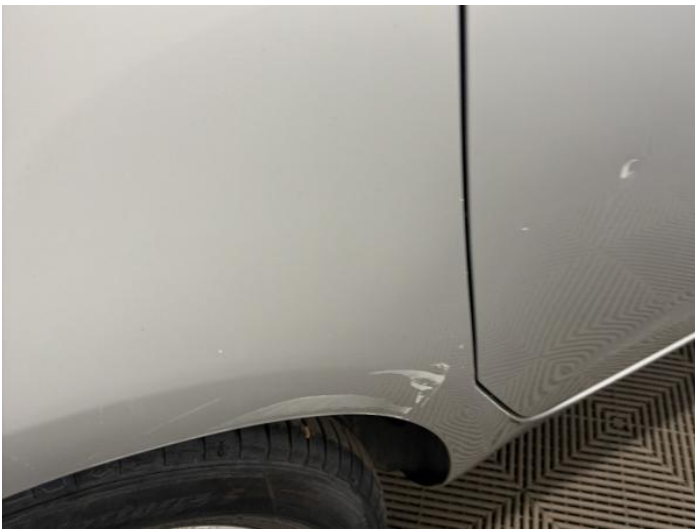
17: Qtr Panel osr  
Dented  
With Paint Damage

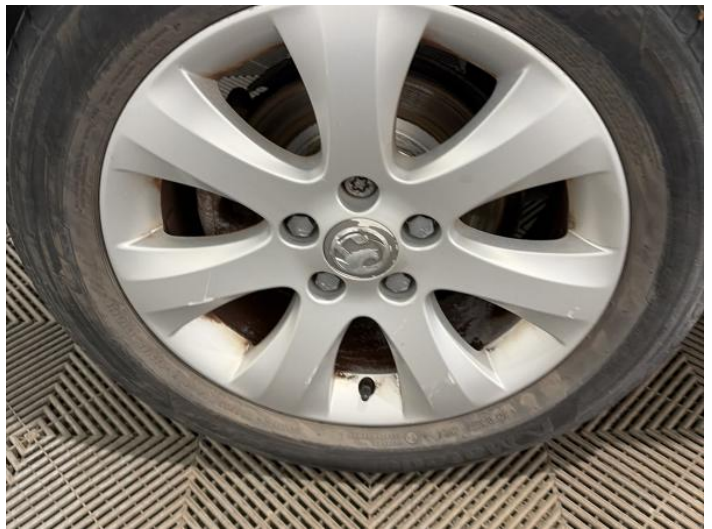
18: Wheel nsr  
Scratched  
Over 50mm

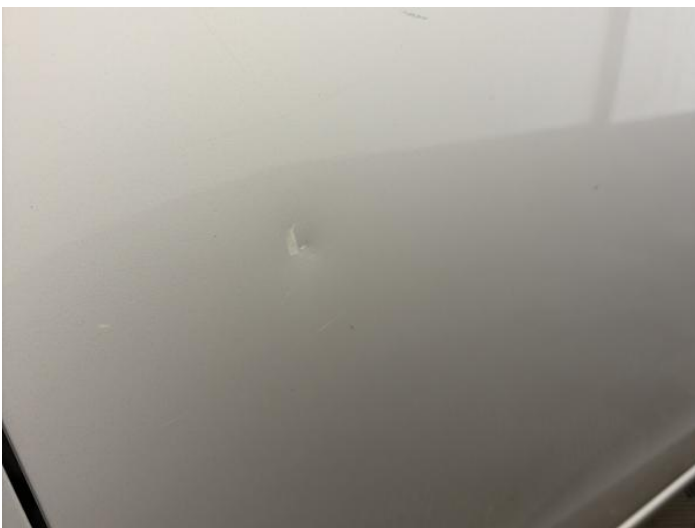
19: Door osr  
Dented  
With Paint Damage

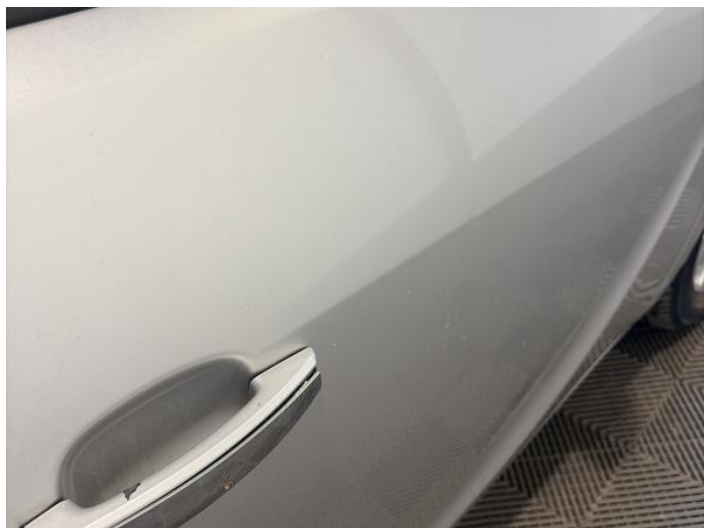
20: Door osf  
Dented  
With Paint Damage

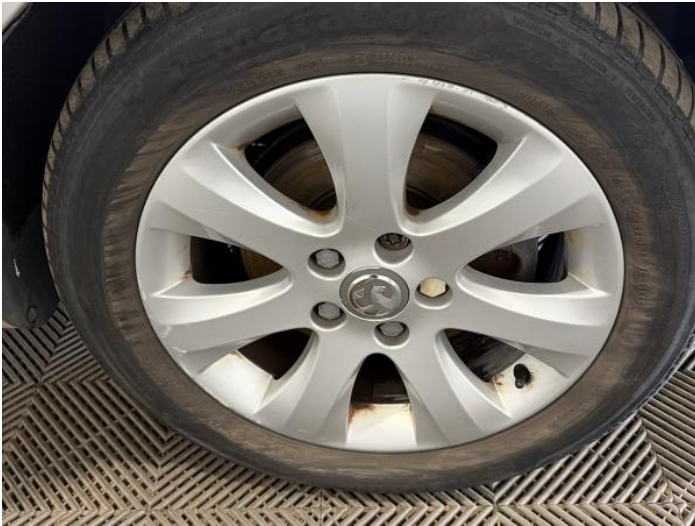
21: Wheel osf  
Scratched  
Over 50mm

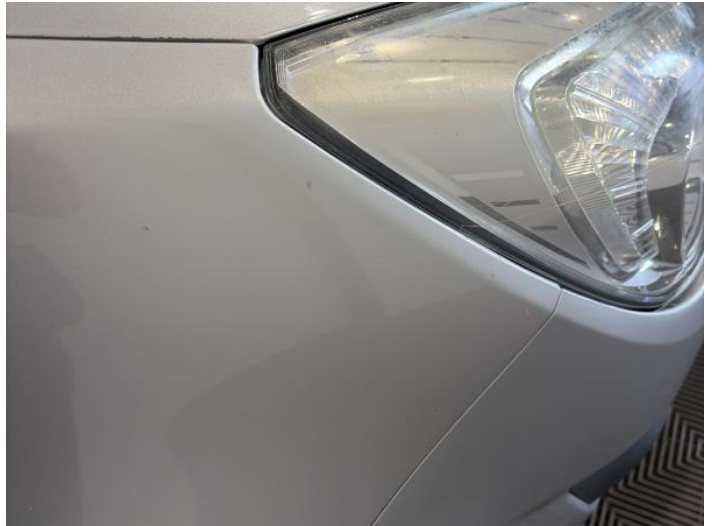
22: Wing osf  
Chipped  
1 To 5

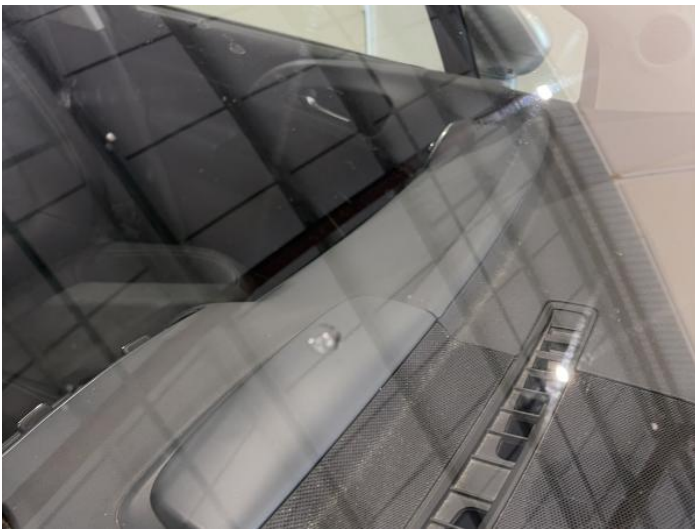
23: Screen Front  
Chipped  
Over 10mm

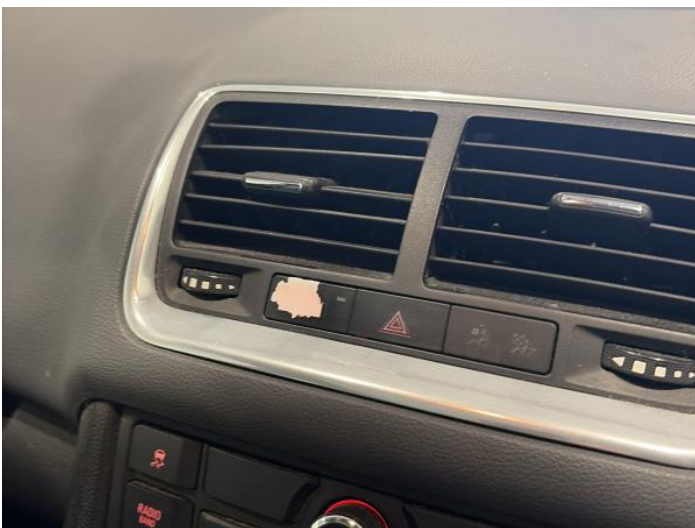
25: Switches And Controls  
Broken  
Replace

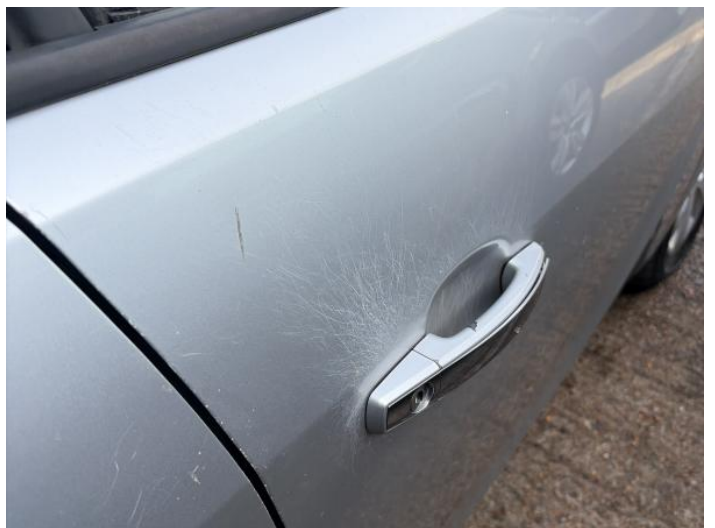
26: Door osf  
Scratched  
Over 25mm Thru Paint

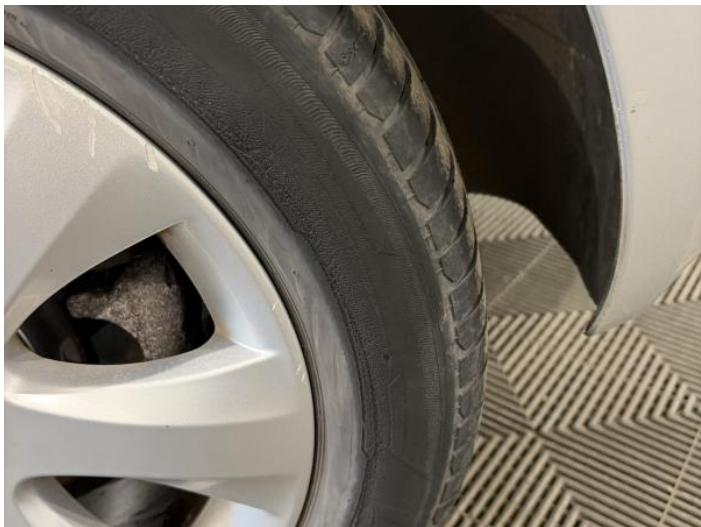
| NSR | MATADOR | Damaged |

27: Tyre nsr  
Damaged  
Replace
