# VEHICLE INSPECTION REPORT

**BU63UFL**

## Volkswagen Golf 1.6 TDI 105 SE 5dr

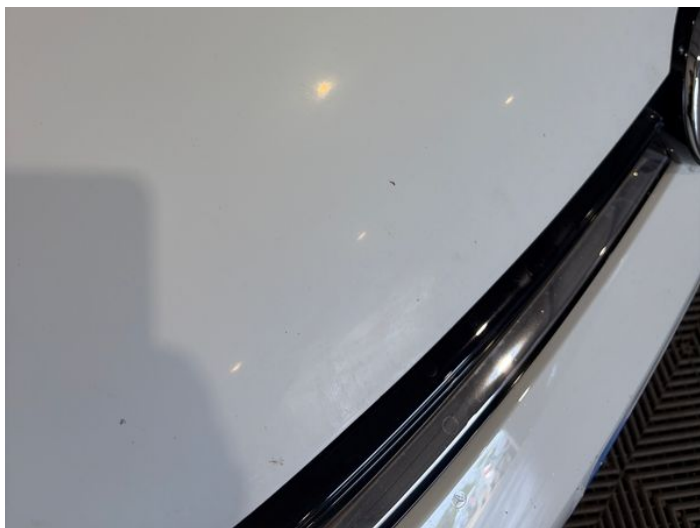
1: Bonnet  
Chipped  
Multiple Chips

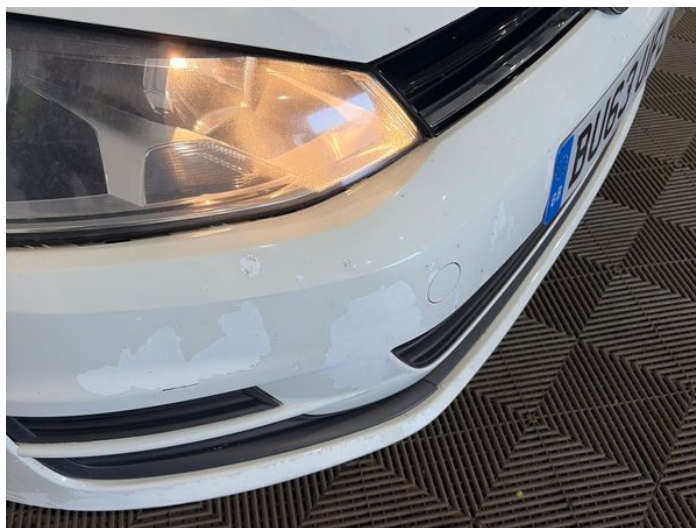
2: Bumper Front  
Poor Previous Repair  
Paint Flake

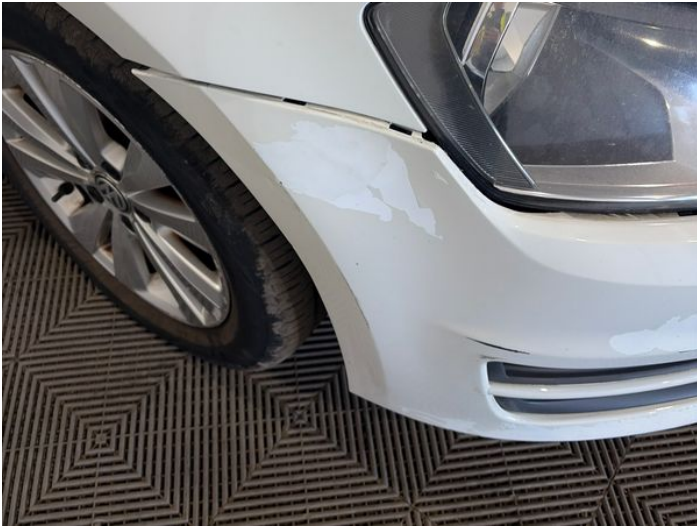
3: Bumper Front  
Insecure  
Action Required

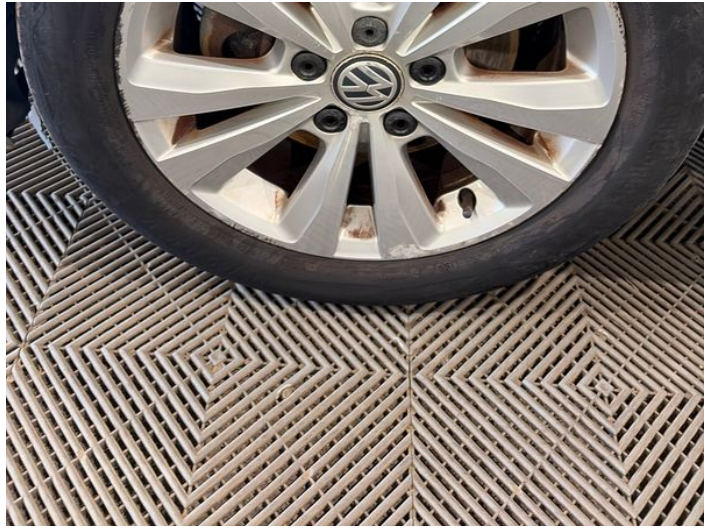
4: Wheel nsf  
Scratched  
Over 50mm

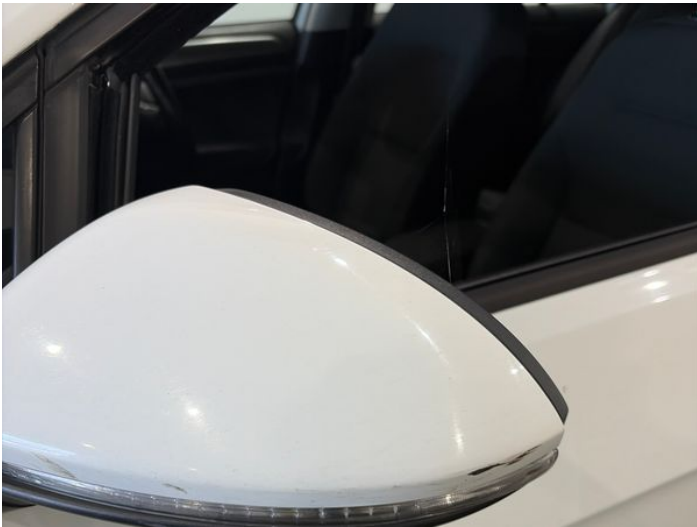
5: Door Mirror Assy nsf  
Scratched (Painted)  
Over 25mm Thru Paint

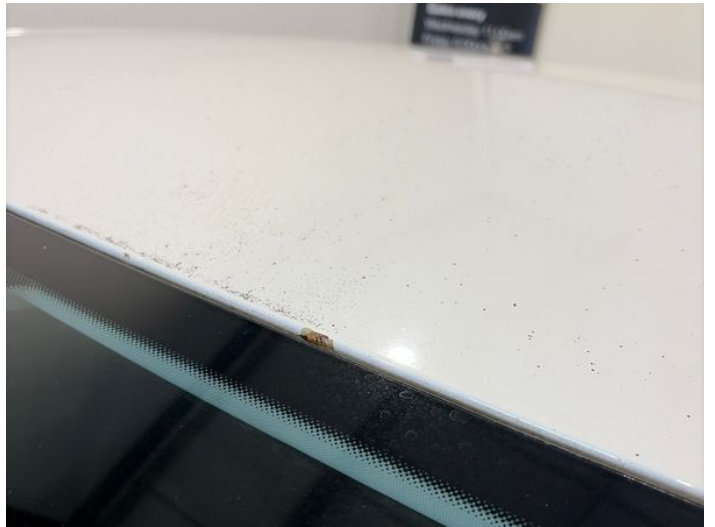
6: Roof  
Chipped  
Over 5mm

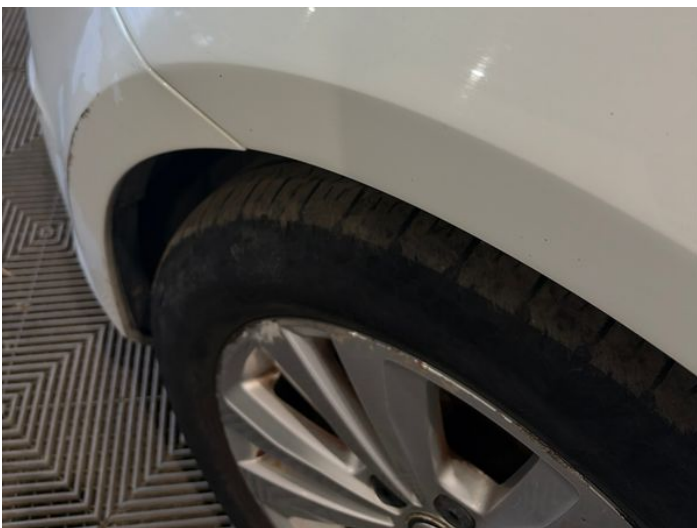
7: Wing nsf  
Chipped  
1 To 5

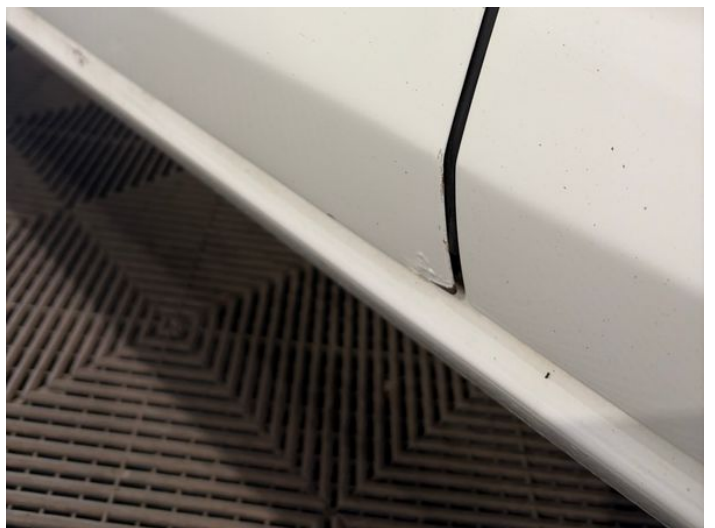
8: Door nsf  
Rusted  
Over 5mm

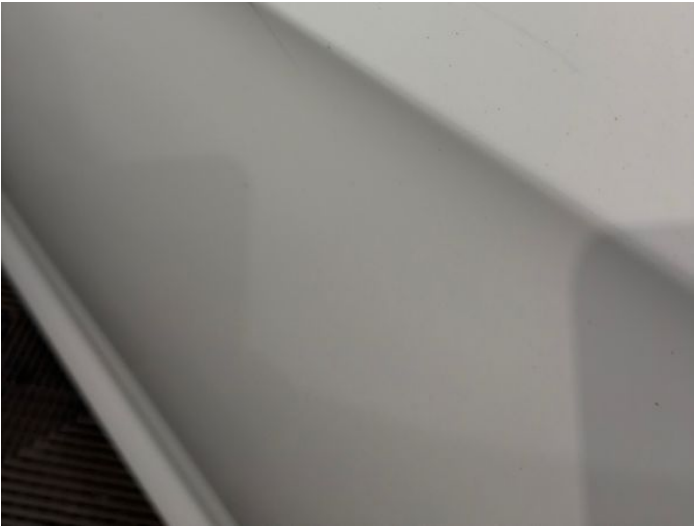
9: Door nsr  
Chipped  
1 To 5

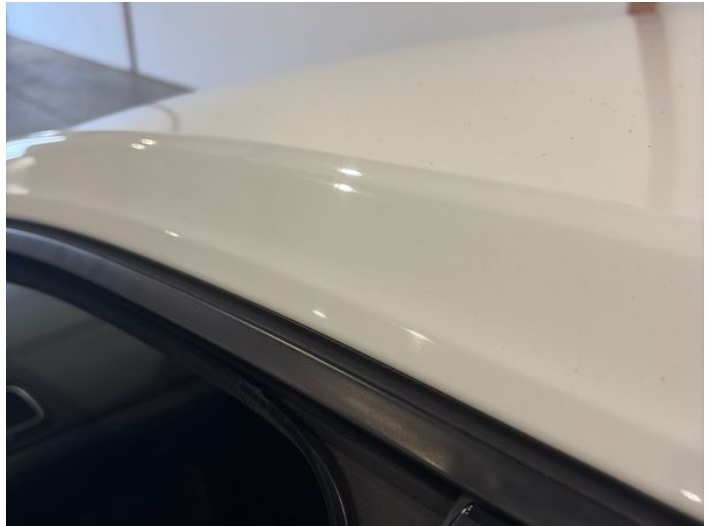
10: A Post ns  
Poor Previous Repair  
Poor Paint

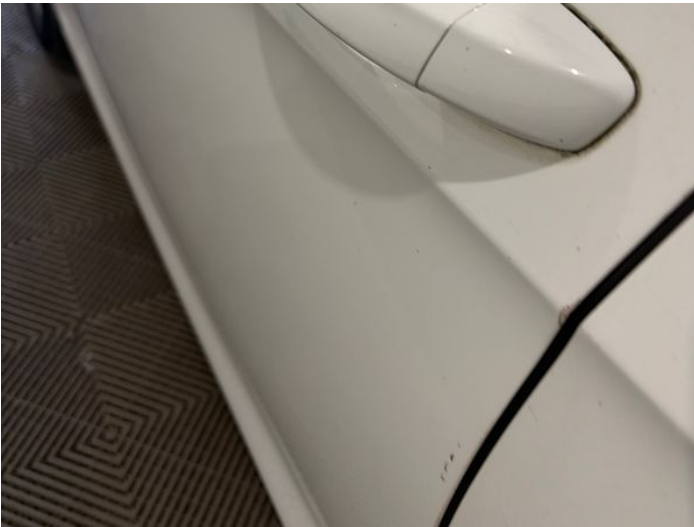
11: Door nsf  
Poor Previous Repair  
Rippled UpTo 30%

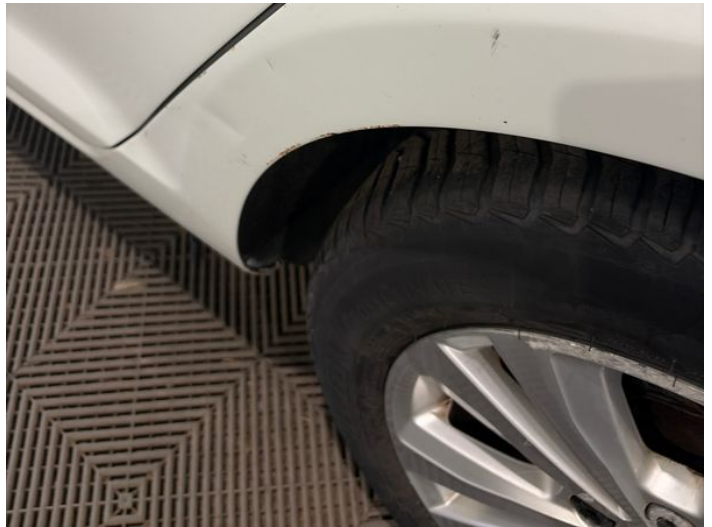
12: Qtr Panel nsr  
Dented  
With Paint Damage

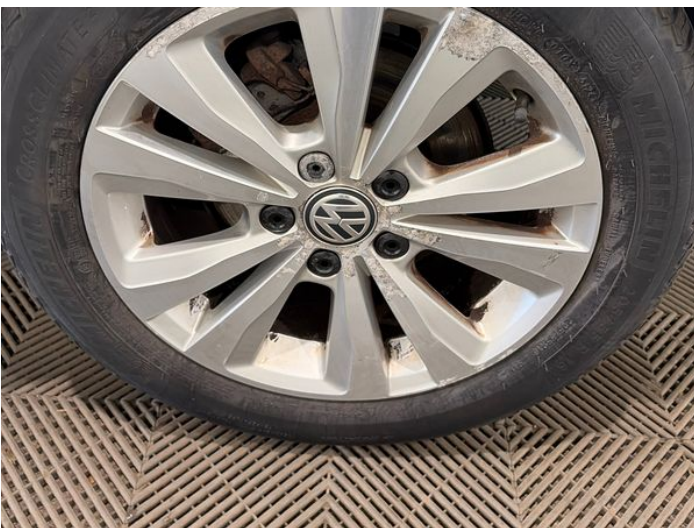
13: Wheel nsr  
Scratched  
Over 50mm

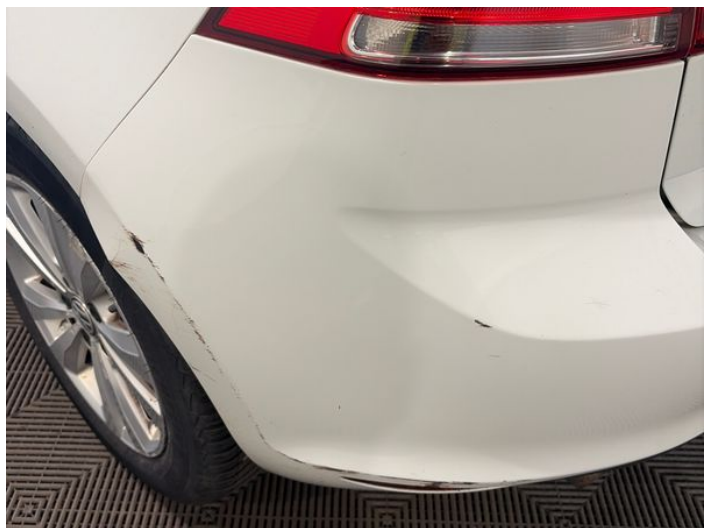
14: Bumper Rear  
Dented  
With Paint Damage

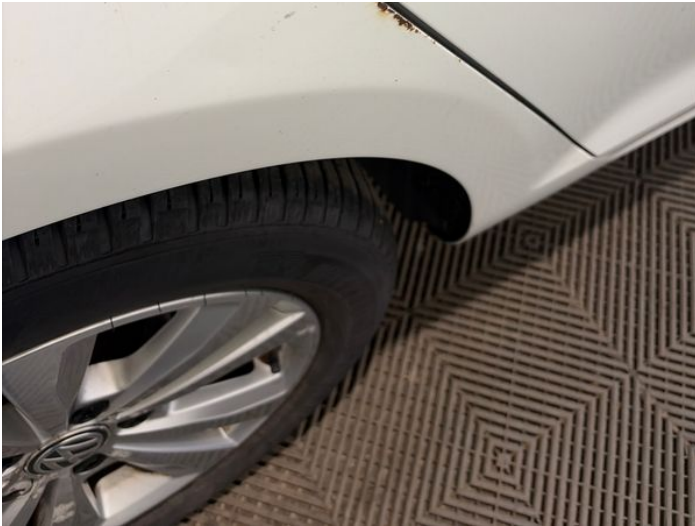
15: Qtr Panel osr  
Dented  
With Paint Damage

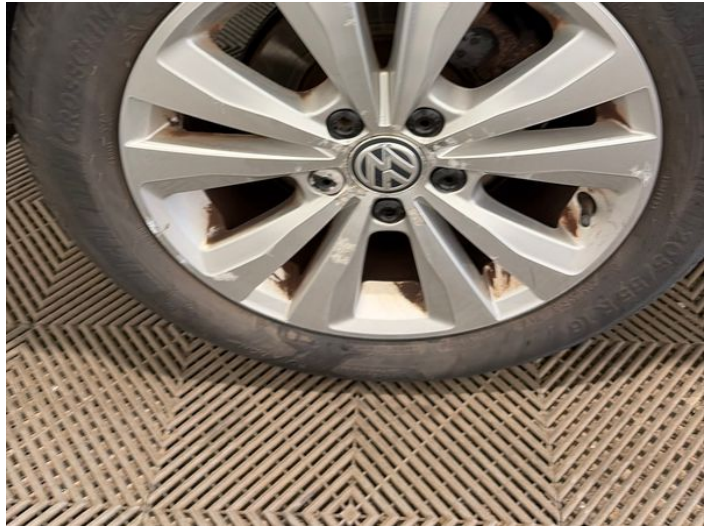
16: Wheel osr  
Scratched  
Over 50mm

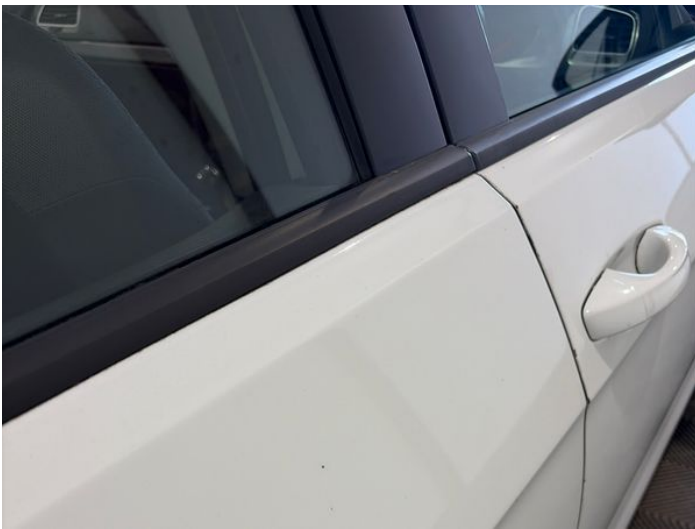
17: Door osr  
Dented  
Between 10mm + 30mm

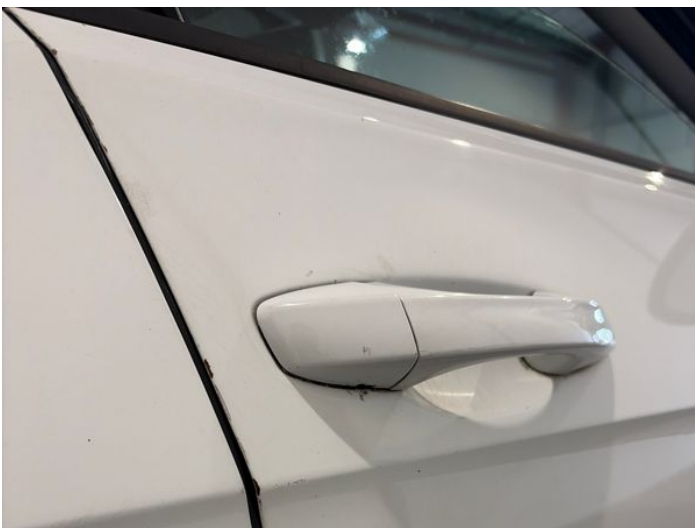
19: Door osf  
Scratched  
Rusted

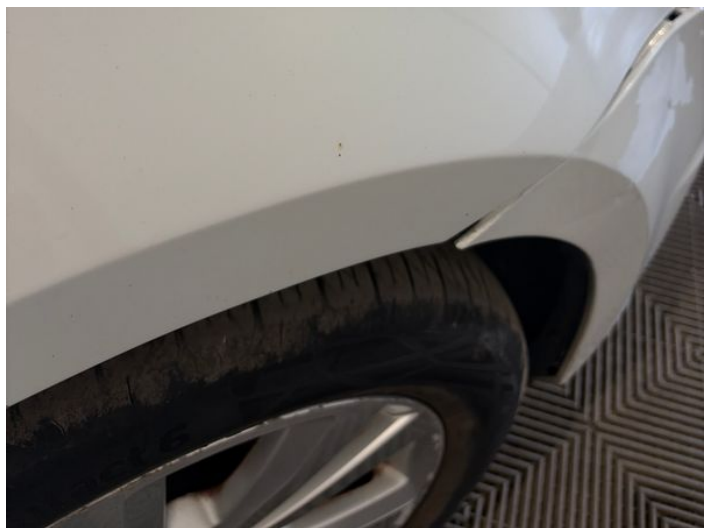
20: Wing osf  
Chipped  
1 To 5

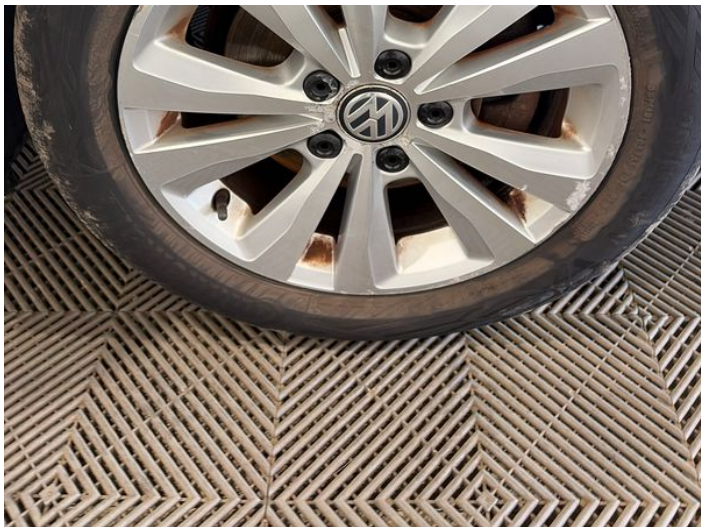
21: Wheel of  
Scratched  
Over 50mm
