## VEHICLE INSPECTION REPORT

**DX63ONM**

### Toyota Prius+ 1.8 VVTi T4 5dr CVT Auto

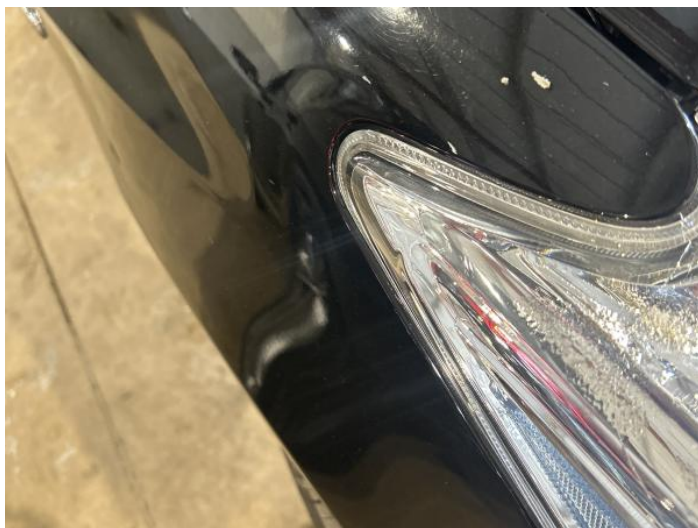
1: Wing of  
Chipped  
1 To 5

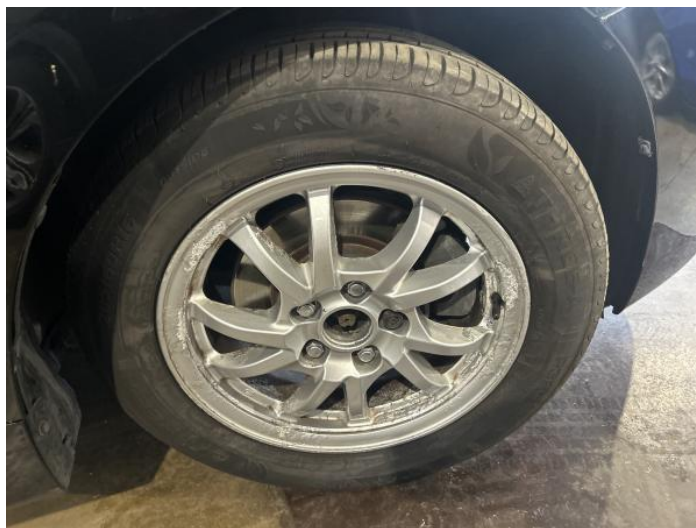
2: Wheel of  
Corroded  
Light

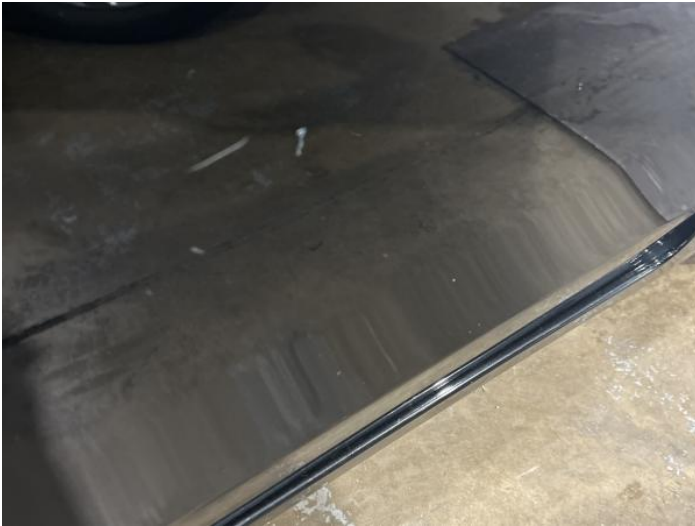
3: Door osf  
Scratched  
UpTo 25mm Thru Paint

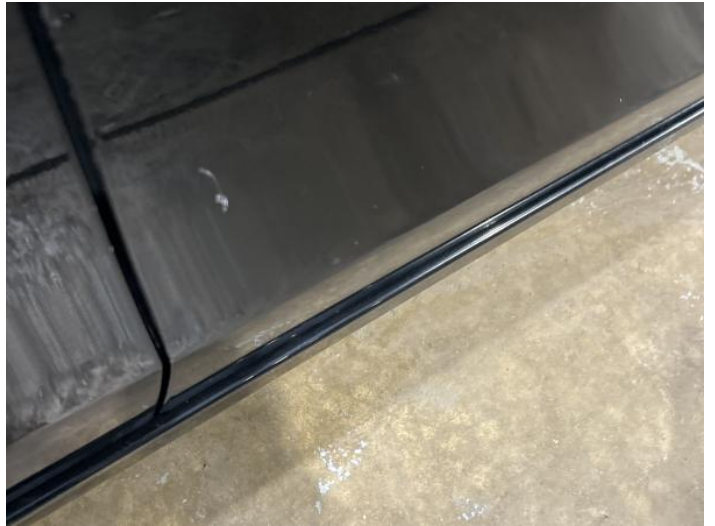
4: Door osf  
Chipped  
1 To 5

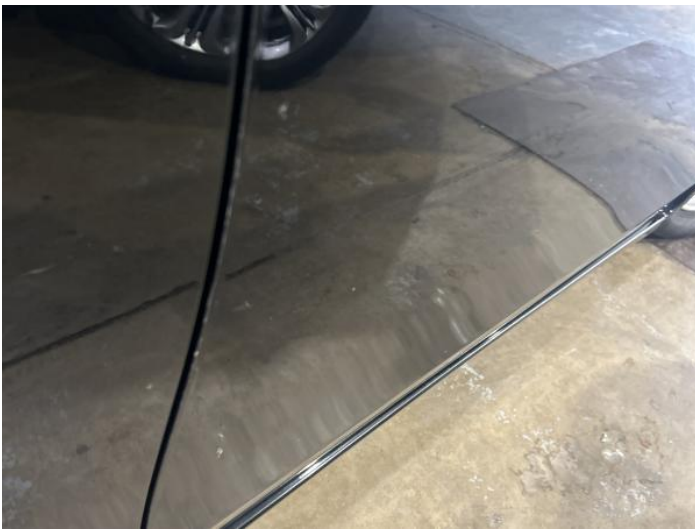
5: Door osf  
Chipped  
Edge Chip

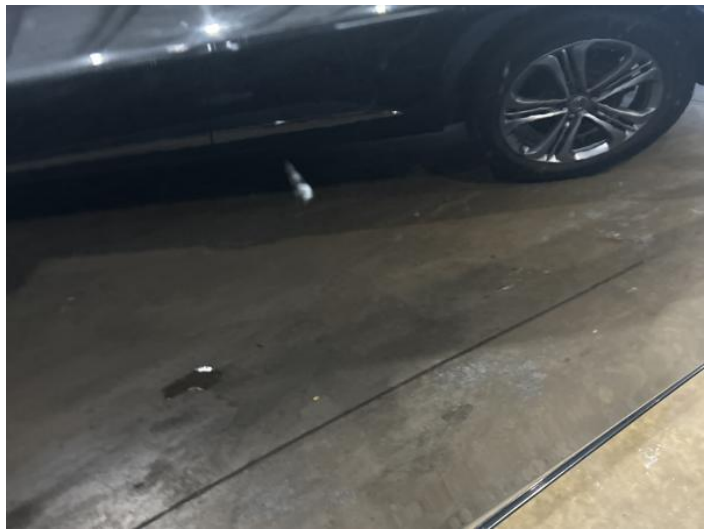
6: Door osr  
Chipped  
1 To 5

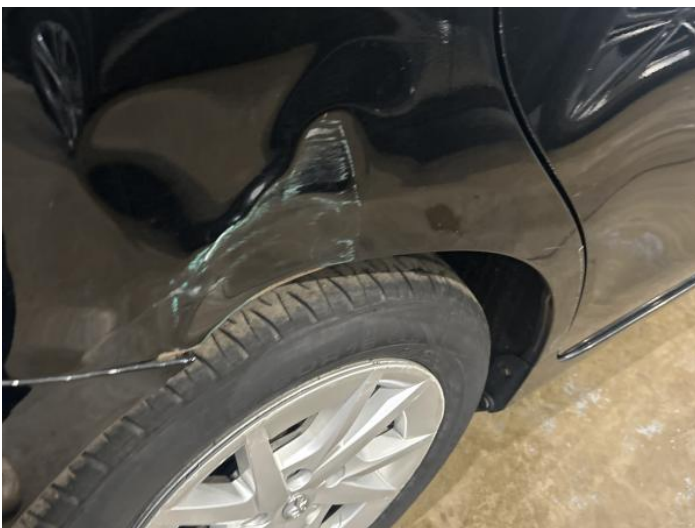
7: Qtr Panel osr  
Dented  
With Paint Damage

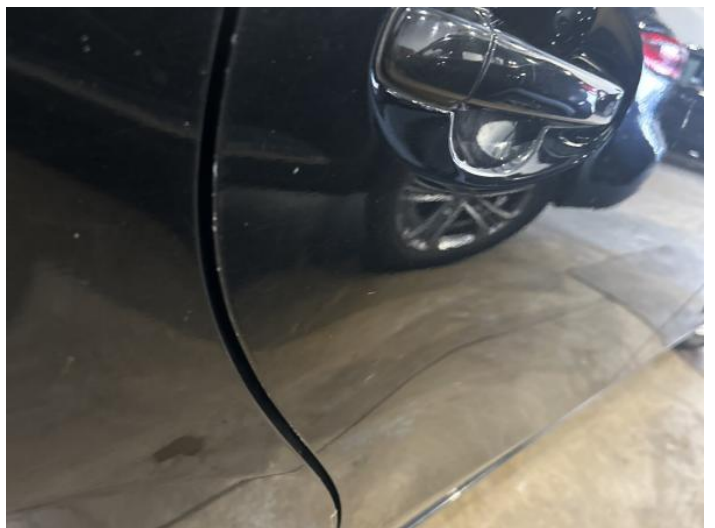
8: Door osr  
Chipped  
Edge Chip

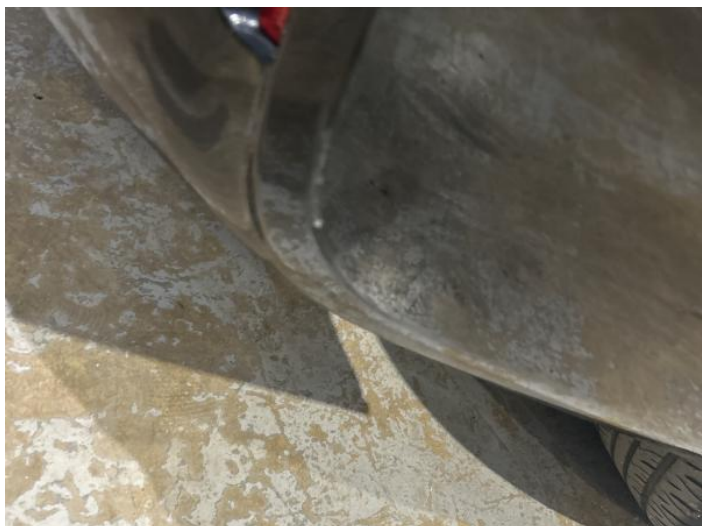
9: Bumper Rear  
Scratched  
Up To 25mm Thru Paint

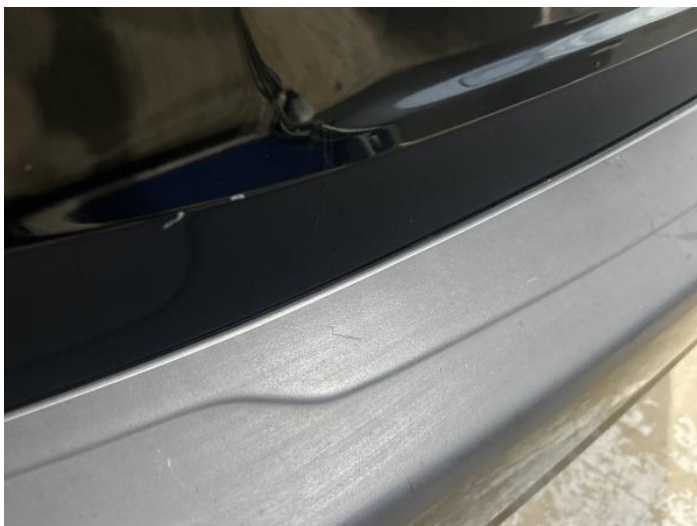
10: Tailgate  
Chipped  
1 To 5

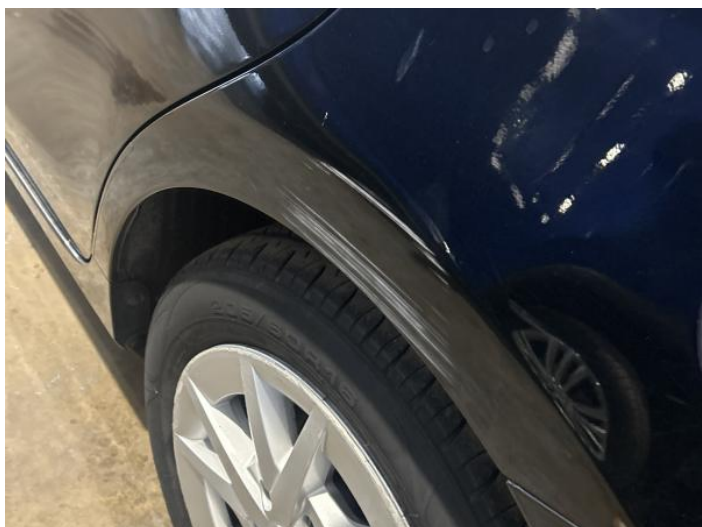
11: Qtr Panel nsr  
Scratched  
Over 25mm Thru Paint

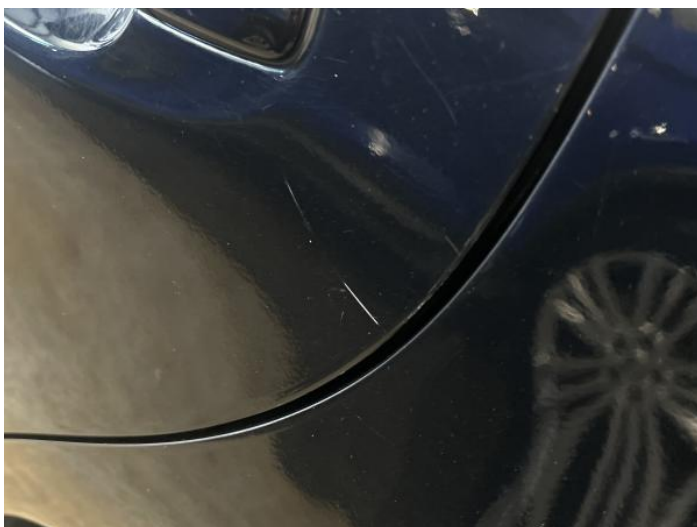
12: Door nsr  
Scratched  
UpTo 25mm Thru Paint

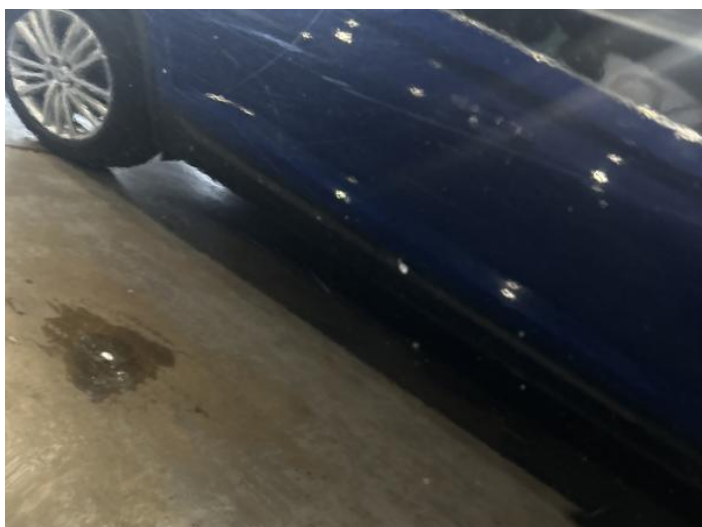
13: Door nsr  
Chipped  
1 To 5

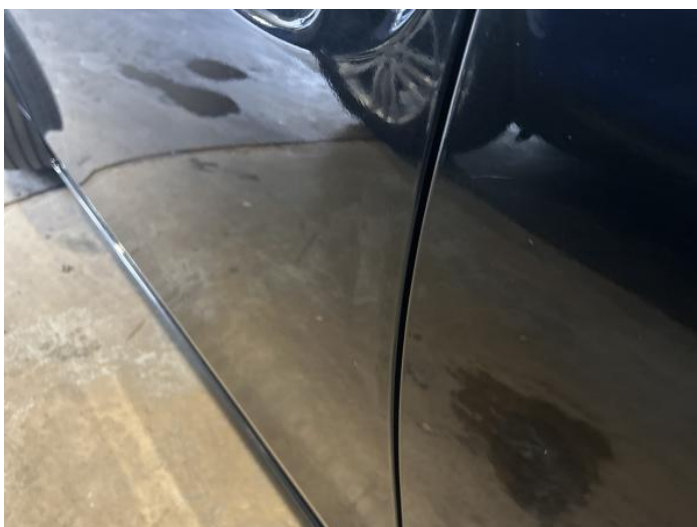
14: Door nsf  
Dented  
Over 30mm

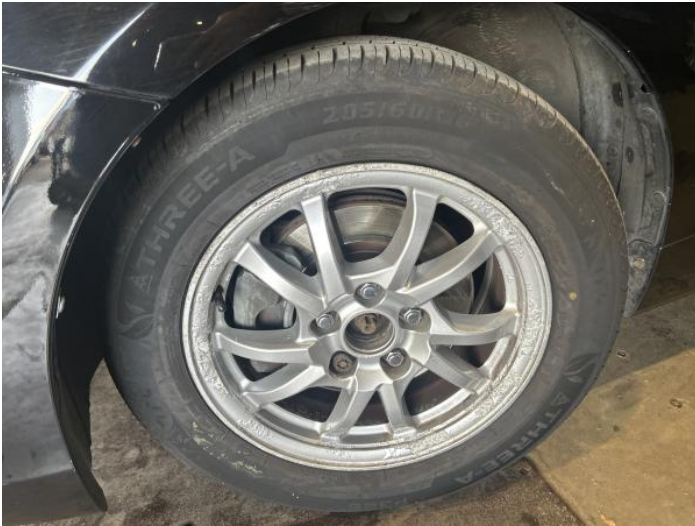
15: Wheel nsf  
Corroded  
Light

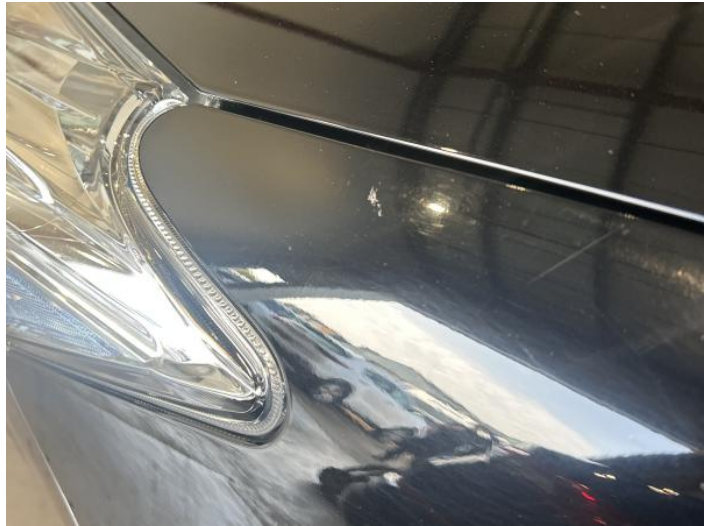
16: Wing nsf  
Chipped  
1 To 5

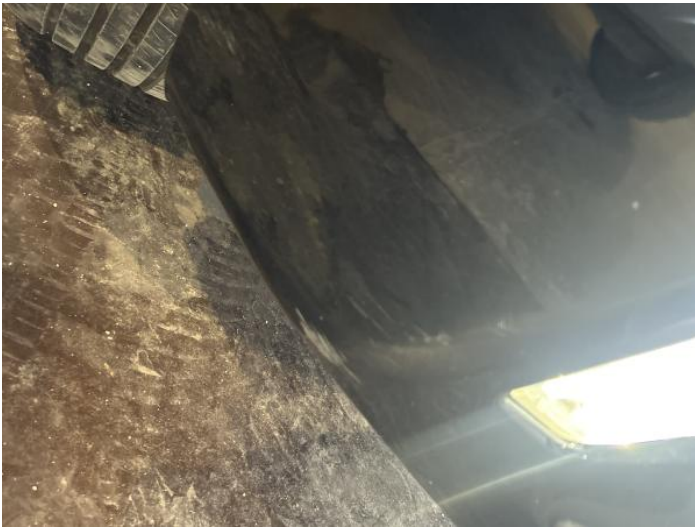
17: Bumper Front  
Scratched  
25 to 100mm Thru Paint

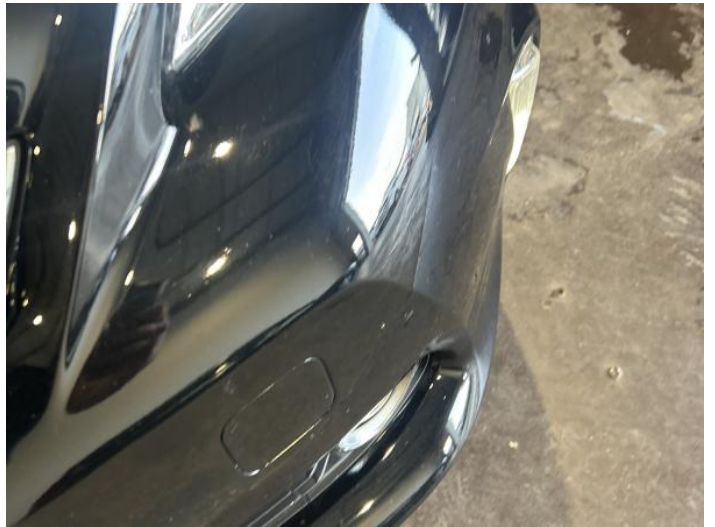
18: Bumper Front  
Chipped  
Multiple Chips

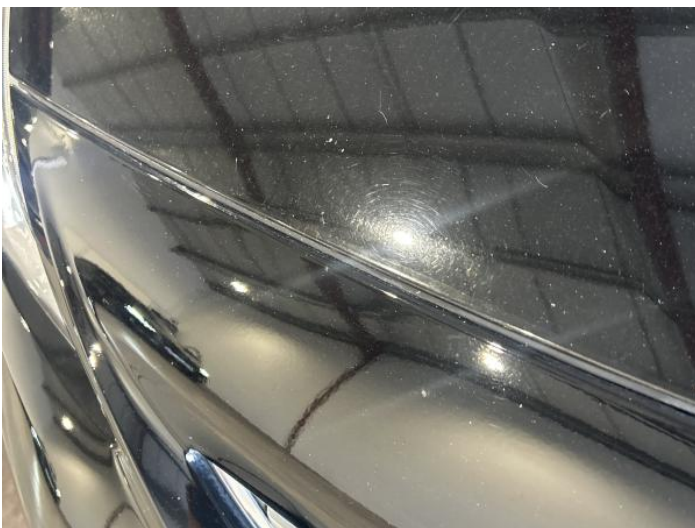
19: Bonnet  
Chipped  
1 To 5

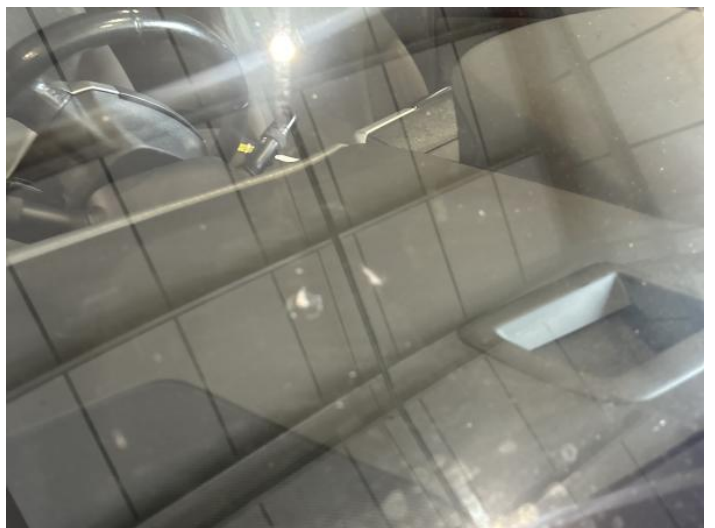
20: Screen Front  
Chipped  
Over 10mm

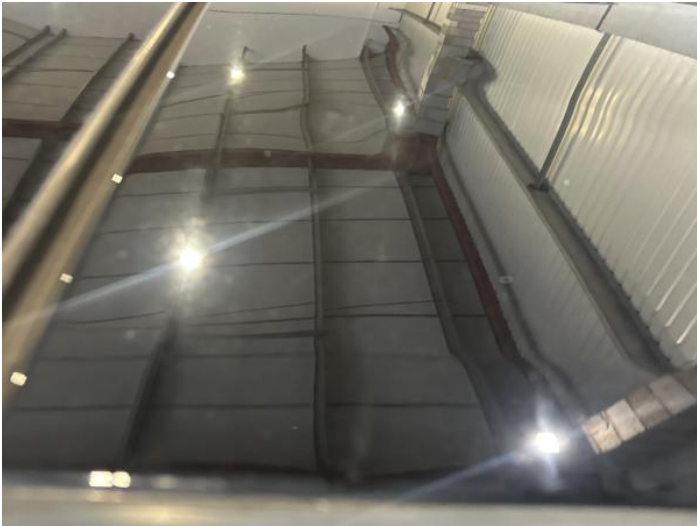
21: Roof  
Dented  
Over 30mm

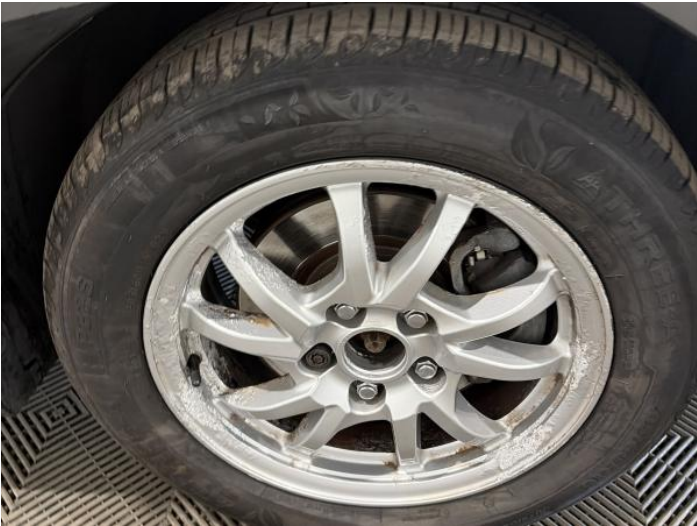
22: Wheel Trim osf  
Missing  
Replace

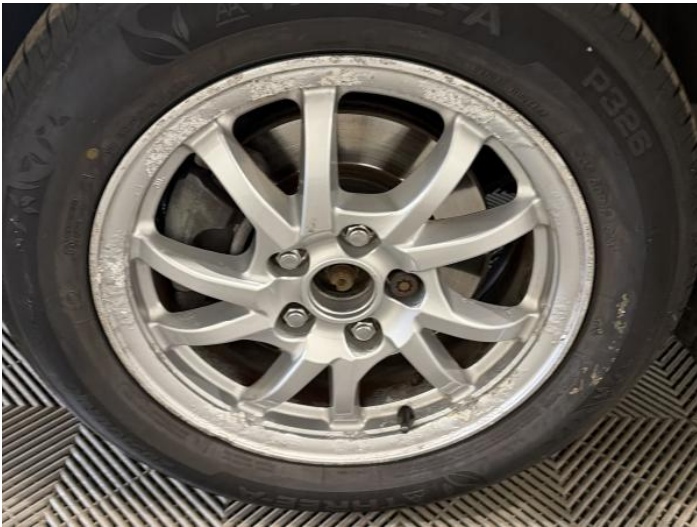
23: Wheel Trim nsf  
Missing  
Replace
