## VEHICLE INSPECTION REPORT

**LT59RZJ**

### Land Rover Discovery 3.0 TDV6 XS 5dr Auto

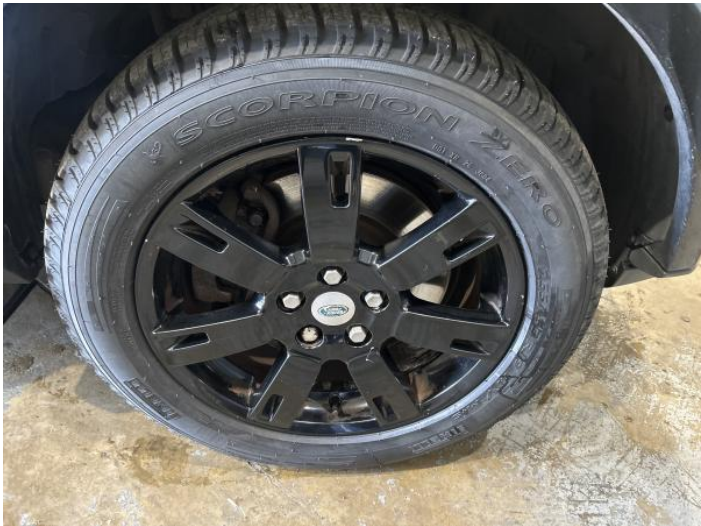
2: Wheel osf  
Scratched  
Up To 50mm

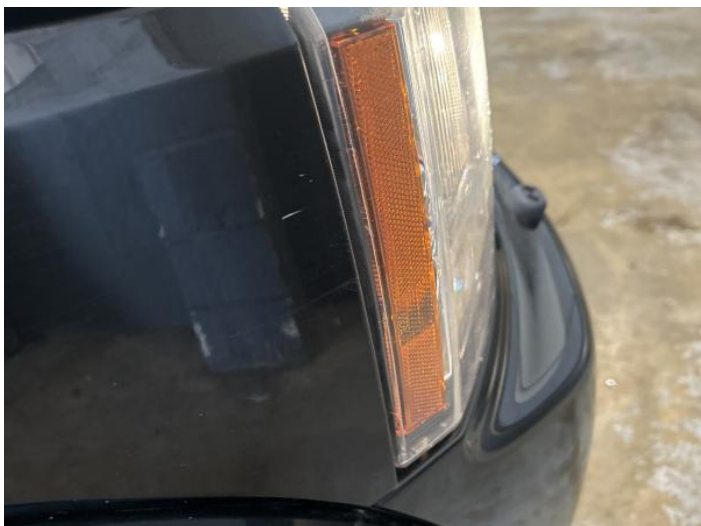
3: Wing osf  
Chipped  
1 To 5

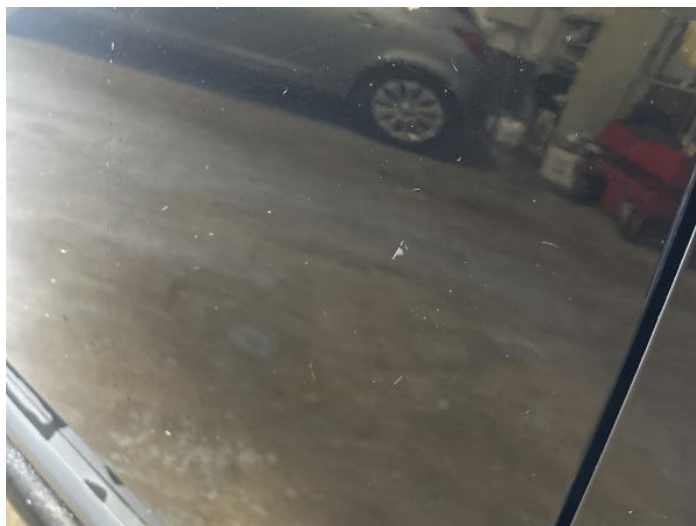
4: Door osf  
Chipped  
1 To 5

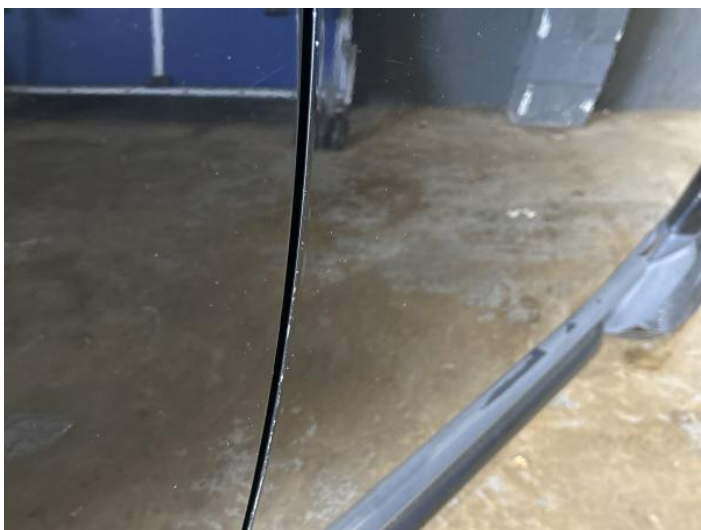
5: Door osf  
Chipped  
Edge Chip

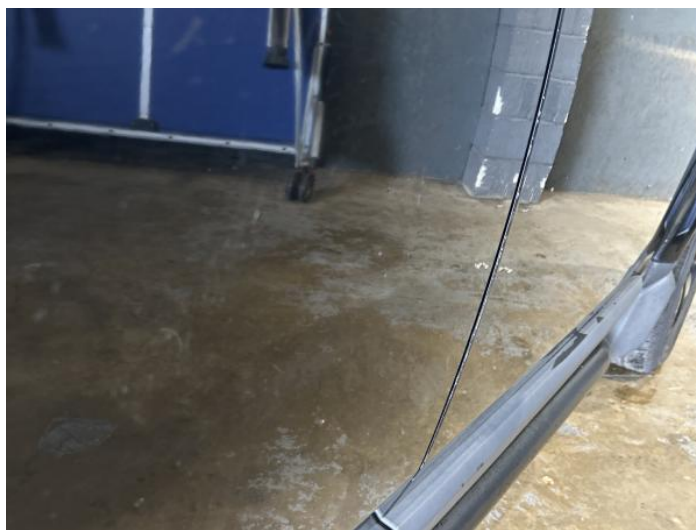
6: Door osr  
Dented  
Over 30mm

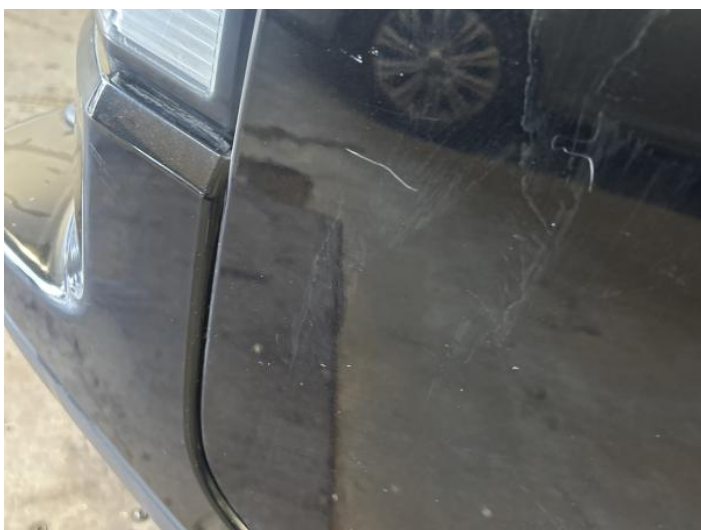
7: Qtr Panel osr  
Scratched  
UpTo 25mm Thru Paint

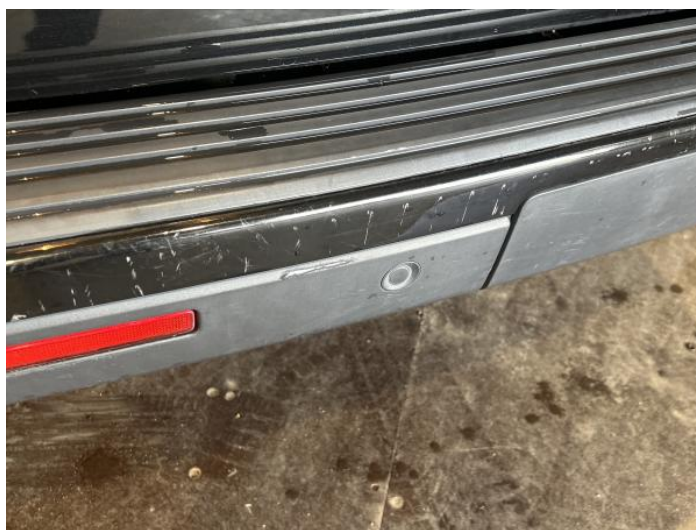
8: Bumper Rear  
Scratched  
Over 100mm Thru Paint

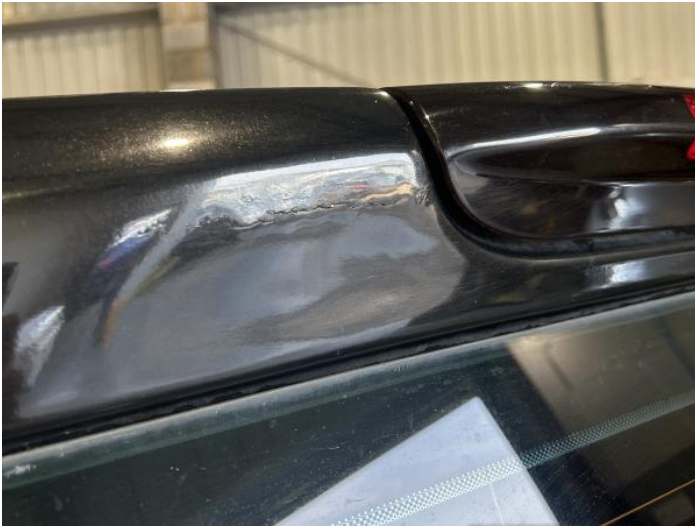
9: Boot Lid  
Poor Previous Repair  
Poor Paint

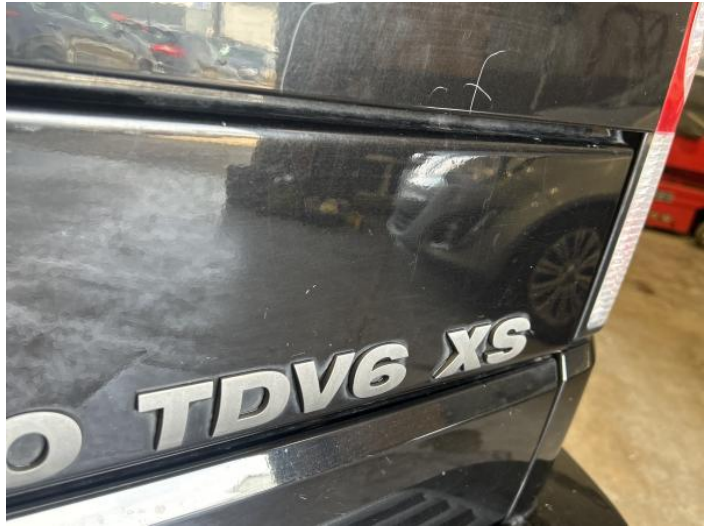
10: Tailgate  
Scratched  
Over 25mm Thru Paint

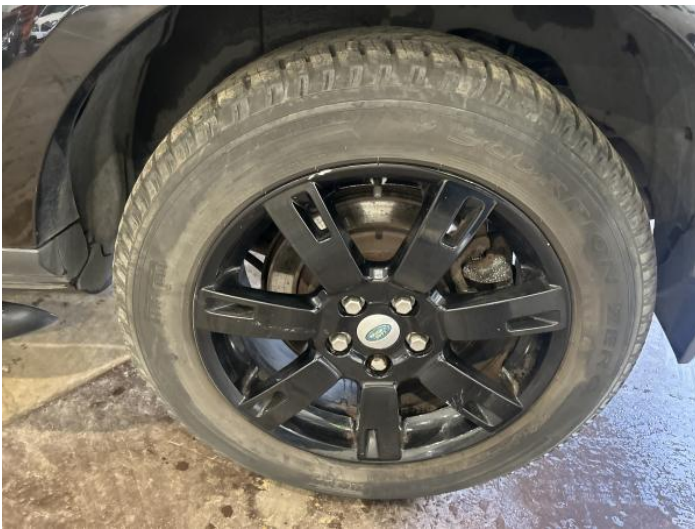
11: Wheel nsr  
Scratched  
Up To 50mm

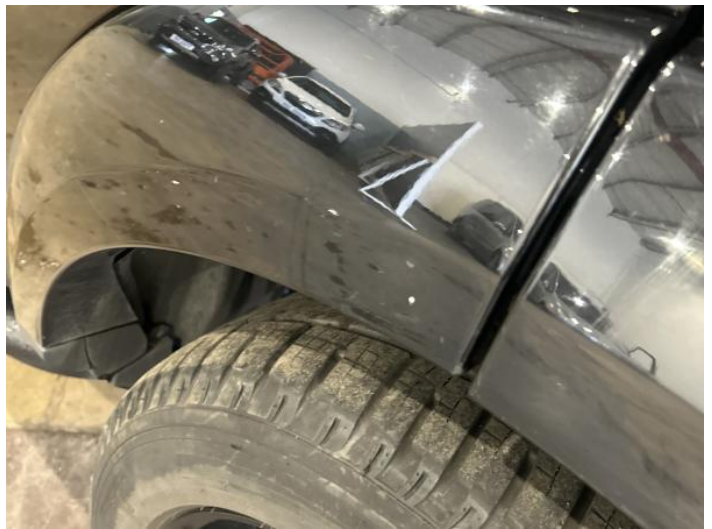
12: Door nsr  
Chipped  
1 To 5

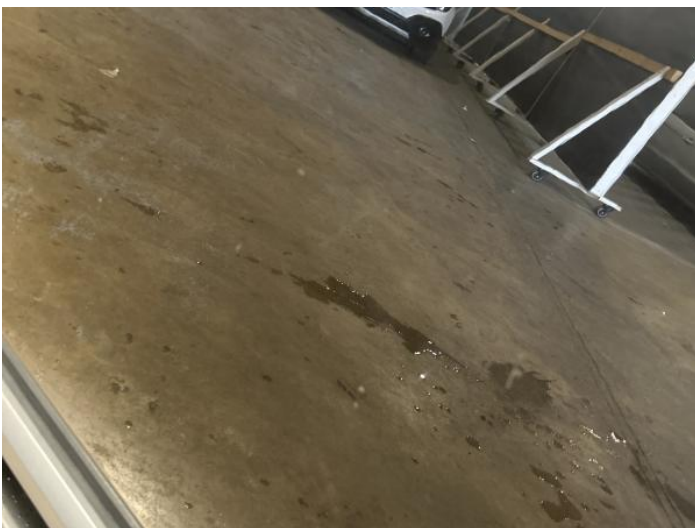
13: Door nsf  
Chipped  
1 To 5

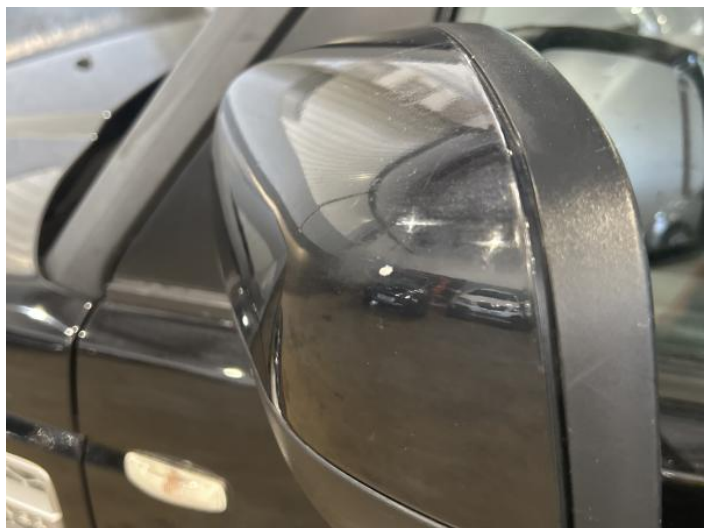
14: Door Mirror Assy nsf  
Scratched (Painted)  
UpTo 25mm Thru Paint

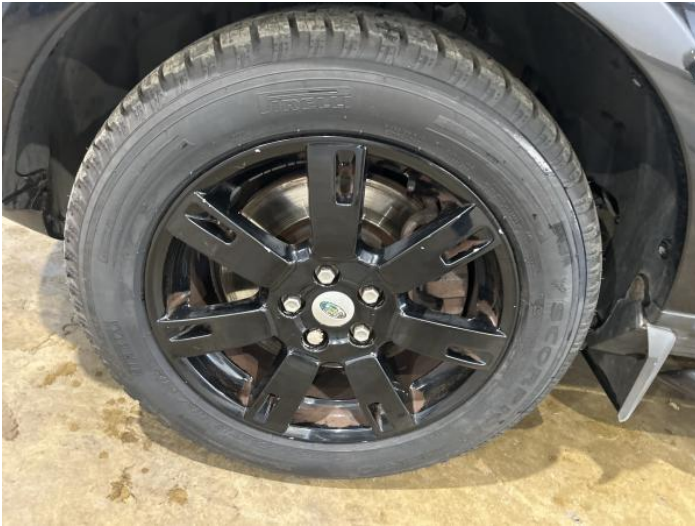
15: Wheel nsf  
Scratched  
Up To 50mm

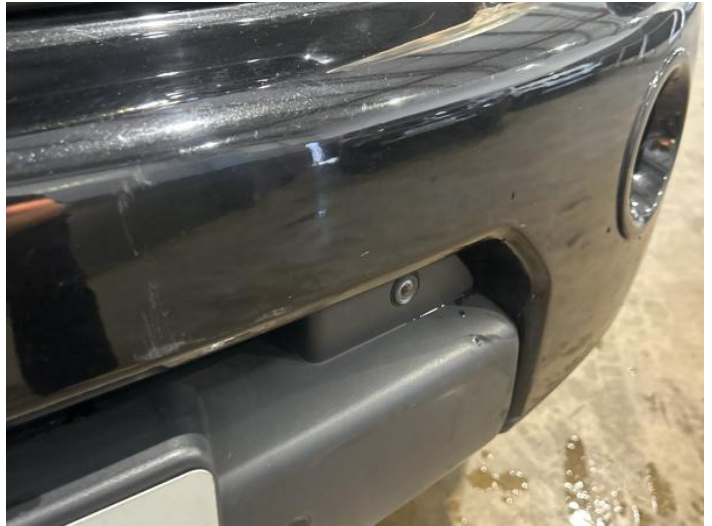
16: Bumper Front  
Scratched  
Over 100mm Thru Paint

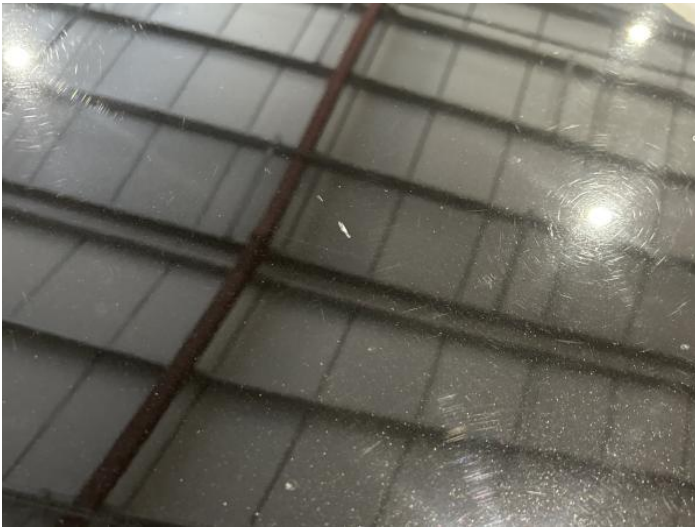
17: Bonnet  
Chipped  
1 To 5

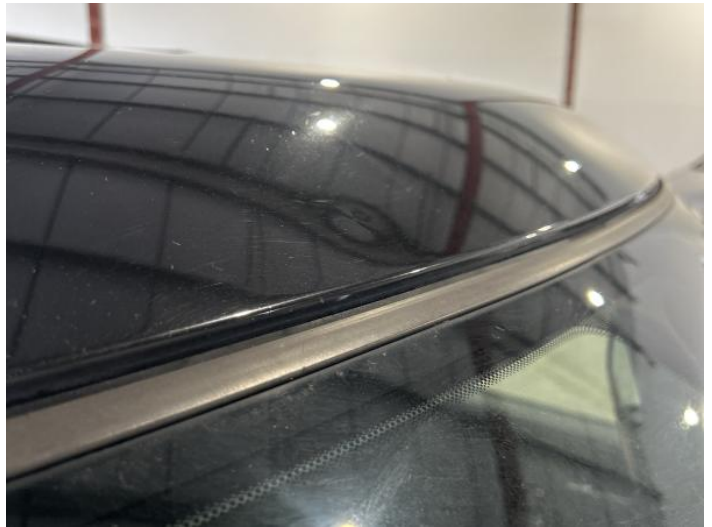
18: Roof  
Dented  
Over 30mm

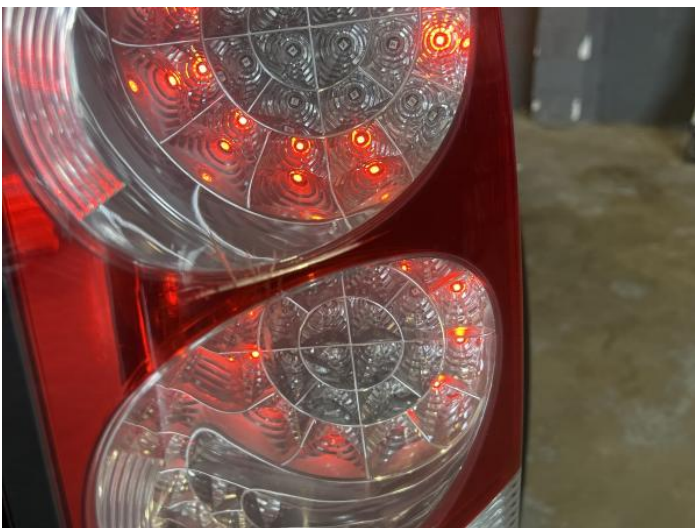
19: Lamp osr  
Broken  
Replace

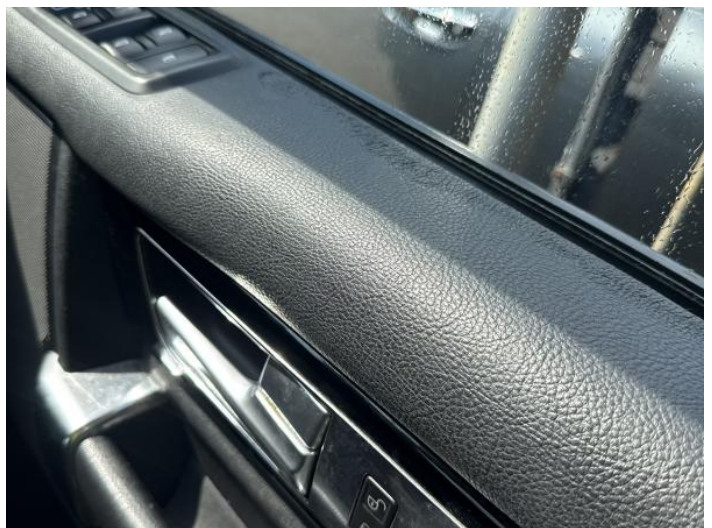
20: Door Pad osf  
Scuffed  
Over 25mm
