# VEHICLE INSPECTION REPORT

**YT11NXH**

## Lexus CT 200h 1.8 SE-L Premier 5dr CVT Auto

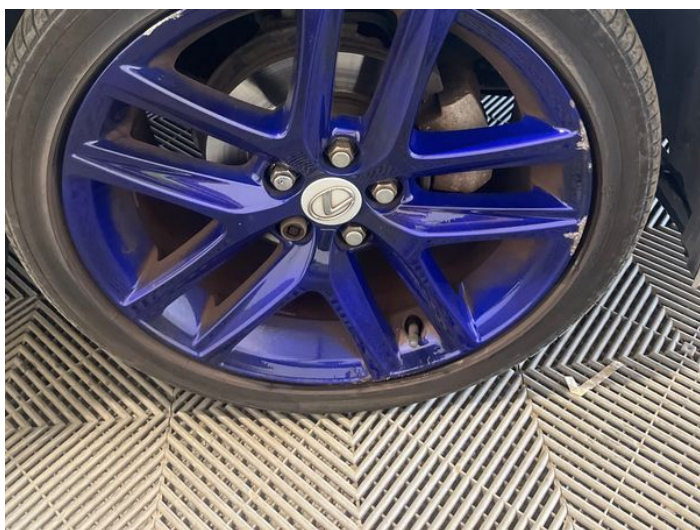
1: Wheel osf  
Scratched  
Over 50mm

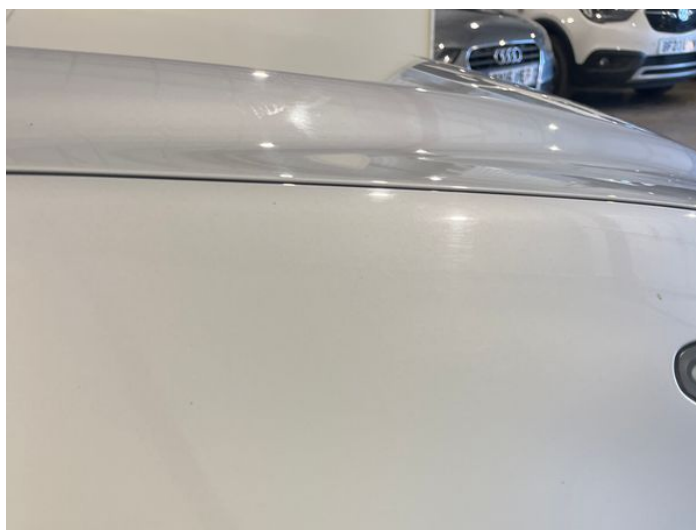
2: Wing osf  
Chipped  
1 To 5

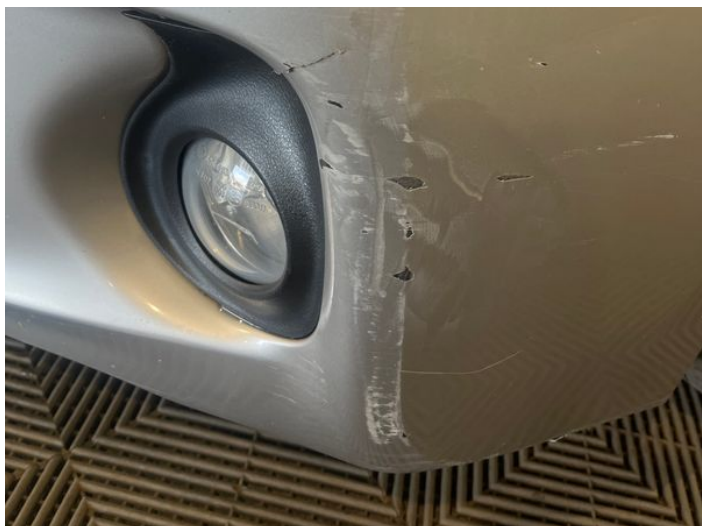
3: Bumper Front  
Cracked  
Over 25mm

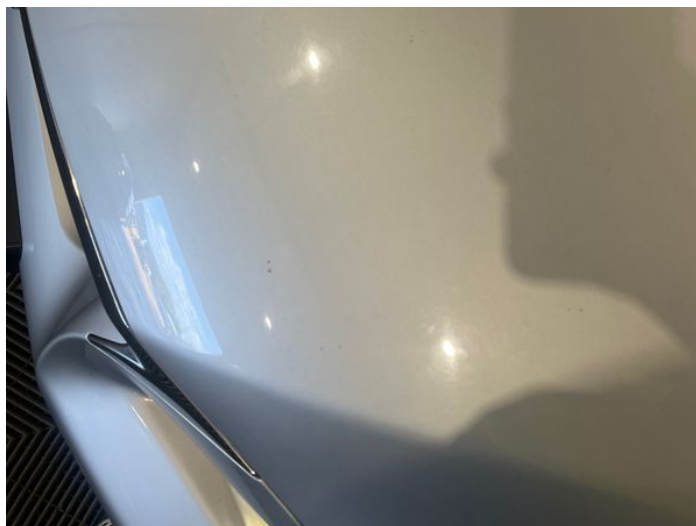
4: Bonnet  
Chipped  
Multiple Chips

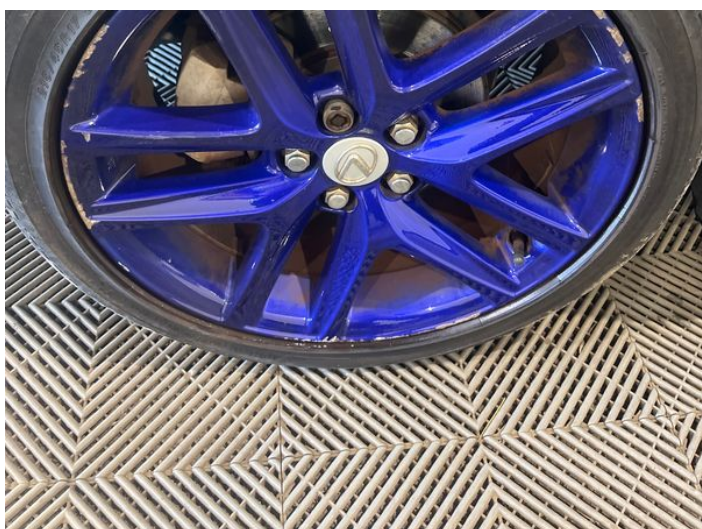
5: Wheel nsf  
Scratched  
Over 50mm

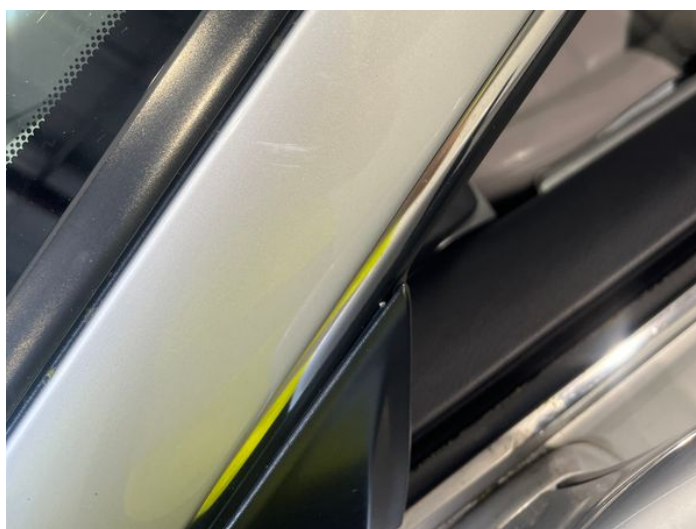
6: A Post ns  
Scratched  
UpTo 25mm Thru Paint

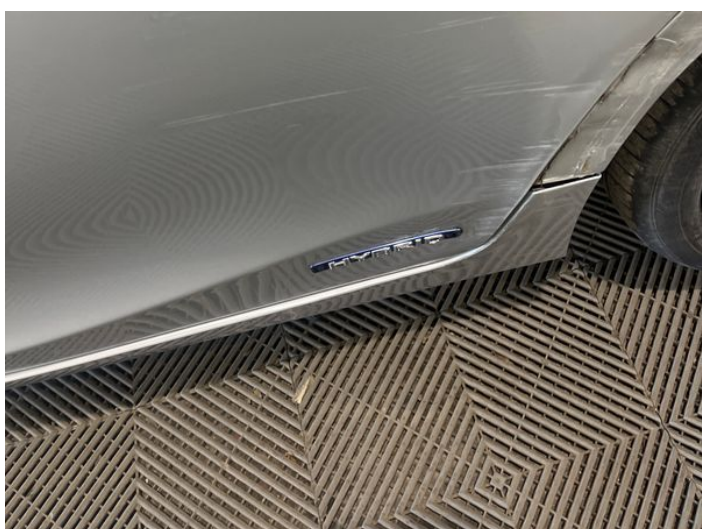
7: Door nsr  
Scratched  
Over 25mm Thru Paint

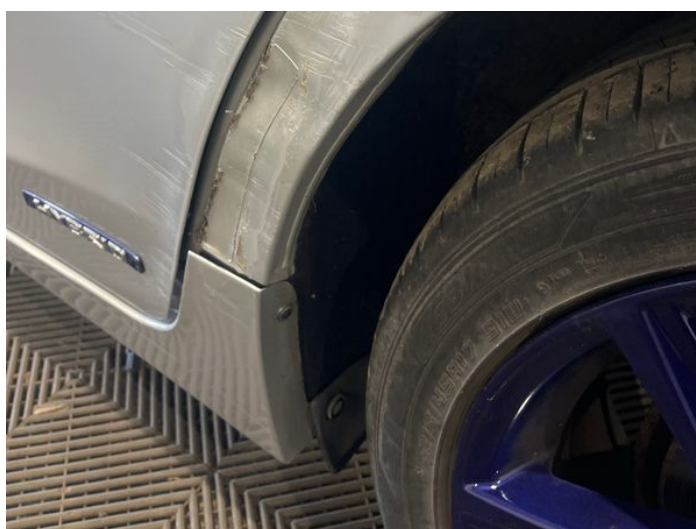
8: Qtr Panel nsr  
Dented  
With Paint Damage

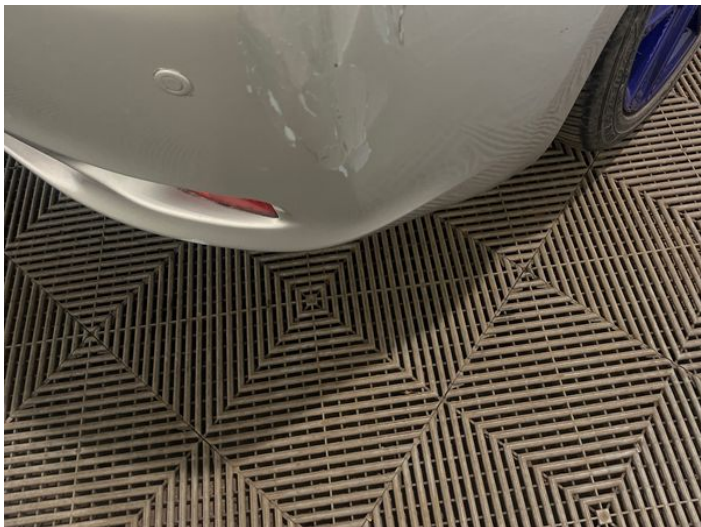
9: Bumper Rear  
Poor Previous Repair  
Paint Flake

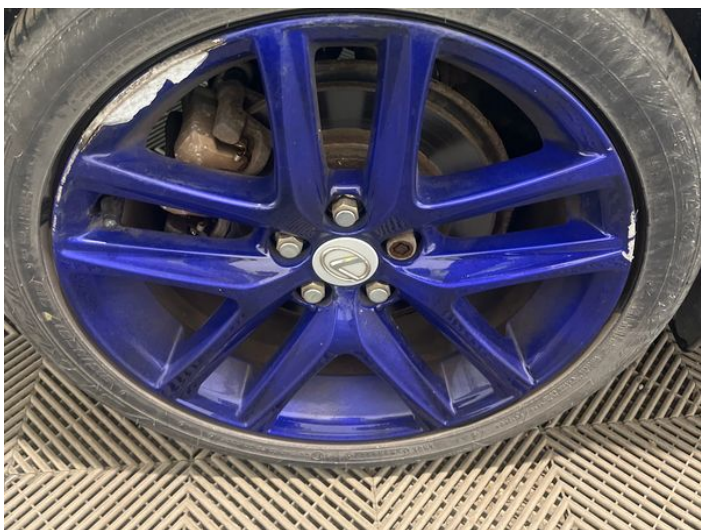
11: Wheel osr  
Scratched  
Over 50mm

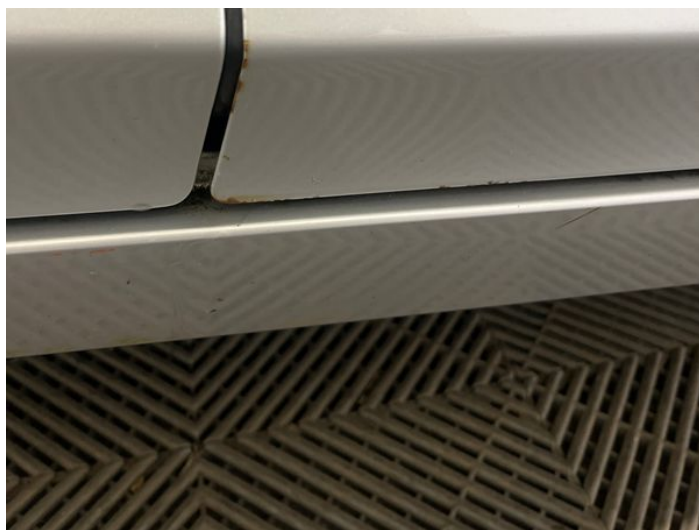
12: Door osf  
Rusted  
UpTo 5mm

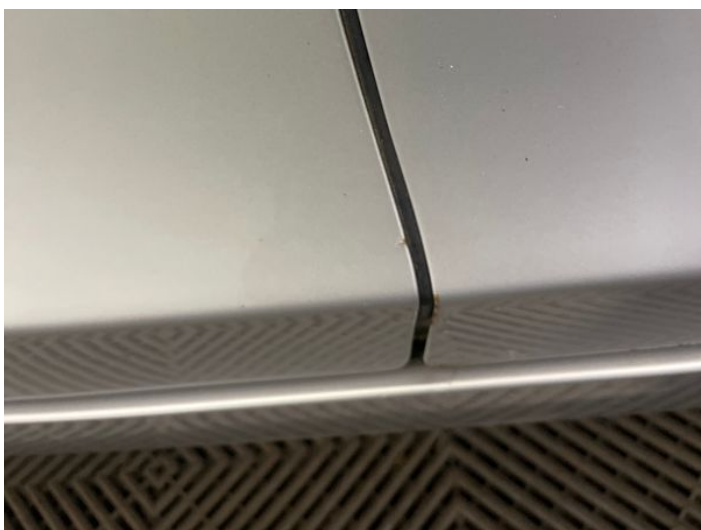
13: Door osr  
Chipped  
1 To 5

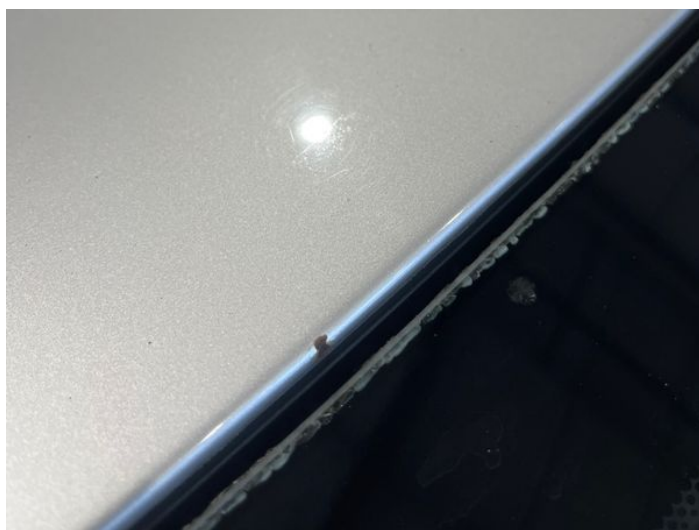
14: Roof  
Chipped  
1 To 5
