# VEHICLE INSPECTION REPORT

**LE69GCY**

## MG Mg Hs EXCLUSIVE DCT

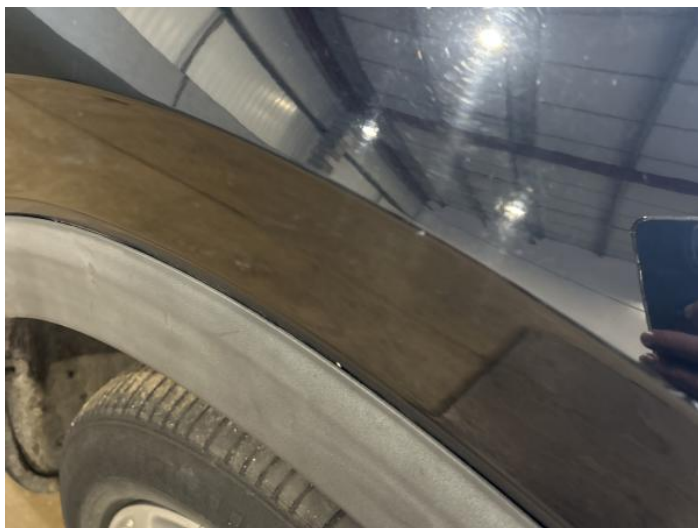
1: Wing osf  
Chipped  
1 To 5

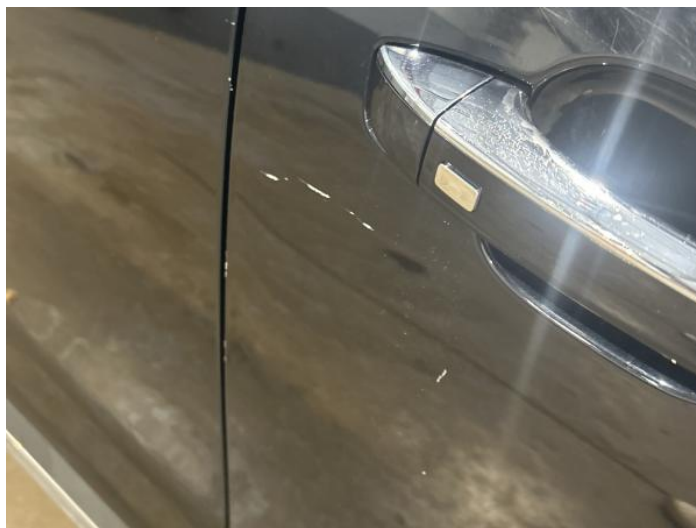
2: Door osf  
Scratched  
Over 25mm Thru Paint

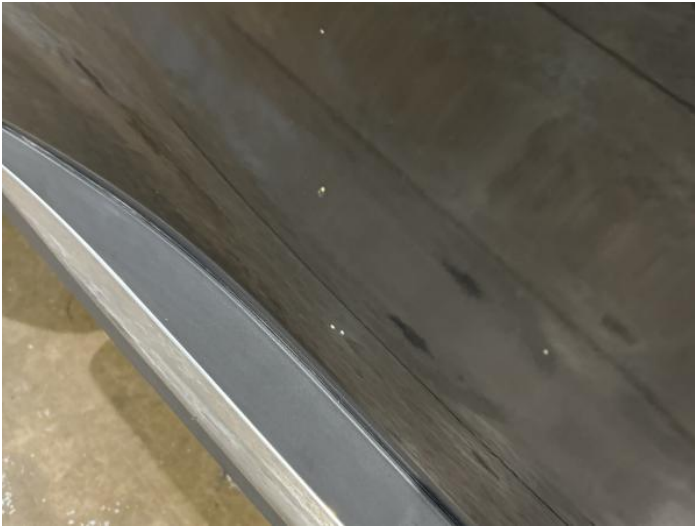
3: Door osr  
Chipped  
1 To 5

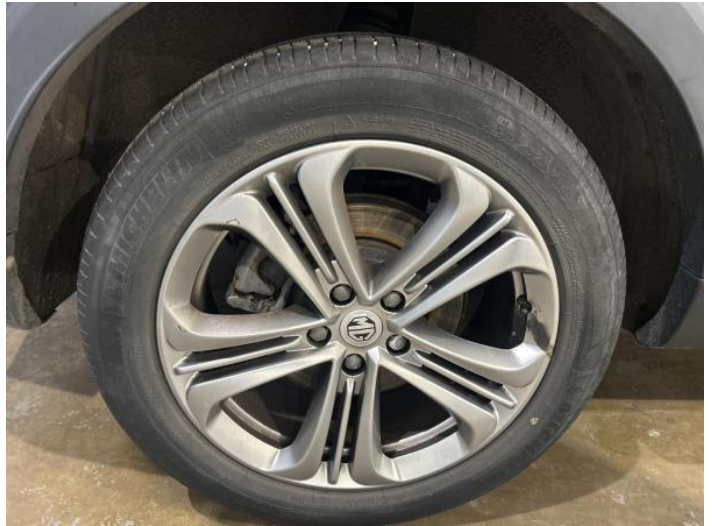
4: Wheel osr  
Scratched  
Over 50mm

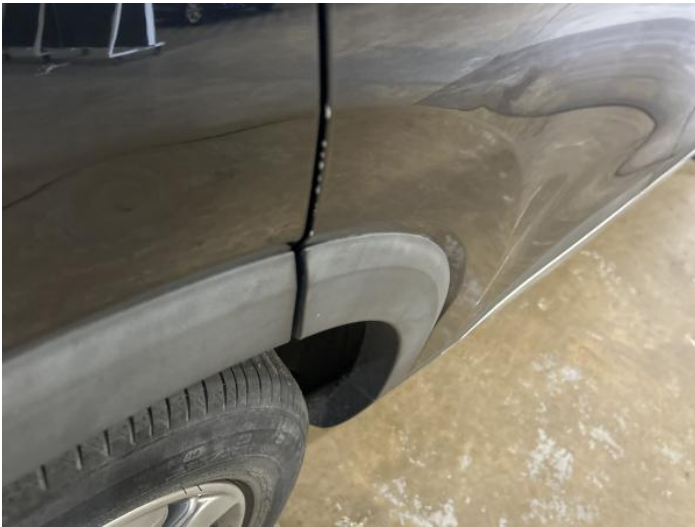
5: Door osr  
Chipped  
Edge Chip

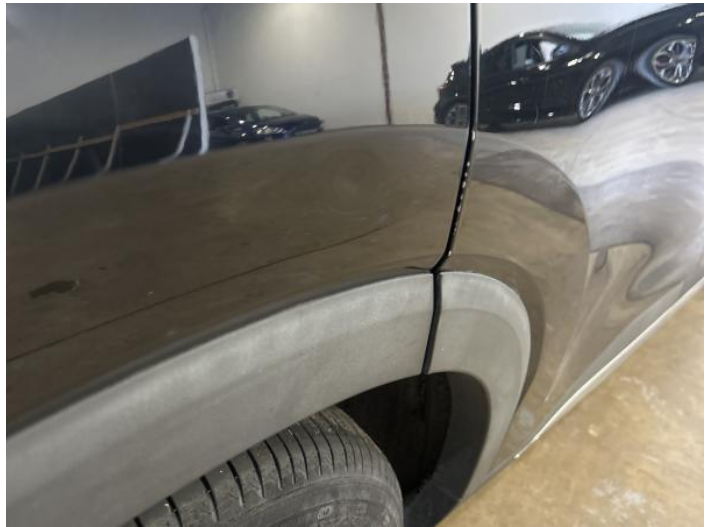
6: Qtr Panel osr  
Dented  
Between 10mm + 30mm

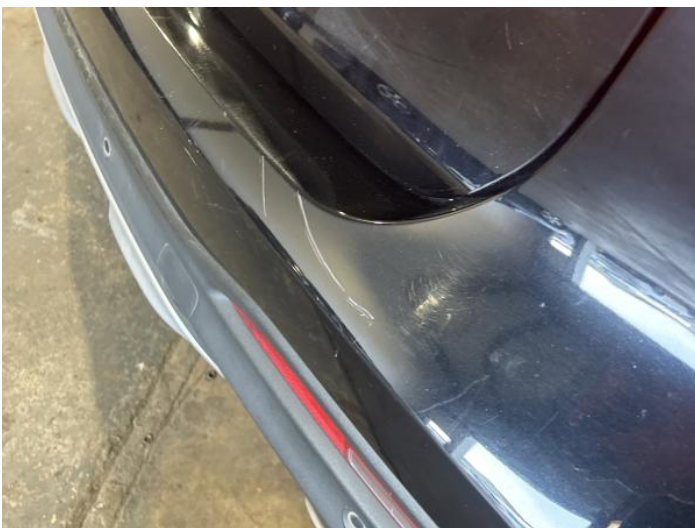
7: Bumper Rear  
Scratched  
25 to 100mm Thru Paint

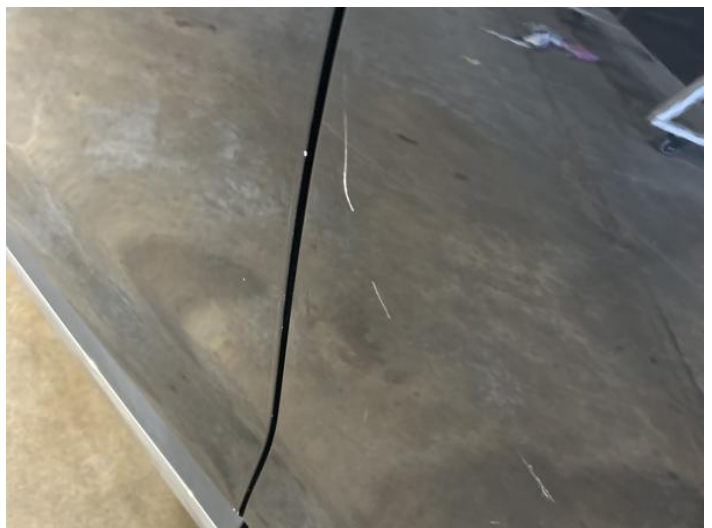
8: Door nsr  
Scratched  
Over 25mm Thru Paint

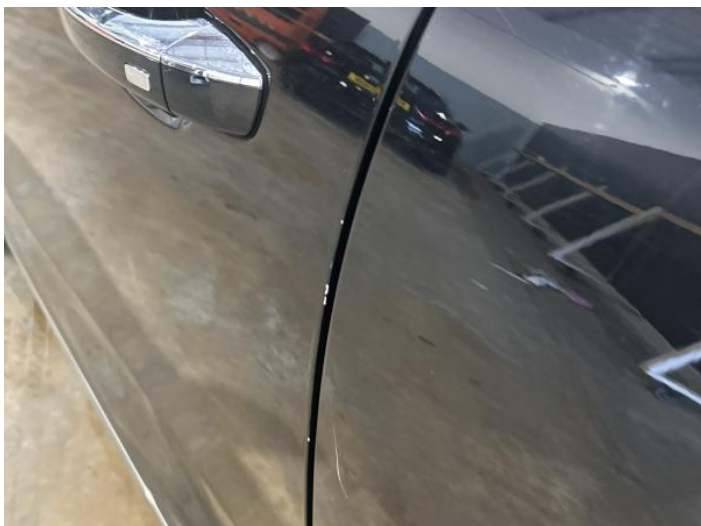
9: Door nsf  
Chipped  
Edge Chip

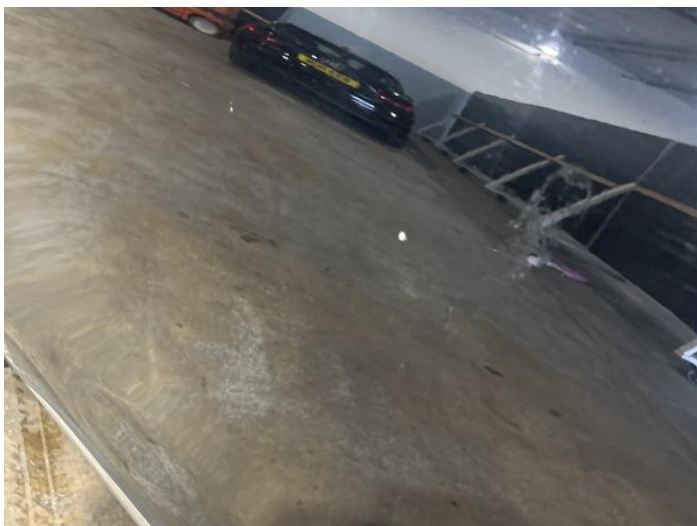
10: Door nsf  
Chipped  
1 To 5

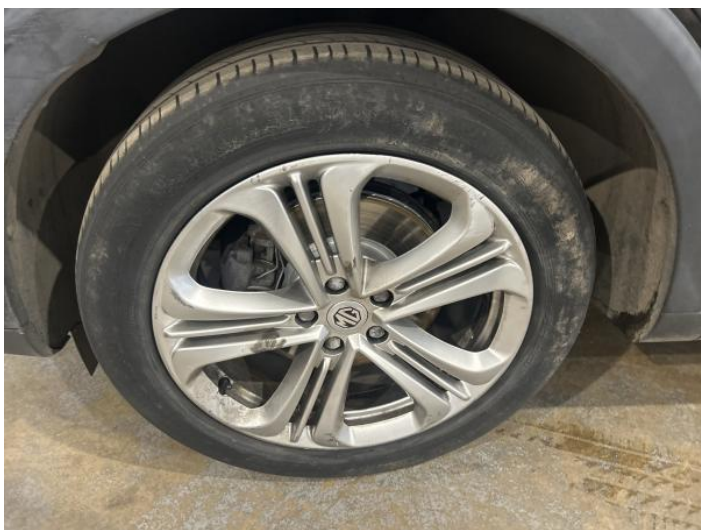
11: Wheel nsf  
Scratched  
Over 50mm

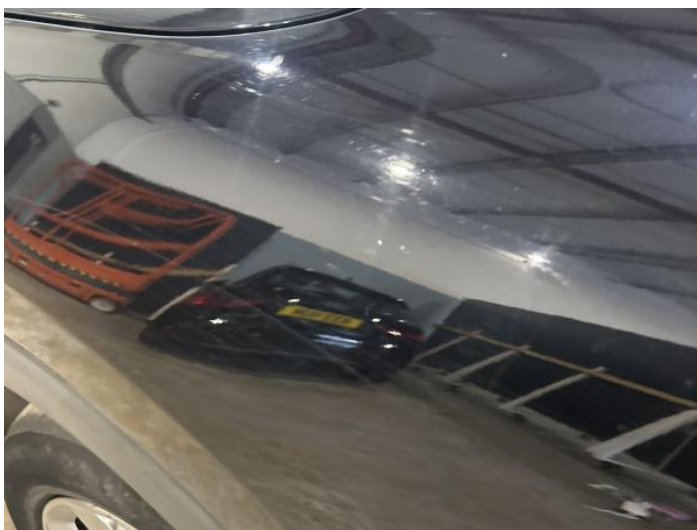
12: Wing nsf  
Chipped  
1 To 5

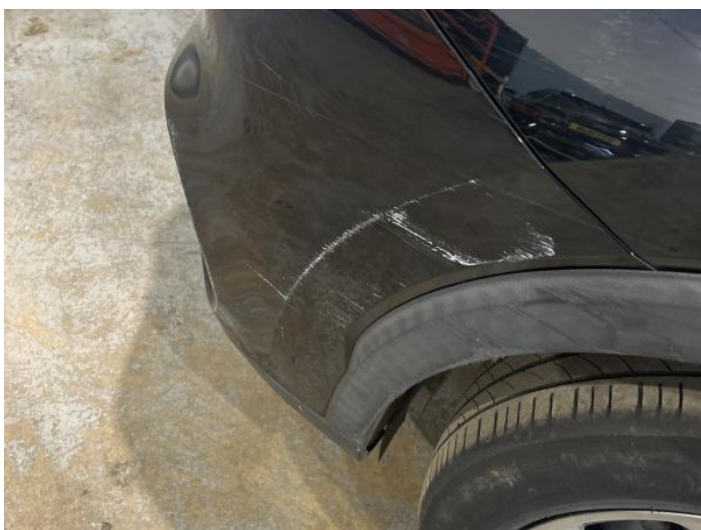
13: Bumper Front  
Scratched  
25 to 100mm Thru Paint

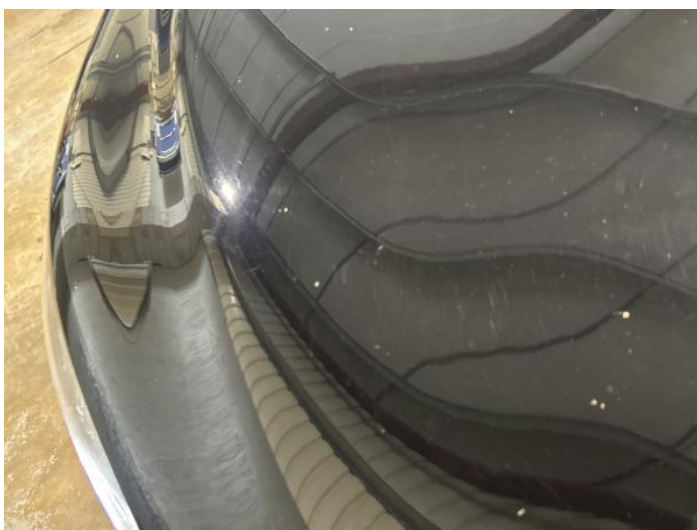
14: Bonnet  
Chipped  
1 To 5

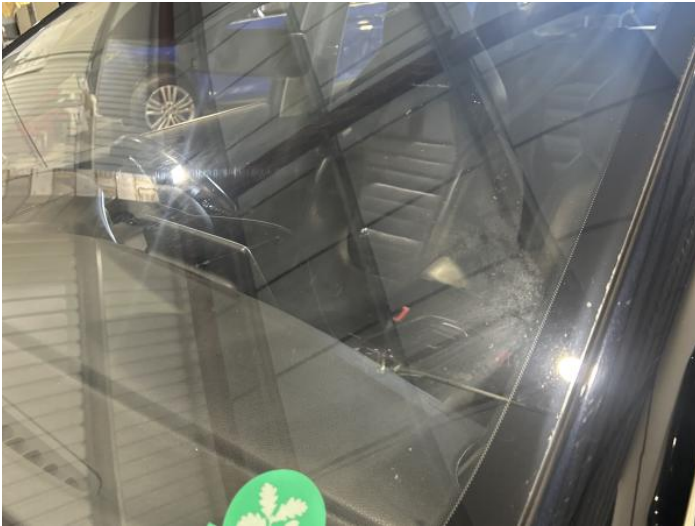
15: Screen Front  
Cracked  
Replace

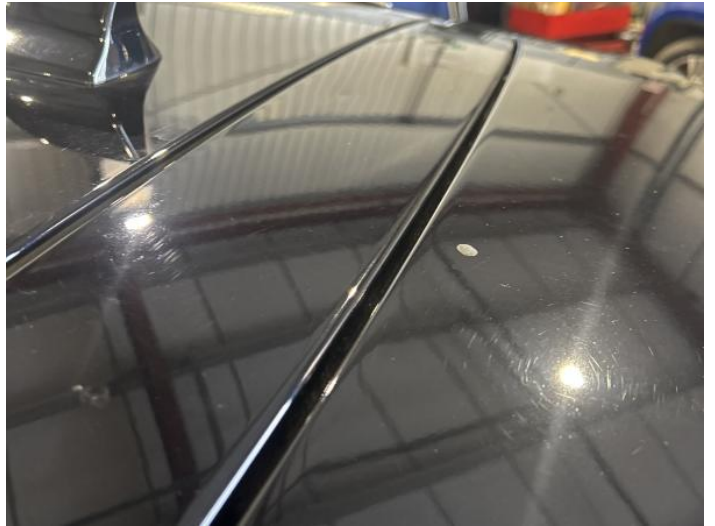
16: Boot Lid  
Dented  
2 Or Less UpTo 10mm

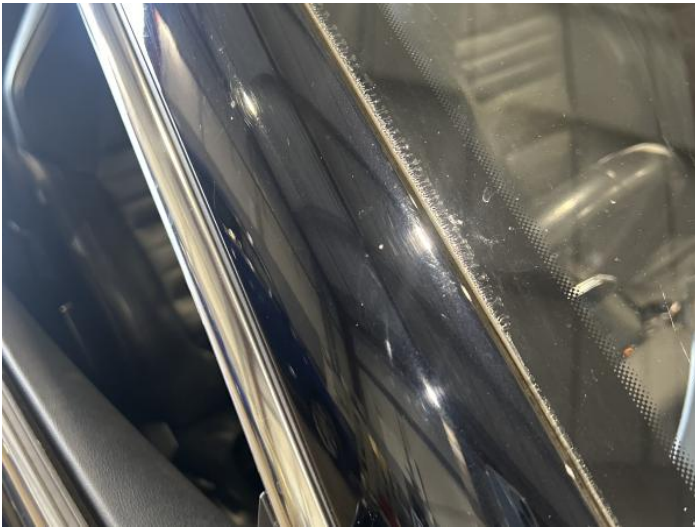
17: A Post os  
Chipped  
1 To 5

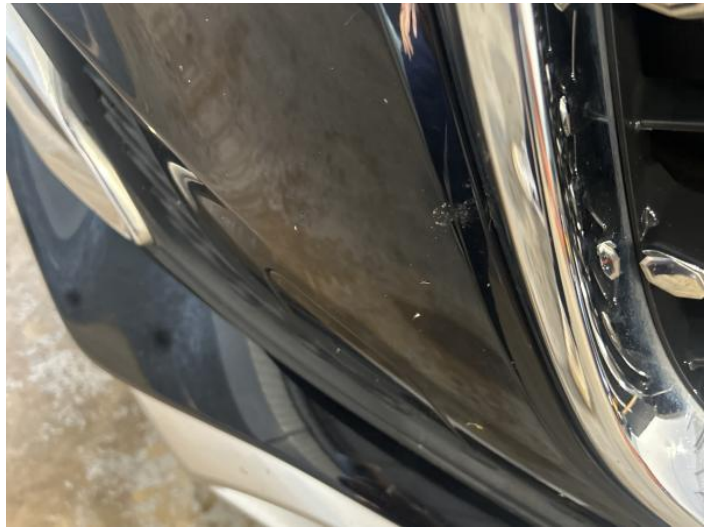
18: Bumper Front  
Chipped  
Multiple Chips

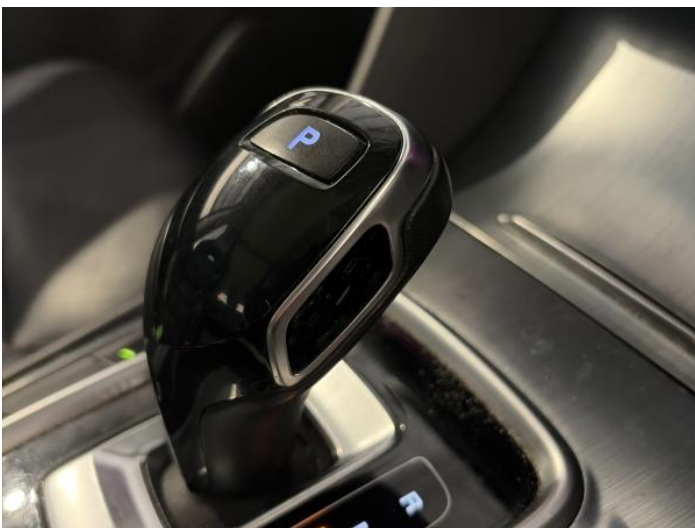
19: Switches And Controls  
Broken  
Replace

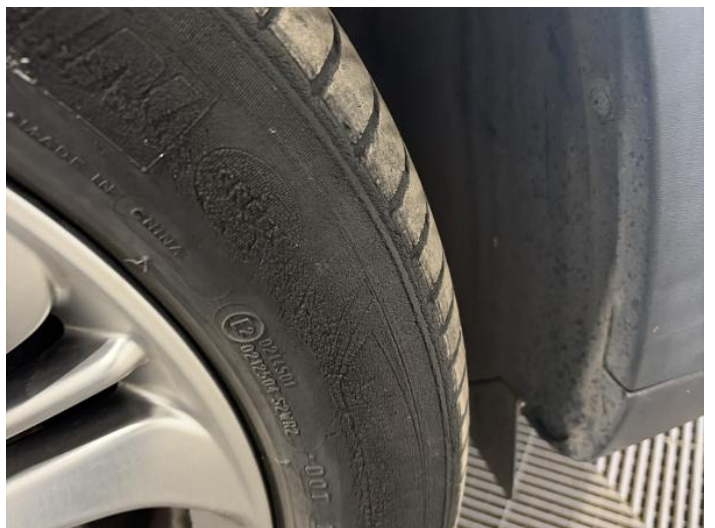
| Tyres | | |
|---|---|---|
| OSF | MICHELIN | Damaged |

20: Tyre osf  
Damaged  
Replace

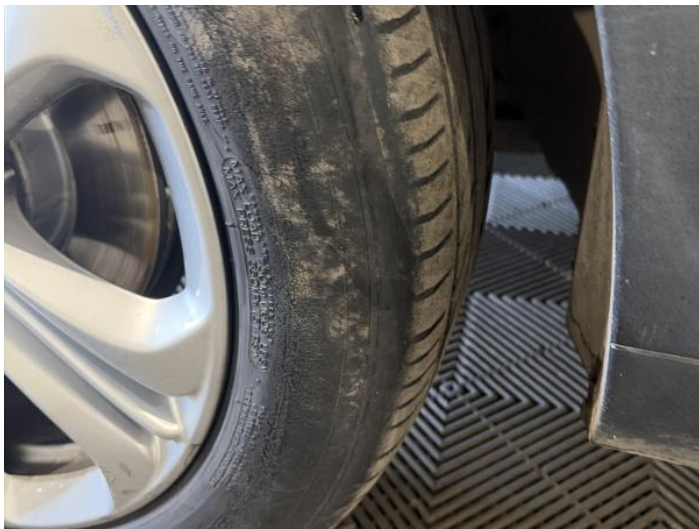
| Tyres | | |
|---|---|---|
| NSF | MICHELIN | Damaged |

21: Tyre nsf  
 Damaged  
 Replace
