VEHICLE INSPECTION REPORT

EO67PPK

Ford Kuga 2.0 TDCi 180 Titanium X 5dr Auto

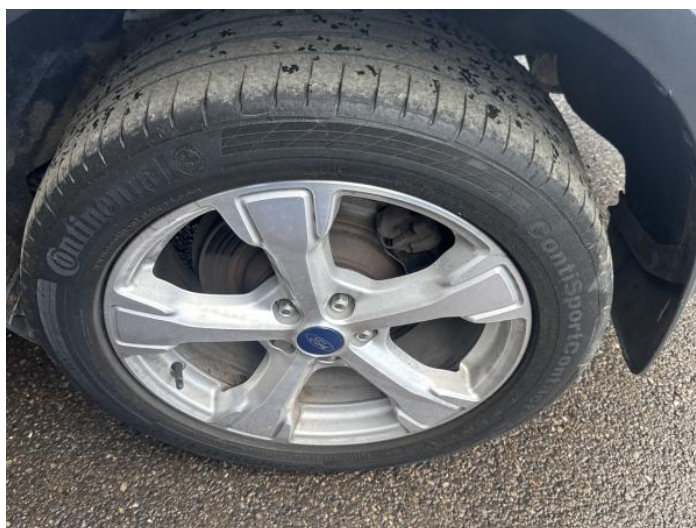
2: Wheel nsr
Scratched
Up To 50mm

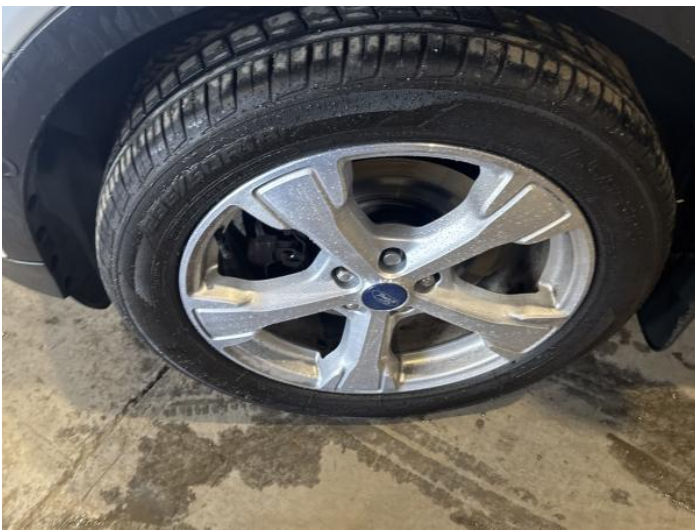
5: Wheel nsr
Scratched
Up To 50mm

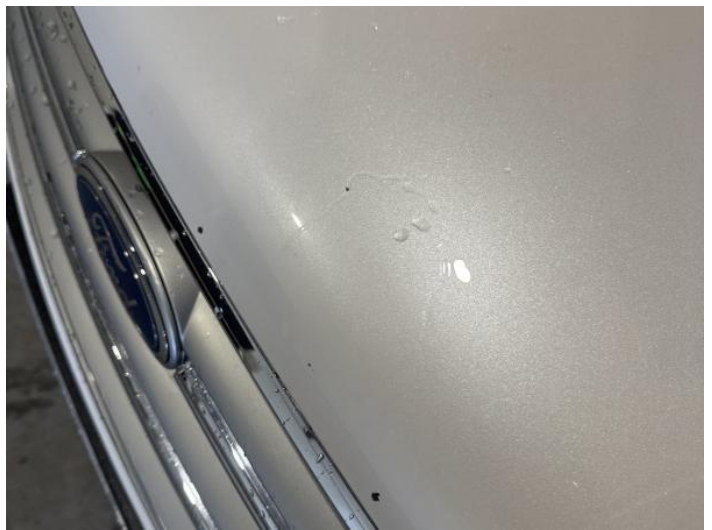
6: Bonnet
Chipped
Multiple Chips

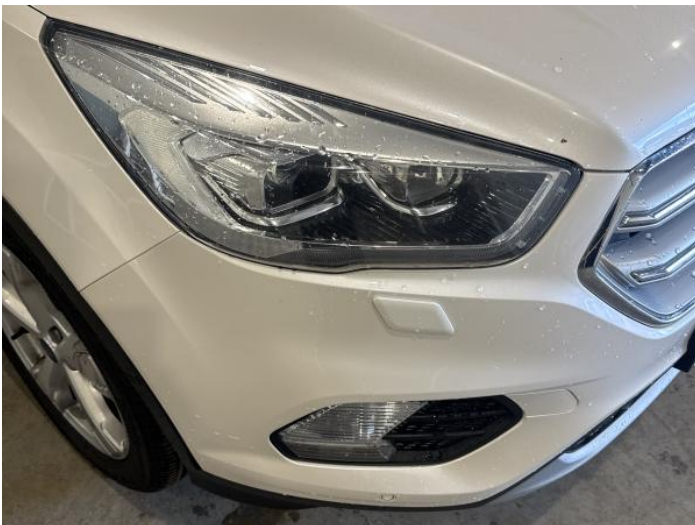
7: Bumper Front
Poor Previous Repair
Poor Colour

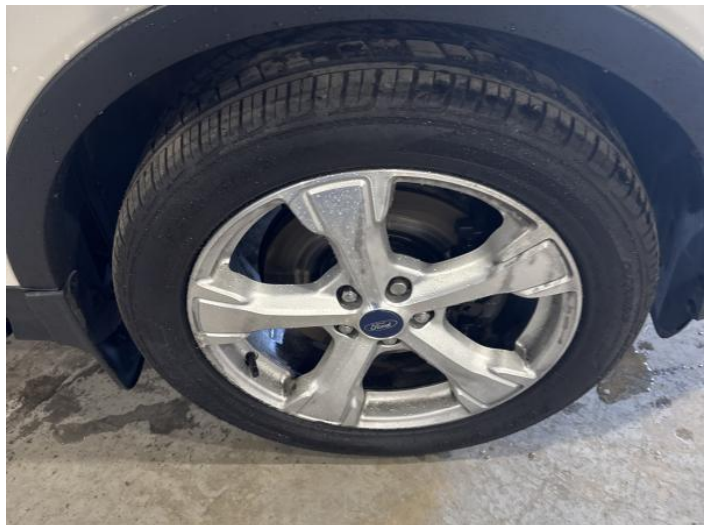
8: Wheel osf
Scratched
Up To 50mm

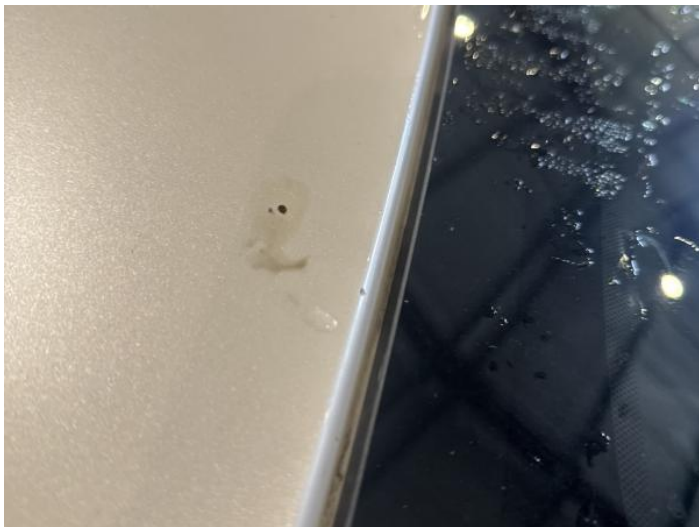
9: Roof
Chipped
1 To 5
