# VEHICLE INSPECTION REPORT

**MM18JWD**

## Vauxhall Insignia 1.5T SRi Nav 5dr

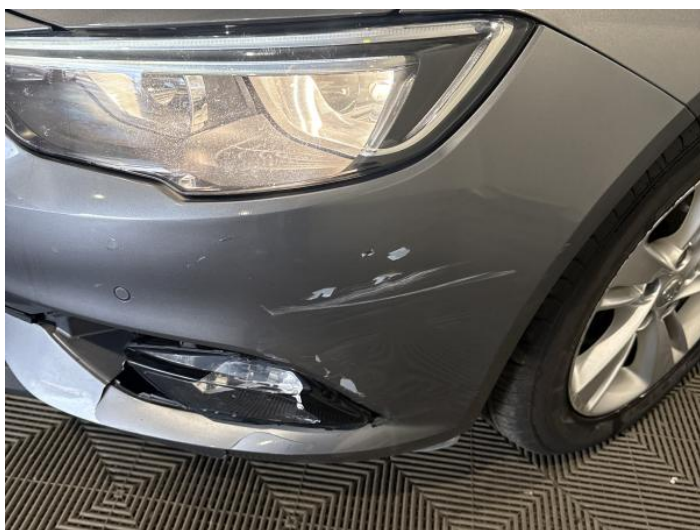
1: Bumper Front  
Cracked  
Over 25mm

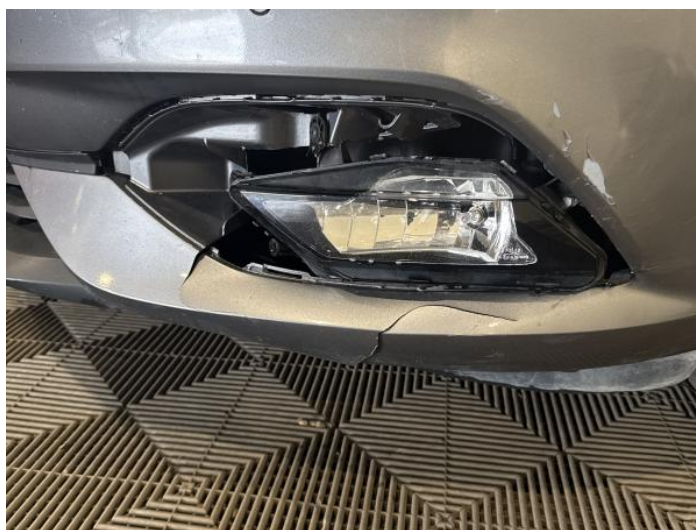
2: Fog Lamp Surrounds  
Missing  
Replace

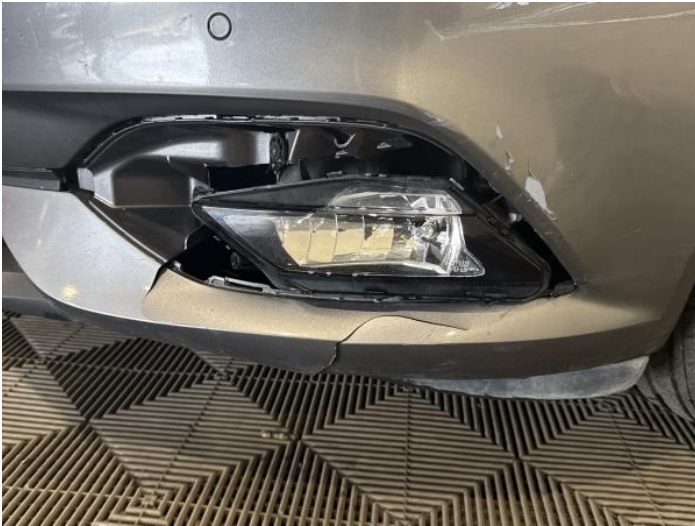
3: Fogdriving Lamp osf  
Broken  
Replace

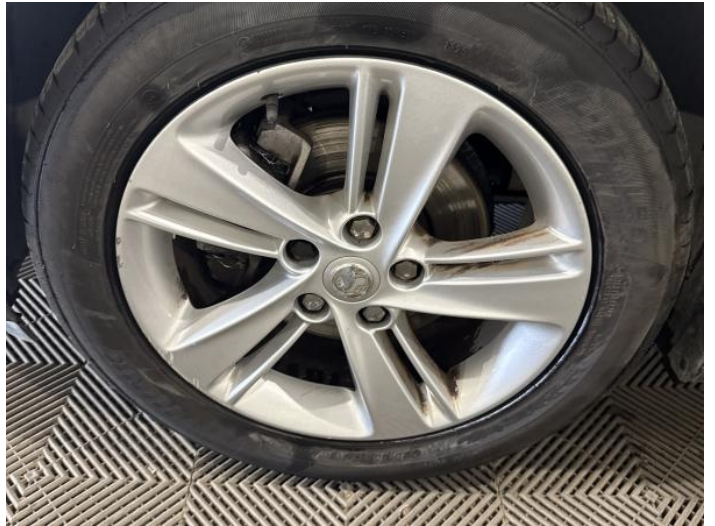
4: Wheel nsf  
Scratched  
Over 50mm

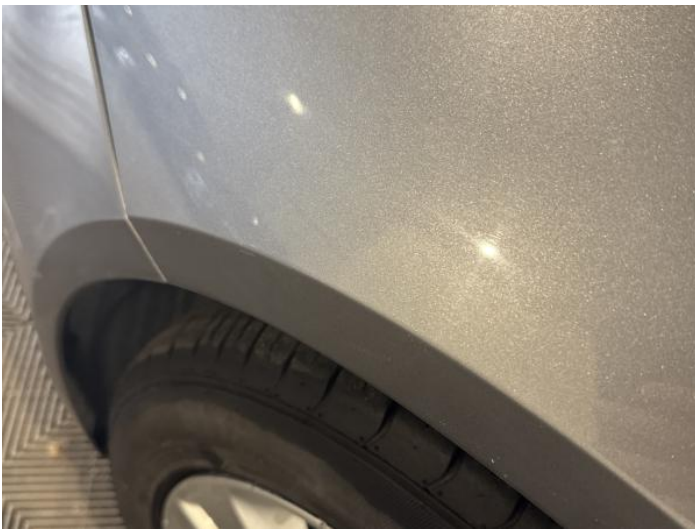
5: Wing nsf  
Chipped  
1 To 5

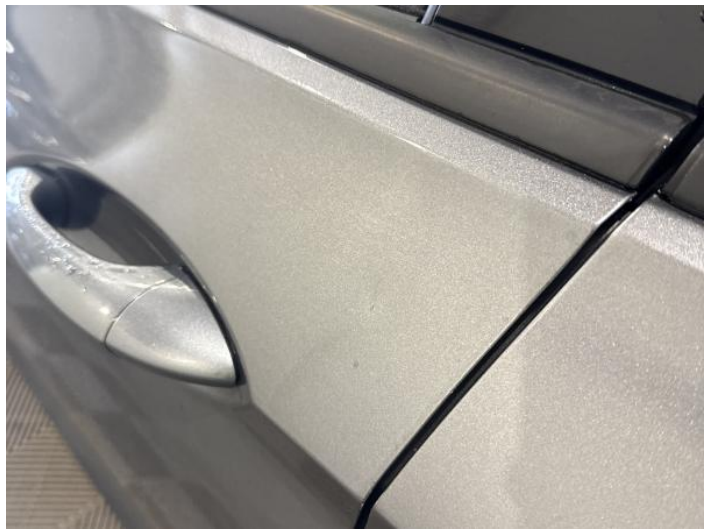
6: Door nsf  
Dented  
Between 10mm + 30mm

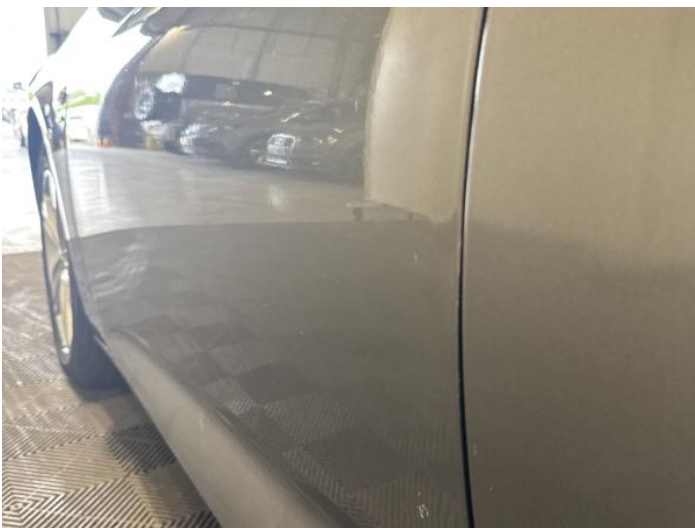
7: Door nsf  
Poor Previous Repair  
Rippled UpTo 30%

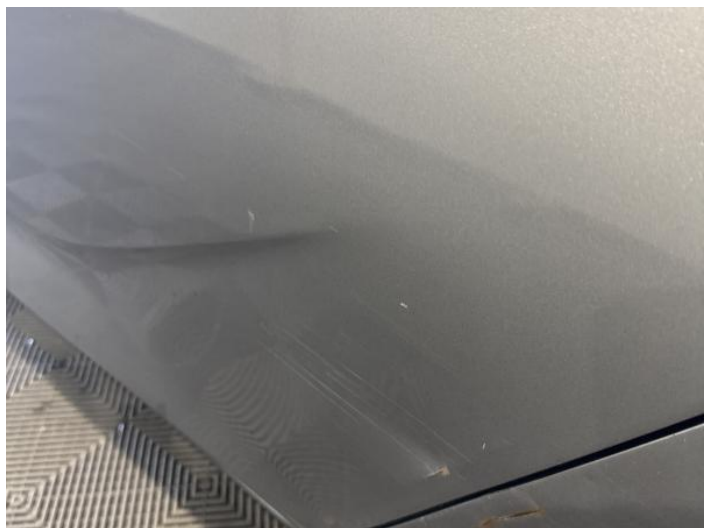
8: Door nsr  
Dented  
With Paint Damage

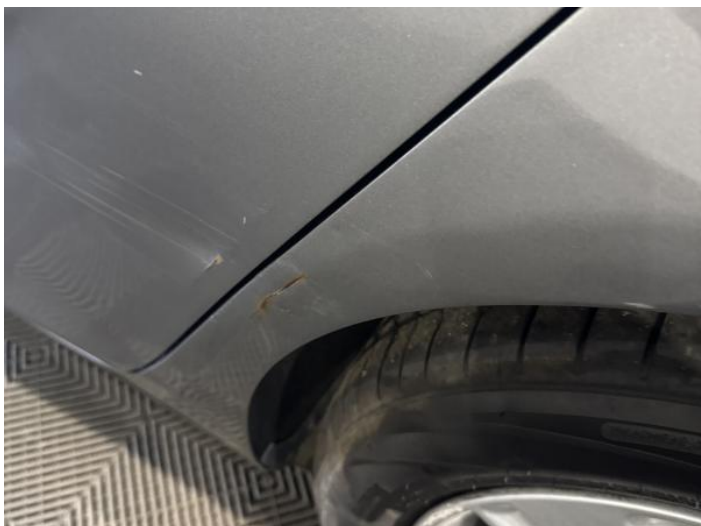
9: Qtr Panel nsr  
Cracked  
Replace

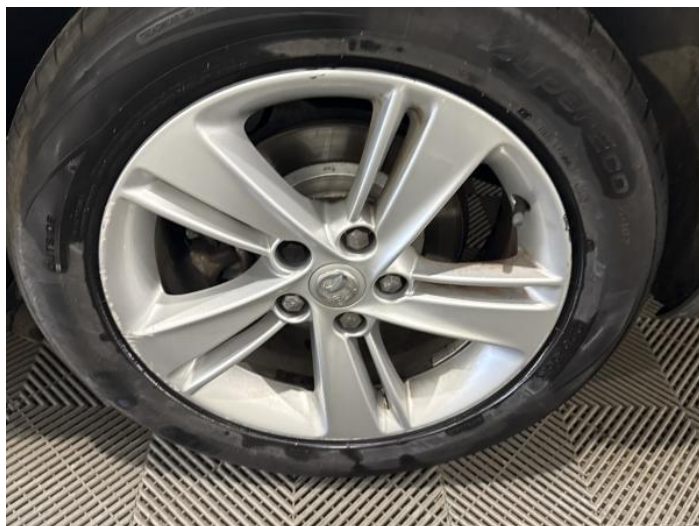
10: Wheel nsr  
Scratched  
Over 50mm

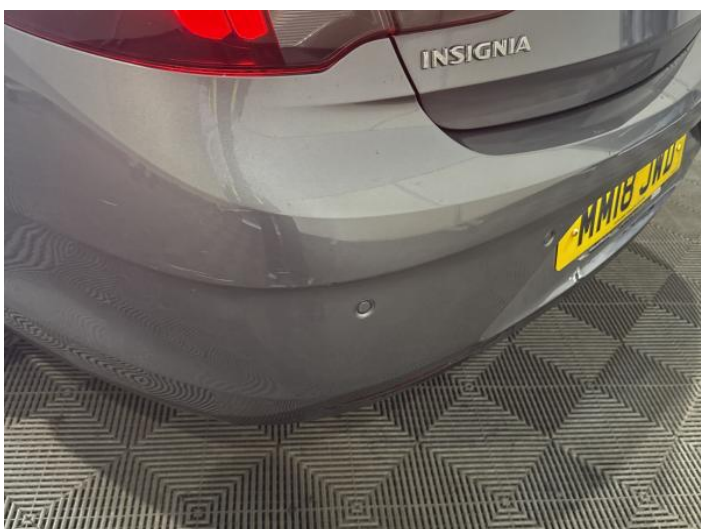
11: Bumper Rear  
Scratched  
Over 100mm Thru Paint

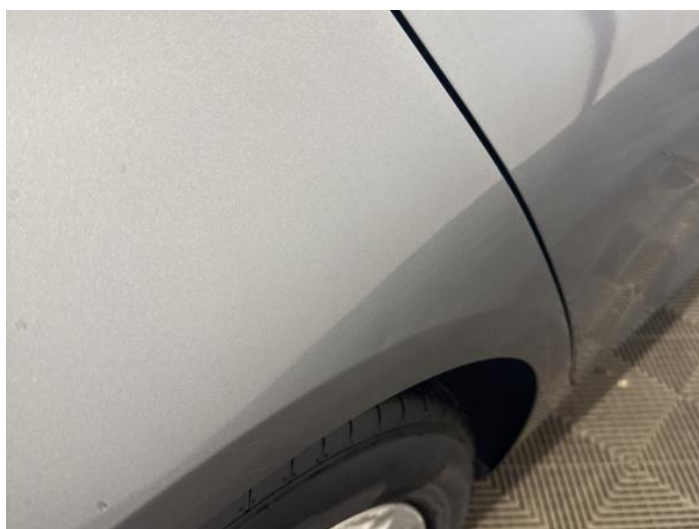
12: Qtr Panel osr  
Dented  
Between 10mm + 30mm

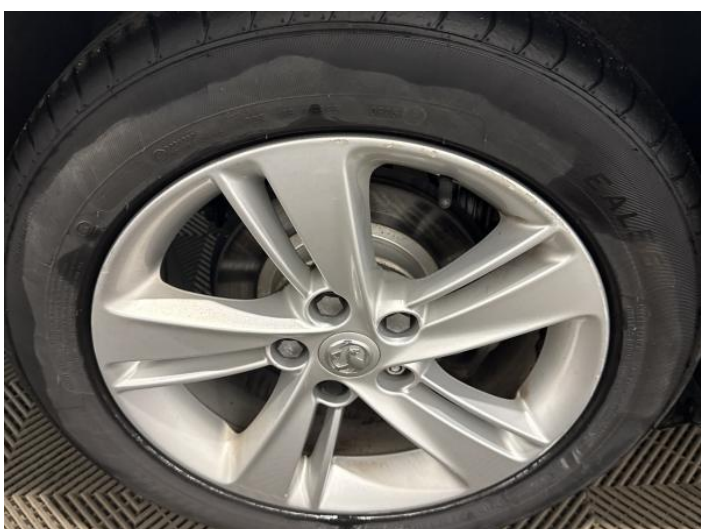
13: Wheel osr  
Scratched  
Over 50mm

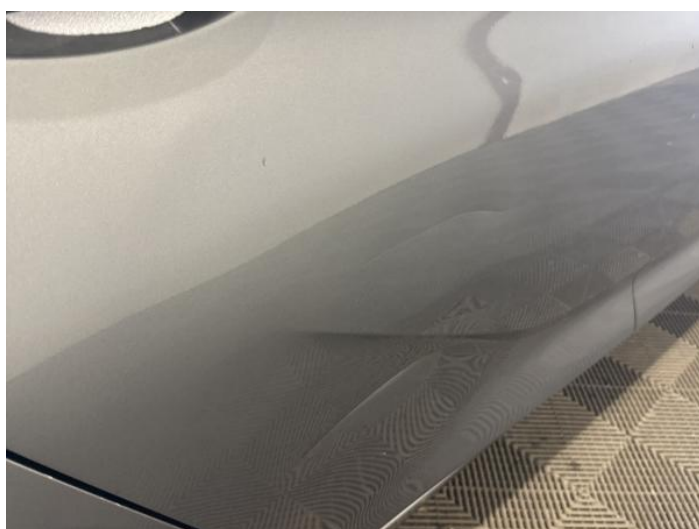
14: Door nsr  
Dented  
With Paint Damage

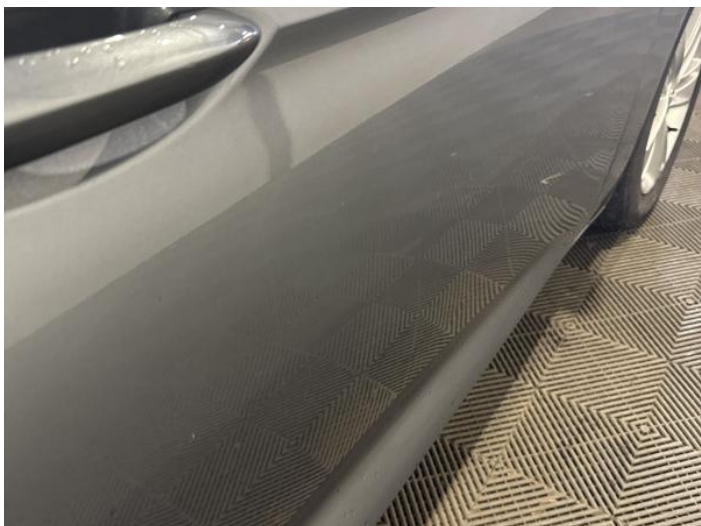
15: Door osf  
Scratched  
Over 25mm Thru Paint

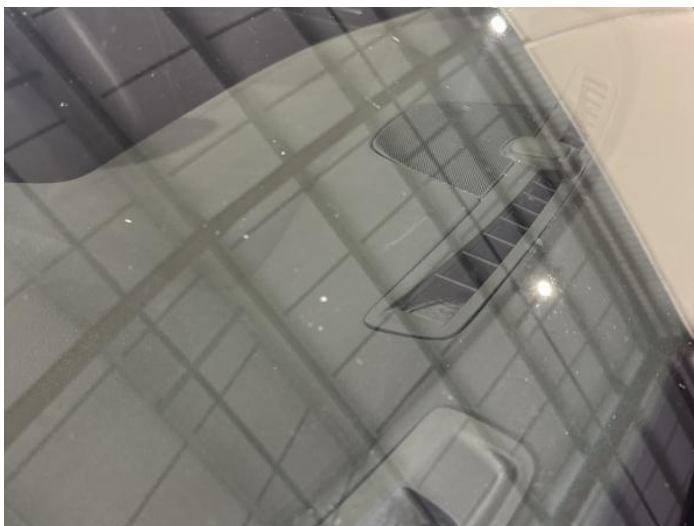
16: Screen Front  
Chipped  
UpTo 10mm

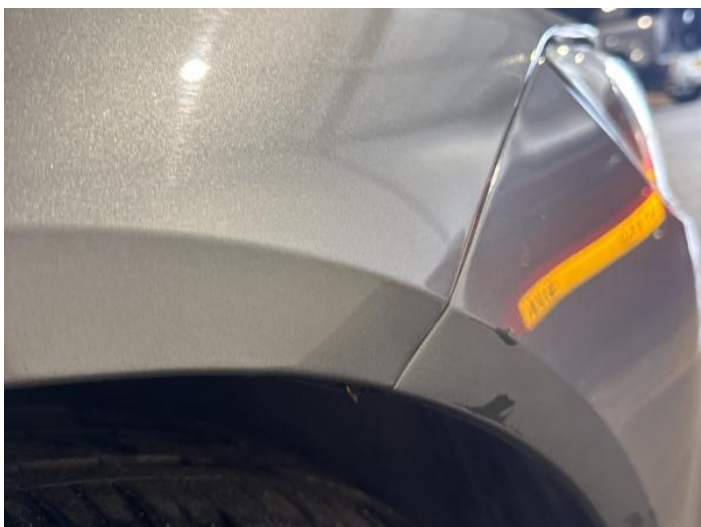
17: Wing osf  
Scratched  
UpTo 25mm Thru Paint

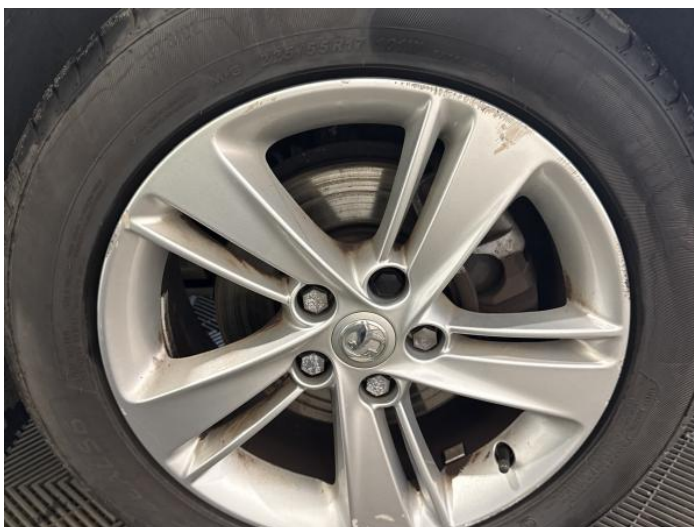
18: Wheel osf  
Scratched  
Over 50mm

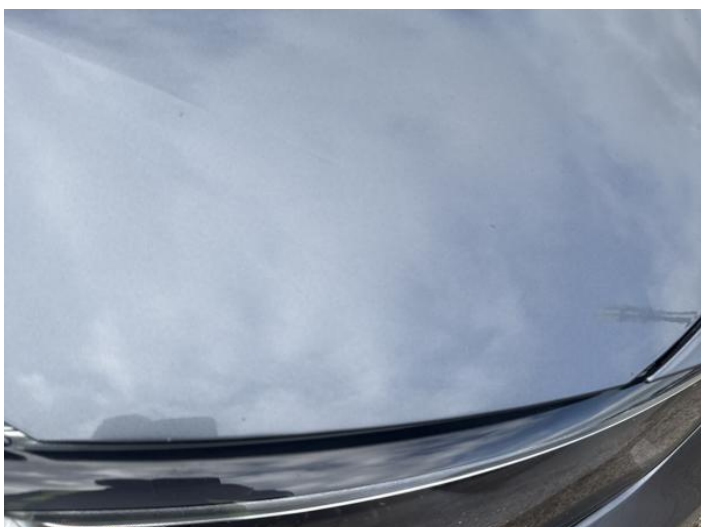
19: Bonnet  
Chipped  
1 To 5

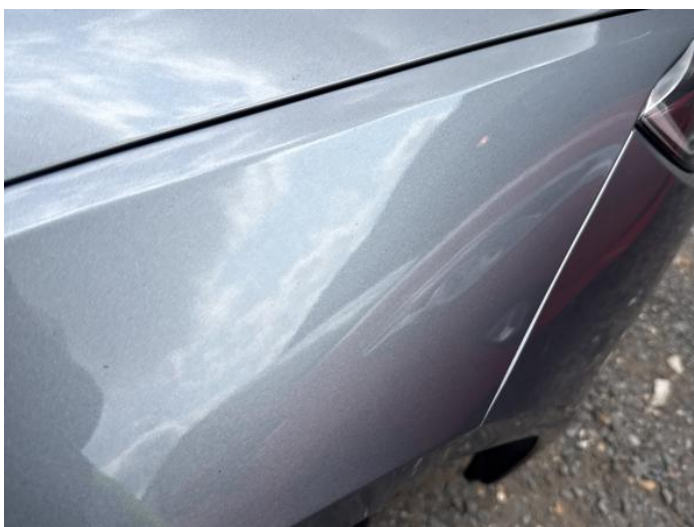
20: Wing osf  
Dented  
Between 10mm + 30mm
