VEHICLE INSPECTION REPORT

LR14JVJ

Toyota Prius+ 1.8 VVTi T4 5dr CVT Auto

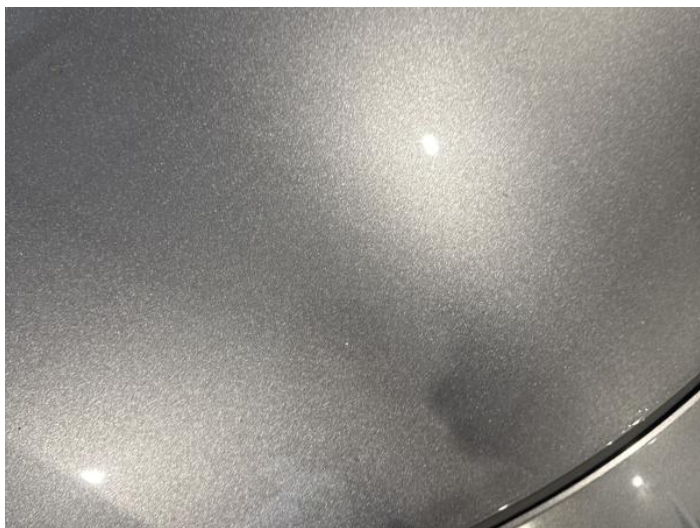
1: Bonnet
Chipped
1 To 5

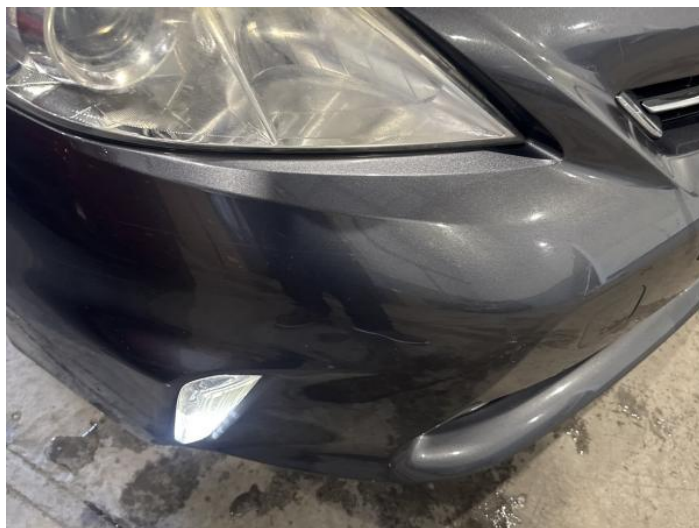
2: Bumper Front
Scratched
Over 100mm Thru Paint

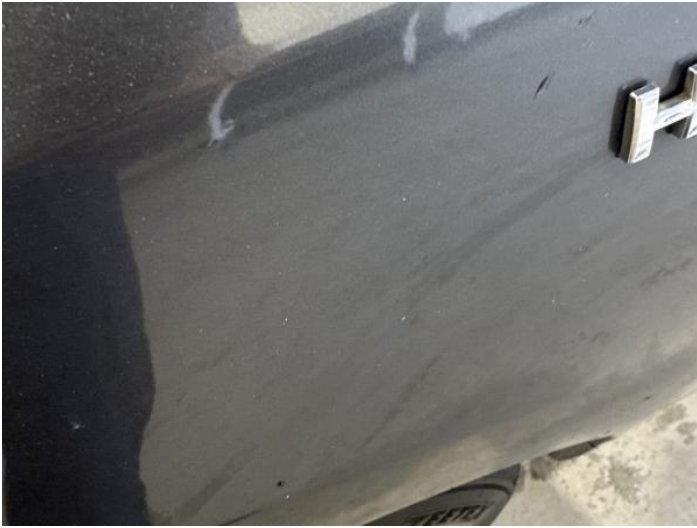
3: Wing nsf
Chipped
1 To 5

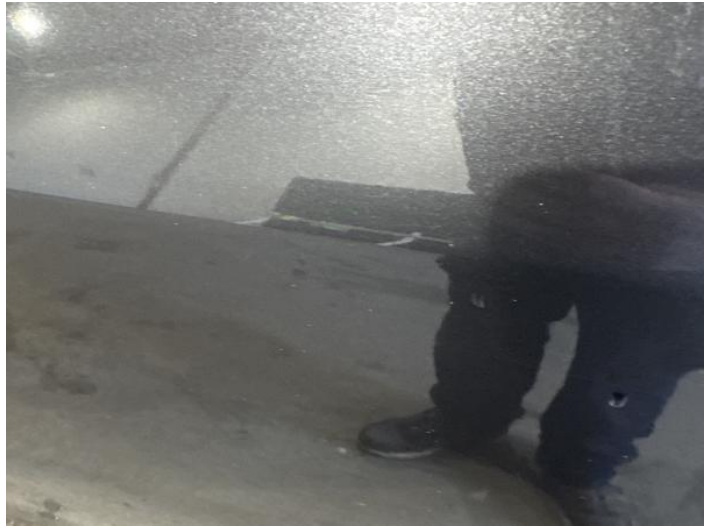
4: Door nsf
Chipped
1 To 5

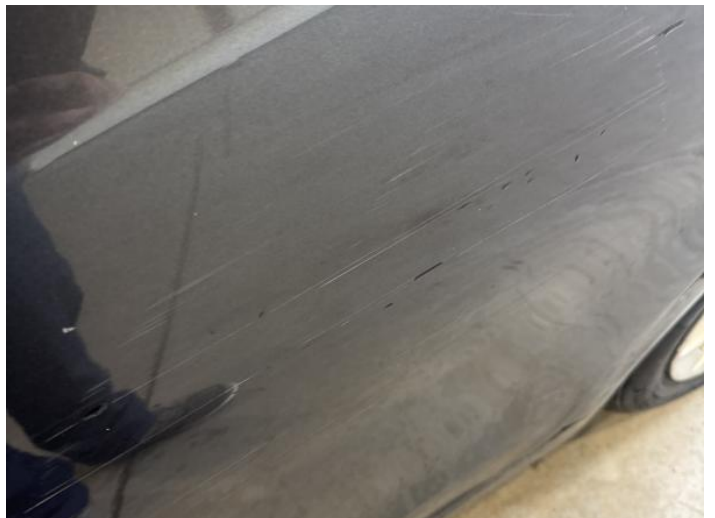
6: Door nsf
Dented
With Paint Damage

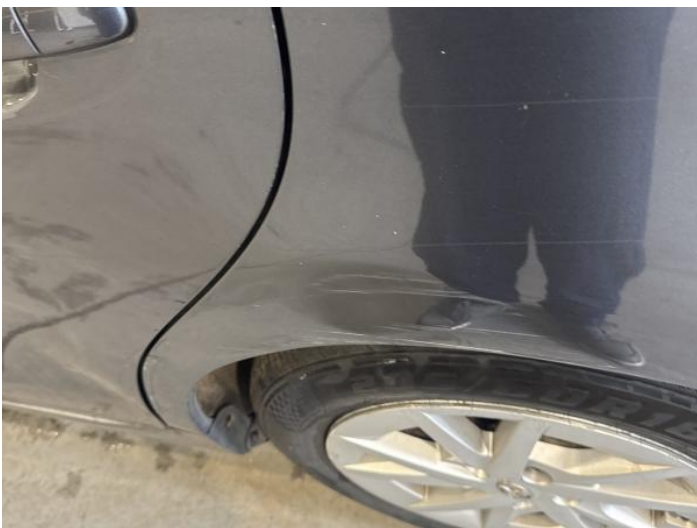
7: Qtr Panel nsr
Dented
With Paint Damage

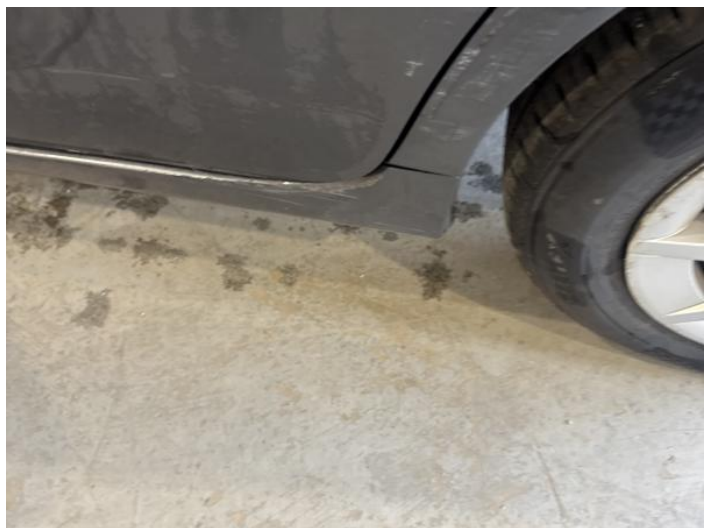
8: Sill ns
Dented
With Paint Damage

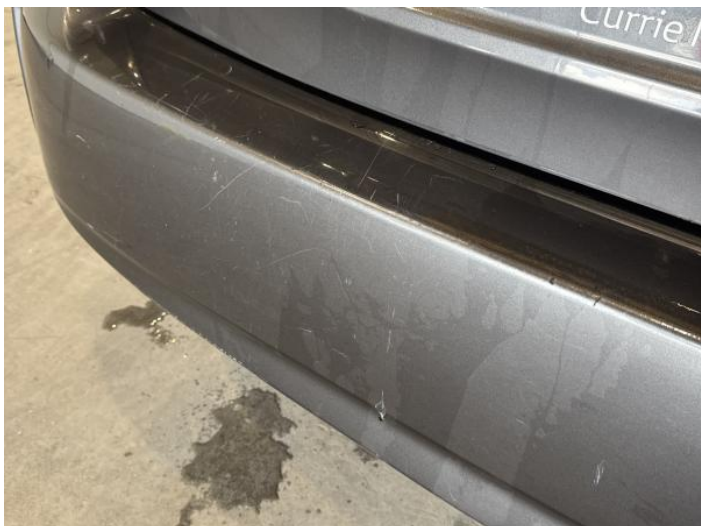
9: Bumper Rear
Dented
With Paint Damage

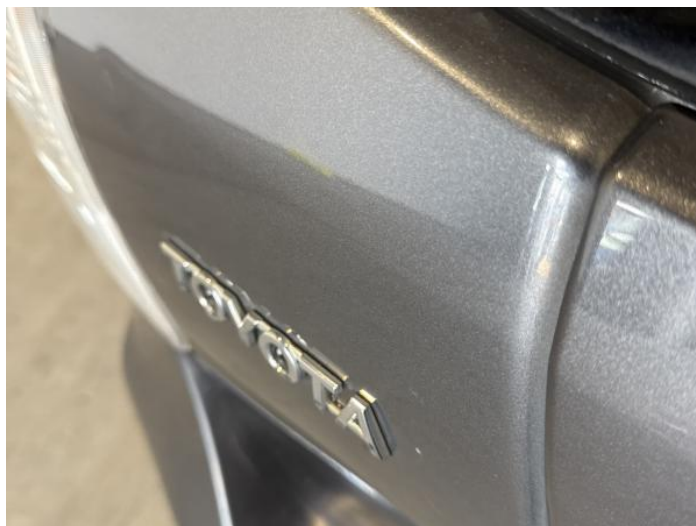
10: Boot Lid
Dented
Between 10mm + 30mm

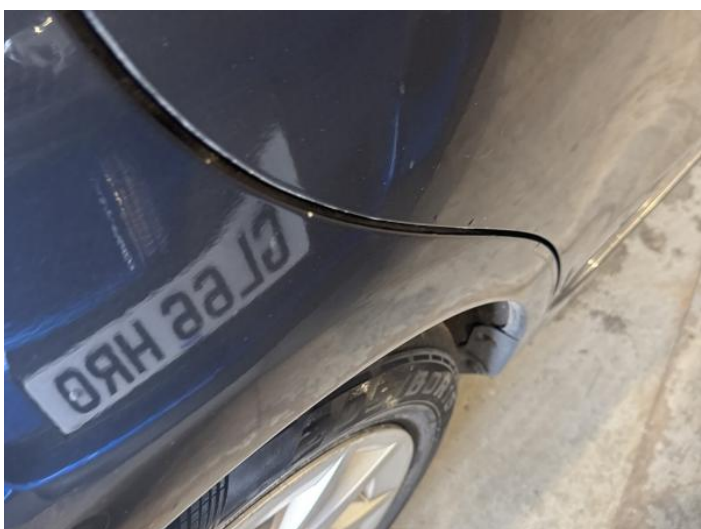
11: Qtr Panel osr
Dented
2 Or Less UpTo 10mm

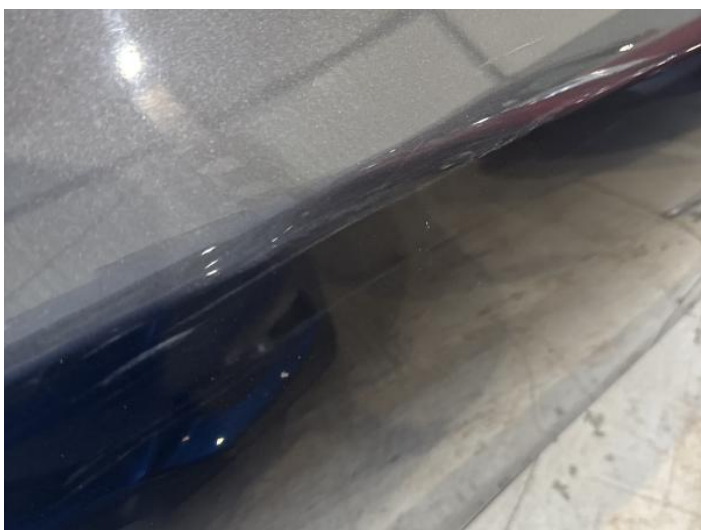
13: Door osr
Dented
With Paint Damage

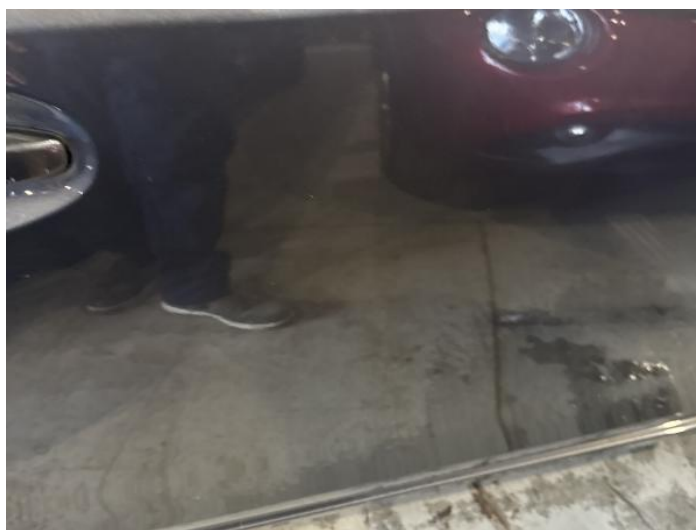
14: Door osf
Chipped
1 To 5

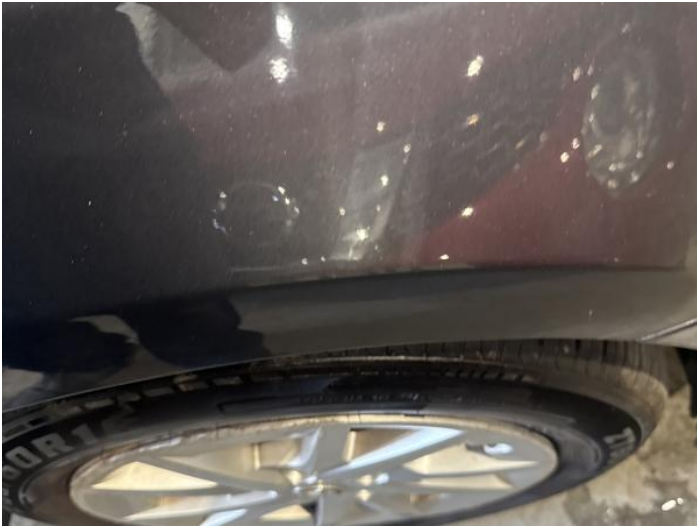
15: Wing osf
Chipped
1 To 5

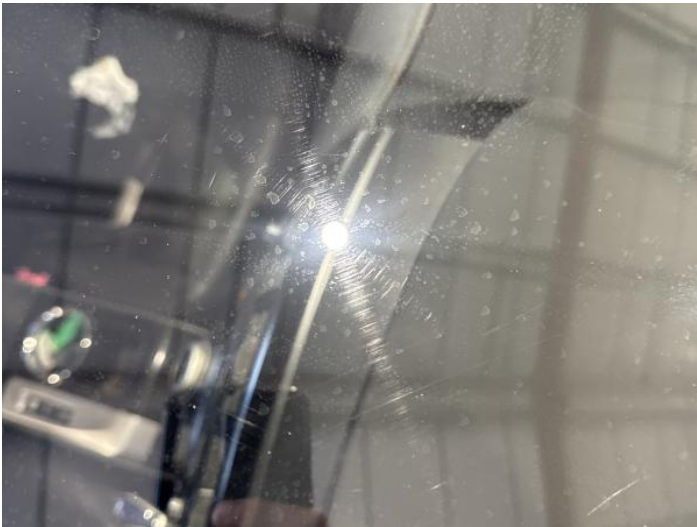
17: Screen Front
Chipped
UpTo 10mm
