# VEHICLE INSPECTION REPORT

**VA11OAD**

## Nissan Micra 1.2 DiG-S Tekna 5dr CVT

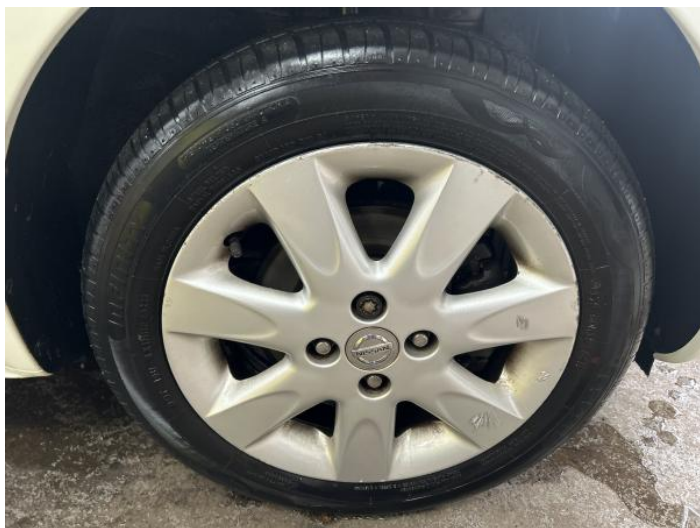
1: Wheel osf  
Scratched  
Over 50mm

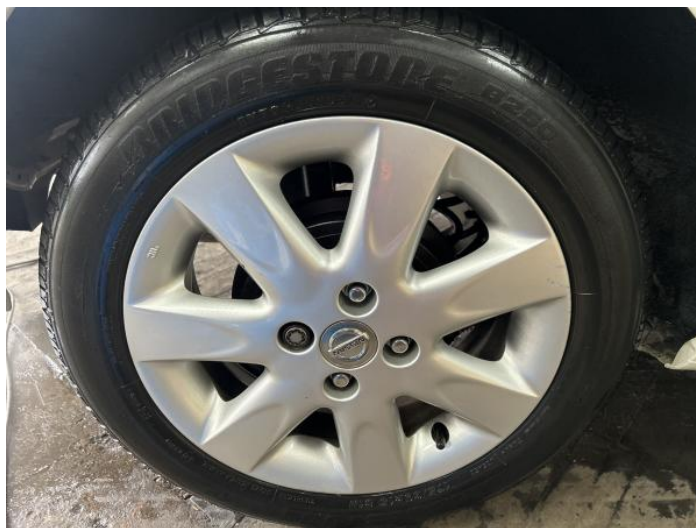
2: Wheel osr  
Scratched  
Up To 50mm

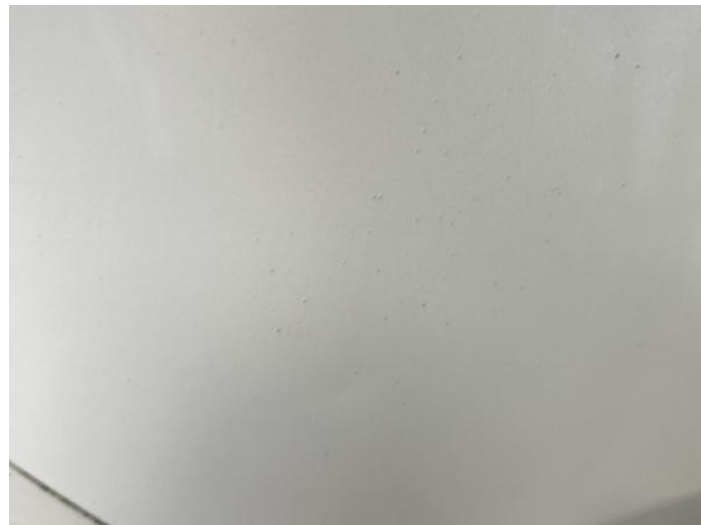
7: Qtr Panel osr  
Dented  
2 Or Less UpTo 10mm

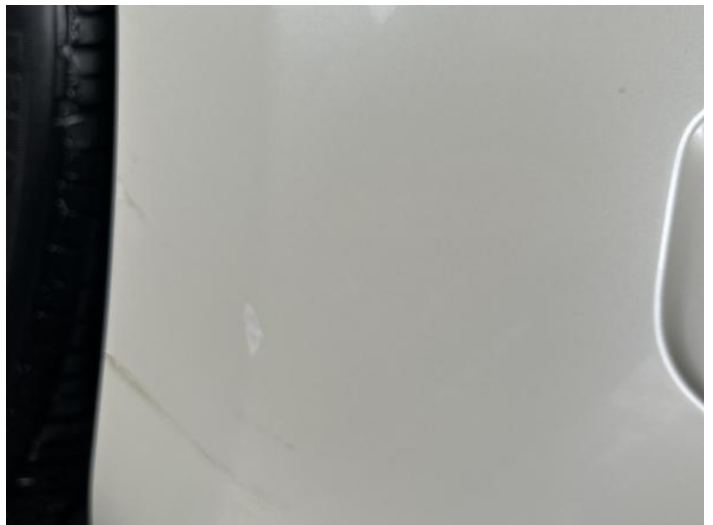
8: Bumper Rear  
Scratched  
Over 100mm Thru Paint

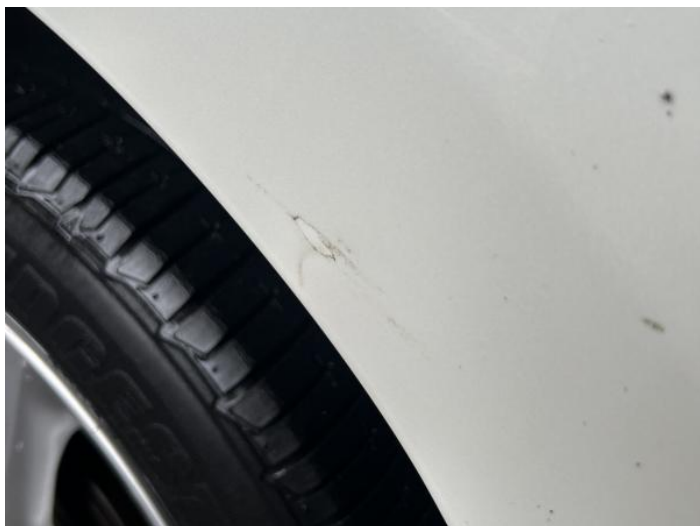
9: Qtr Panel nsr  
Chipped  
1 To 5

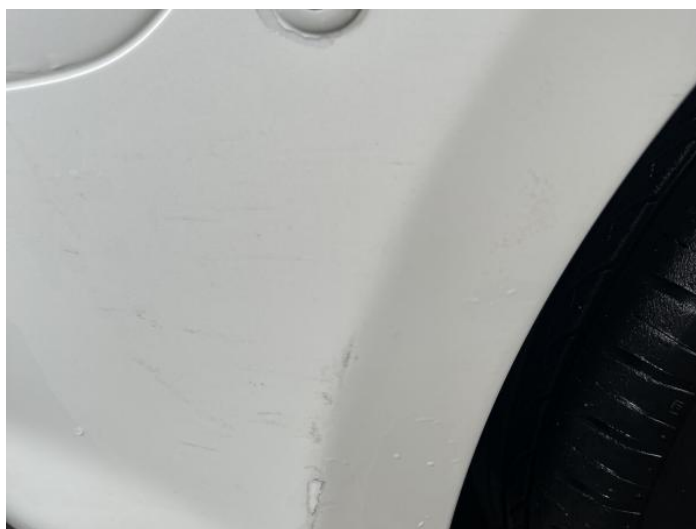
14: Bumper Front  
Scratched  
25 to 100mm Thru Paint

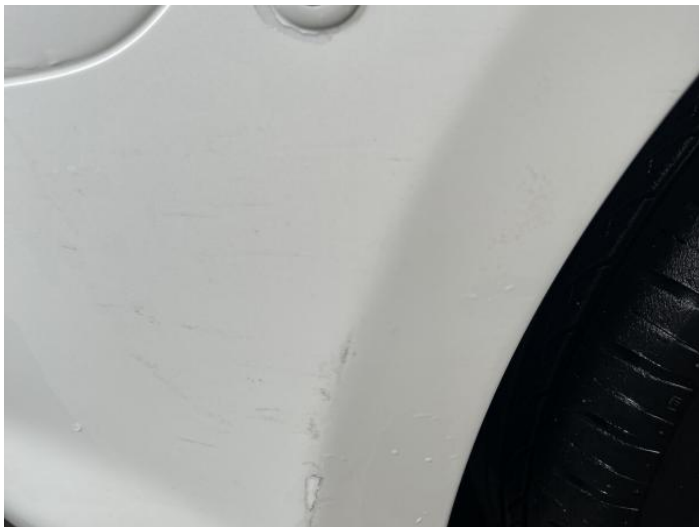
15: Bumper Front  
Scratched  
25 to 100mm Thru Paint

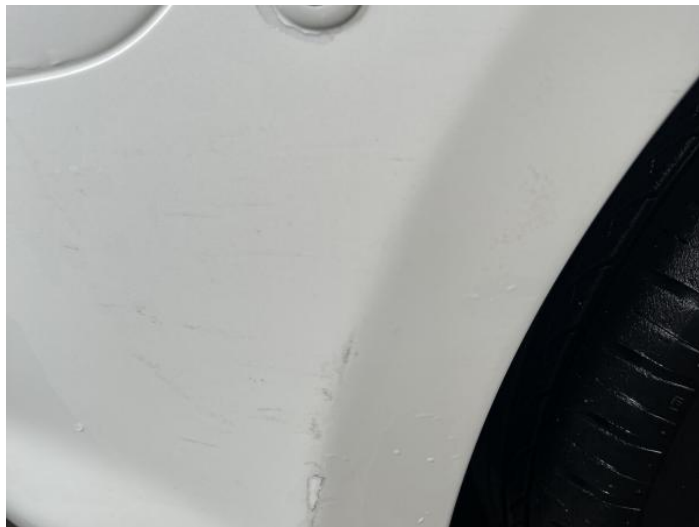
16: Bumper Front  
Scratched  
25 to 100mm Thru Paint

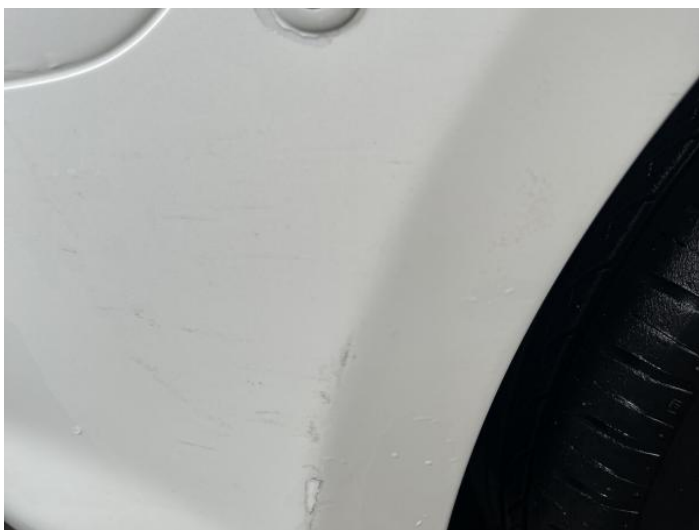
17: Bumper Front  
Scratched  
25 to 100mm Thru Paint

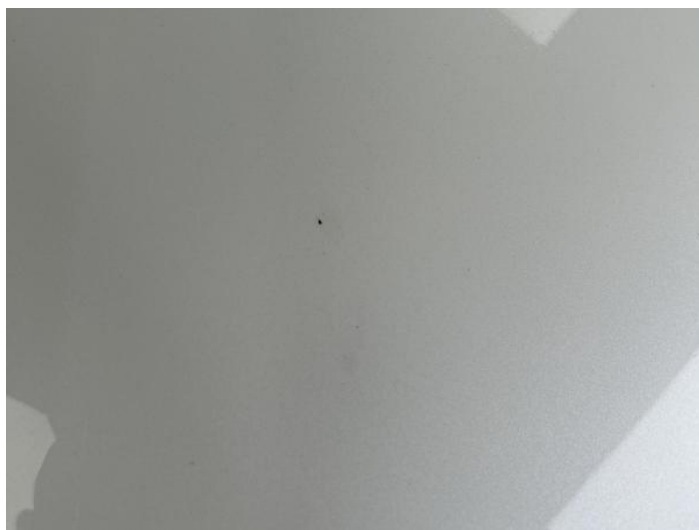
18: Bonnet  
Chipped  
1 To 5

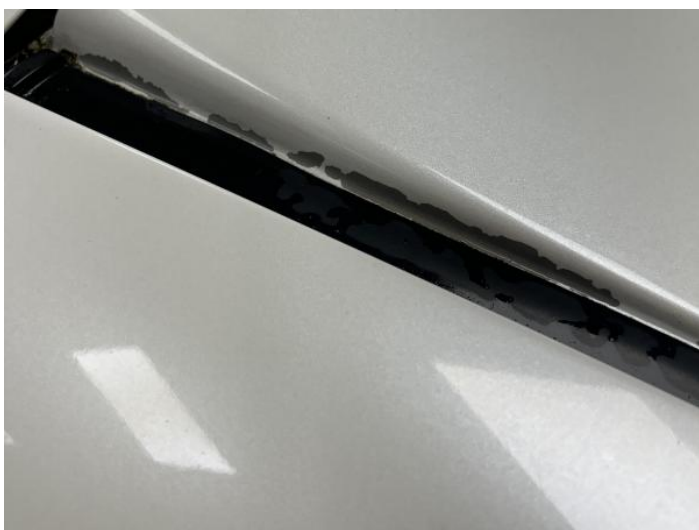
19: Roof  
Poor Previous Repair  
Paint Flake

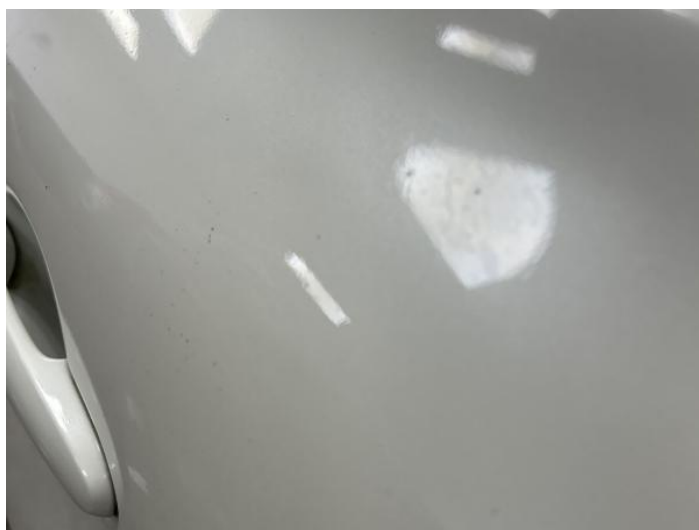
20: Door osr  
Dented  
Over 2 UpTo 10mm

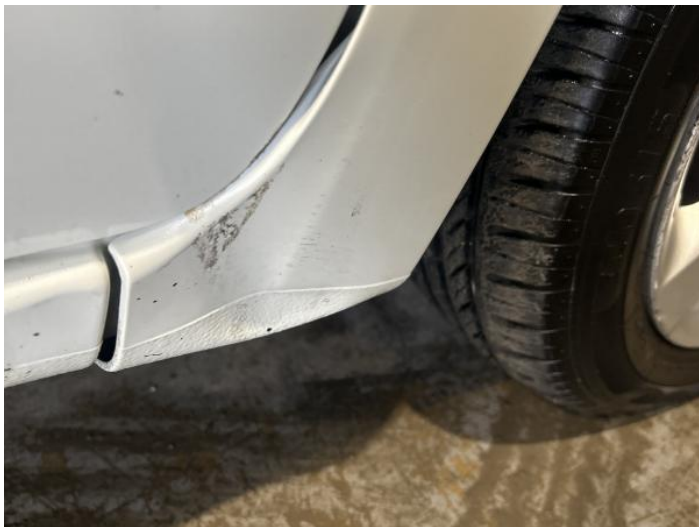
21: Wing osf  
Dented  
Over 30mm
