# VEHICLE INSPECTION REPORT

**HV11ZYY**

## Hyundai I10 1.2 Classic 5dr

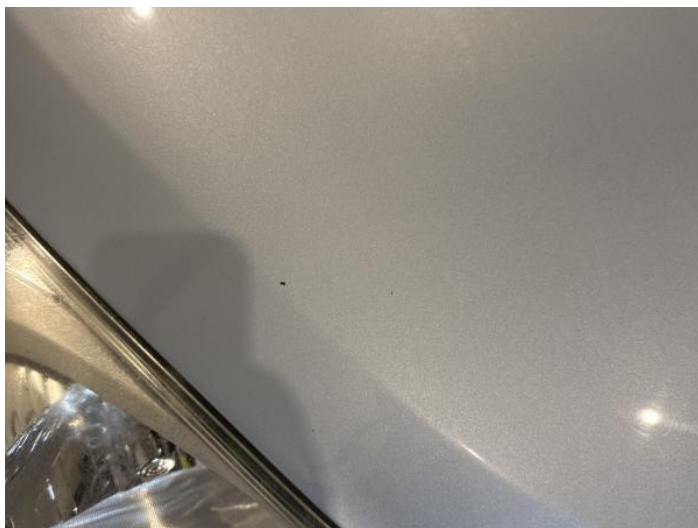
1: Bonnet  
Chipped  
1 To 5

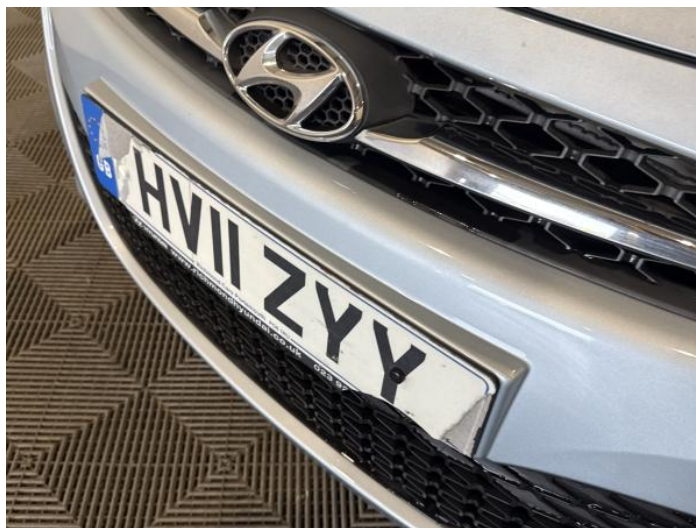
2: Number Plate Front  
Broken  
Replace

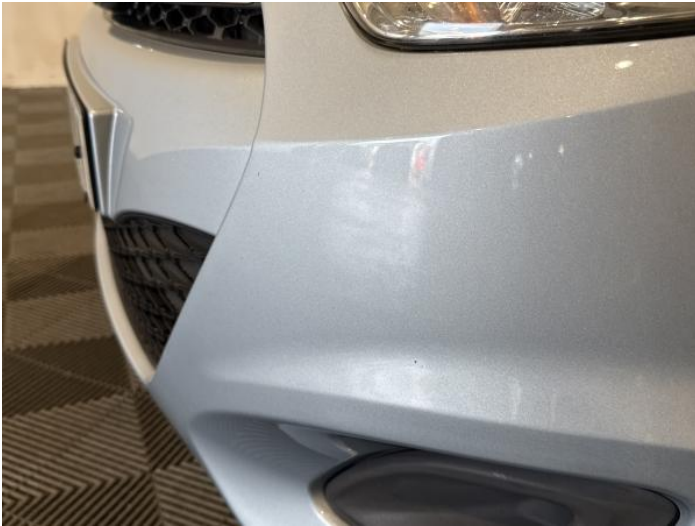
3: Bumper Front  
Chipped  
1 To 5

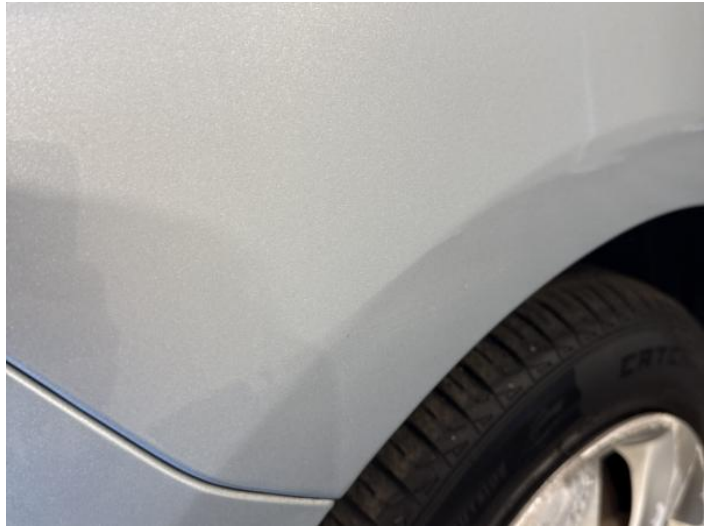
4: Wing nsf  
Chipped  
1 To 5

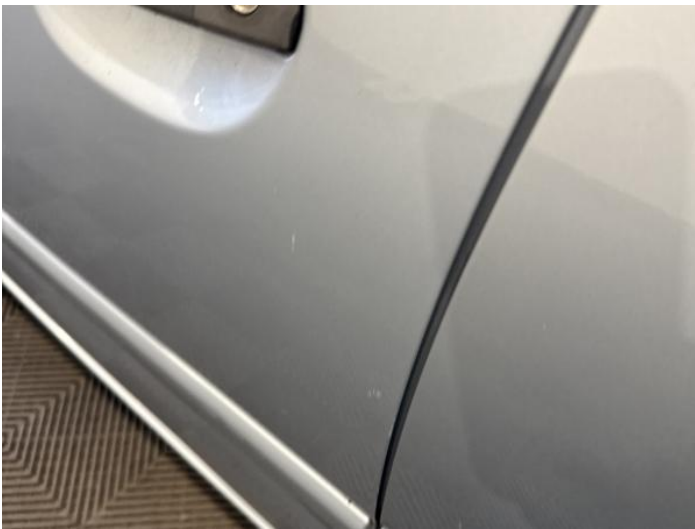
5: Door nsf  
Scratched  
UpTo 25mm Thru Paint

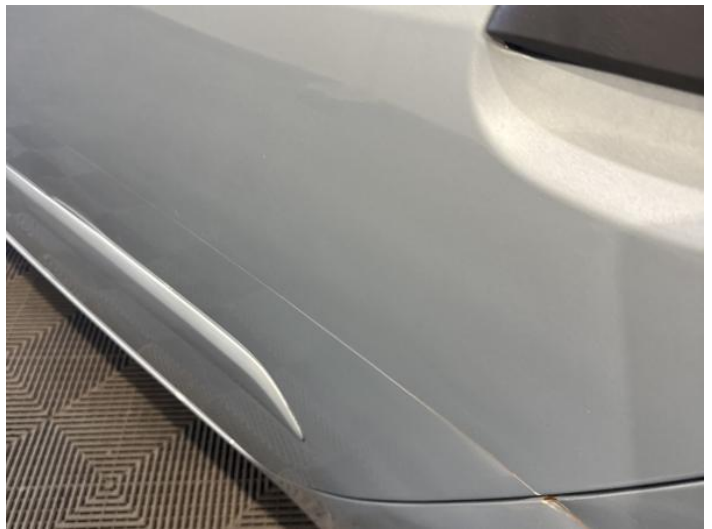
6: Door nsr  
Dented  
With Paint Damage

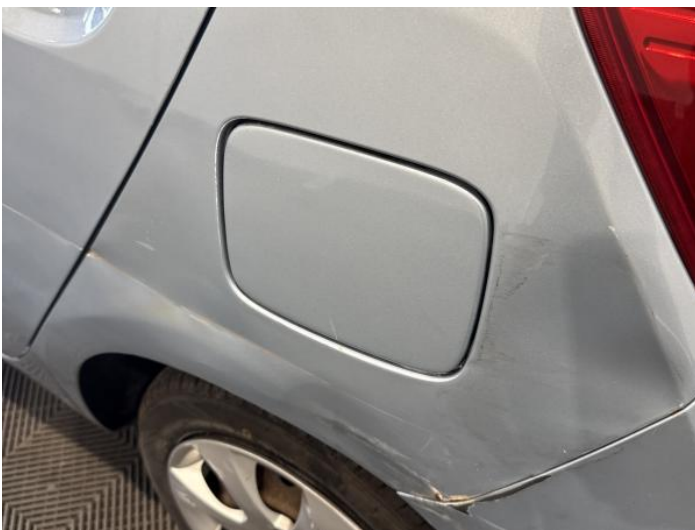
7: Qtr Panel nsr  
Dented  
With Paint Damage

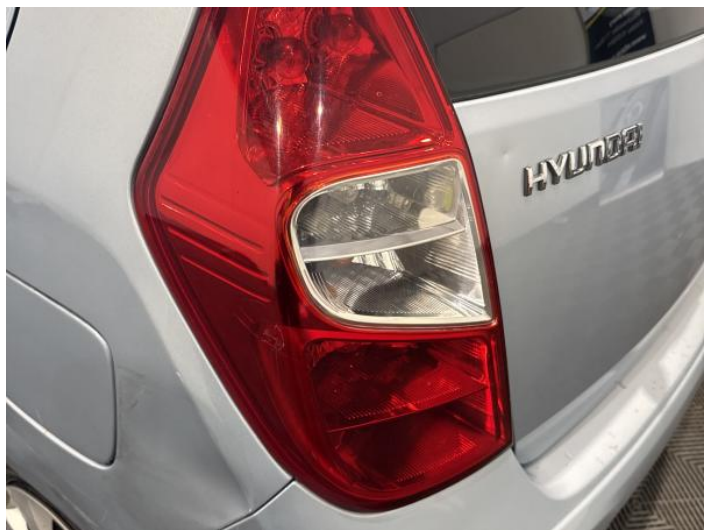
8: Lamp nsr  
Broken  
Replace

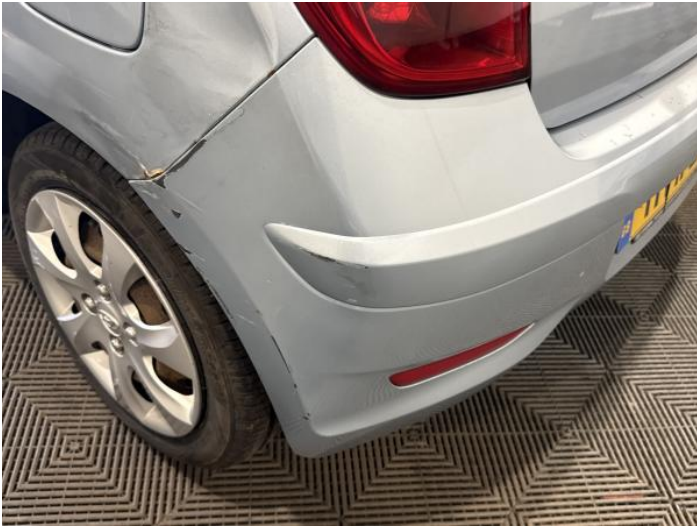
9: Bumper Rear  
Scratched  
Over 100mm Thru Paint

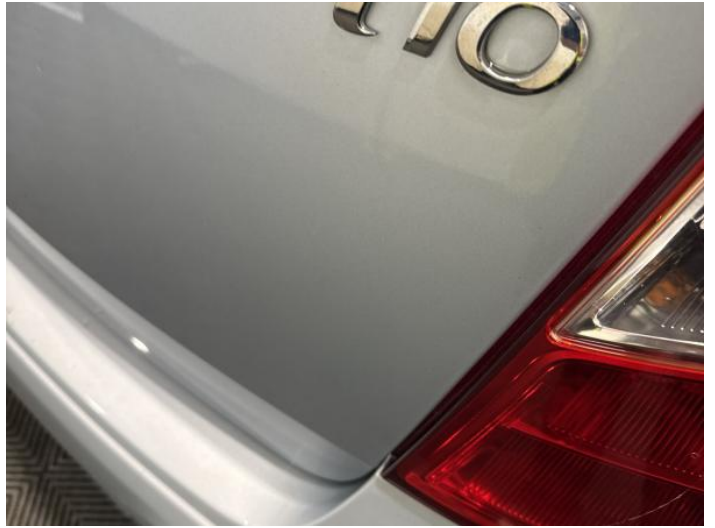
10: Tailgate  
Chipped  
1 To 5

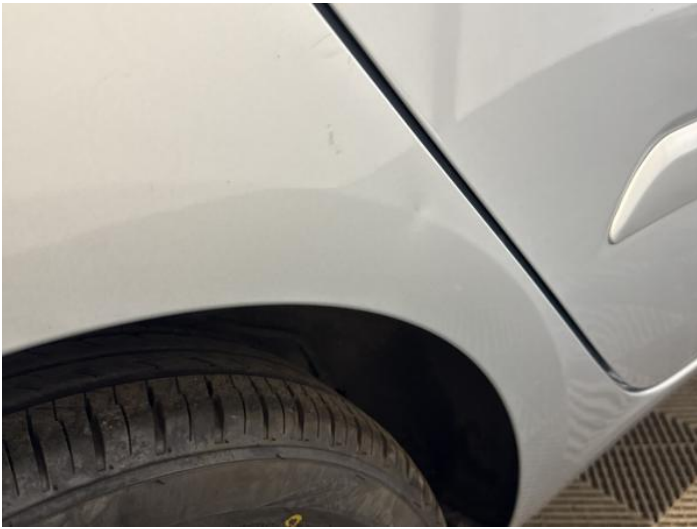
11: Qtr Panel osr  
Dented  
Between 10mm + 30mm

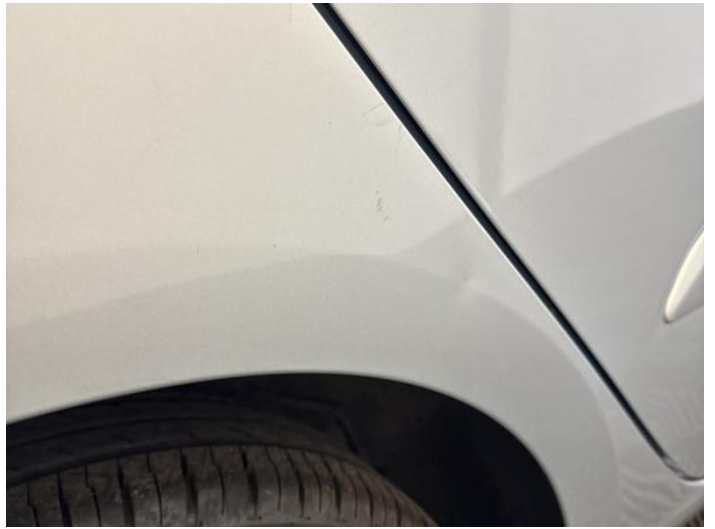
12: Qtr Panel osr  
Scratched  
UpTo 25mm Thru Paint

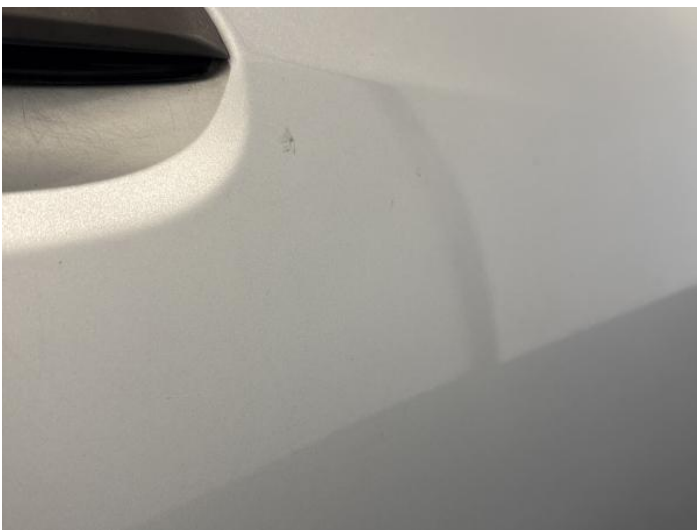
13: Door osr  
Scratched  
UpTo 25mm Thru Paint

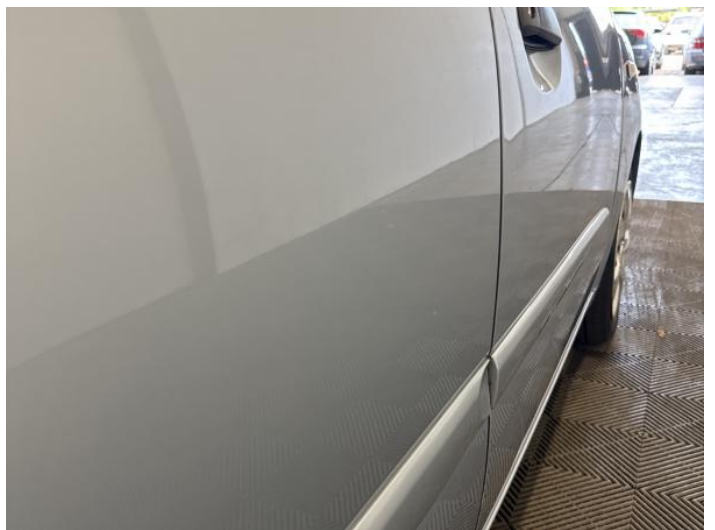
14: Door osr  
Dented  
Between 10mm + 30mm

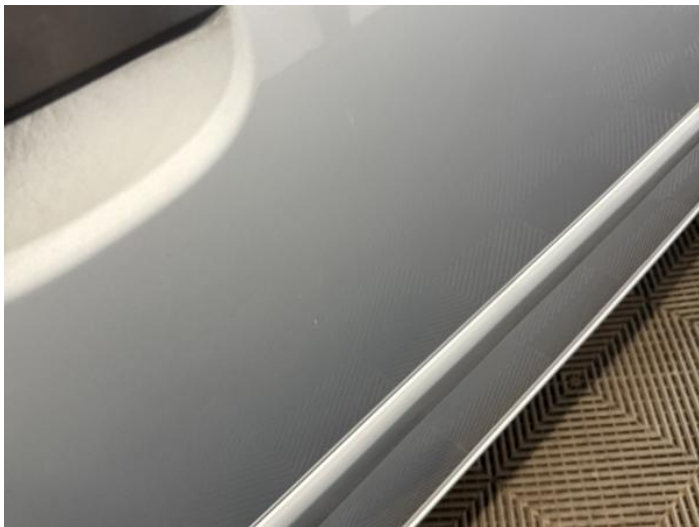
15: Door osf  
Scratched  
UpTo 25mm Thru Paint

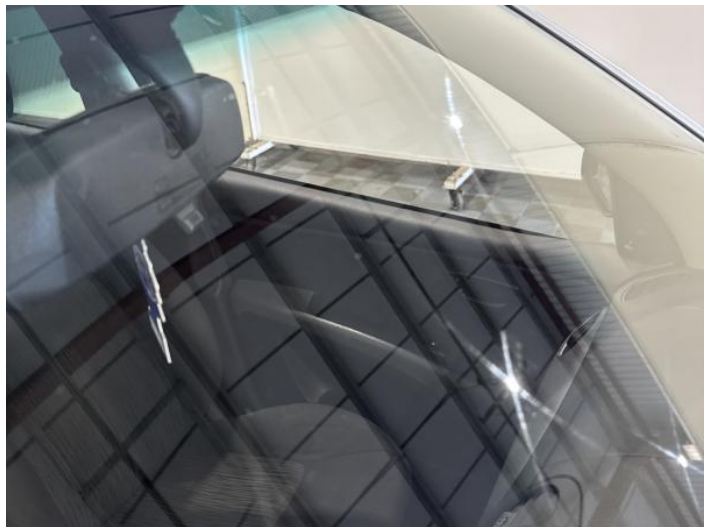
16: Screen Front  
Chipped  
Over 10mm
