# VEHICLE INSPECTION REPORT

**KP66URK**

## Mercedes-Benz B Class B180d AMG Line Executive 5dr Auto

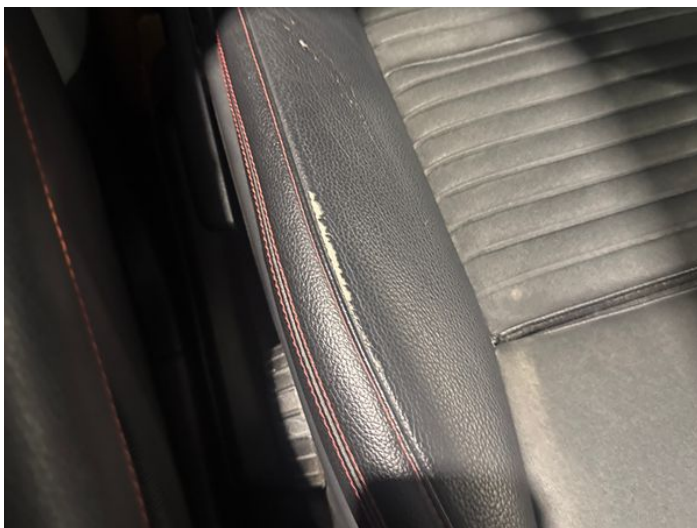
1: Seat Base Cover osf  
Scuffed  
Over 25mm

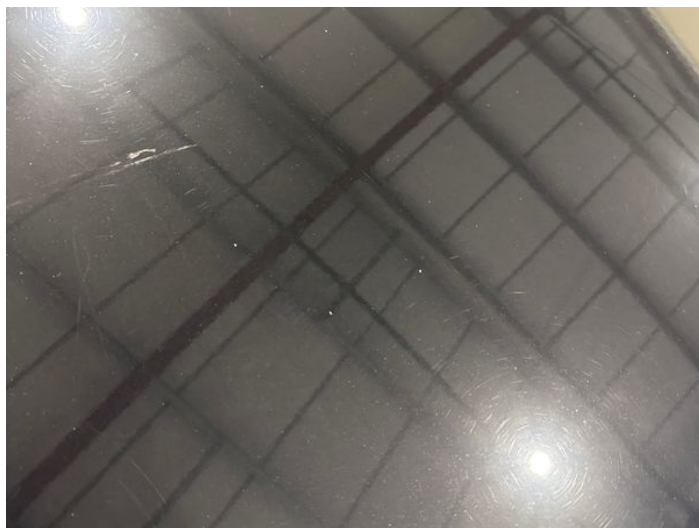
2: Bonnet  
Chipped  
Multiple Chips

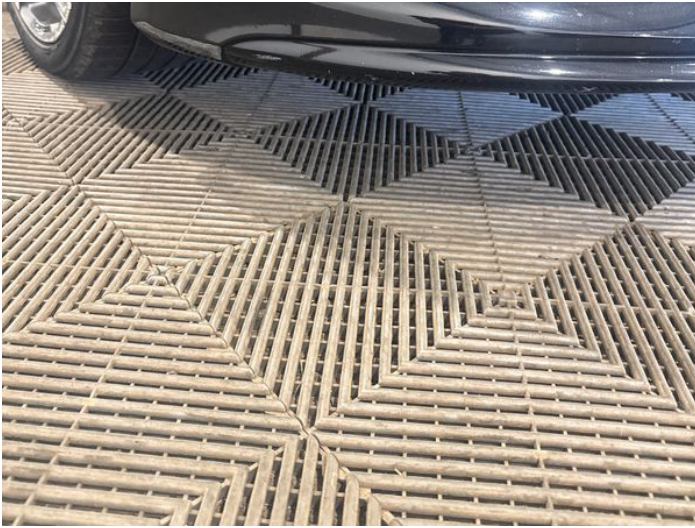
3: Bumper Front  
Scratched  
25 to 100mm Thru Paint

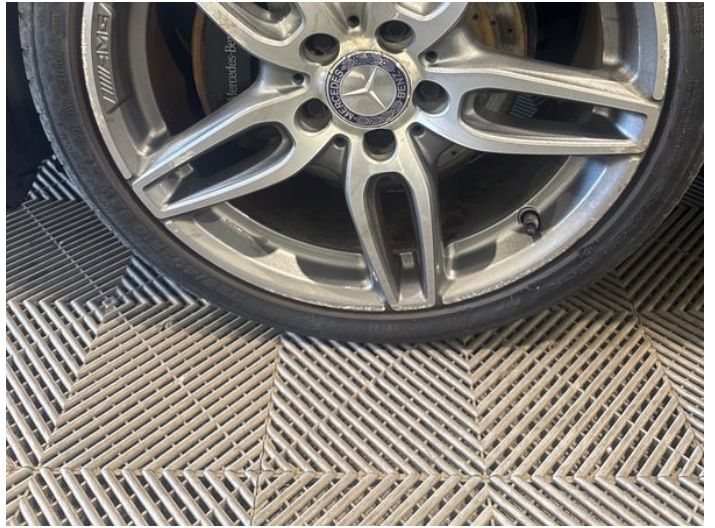
4: Wheel nsf  
Scratched  
Over 50mm

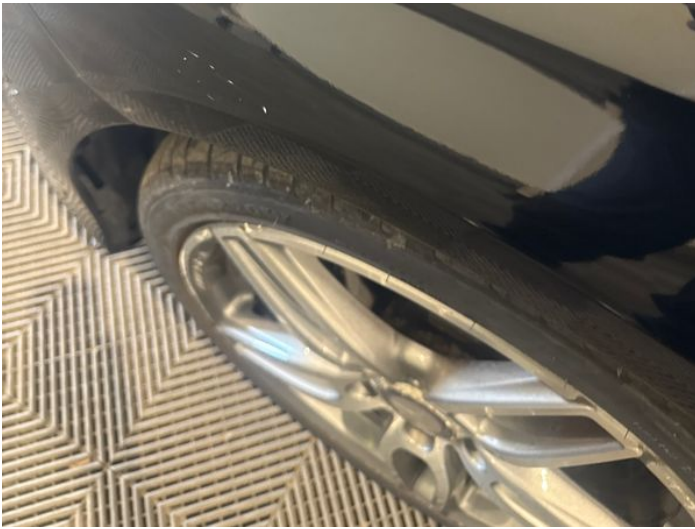
5: Wing nsf  
Chipped  
1 To 5

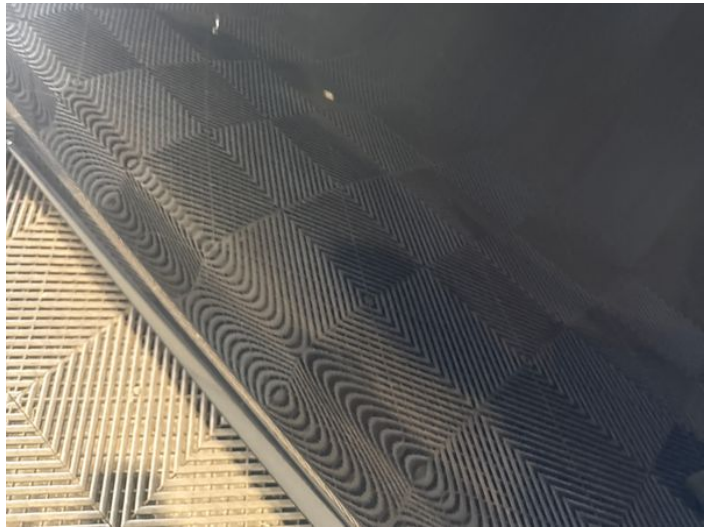
6: Door nsf  
Chipped  
Over 5mm

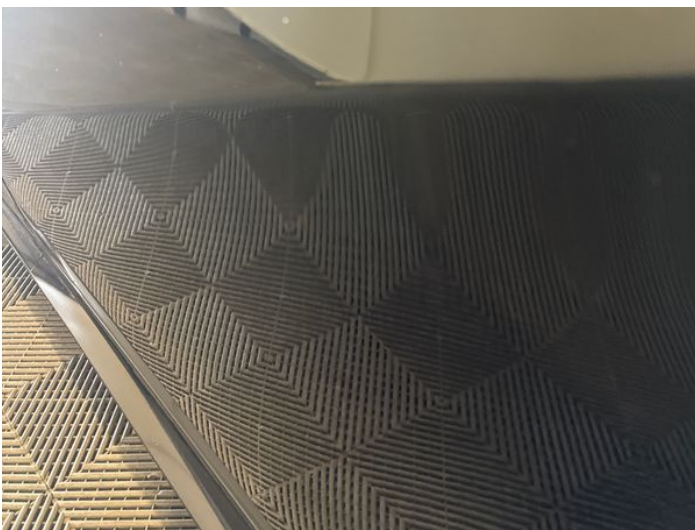
7: Door nsr  
Chipped  
1 To 5

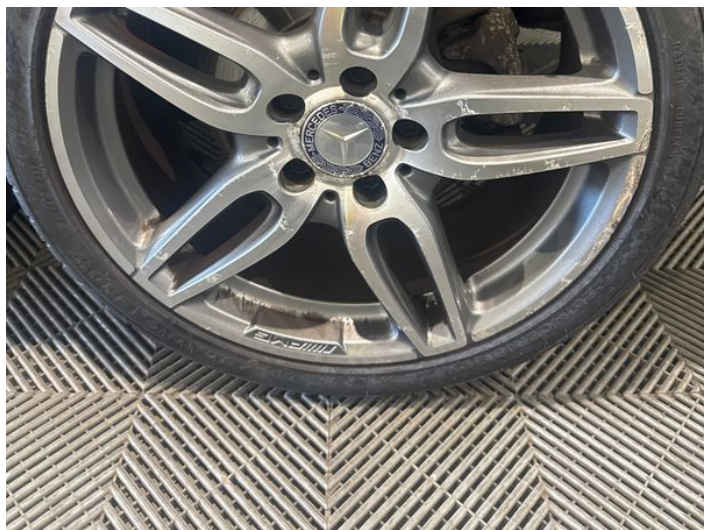
8: Wheel nsr  
Scratched  
Over 50mm

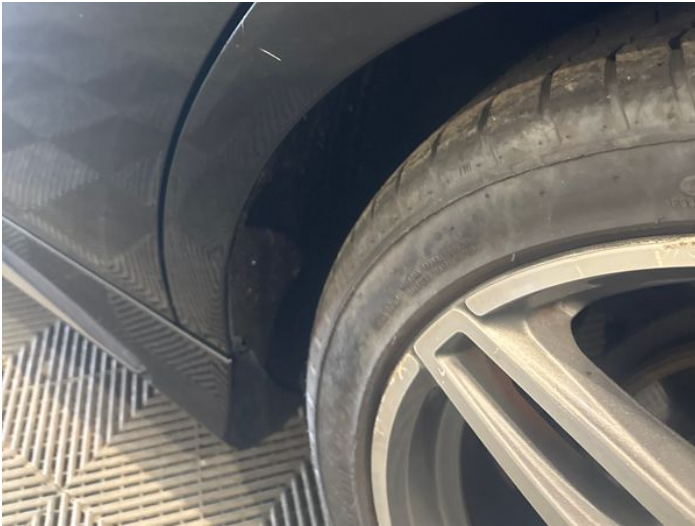
9: Qtr Panel nsr  
Scratched  
UpTo 25mm Thru Paint

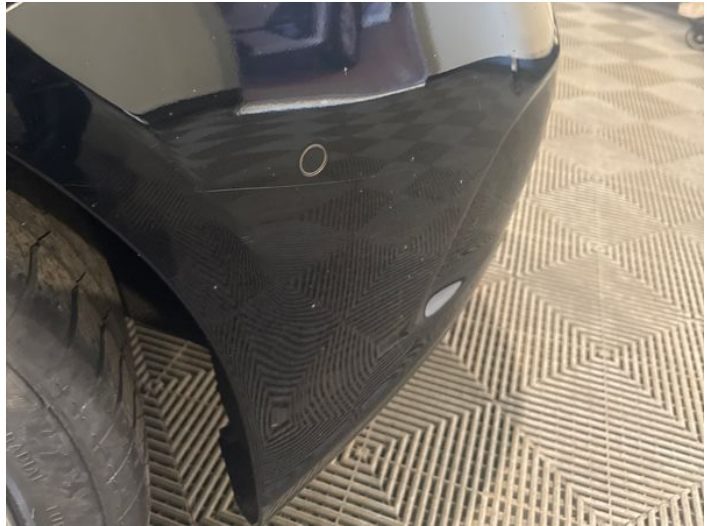
10: Bumper Rear  
Poor Previous Repair  
Poor Paint

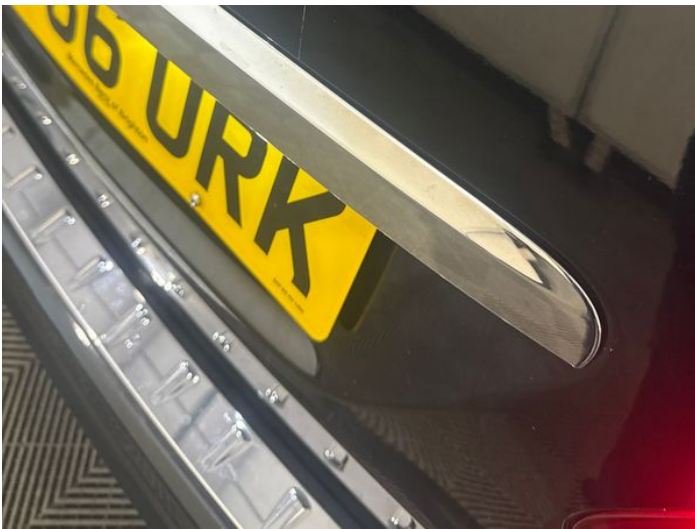
11: Tailgate  
Scratched  
Over 25mm Thru Paint

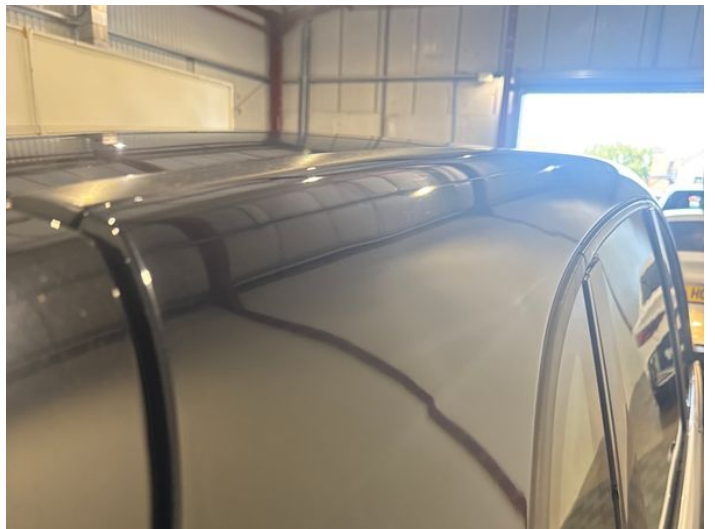
12: Qtr Panel osr  
Dented  
Over 30mm

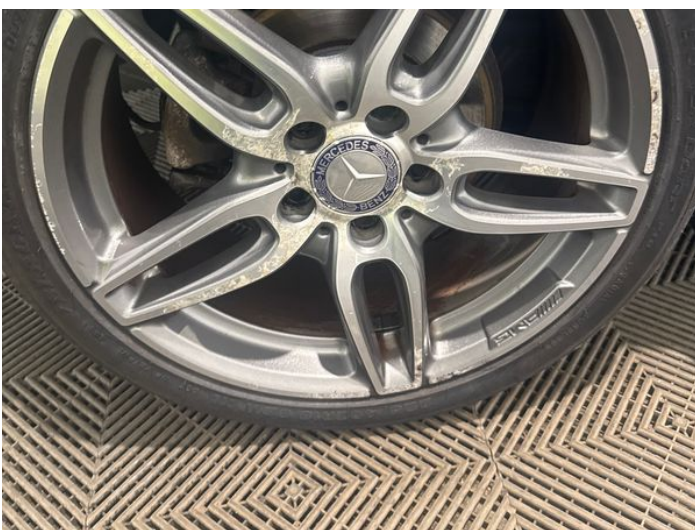
13: Wheel osr  
Scratched  
Over 50mm

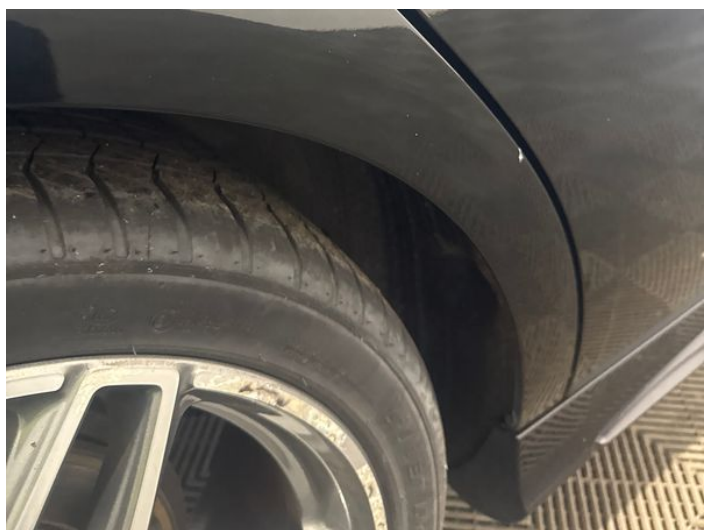
14: Qtr Panel osr  
Scratched  
UpTo 25mm Thru Paint

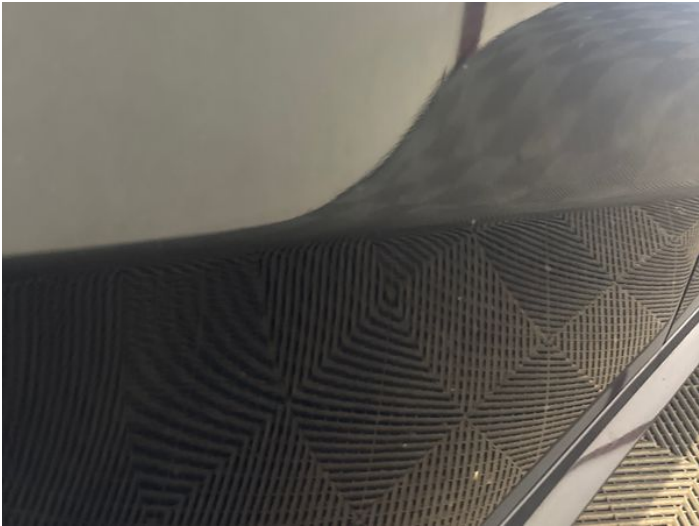
15: Door osr  
Chipped  
1 To 5

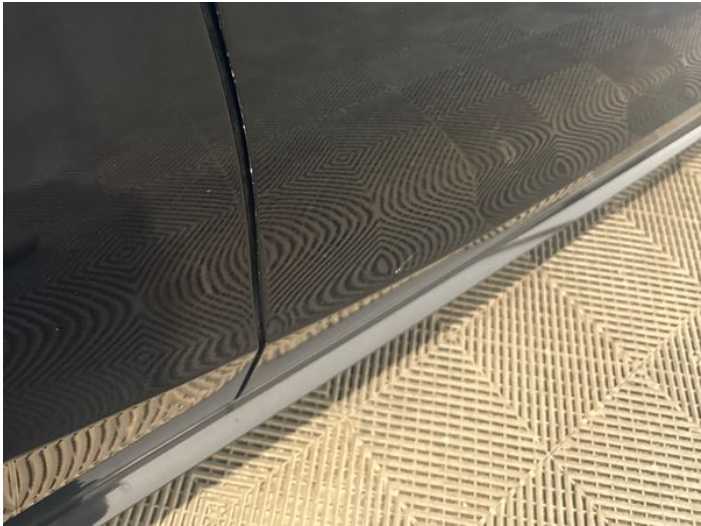
16: Door osf  
Chipped  
Edge Chip

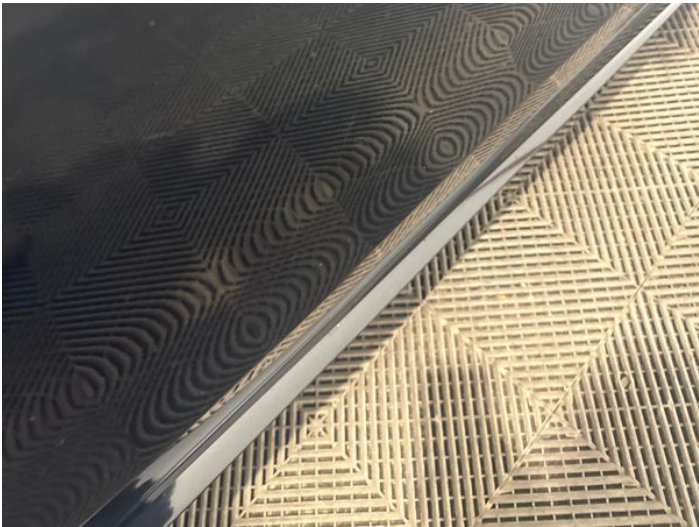
17: Door osf  
Scratched  
UpTo 25mm Thru Paint

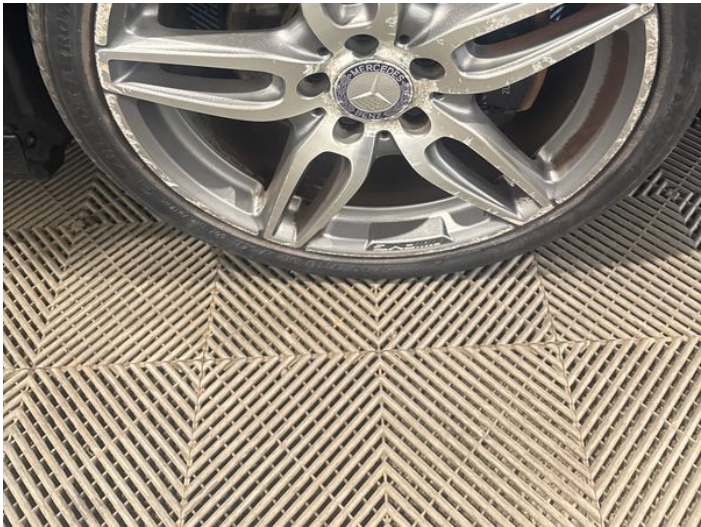
18: Wheel osf  
Scratched  
Over 50mm
