# VEHICLE INSPECTION REPORT

**MV66NNR**

## BMW X3 xDrive20d SE 5dr

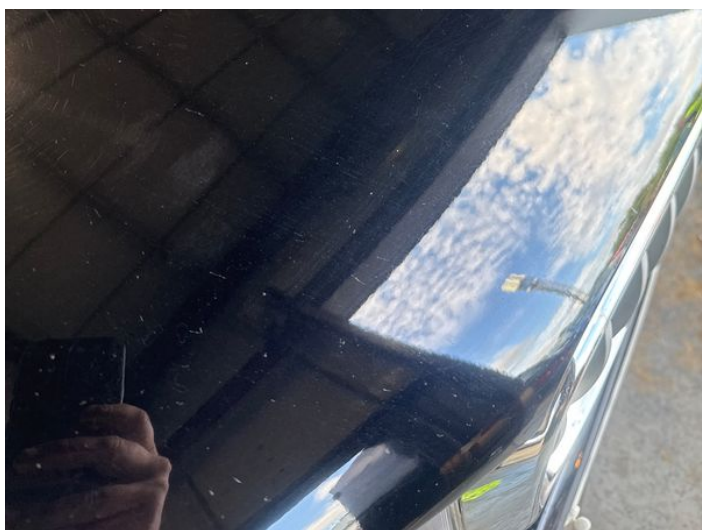
1: Bonnet  
Chipped  
Multiple Chips

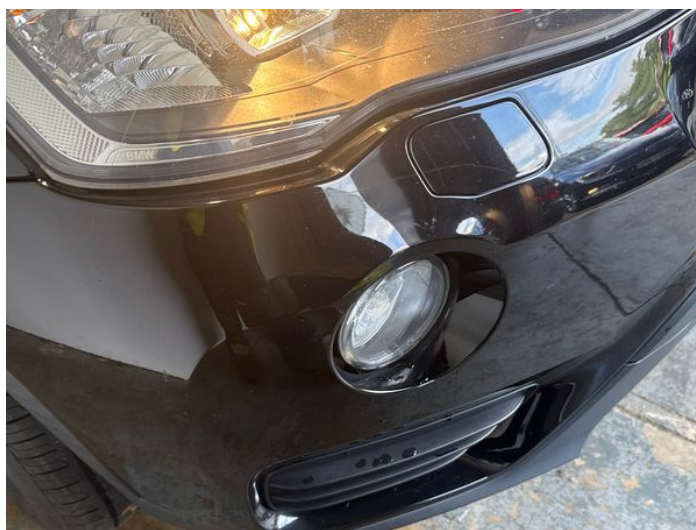
2: Bumper Front  
Scratched  
25 to 100mm Thru Paint

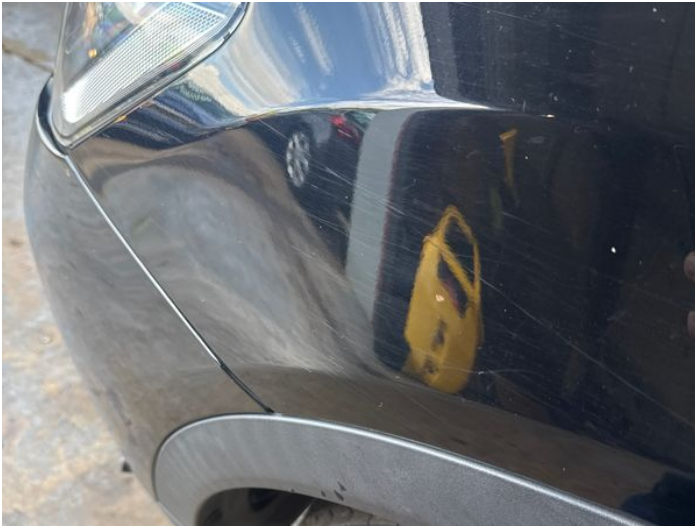
3: Wing nsf  
Scratched  
UpTo 25mm Thru Paint

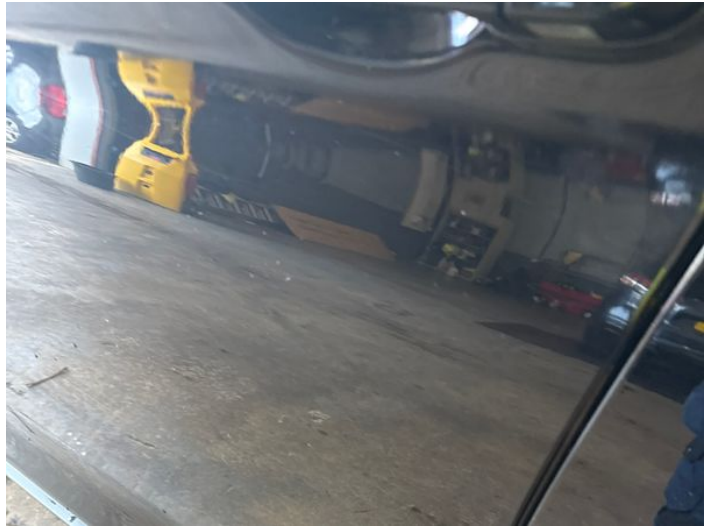
4: Door nsf  
Chipped  
1 To 5

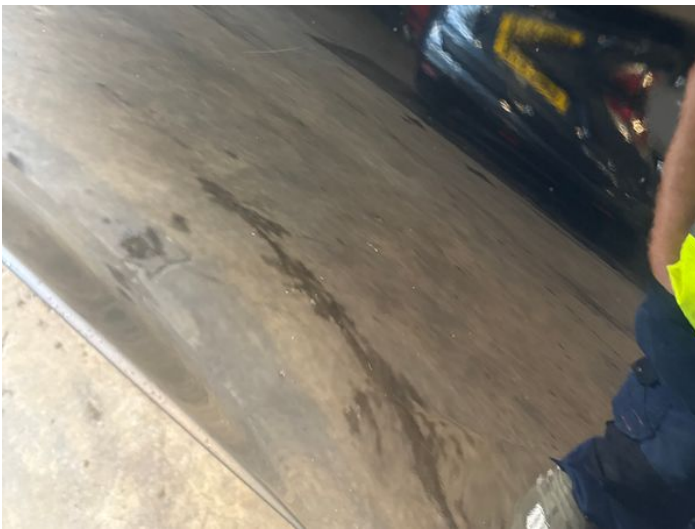
5: Door nsr  
Scratched  
UpTo 25mm Thru Paint

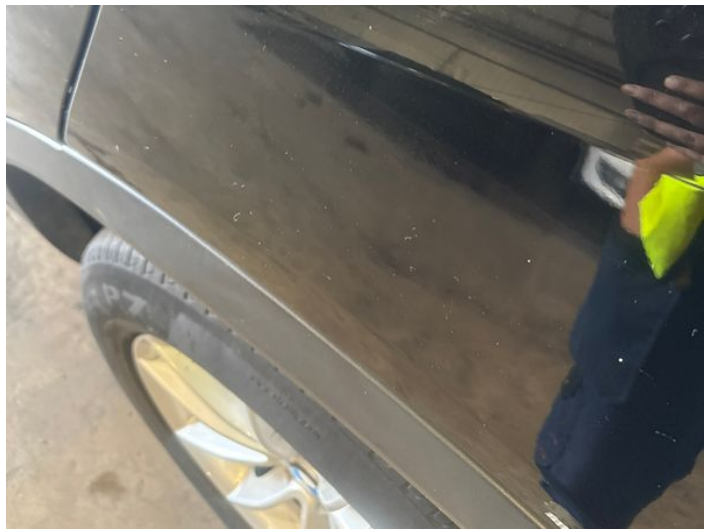
6: Qtr Panel nsr  
Chipped  
1 To 5

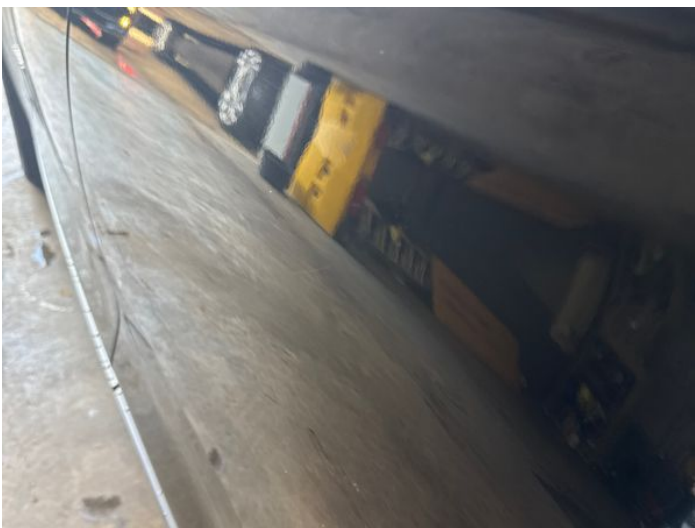
7: Door nsr  
Dented  
Between 10mm + 30mm

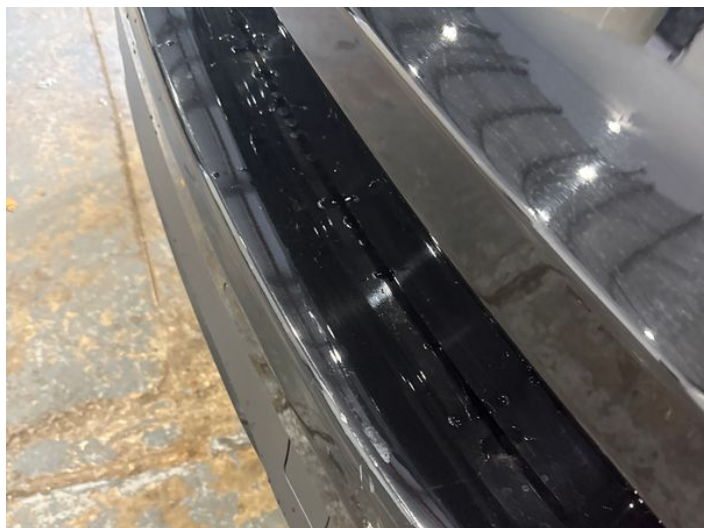
8: Bumper Rear  
Scratched  
25 to 100mm Thru Paint

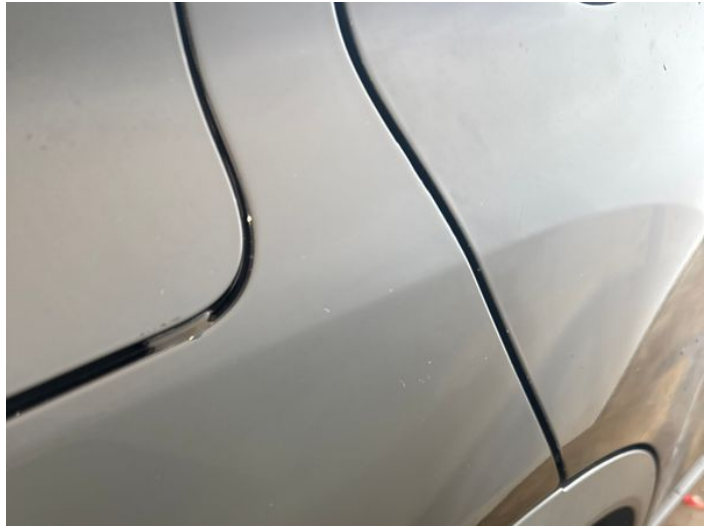
10: Qtr Panel osr  
Chipped  
1 To 5

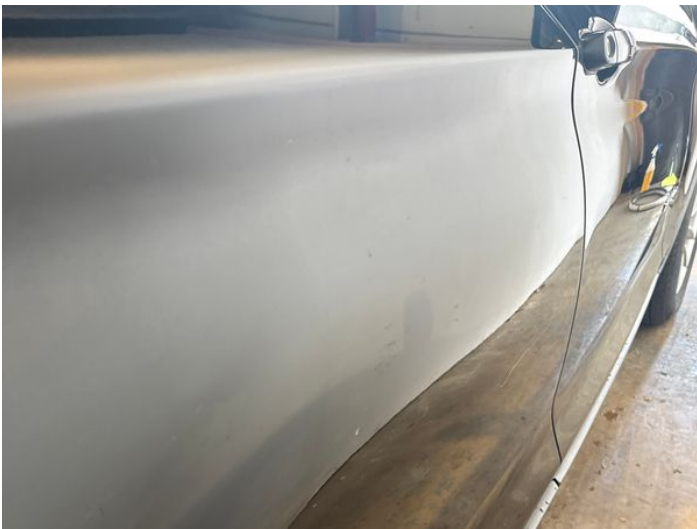
11: Door osr  
Dented  
With Paint Damage

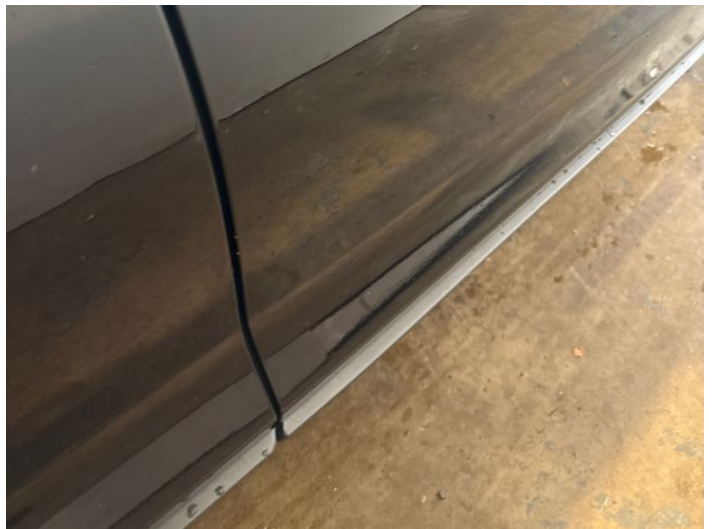
12: Door osf  
Chipped  
Edge Chip

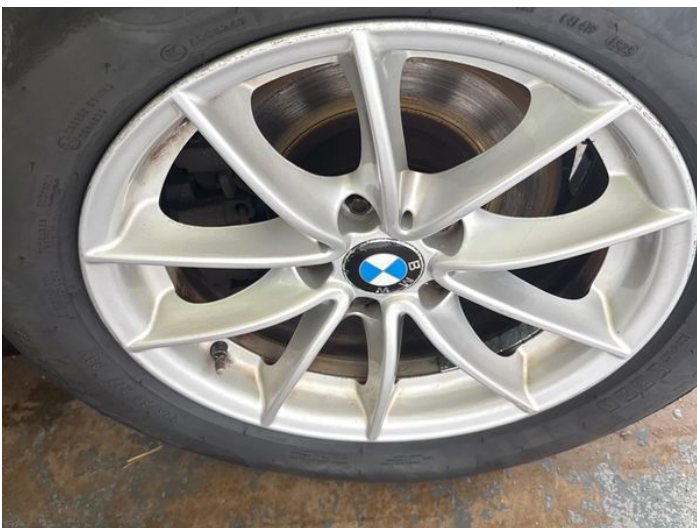
13: Wheel osf  
Scratched  
Over 50mm

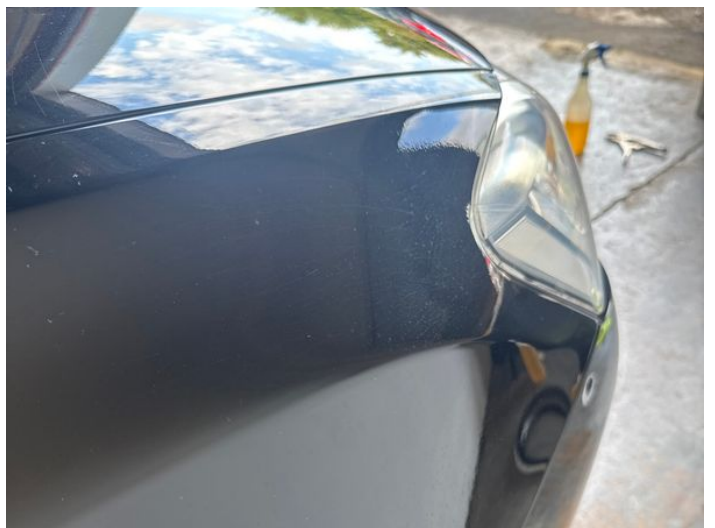
14: Wing osf  
Chipped  
1 To 5

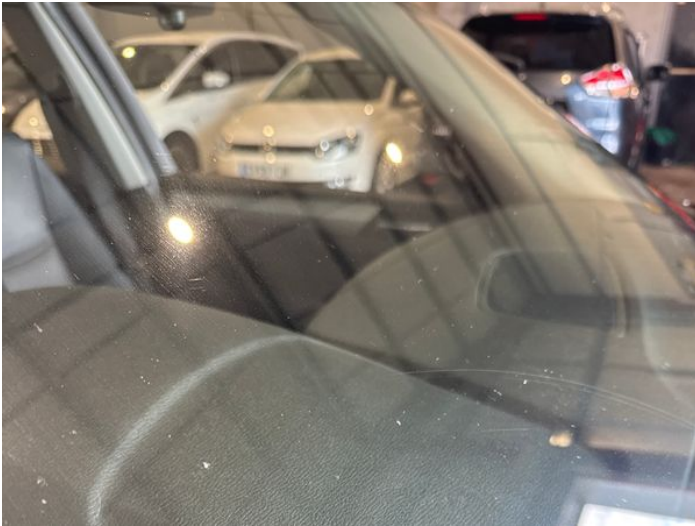
15: Screen Front  
Chipped  
UpTo 10mm

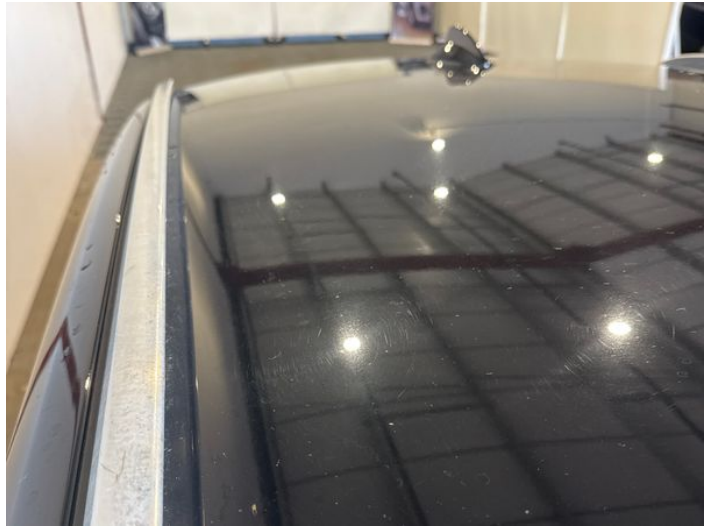
16: Roof  
Dented  
Over 30mm

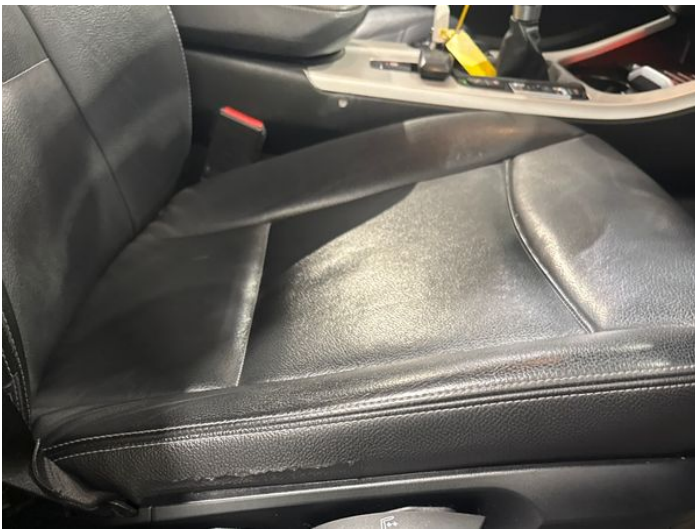
17: Seat Back Cover osf  
Scuffed  
Over 25mm

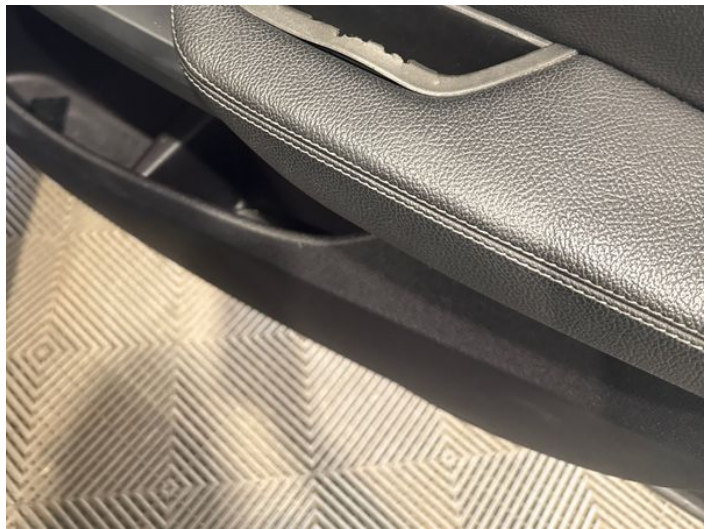
18: Door Pad osf  
Scuffed  
Over 25mm

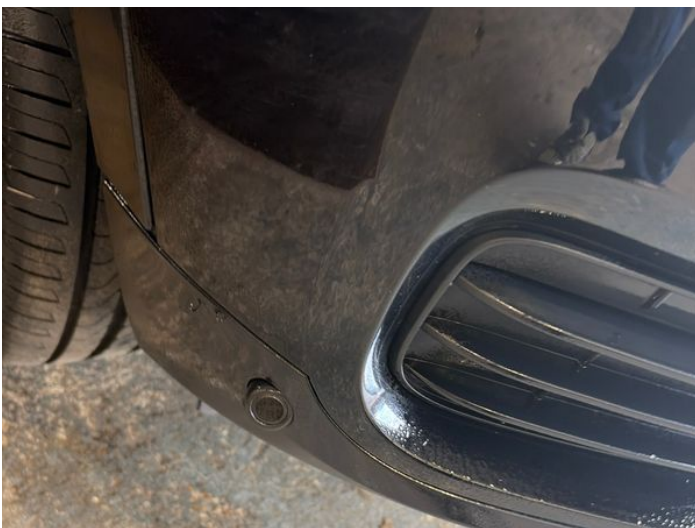
19: Bumper Front Moulding  
Scuffed (Unpainted)  
UpTo 100mm
