## VEHICLE INSPECTION REPORT

**EA71UJO**

### Mercedes-Benz Vito 85kW 41kWh Pure Van Auto

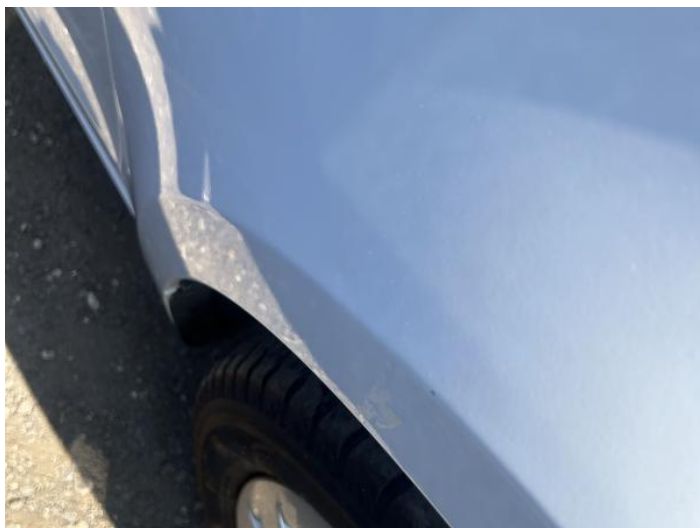
1: Wing osf  
Dented  
2 Or Less UpTo 10mm

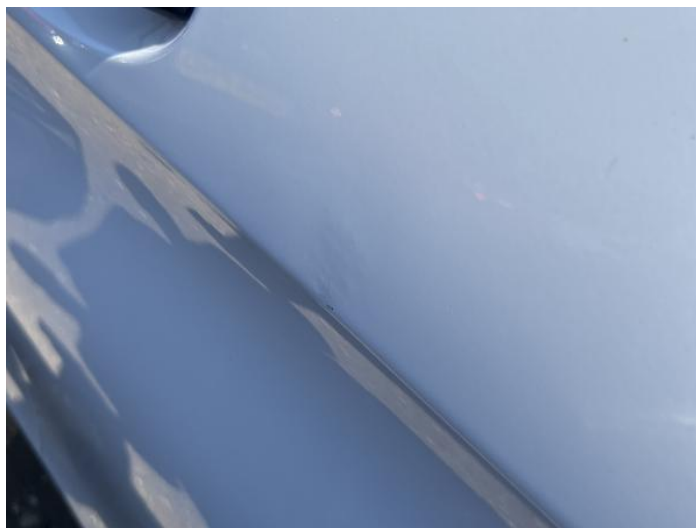
2: Door osf  
Poor Previous Repair  
Rippled UpTo 30%

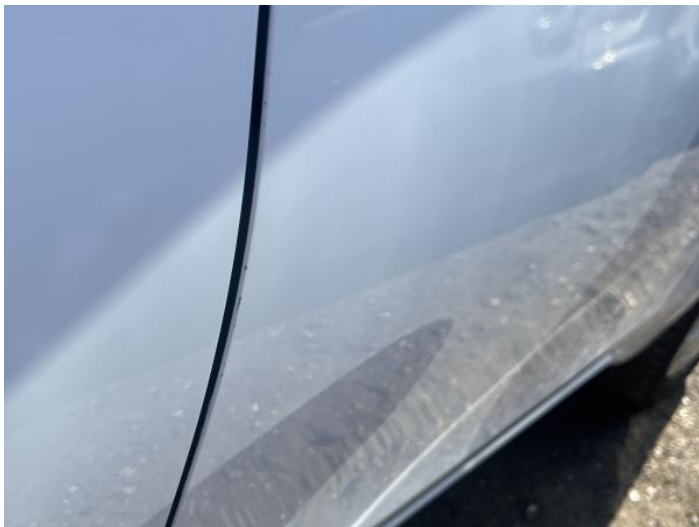
3: Door osf  
Chipped  
Edge Chip

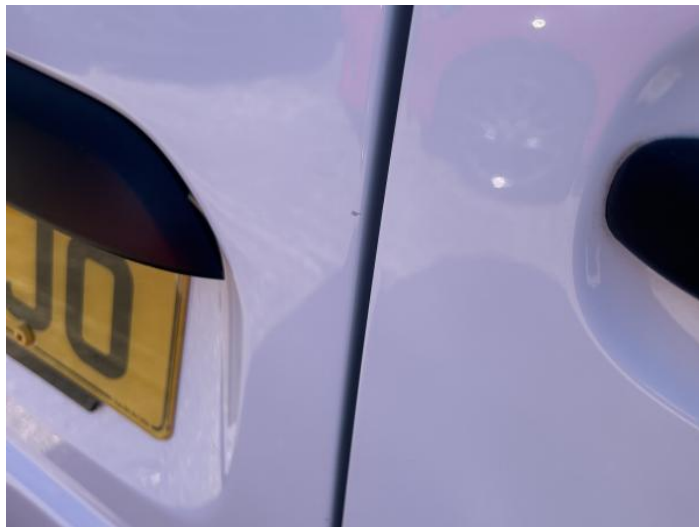
4: Tailgate  
Chipped  
1 To 5

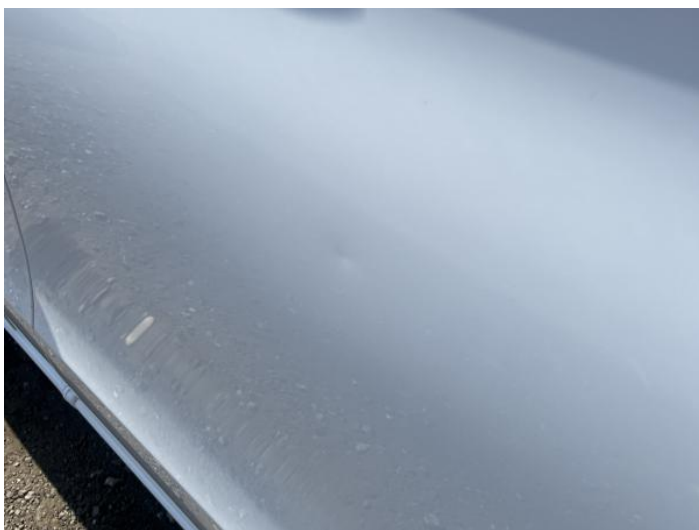
5: Door nsr  
Dented  
2 Or Less UpTo 10mm

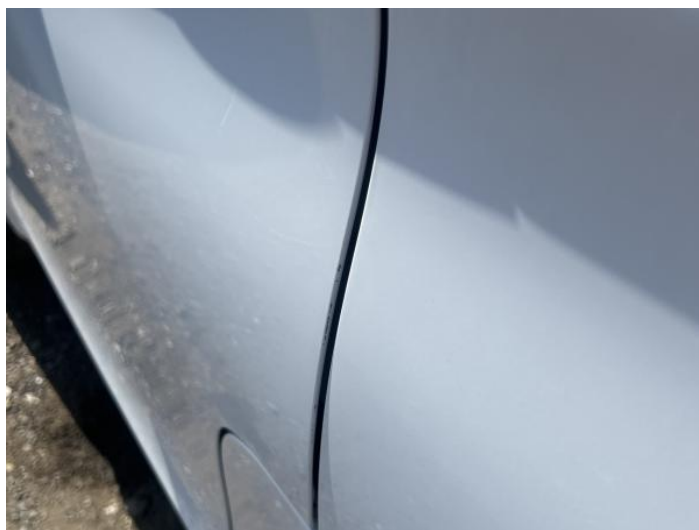
6: Door nsf  
Chipped  
Edge Chip

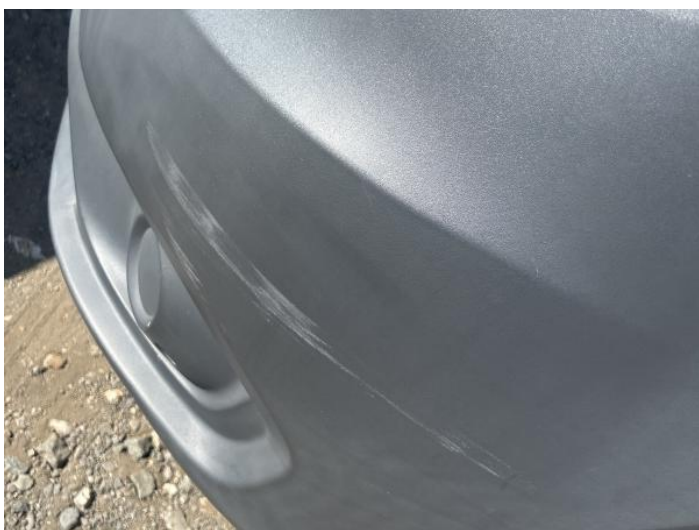
7: Bumper Front Moulding  
Scuffed (Unpainted)  
Over 100mm
