# VEHICLE INSPECTION REPORT

**LG70OBP**

## Ford Focus 1.5 EcoBlue 120 Active X 5dr

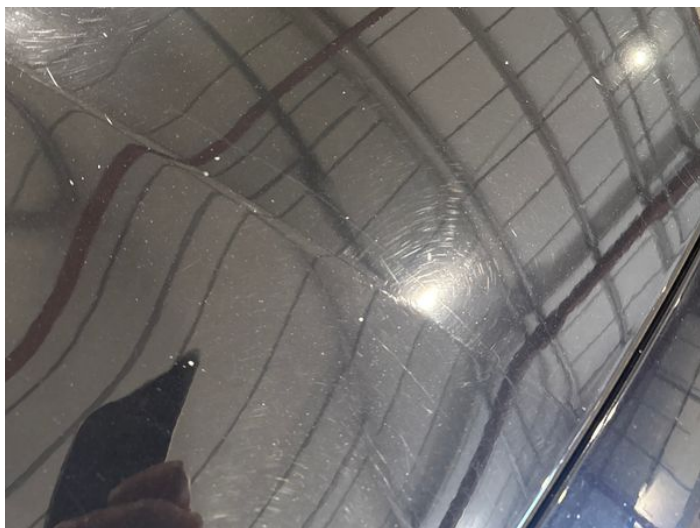
1: Bonnet  
Chipped  
Multiple Chips

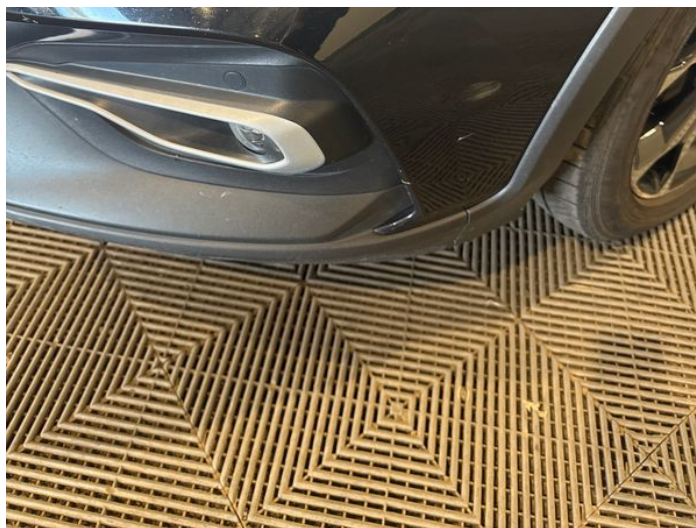
2: Bumper Front  
Chipped  
Multiple Chips

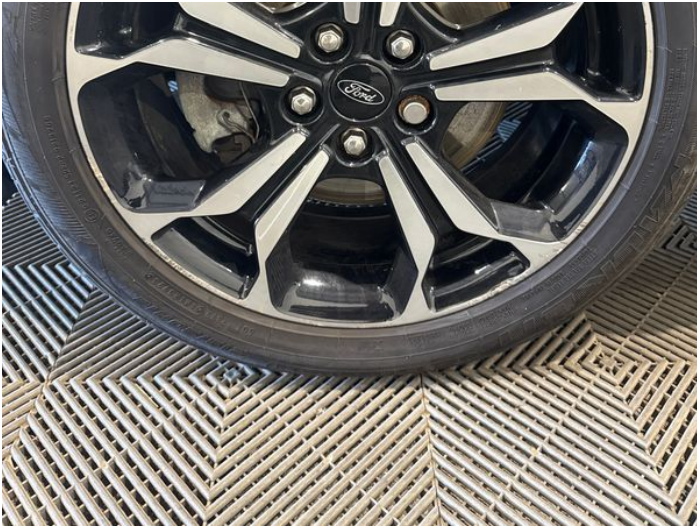
3: Wheel nsf  
Scratched  
Over 50mm

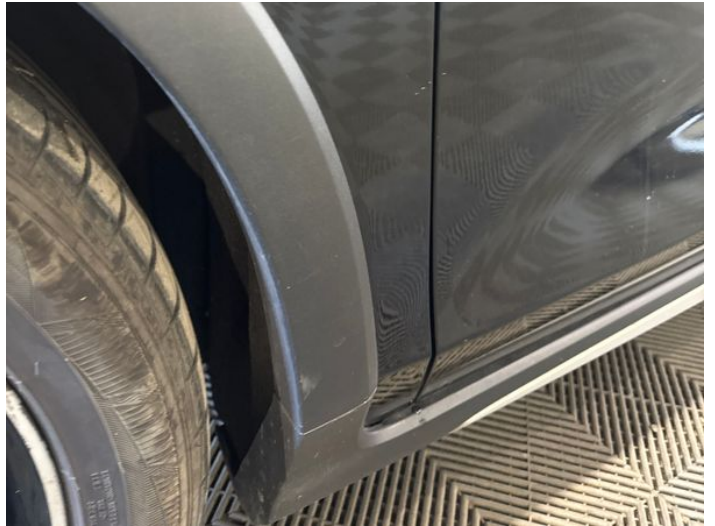
4: Wing nsf  
Chipped  
1 To 5

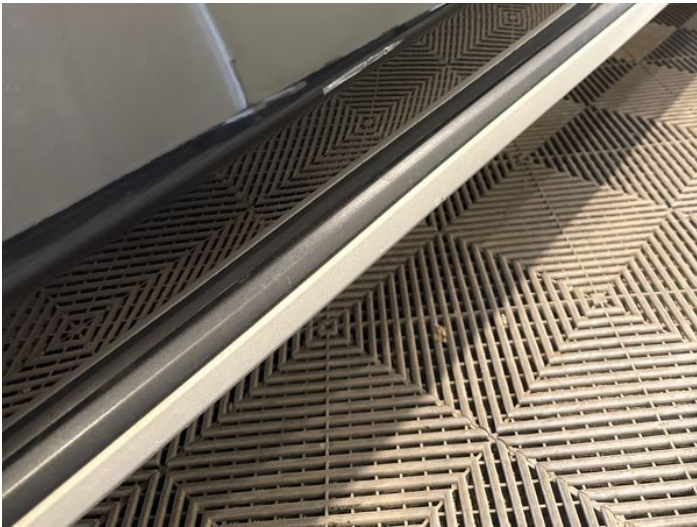
5: Door nsf  
Scratched  
Over 25mm Thru Paint

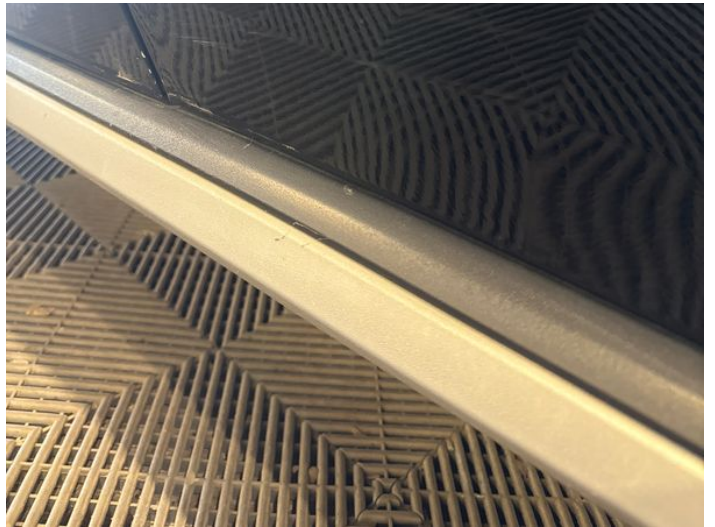
6: Door nsr  
Scratched  
Over 25mm Thru Paint

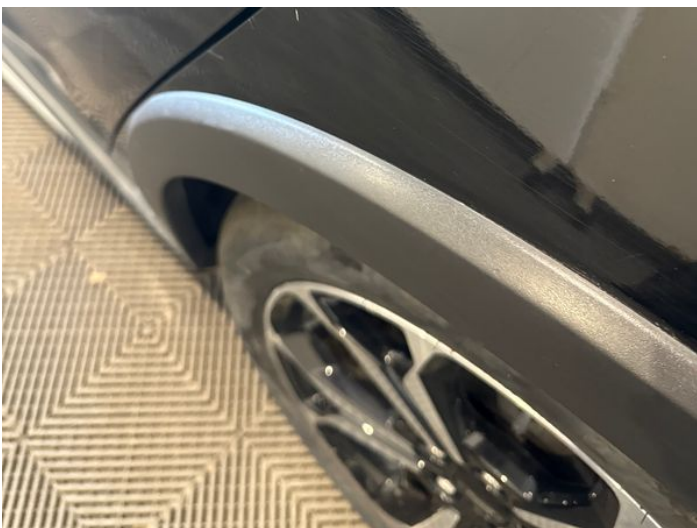
7: Qtr Panel nsr  
Scratched  
UpTo 25mm Thru Paint

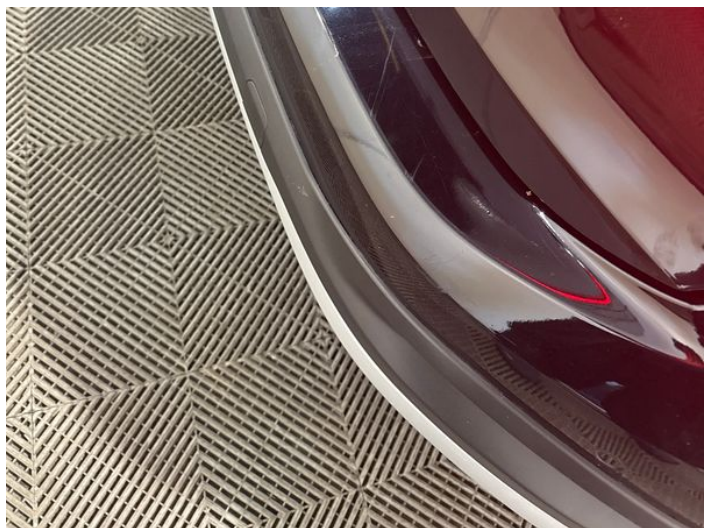
8: Bumper Rear  
Scratched  
25 to 100mm Thru Paint

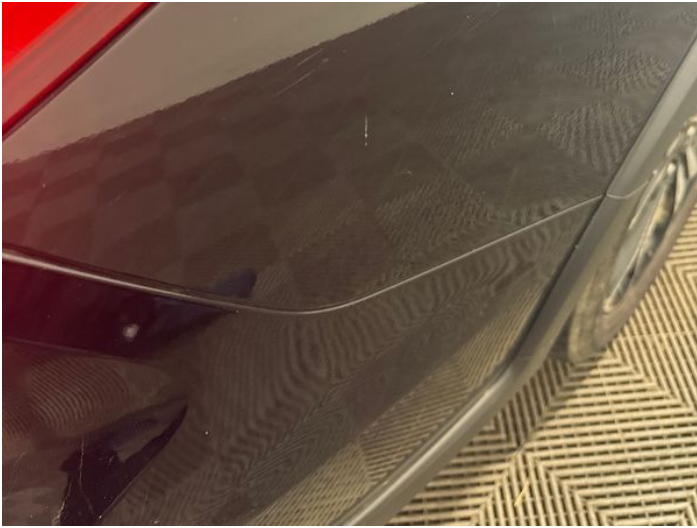
9: Qtr Panel osr  
Scratched  
UpTo 25mm Thru Paint

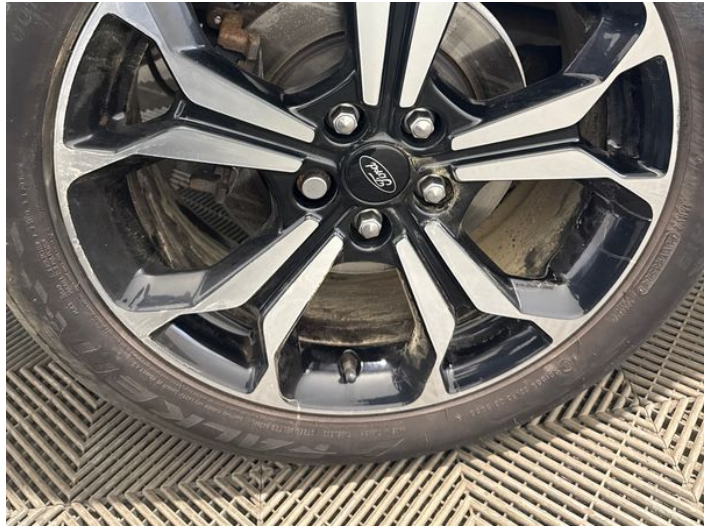
10: Wheel osr  
Scratched  
Over 50mm

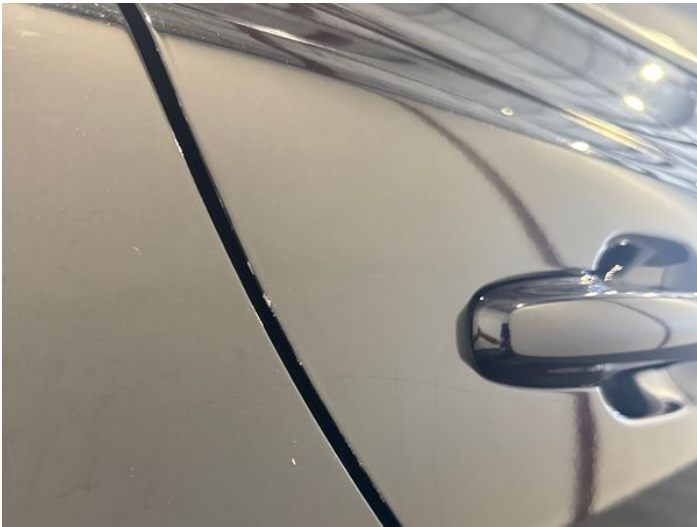
11: Door osr  
Chipped  
Edge Chip

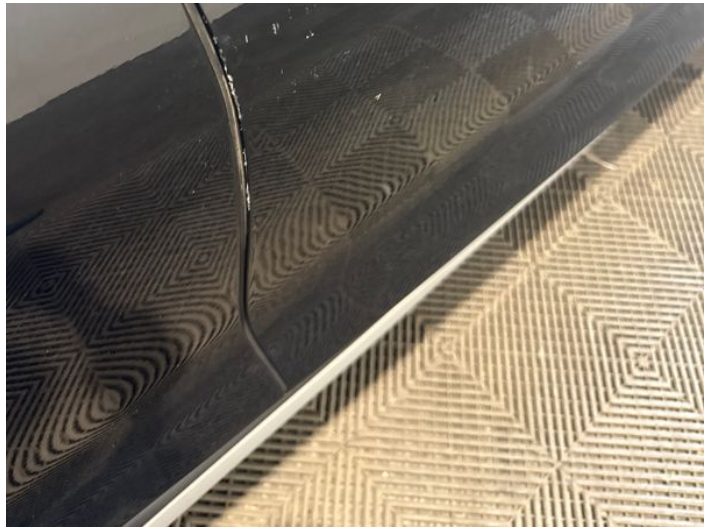
12: Door osf  
Scratched  
Over 25mm Thru Paint

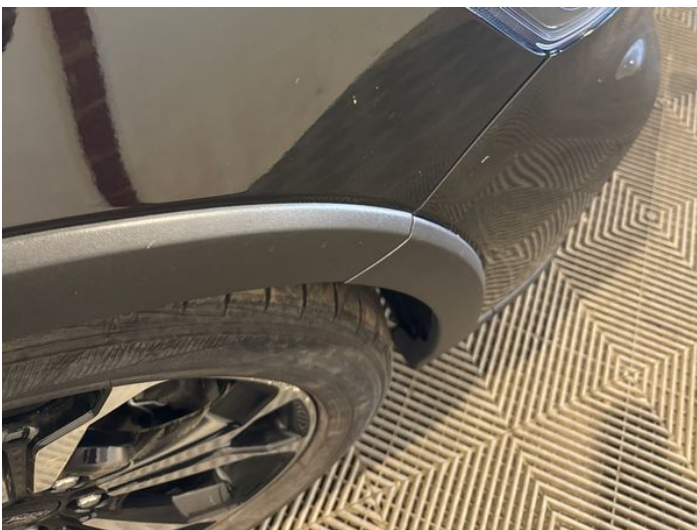
13: Wing osf  
Chipped  
1 To 5

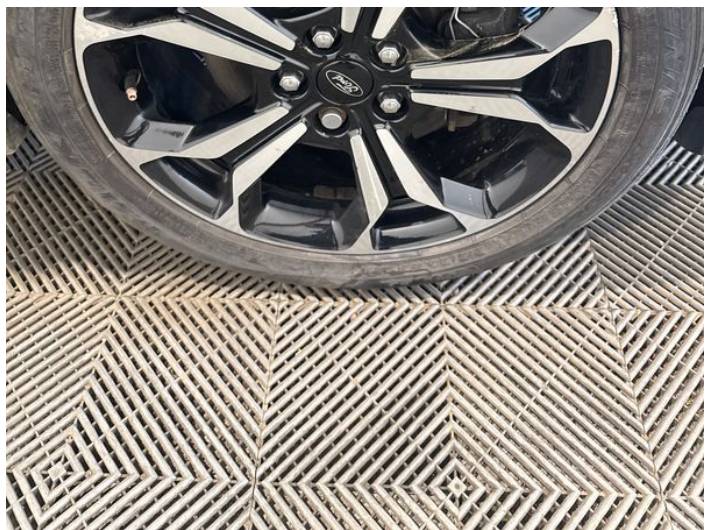
14: Wheel osf  
Scratched  
Over 50mm
