# VEHICLE INSPECTION REPORT

**LD19FKE**

## Ford Mondeo 2.0 TDCi EConetic Titanium Edition 5dr

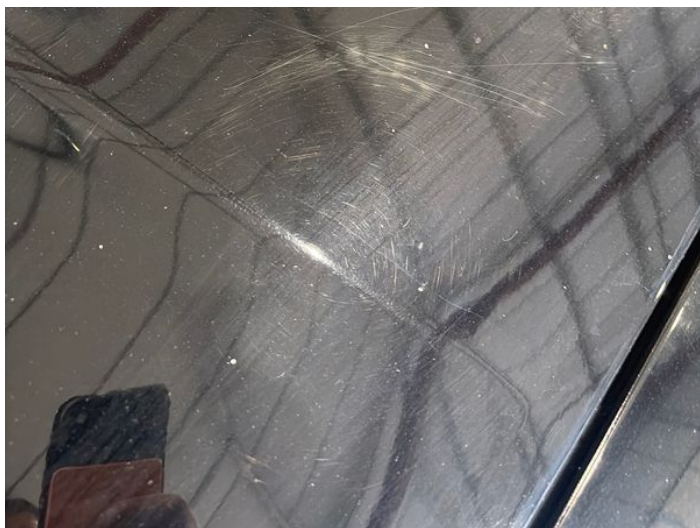
1: Bonnet  
Scratched  
Over 25mm Thru Paint

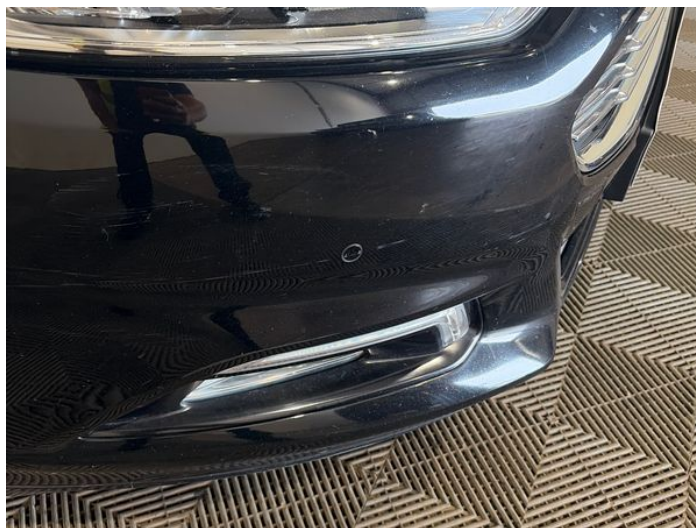
2: Bumper Front  
Scratched  
Over 100mm Thru Paint

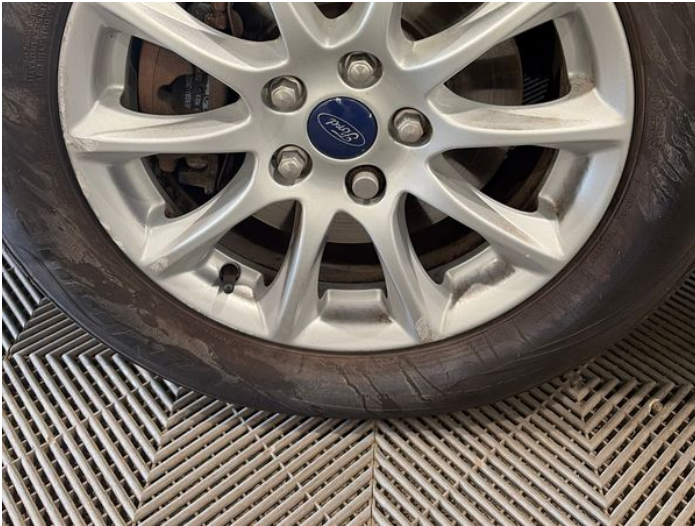
3: Wheel nsf  
Scratched  
Over 50mm

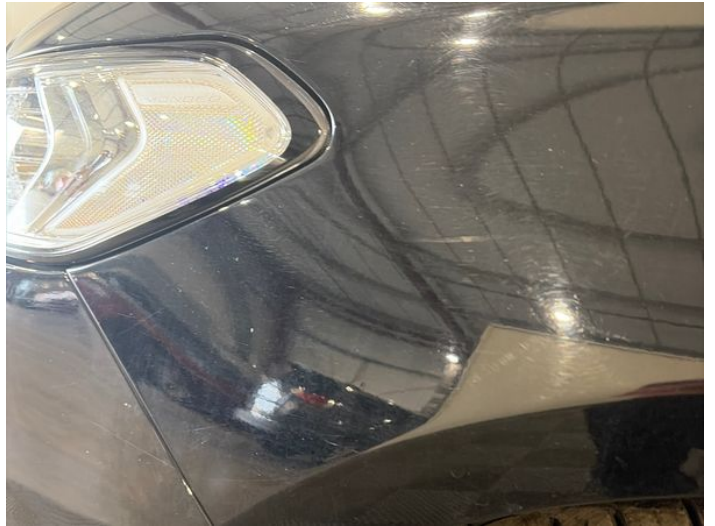
4: Wing nsf  
Chipped  
1 To 5

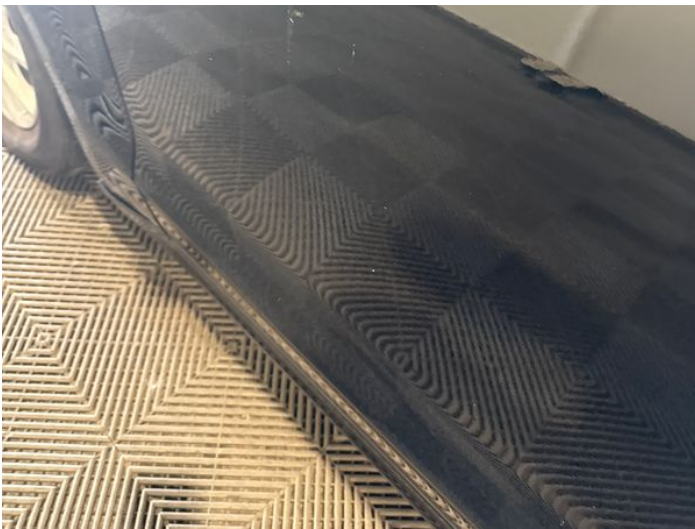
5: Door nsf  
Scratched  
Over 25mm Thru Paint

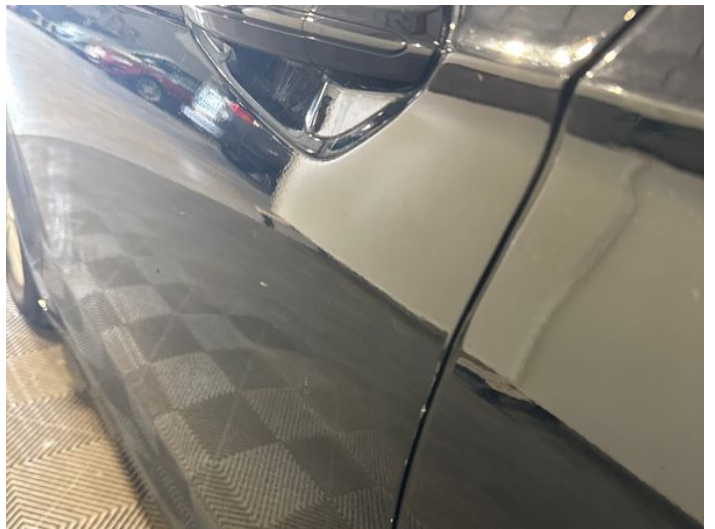
6: Door nsf  
Dented  
Over 30mm

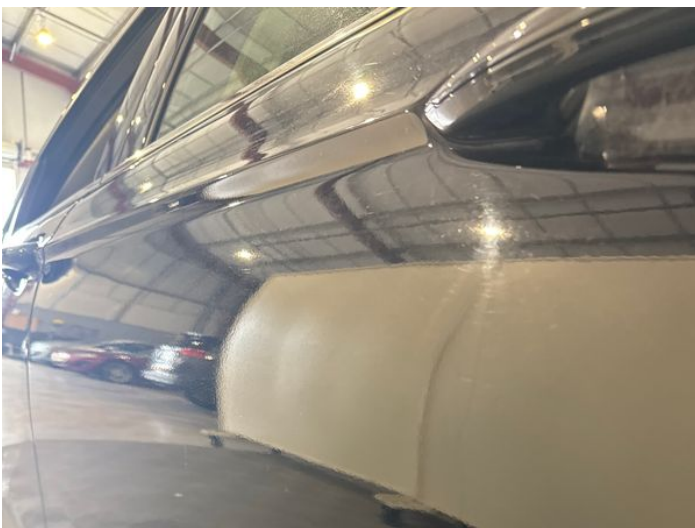
7: Door nsr  
Poor Previous Repair  
Rippled UpTo 30%

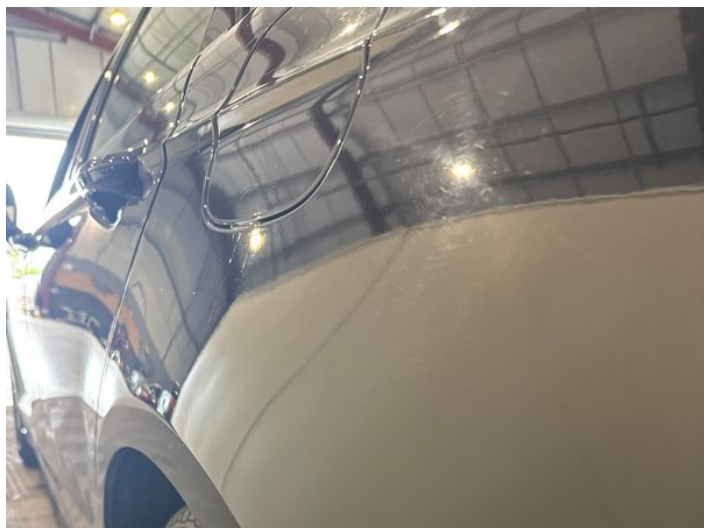
8: Qtr Panel nsr  
Poor Previous Repair  
Rippled UpTo 30%

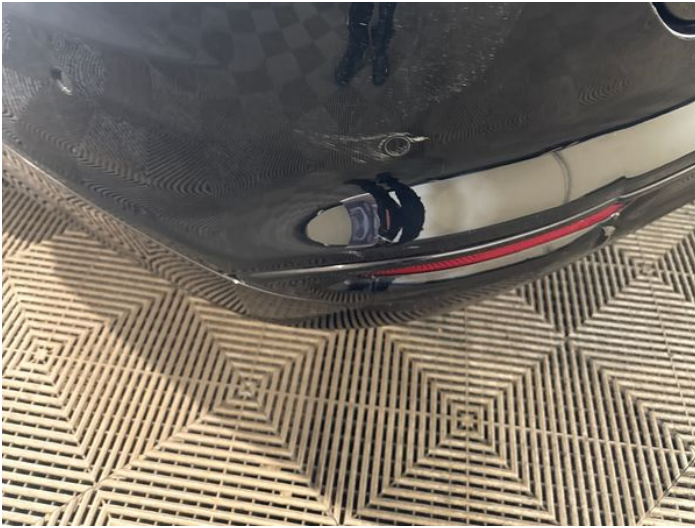
9: Bumper Rear  
Scratched  
Over 100mm Thru Paint

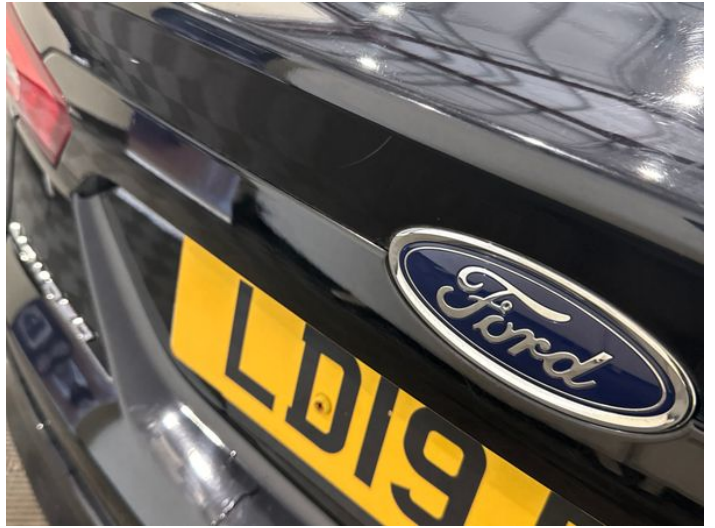
10: Boot Lid  
Scratched  
Over 25mm Thru Paint

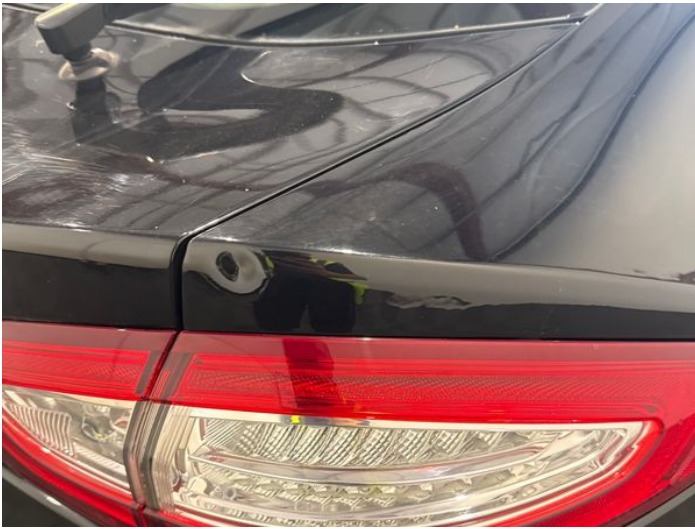
11: Qtr Panel osr  
Dented  
Between 10mm + 30mm

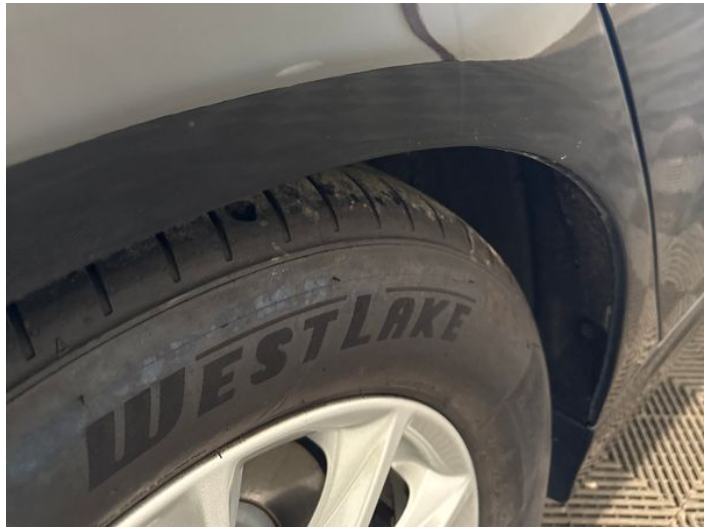
12: Qtr Panel osr  
Scratched  
UpTo 25mm Thru Paint

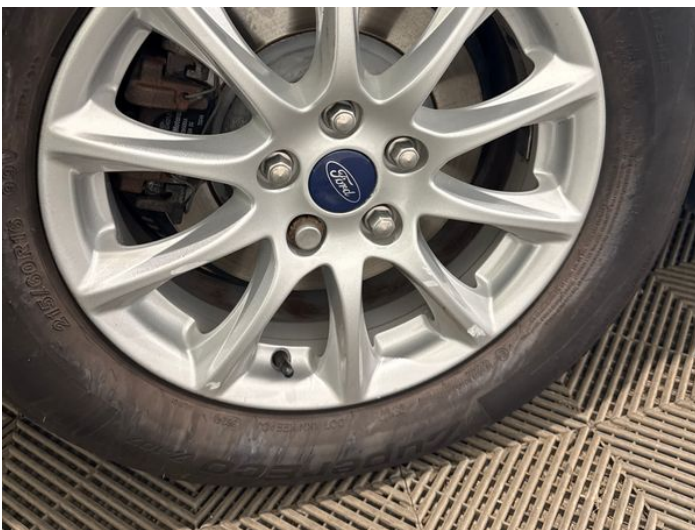
13: Wheel osr  
Scratched  
Over 50mm

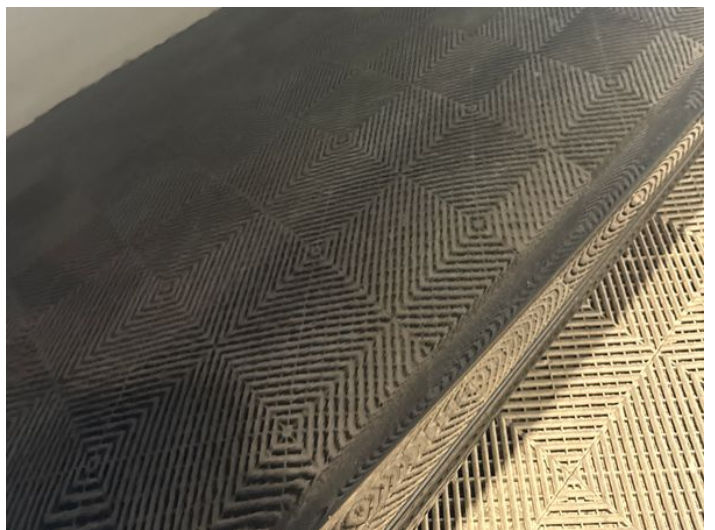
14: Door osr  
Scratched  
UpTo 25mm Thru Paint

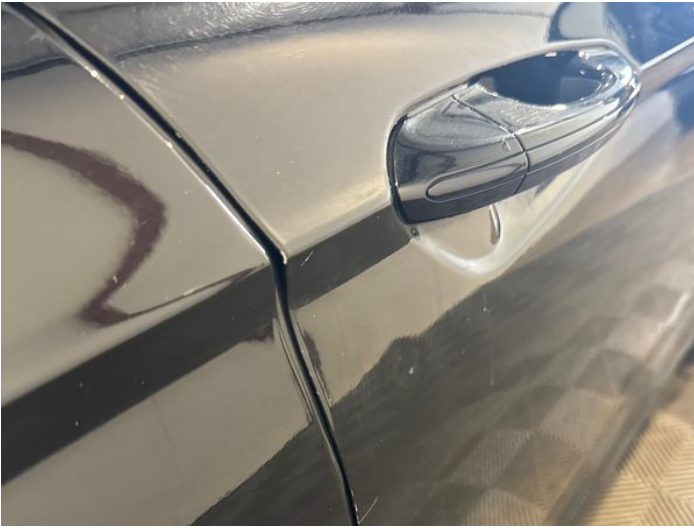
15: Door osf  
Dented  
Between 10mm + 30mm

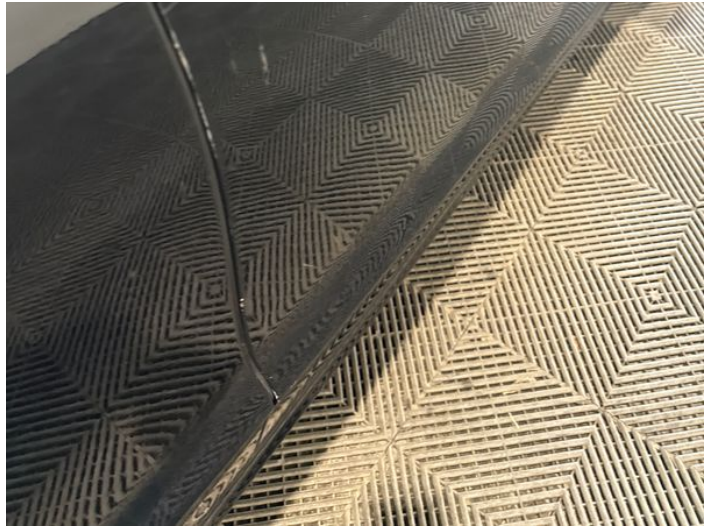
16: Door osf  
Scratched  
Over 25mm Thru Paint

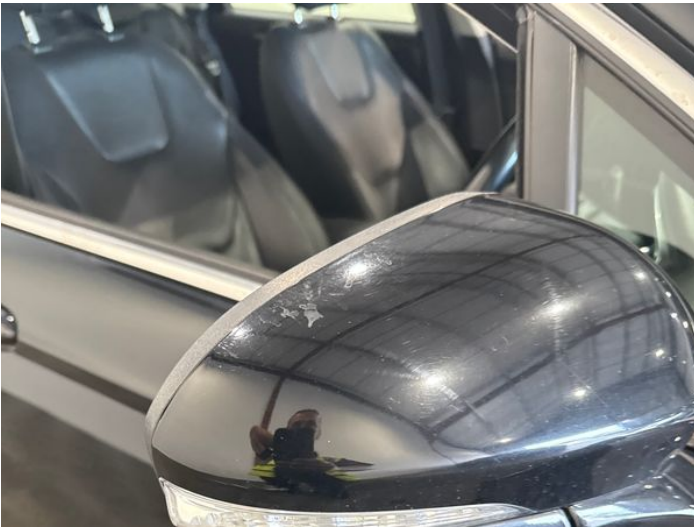
17: Door Mirror Assy osf  
Scratched (Painted)  
UpTo 25mm Thru Paint

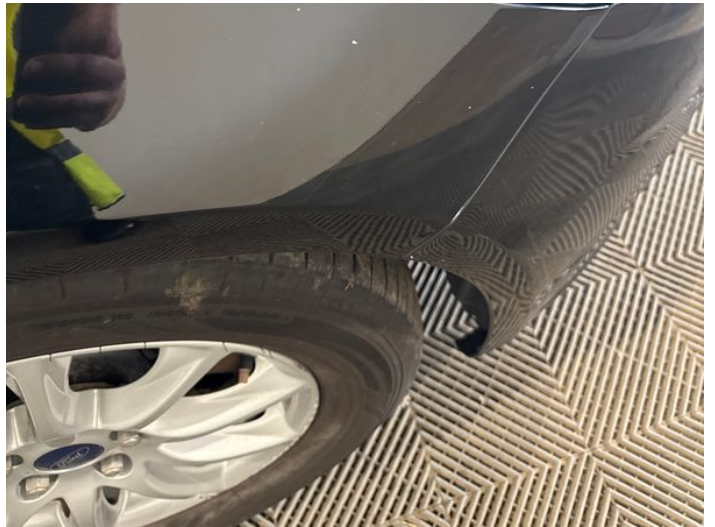
18: Wing osf  
Chipped  
1 To 5

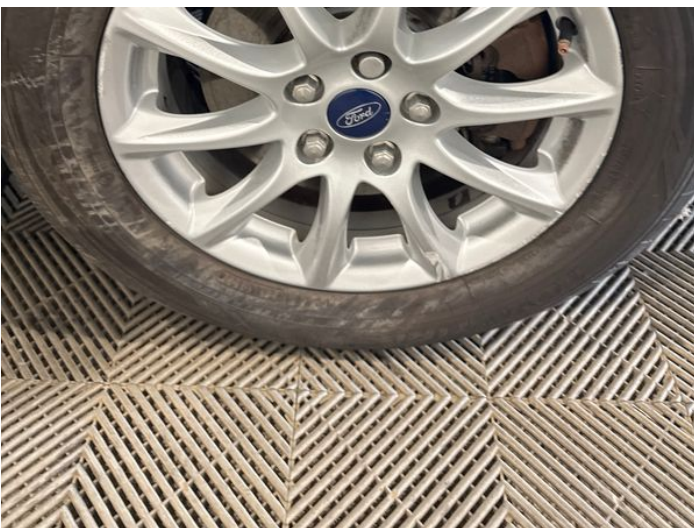
19: Wheel osf  
Scratched  
Over 50mm

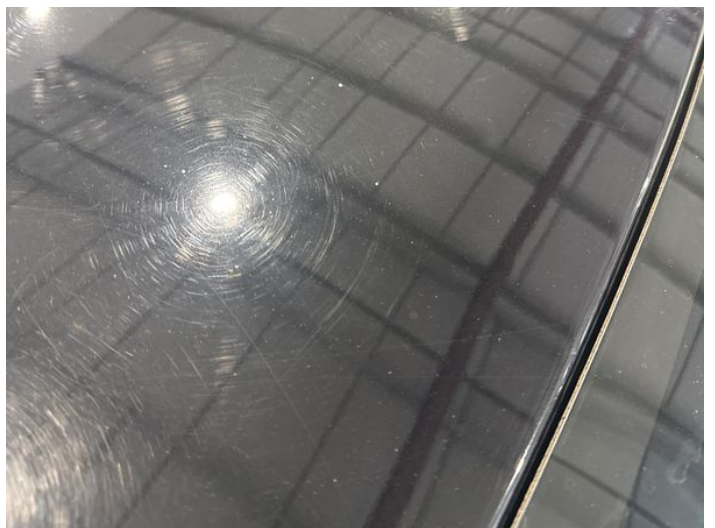
20: Roof  
Chipped  
1 To 5

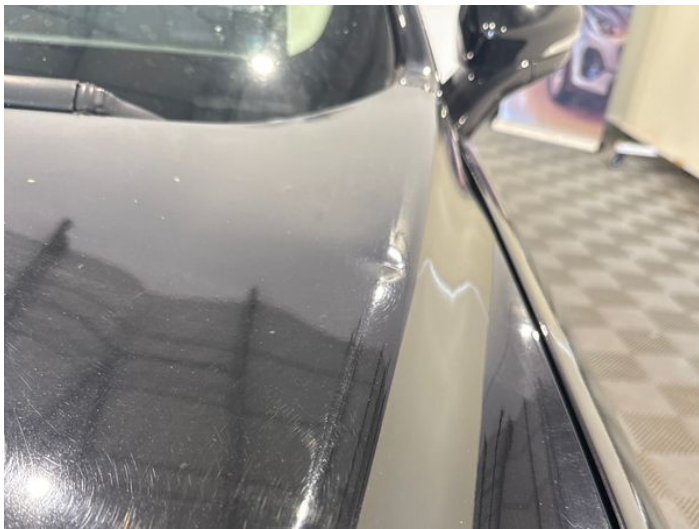
21: Bonnet  
Dented  
Between 10mm + 30mm
