## VEHICLE INSPECTION REPORT

**RK56UHP**

### Honda Civic 1.8 i-VTEC ES 5dr

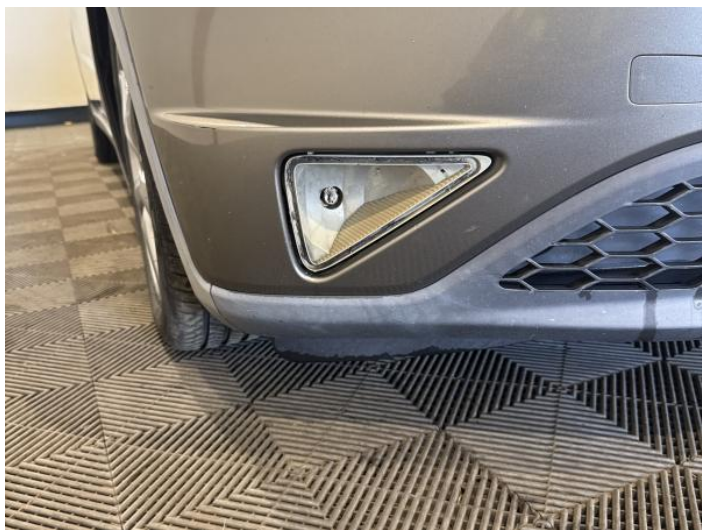
1: Fogdriving Lamp osf  
Broken  
Replace

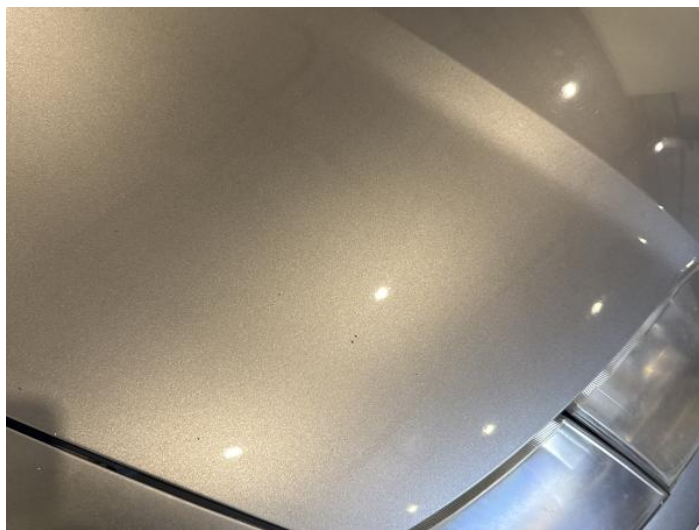
2: Bonnet  
Chipped  
Multiple Chips

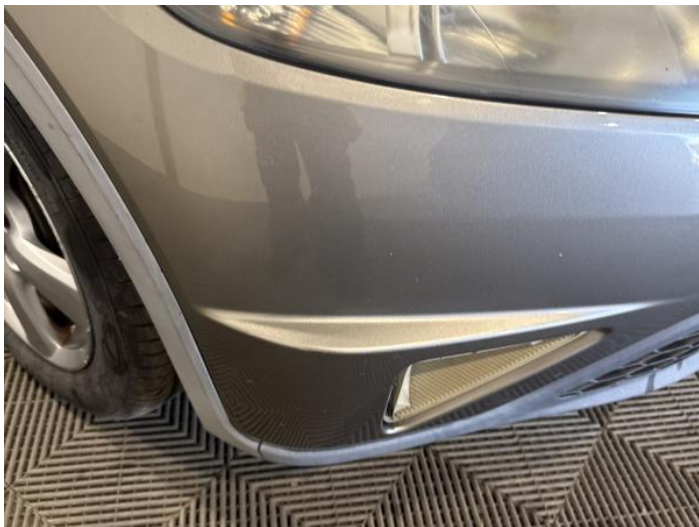
3: Bumper Front  
Scratched  
Over 100mm Thru Paint

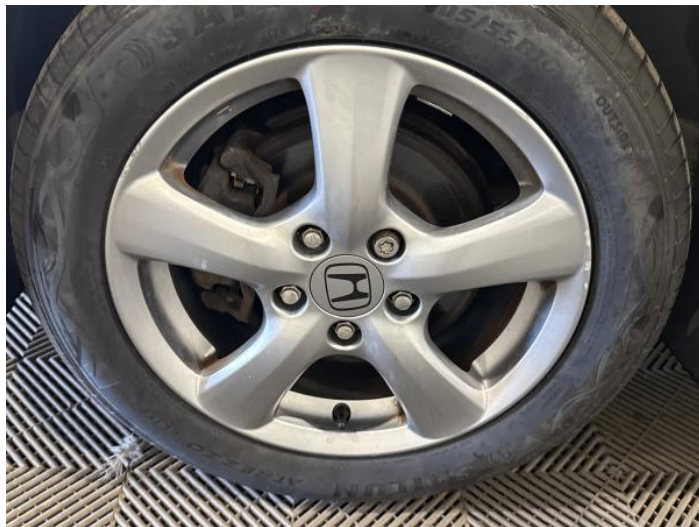
4: Wheel nsf  
Scratched  
Over 50mm

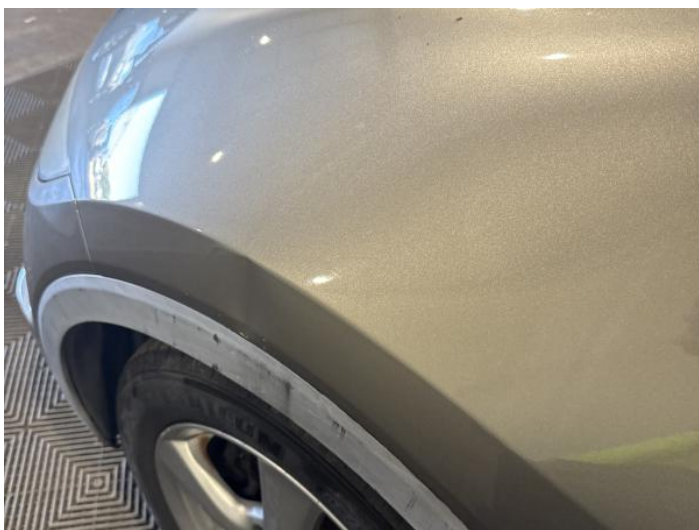
5: Wing nsf  
Dented  
With Paint Damage

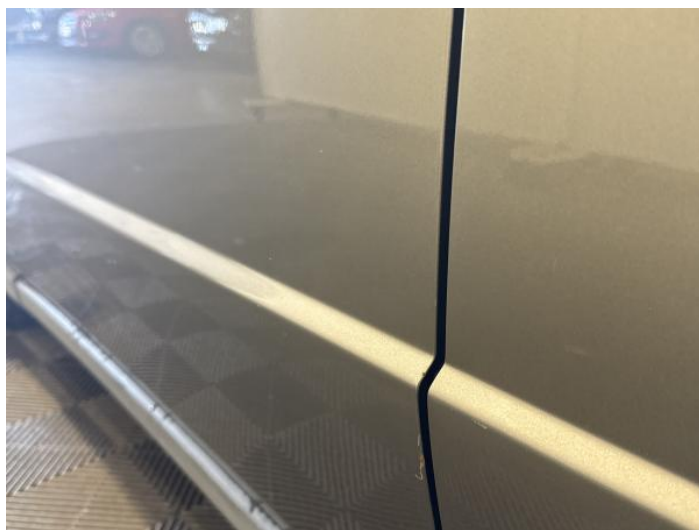
6: Door nsf  
Dented  
With Paint Damage

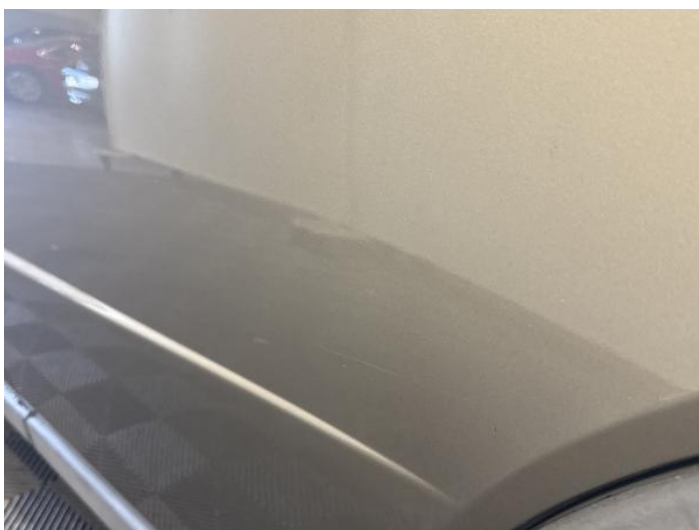
7: Door nsr  
Scratched  
Over 25mm Thru Paint

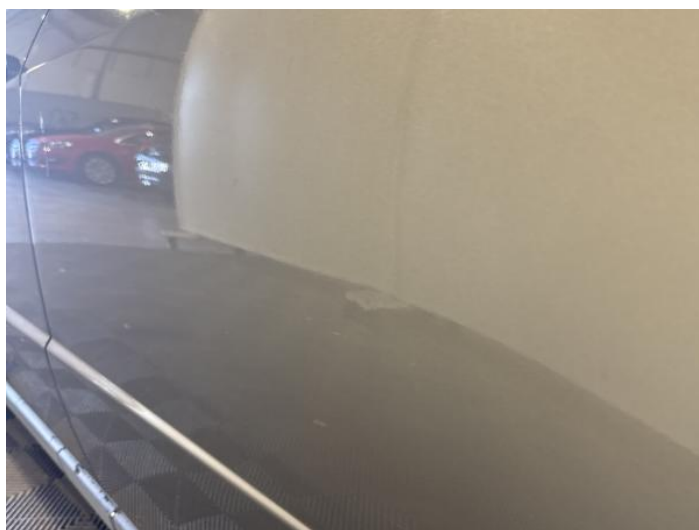
8: Door nsr  
Dented  
Between 10mm + 30mm

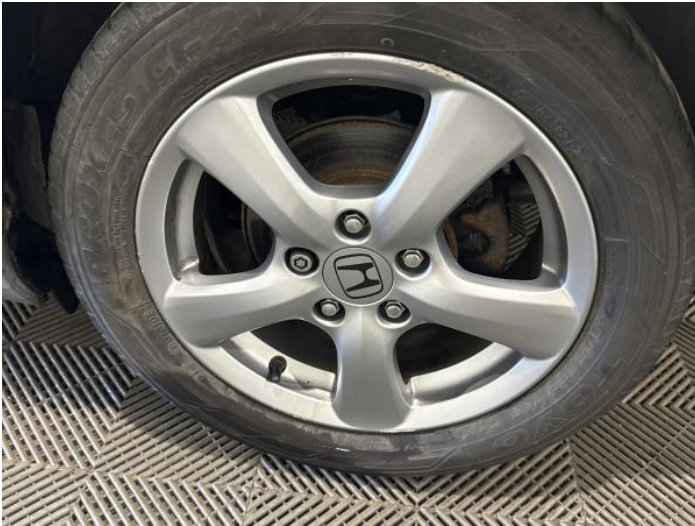
9: Wheel nsr  
Scratched  
Over 50mm

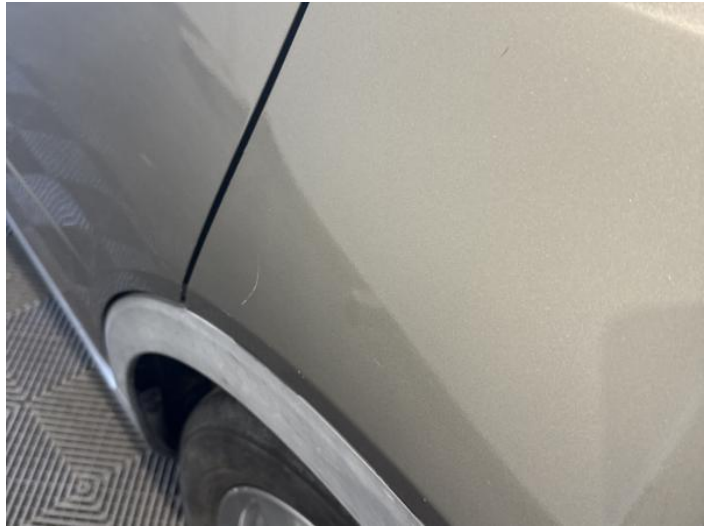
10: Qtr Panel nsr  
Scratched  
Over 25mm Thru Paint

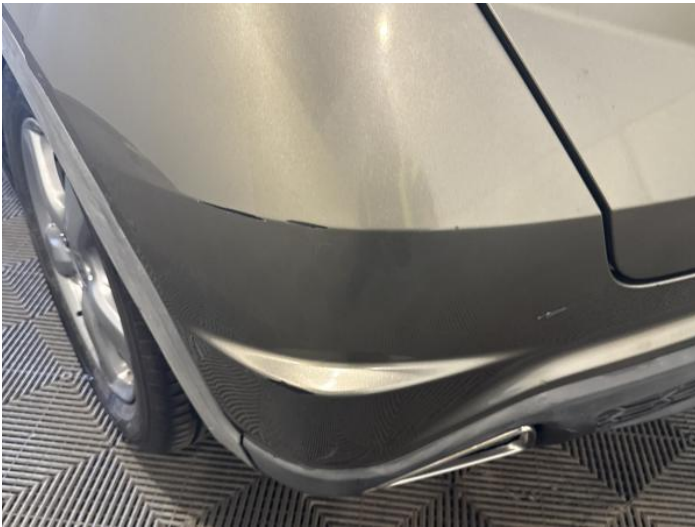
11: Bumper Rear  
Dented  
With Paint Damage

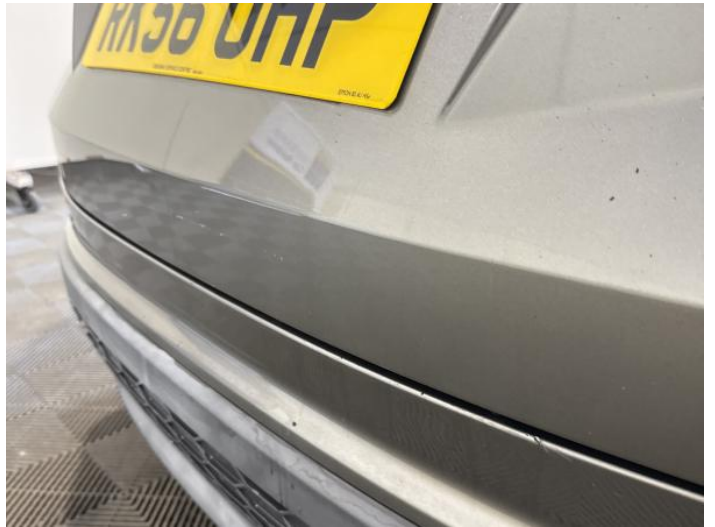
12: Tailgate  
Scratched  
Over 25mm Thru Paint

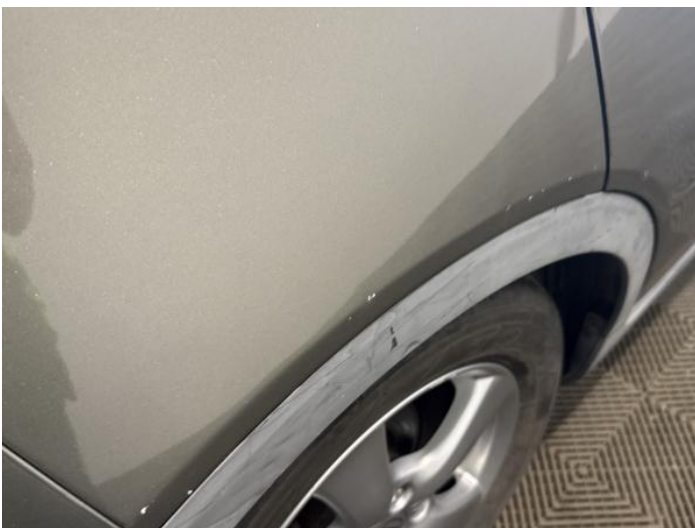
13: Qtr Panel osr  
Dented  
With Paint Damage

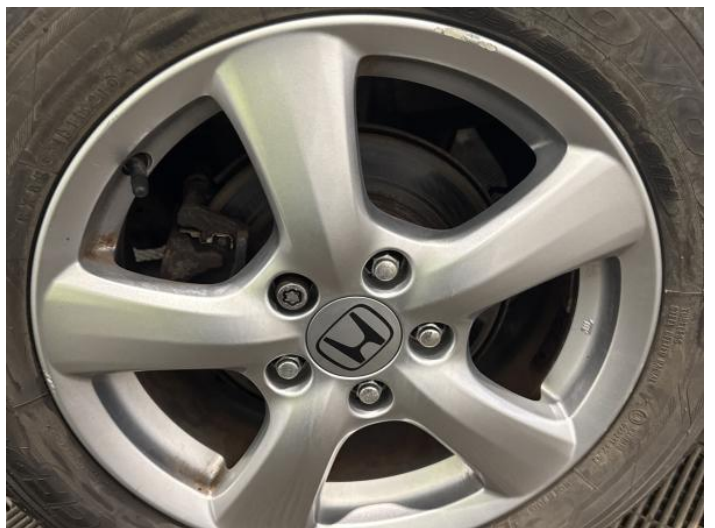
14: Wheel osr  
Scratched  
Over 50mm

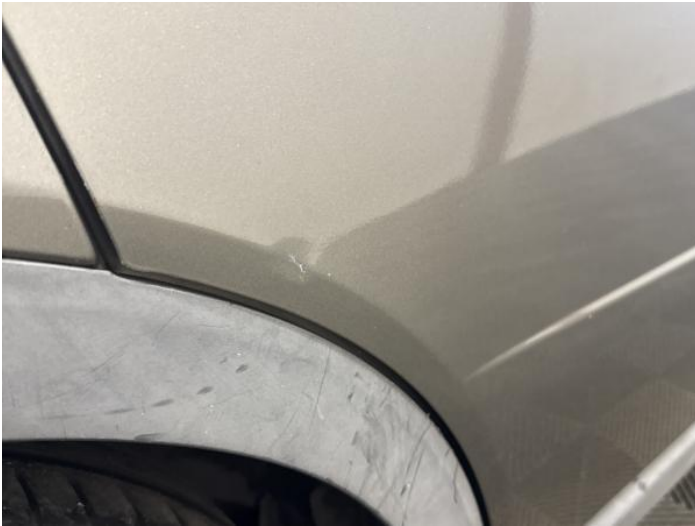
15: Door osr  
Dented  
Between 10mm + 30mm

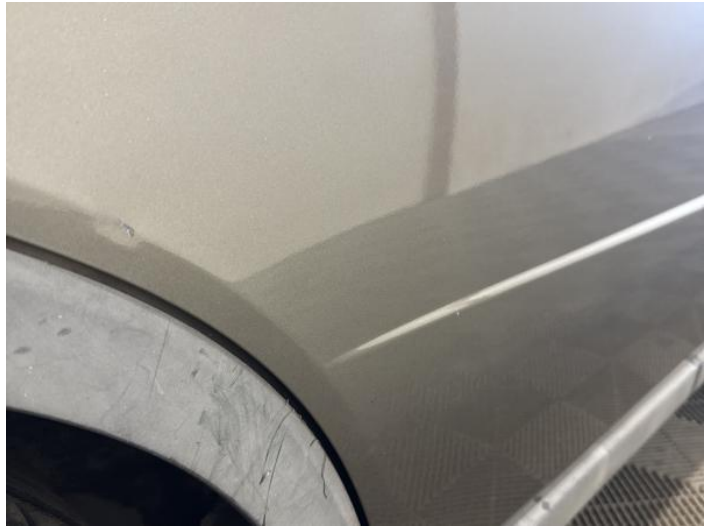
16: Door osr  
Scratched  
Over 25mm Thru Paint

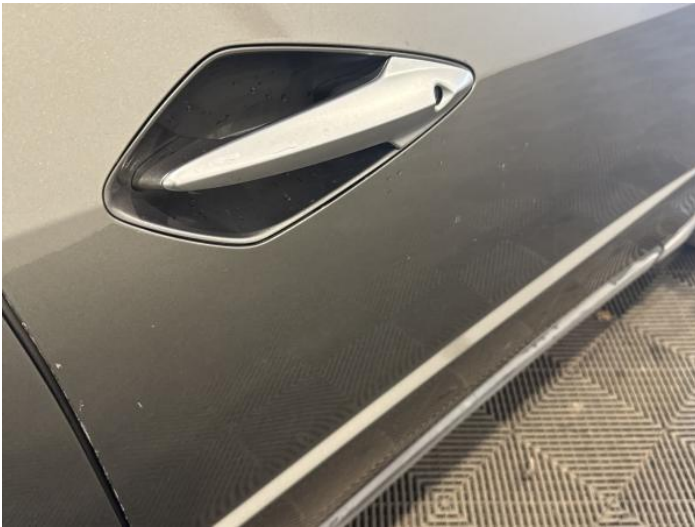
17: Door osf  
Dented  
With Paint Damage

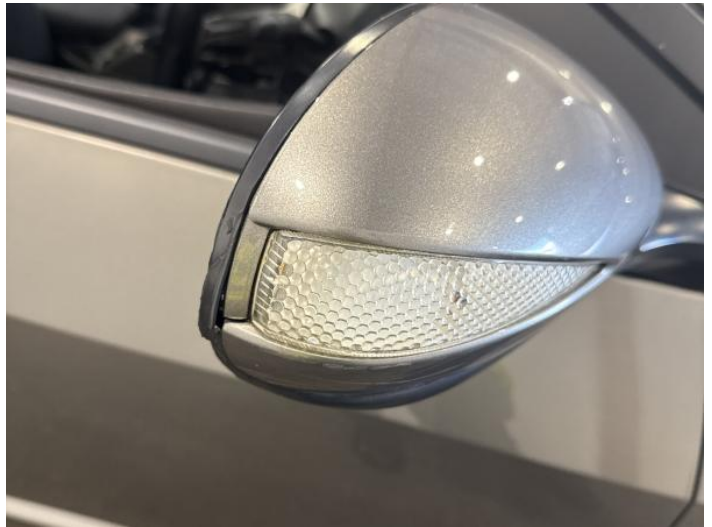
18: Door Mirror Assy osf  
Broken  
Replace

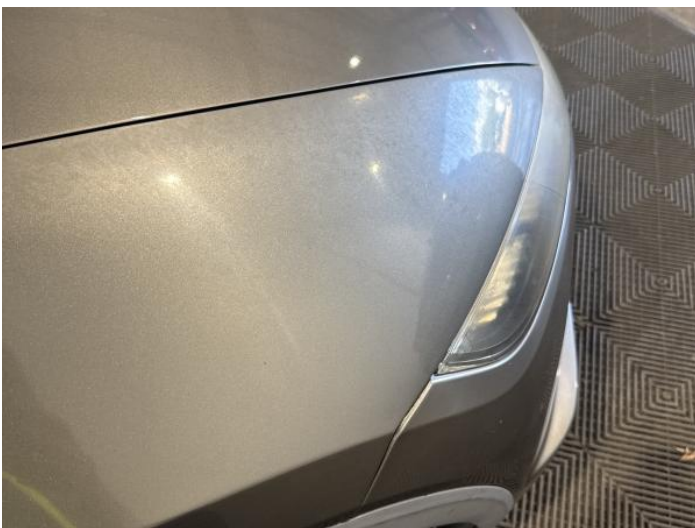
19: Wing osf  
Scratched  
Over 25mm Thru Paint

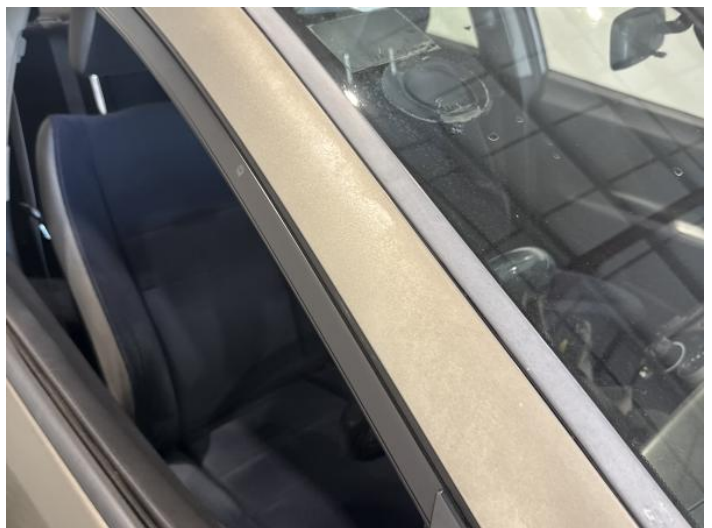
20: A Post os  
Scratched  
Over 25mm Thru Paint

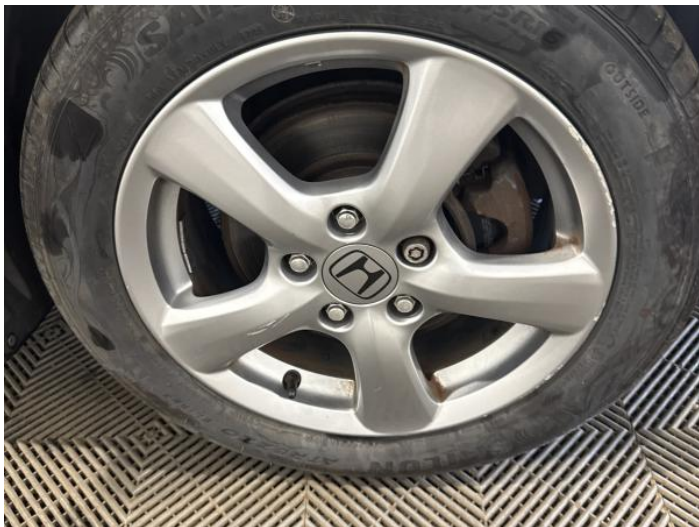
21: Wheel nsf  
Scratched  
Over 50mm

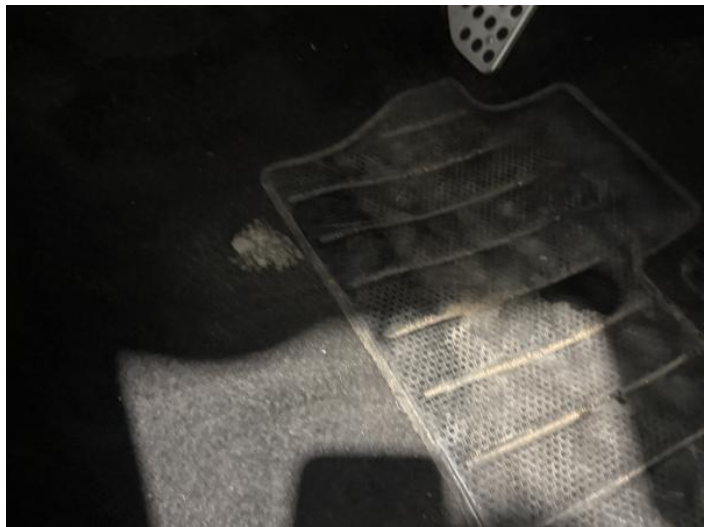
22: Carpets Front  
Scuffed  
Over 25mm
