## VEHICLE INSPECTION REPORT

**SE14DUA**

### Nissan Qashqai 1.2 DiG-T Tekna 5dr

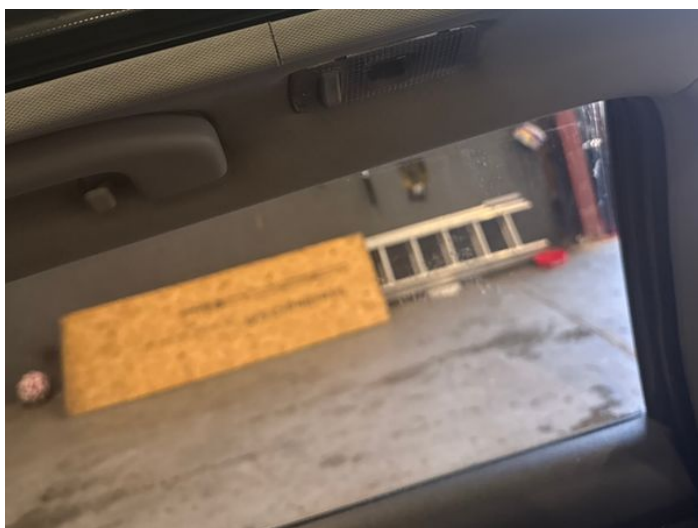
1: Roof Lining  
Scuffed  
UpTo 25mm

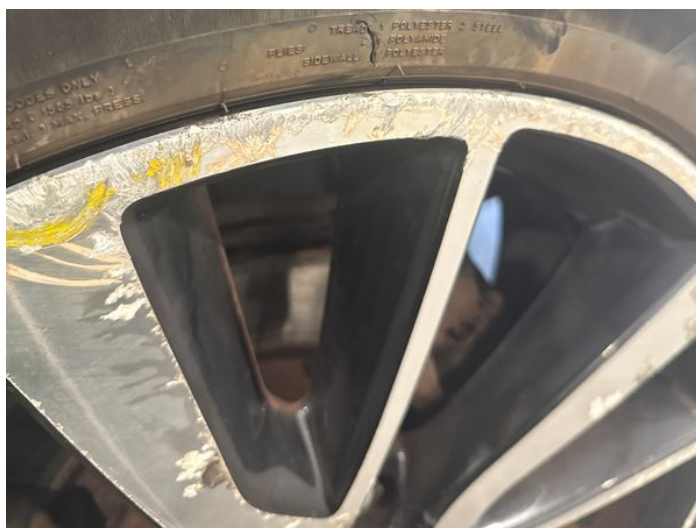
2: Tyre osf  
Damaged  
Replace

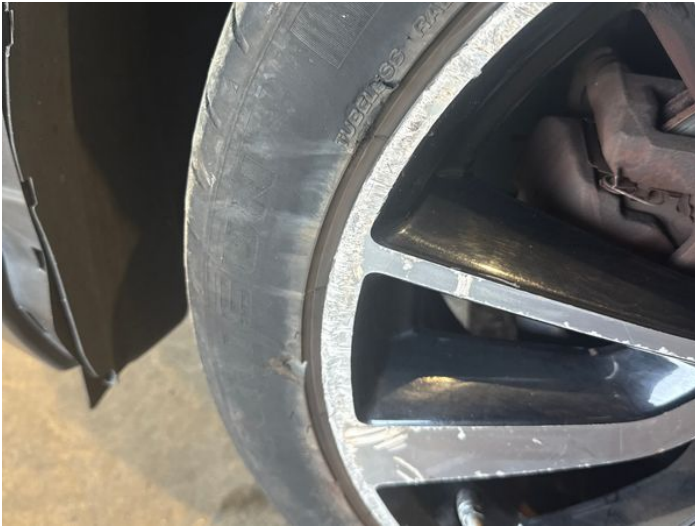
3: Tyre nsf  
Damaged  
Replace

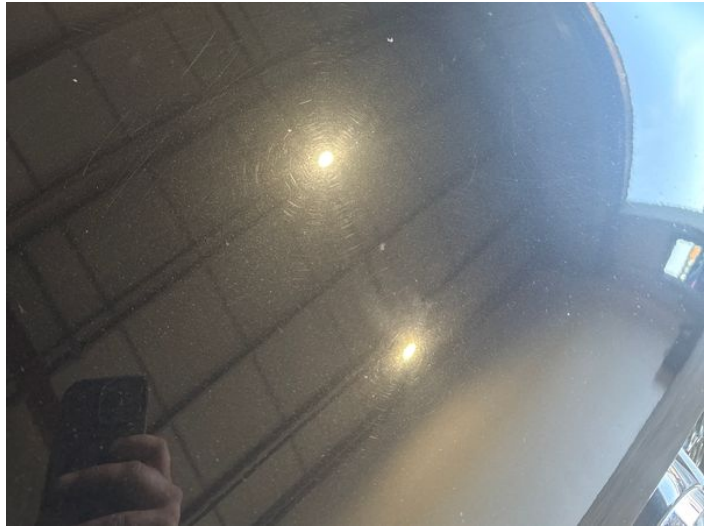
4: Bonnet  
Chipped  
Multiple Chips

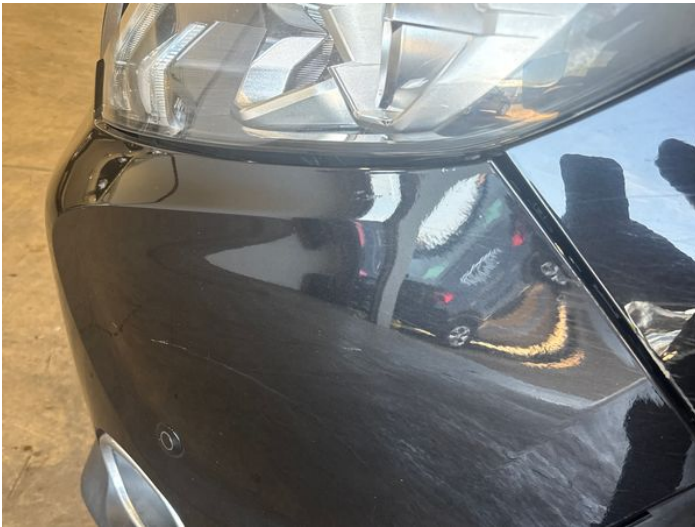
5: Bumper Front  
Scratched  
25 to 100mm Thru Paint

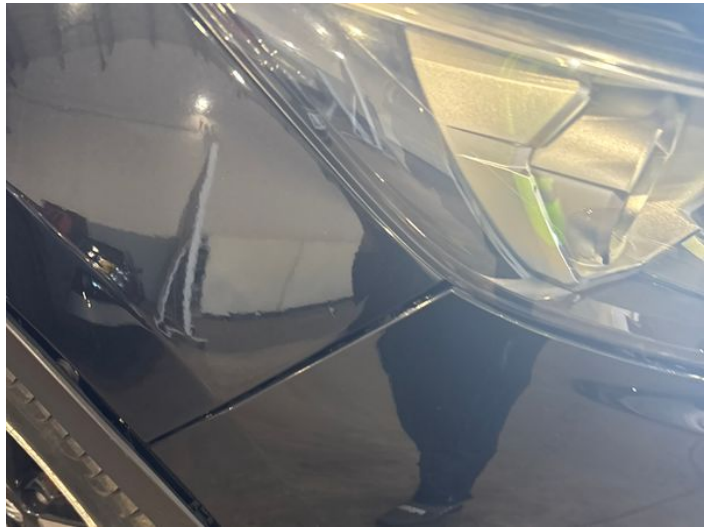
6: Bumper Front  
Insecure  
Action Required

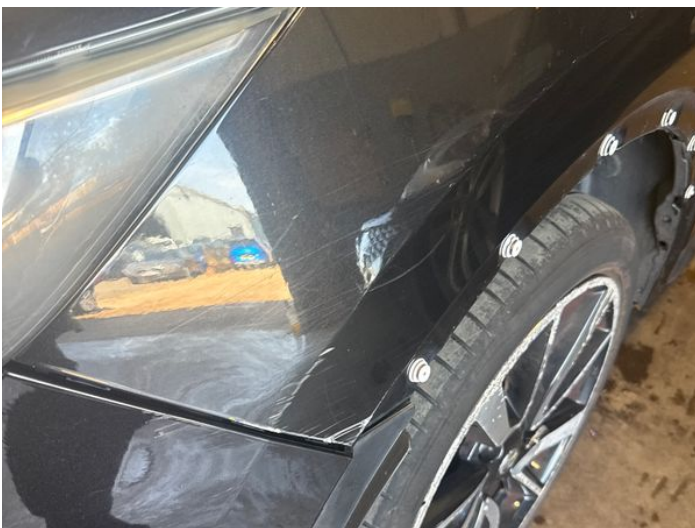
7: Wing nsf  
Dented  
With Paint Damage

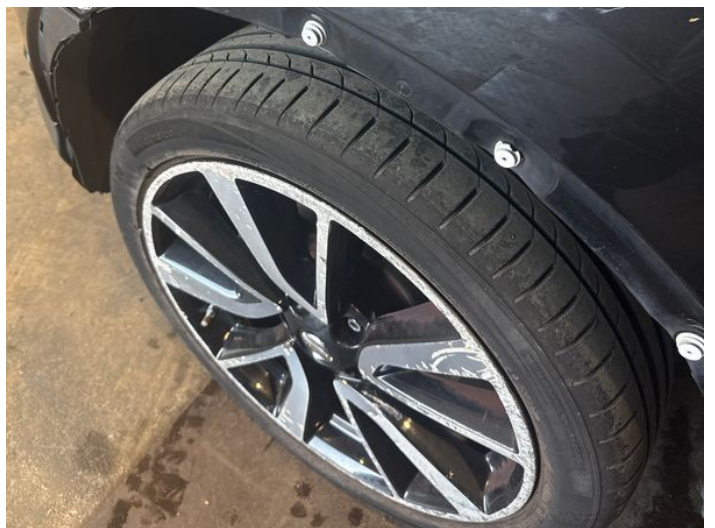
8: Wing Front Arch Extension ns  
Missing  
Replace

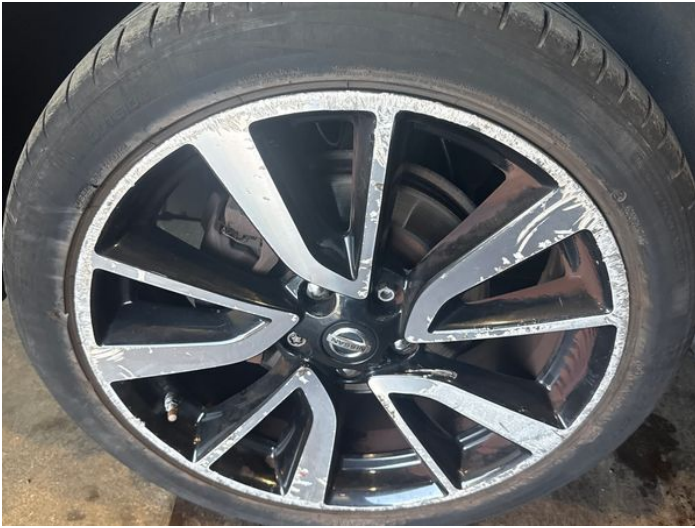
9: Wheel nsf  
Scratched  
Over 50mm

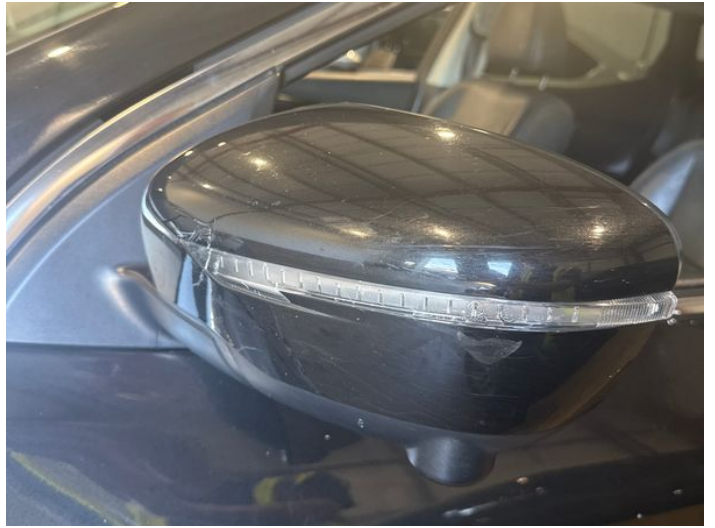
10: Door Mirror Assy nsf  
Broken  
Replace

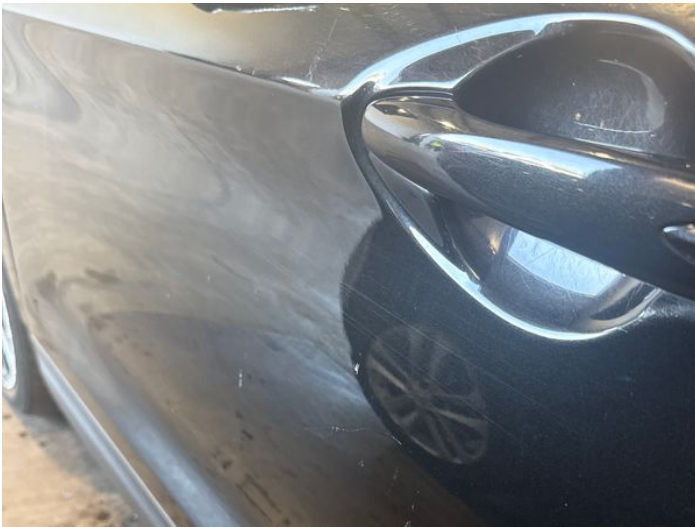
11: Door nsf  
Dented  
With Paint Damage

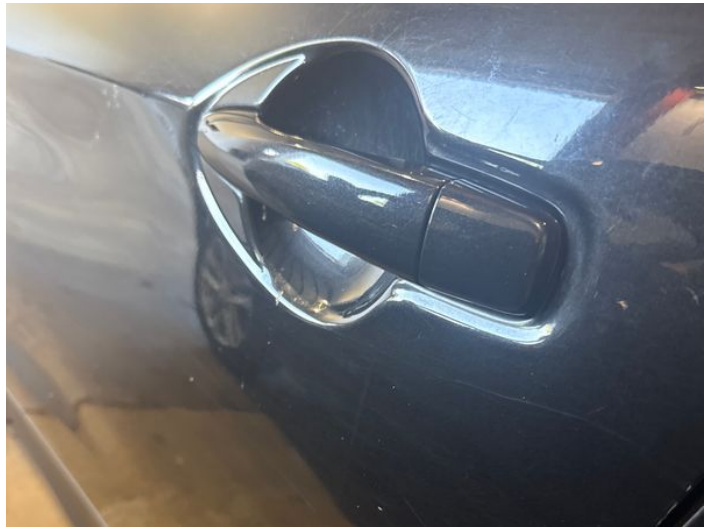
12: Door nsr  
Dented  
With Paint Damage

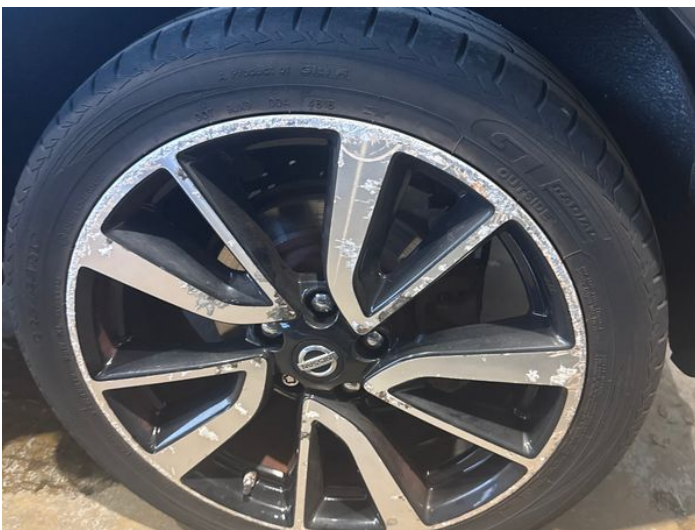
13: Wheel nsr  
Scratched  
Over 50mm

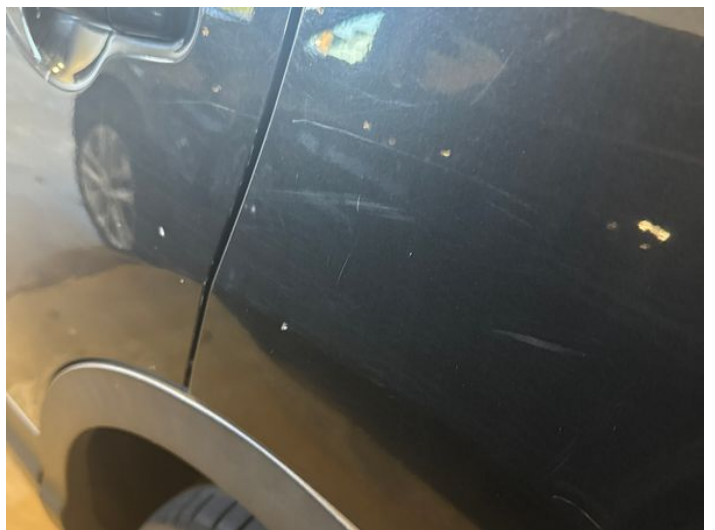
14: Qtr Panel nsr  
Dented  
Between 10mm + 30mm

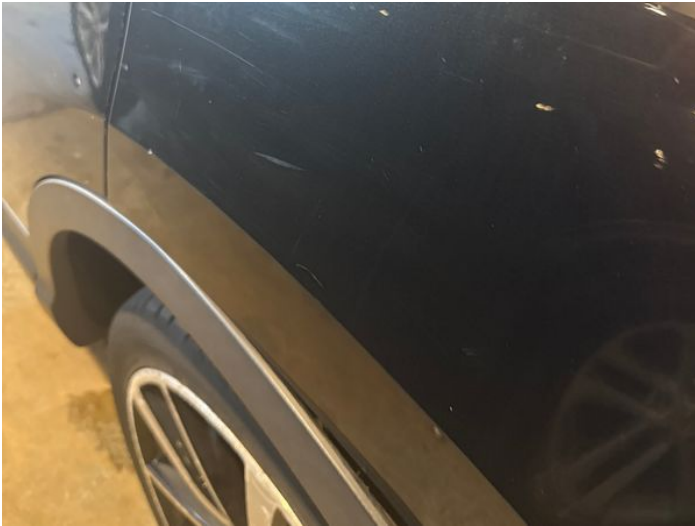
15: Qtr Panel nsr  
Scratched  
Over 25mm Thru Paint

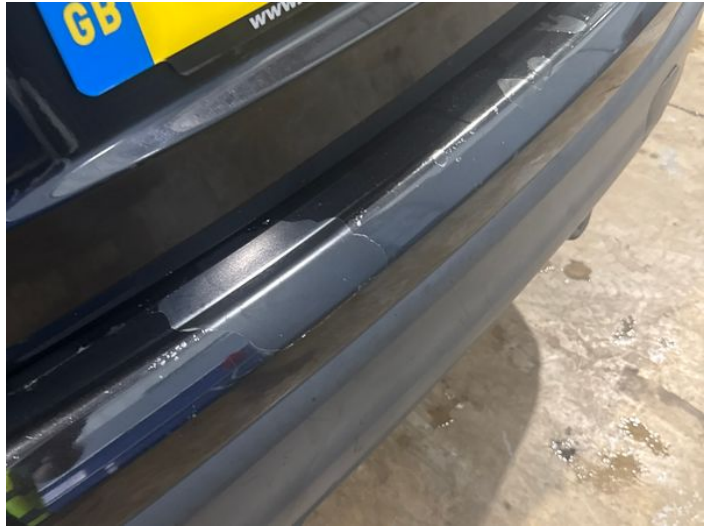
16: Bumper Rear  
Poor Previous Repair  
Paint Flake

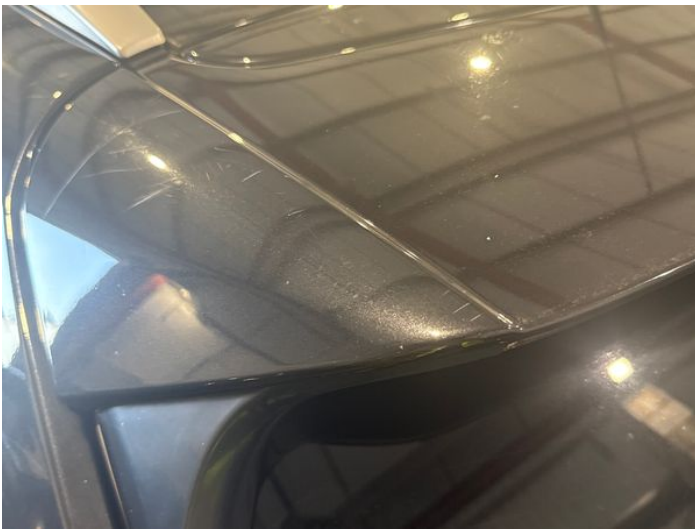
17: Spoiler Rear  
Scratched (Painted)  
Over 25mm Thru Paint

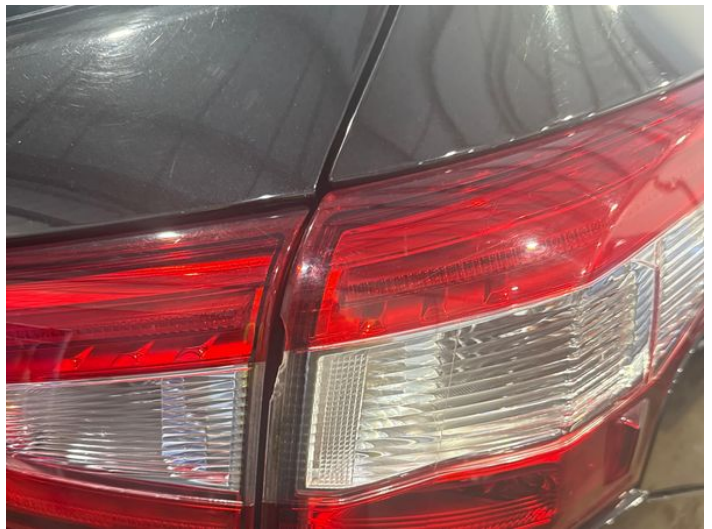
18: Lamp osr  
Broken  
Replace

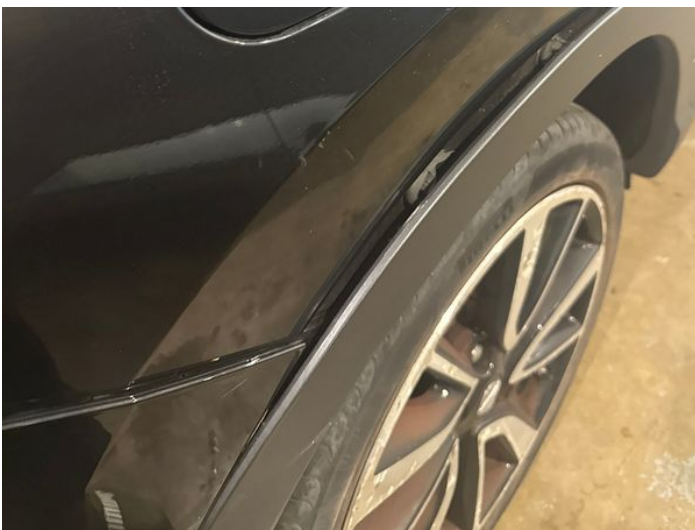
19: Qtr Panel osr  
Dented  
With Paint Damage

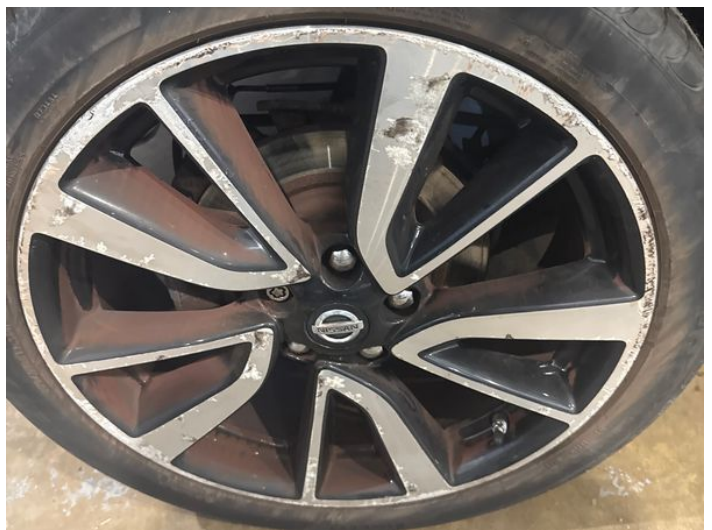
20: Wheel osr  
Scratched  
Over 50mm

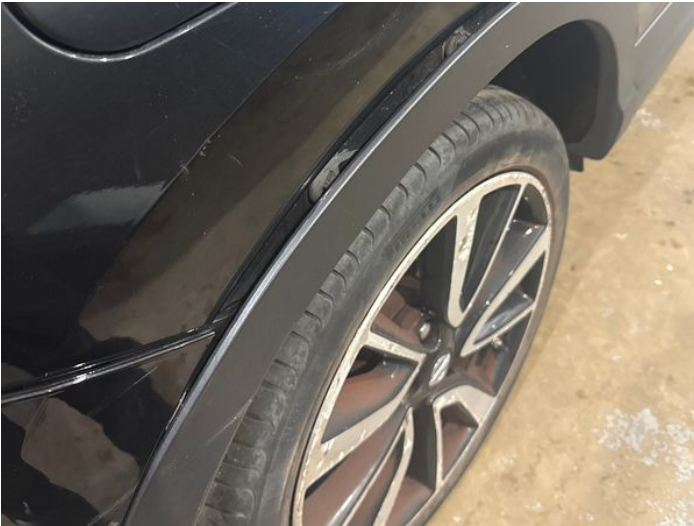
21: Qtr Panel Arch Extension os  
Broken  
Replace

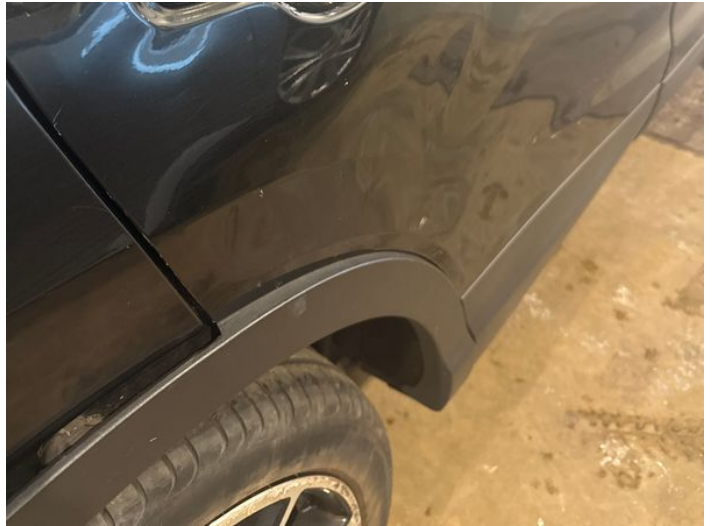
22: Door osr  
Dented  
With Paint Damage

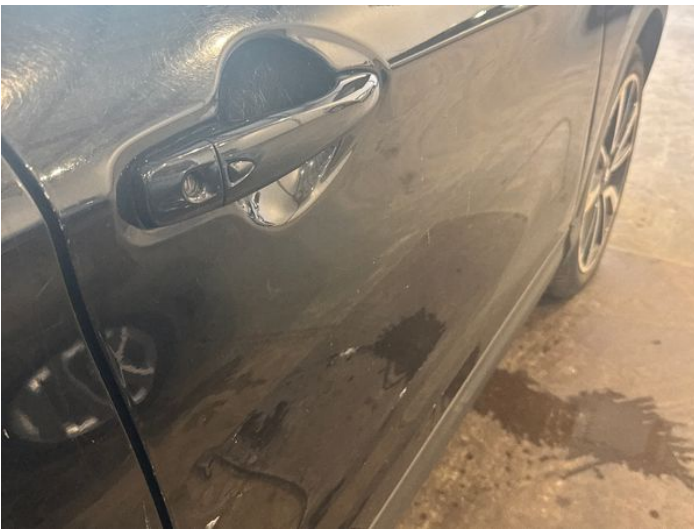
23: Door osf  
Dented  
With Paint Damage

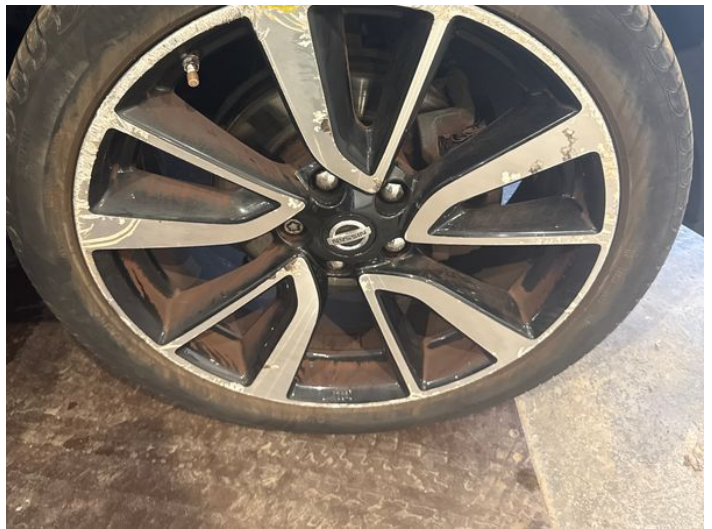
24: Wheel osf  
Scratched  
Over 50mm

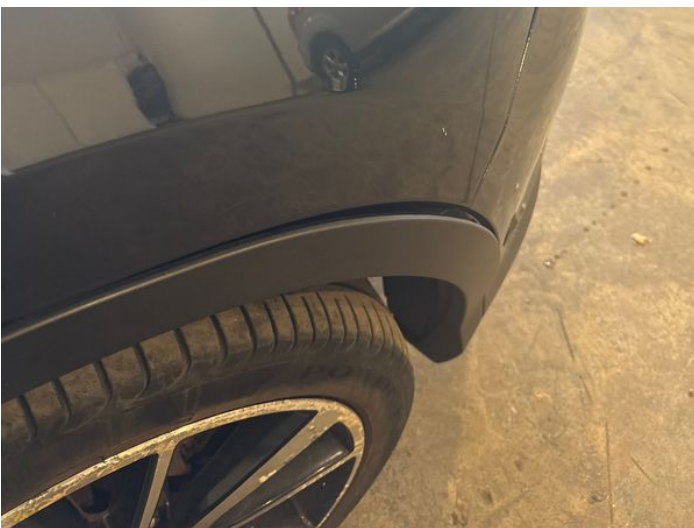
25: Wing osf  
Scratched  
Over 25mm Thru Paint

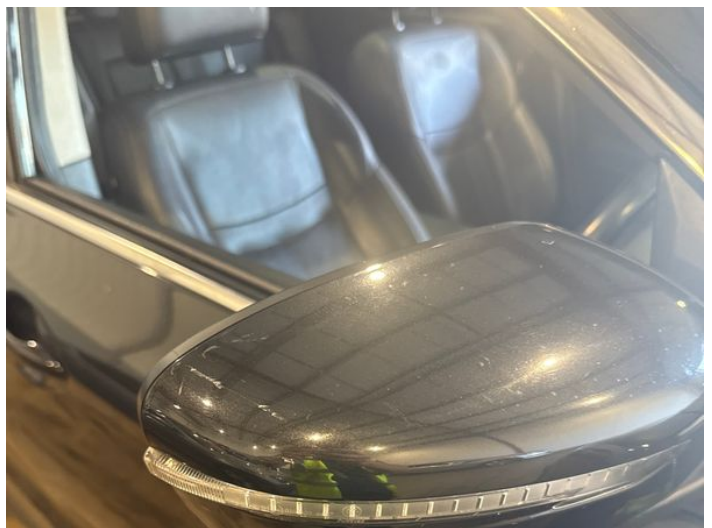
26: Door Mirror Assy osf  
Scratched (Painted)  
Over 25mm Thru Paint

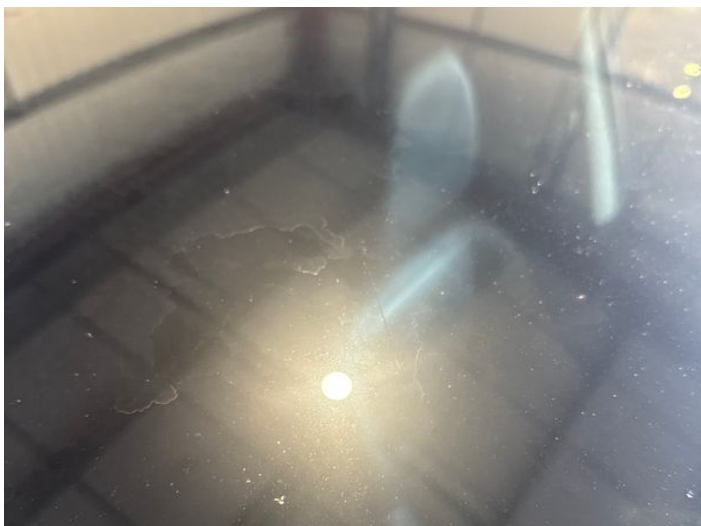
27: Glass Roof  
Scratched  
Over 30mm

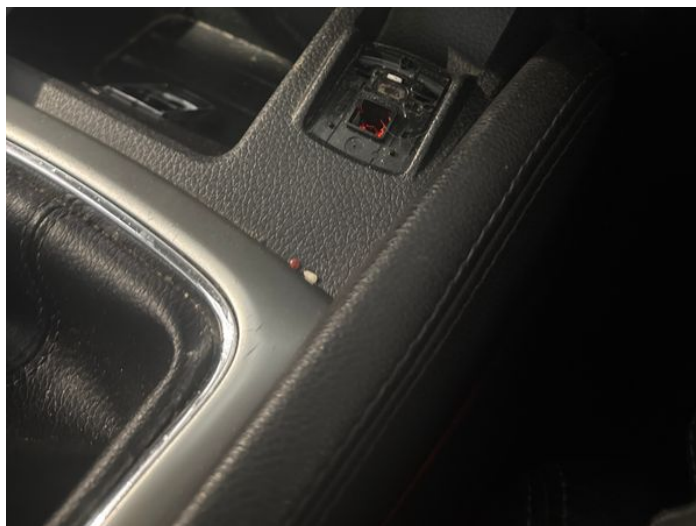
28: Switches And Controls  
Broken  
Replace
