## VEHICLE INSPECTION REPORT

**KX20PUJ**

### Suzuki Vitara 1.4 Boosterjet SZ-T 5dr Auto

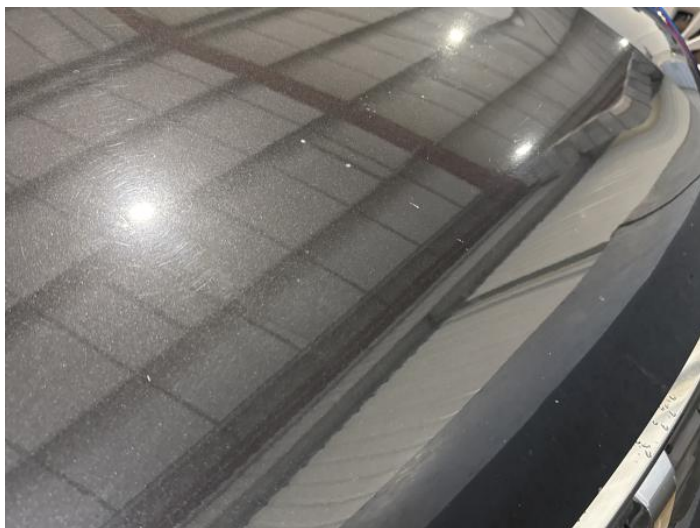
1: Bonnet  
Chipped  
Multiple Chips

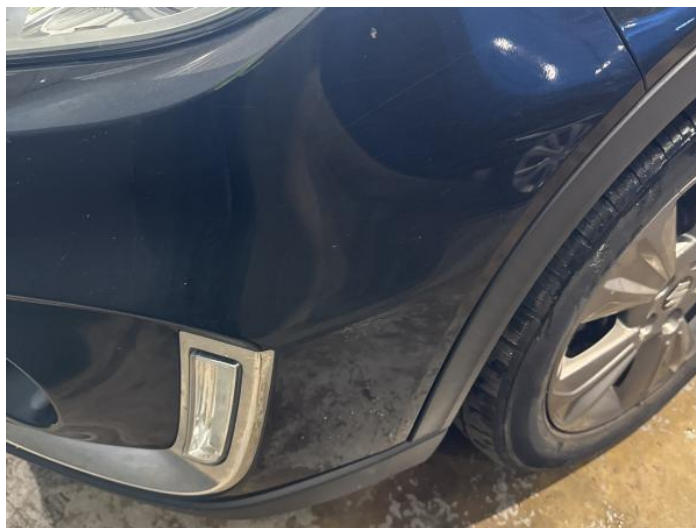
2: Bumper Front  
Scratched  
25 to 100mm Thru Paint

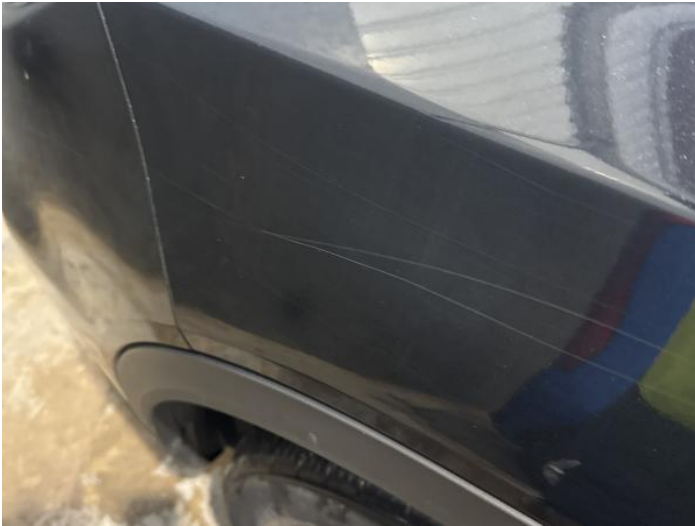
3: Wing nsf  
Chipped  
1 To 5

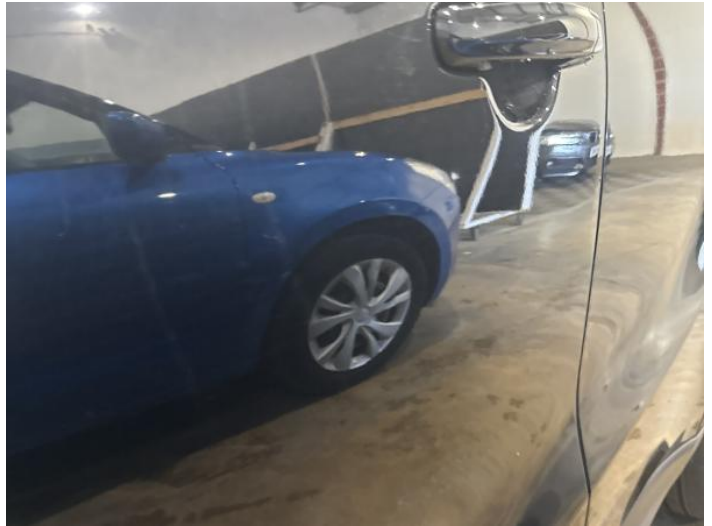
4: Door nsf  
Chipped  
Over 5mm

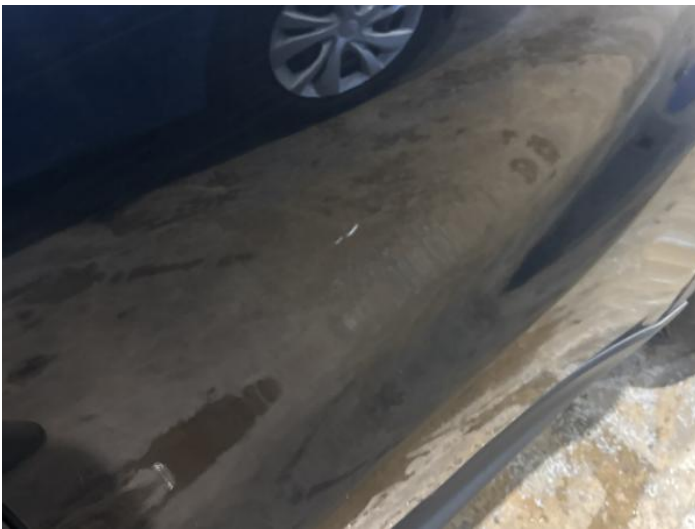
5: Door nsr  
Scratched  
UpTo 25mm Thru Paint

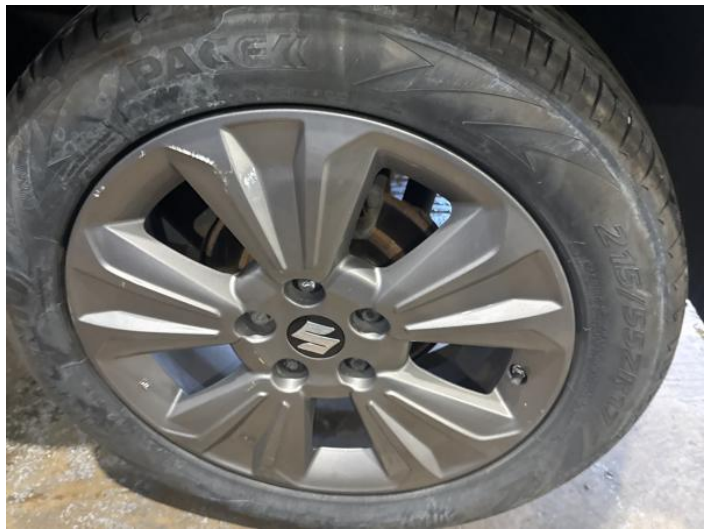
6: Wheel nsr  
Scratched  
Over 50mm

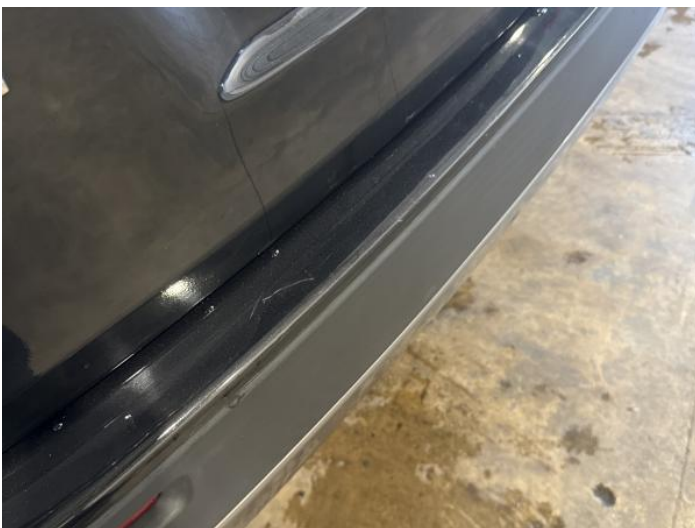
7: Bumper Rear  
Scratched  
25 to 100mm Thru Paint

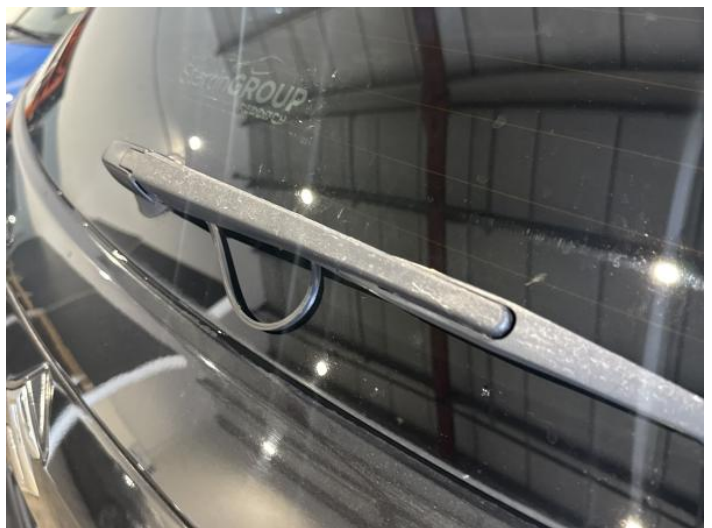
8: Wiper Rear  
Broken  
Replace

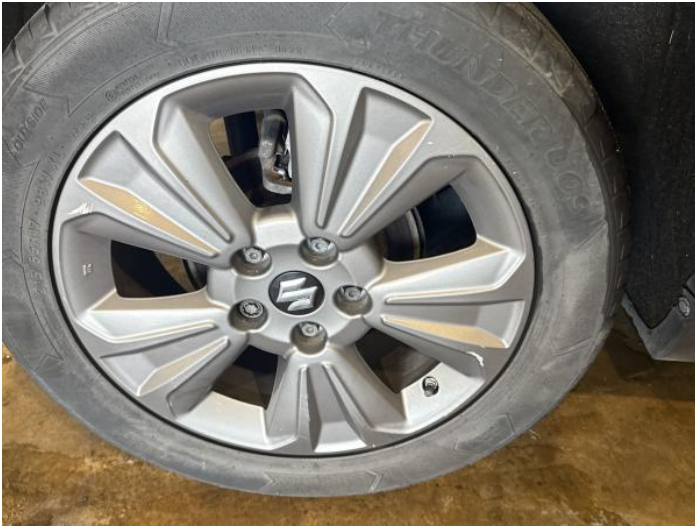
9: Wheel osr  
Scratched  
Over 50mm

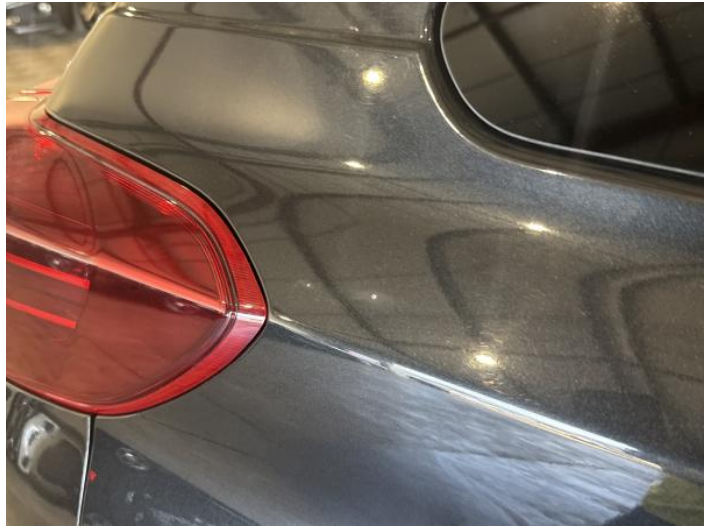
10: Qtr Panel osr  
Chipped  
1 To 5

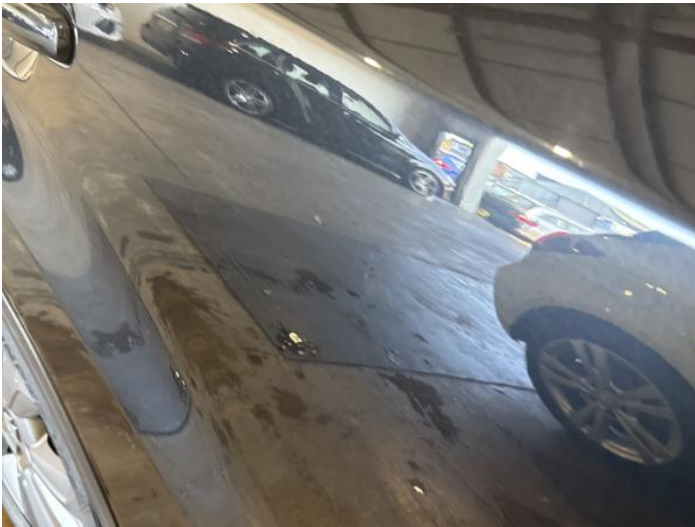
11: Door osr  
Chipped  
1 To 5

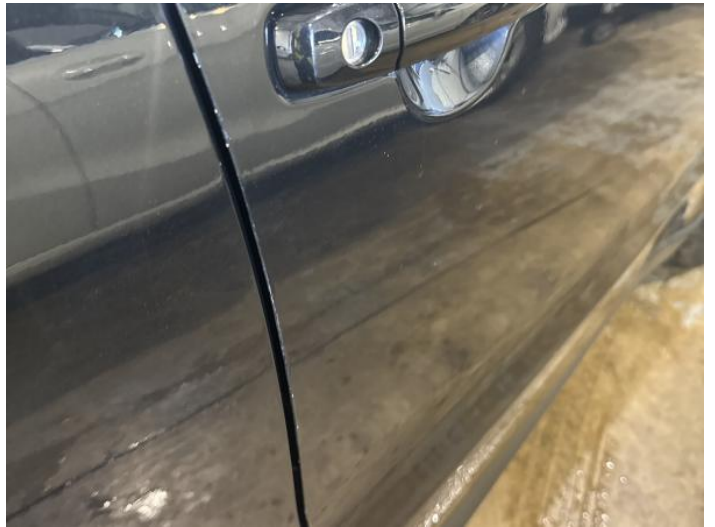
12: Door osf  
Chipped  
Edge Chip

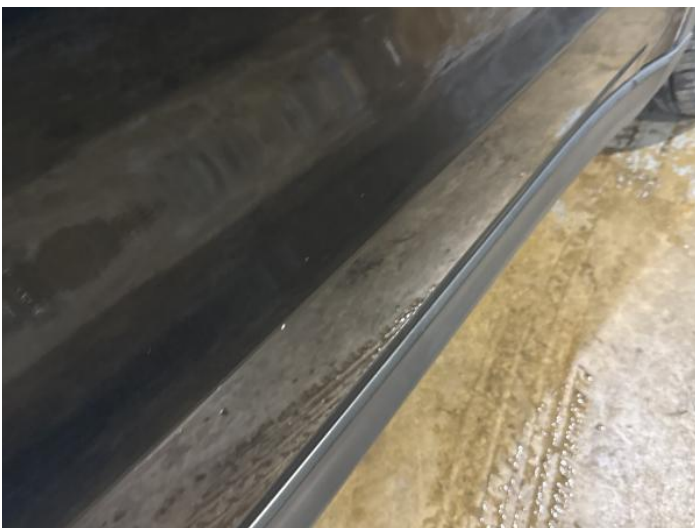
13: Door osf  
Chipped  
1 To 5

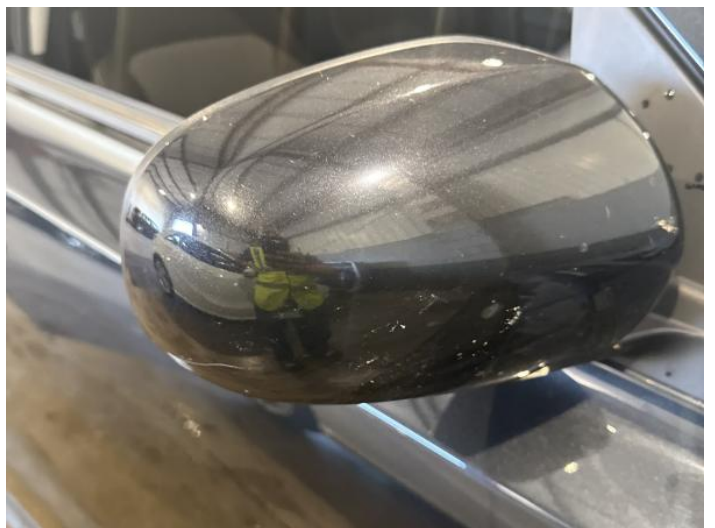
14: Door Mirror Assy osf  
Scratched (Painted)  
UpTo 25mm Thru Paint

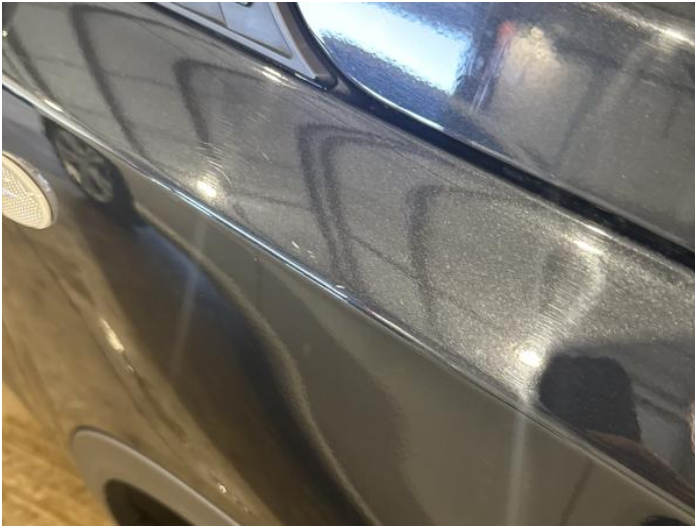
15: Wing osf  
Chipped  
1 To 5

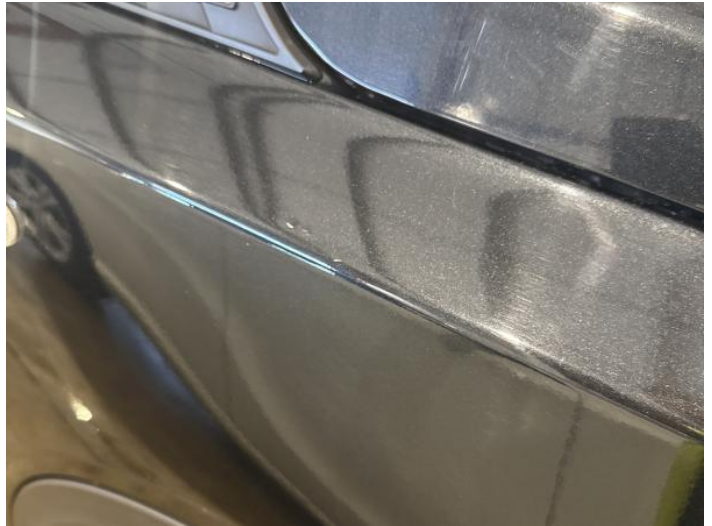
16: Wing osf  
Dented  
Between 10mm + 30mm

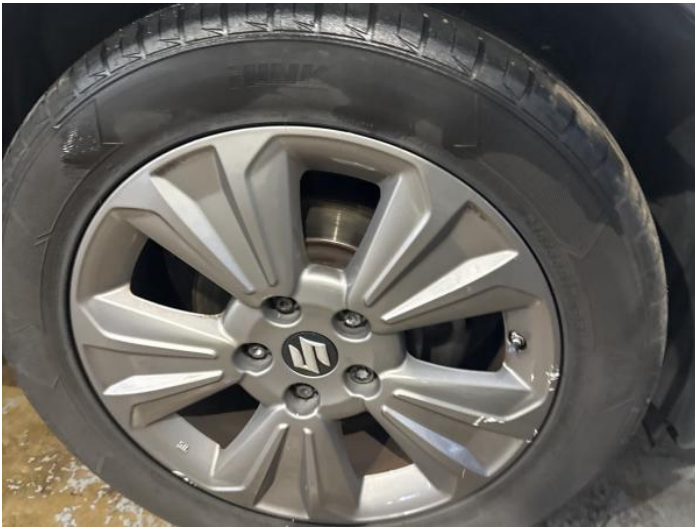
17: Wheel osf  
Scratched  
Over 50mm

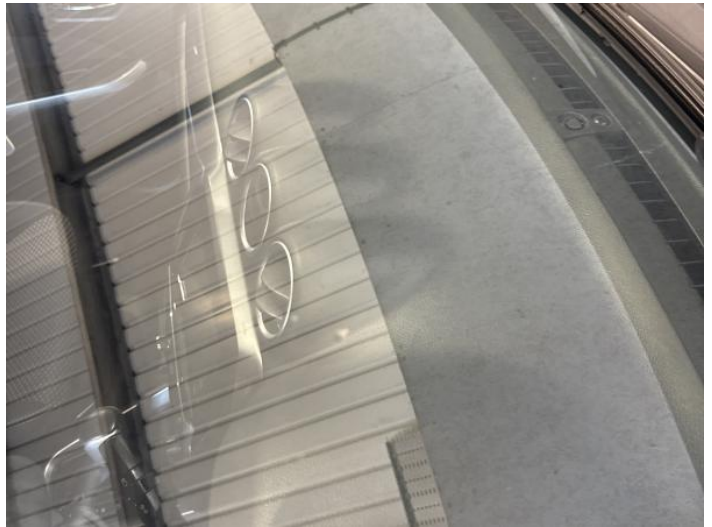
18: Screen Front  
Cracked  
Replace

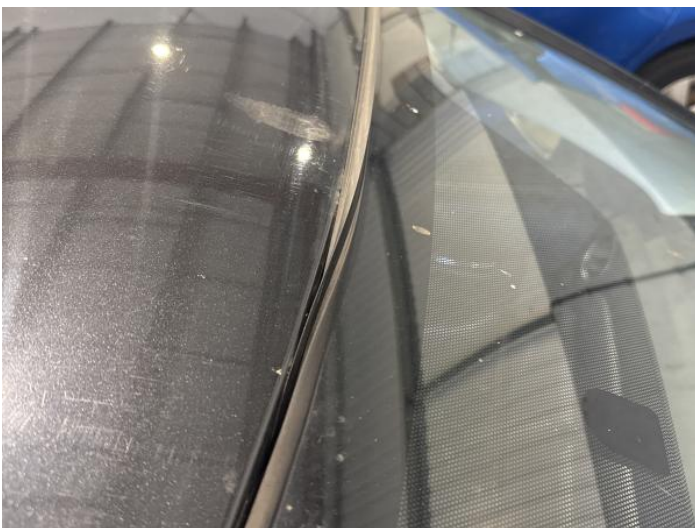
19: Aperture Seal nsf  
Broken  
Replace
