# VEHICLE INSPECTION REPORT

**MV58UNG**

## Ford Focus 1.6 Zetec 5dr Auto

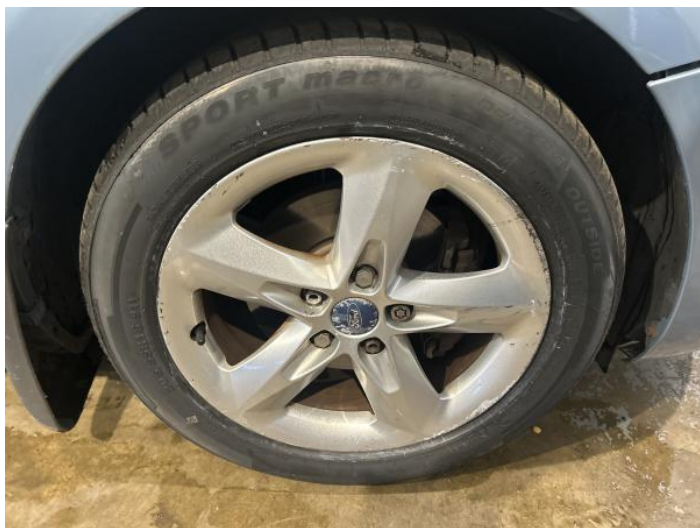
1: Wheel osf  
Scratched  
Over 50mm

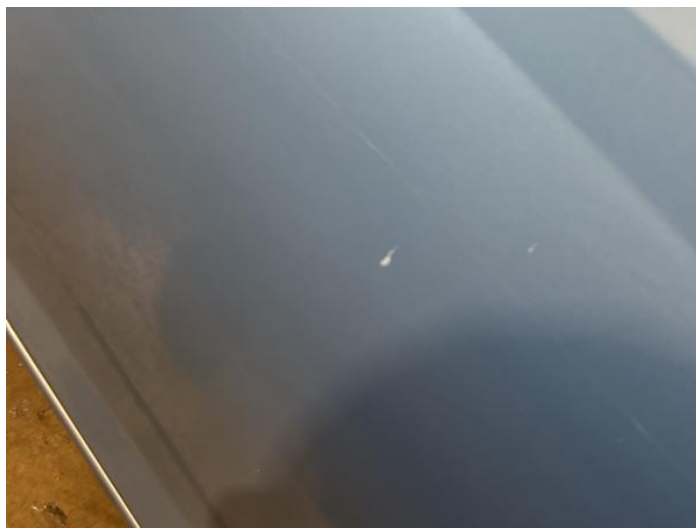
2: Door osf  
Chipped  
1 To 5

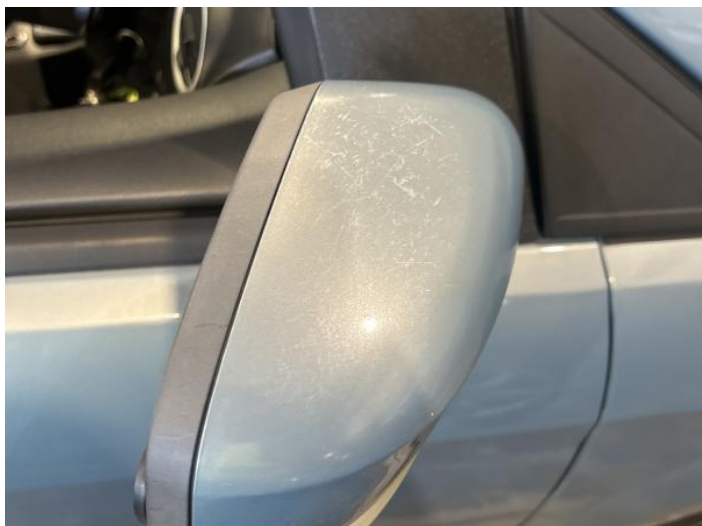
3: Door Mirror Assy osf  
Scratched (Painted)  
Over 25mm Thru Paint

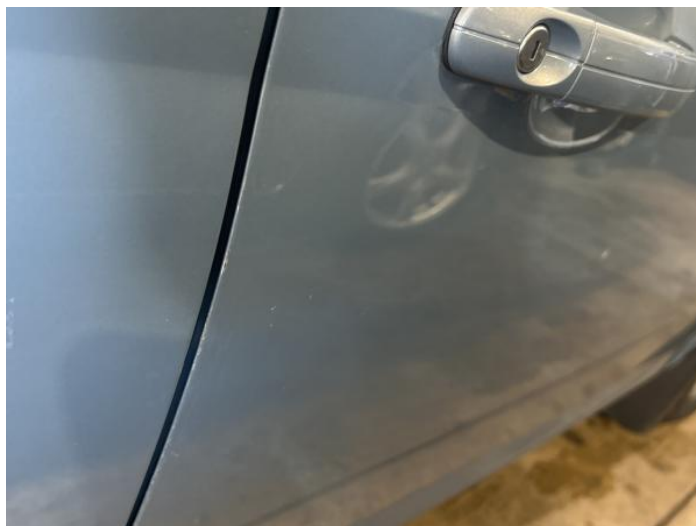
4: Door osf  
Chipped  
Edge Chip

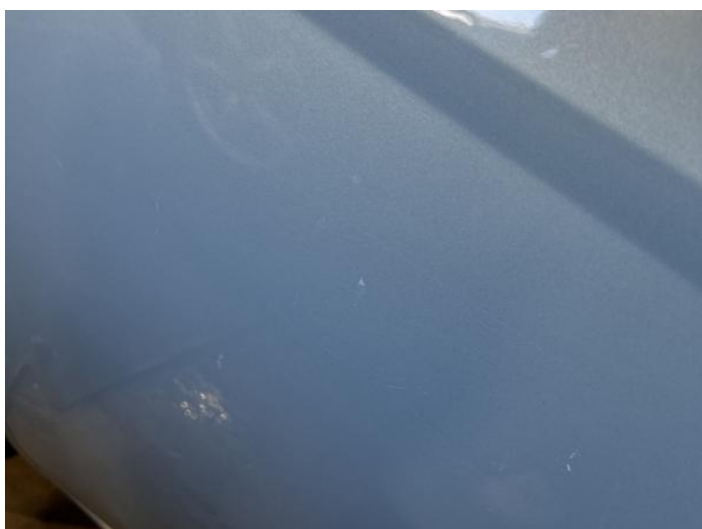
5: Door osr  
Chipped  
1 To 5

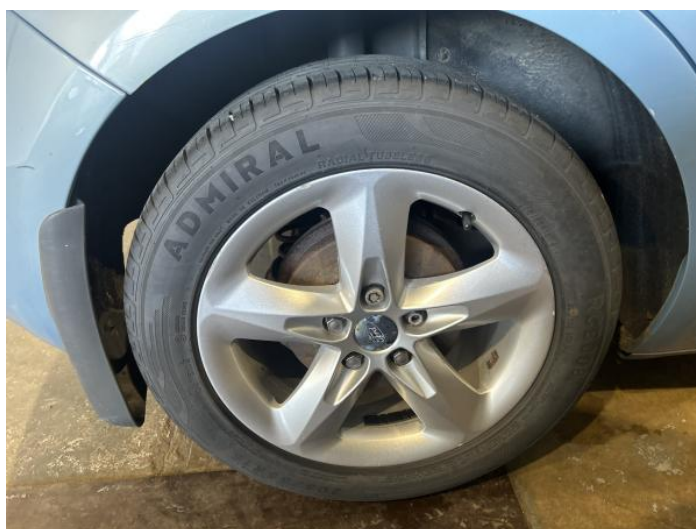
6: Wheel osr  
Scratched  
Up To 50mm

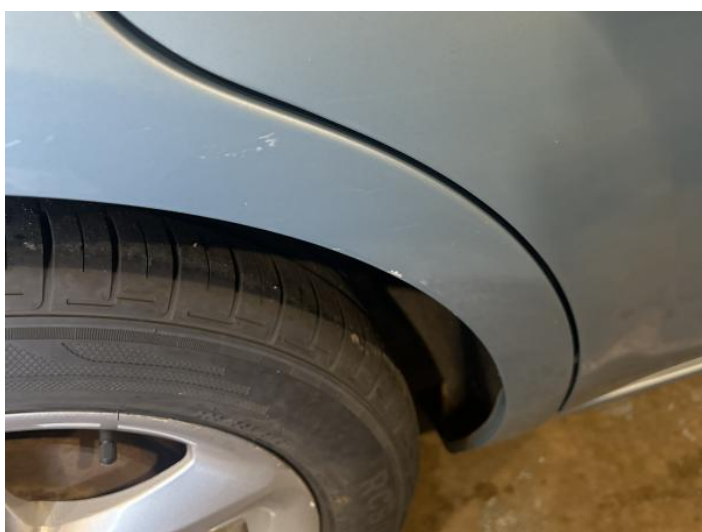
7: Qtr Panel osr  
Chipped  
1 To 5

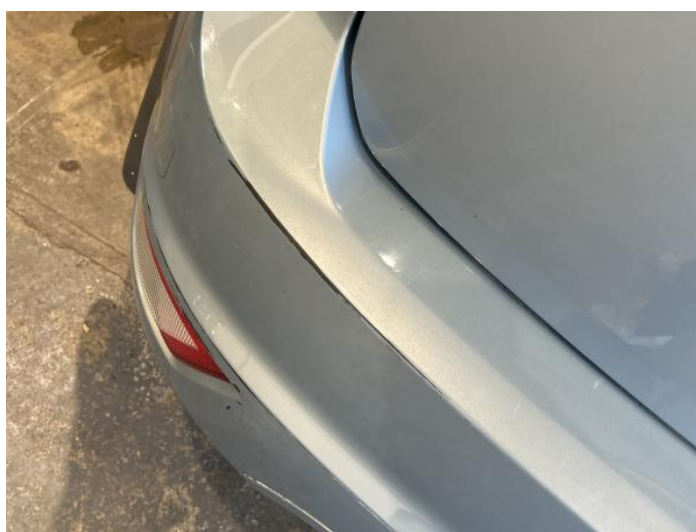
8: Bumper Rear  
Scratched  
Over 100mm Thru Paint

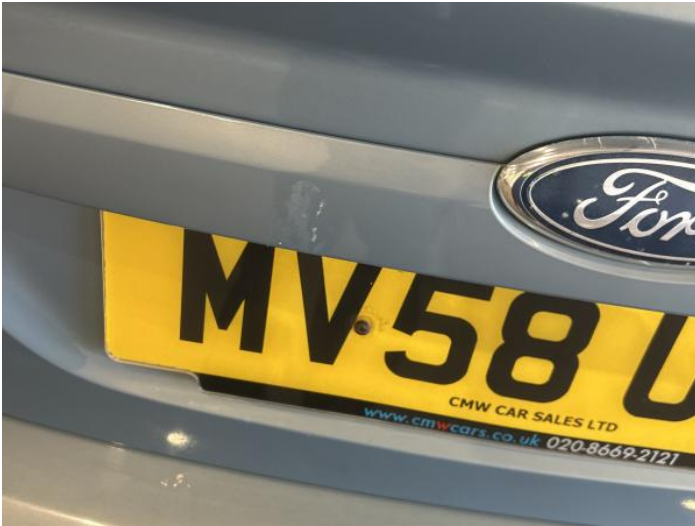
9: Tailgate  
Scratched  
UpTo 25mm Thru Paint

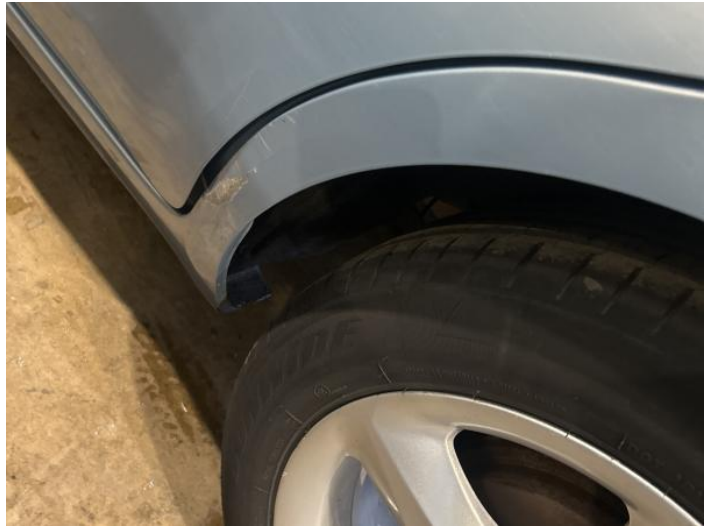
10: Qtr Panel nsr  
Dented  
With Paint Damage

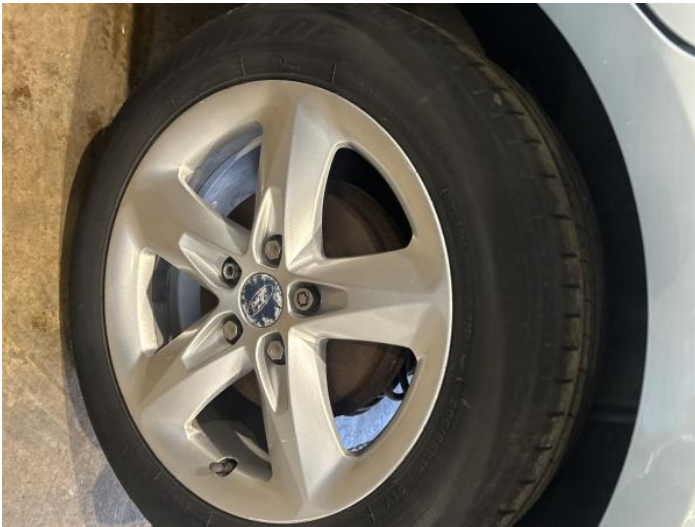
11: Wheel nsr  
Scratched  
Over 50mm

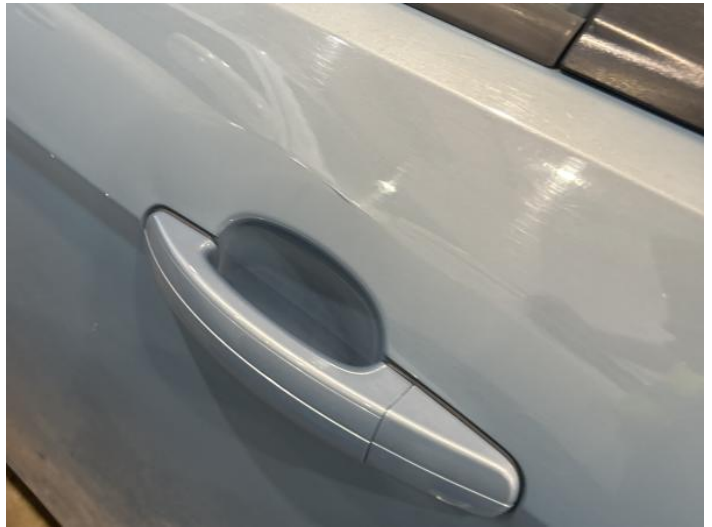
12: Door nsr  
Dented  
With Paint Damage

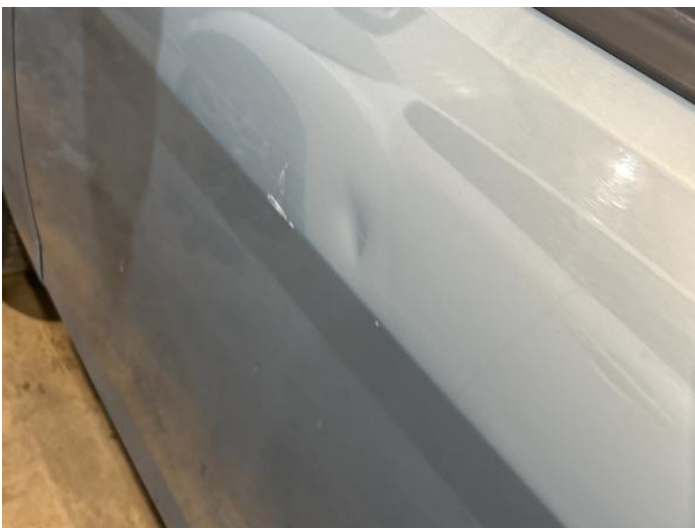
13: Door nsf  
Dented  
With Paint Damage

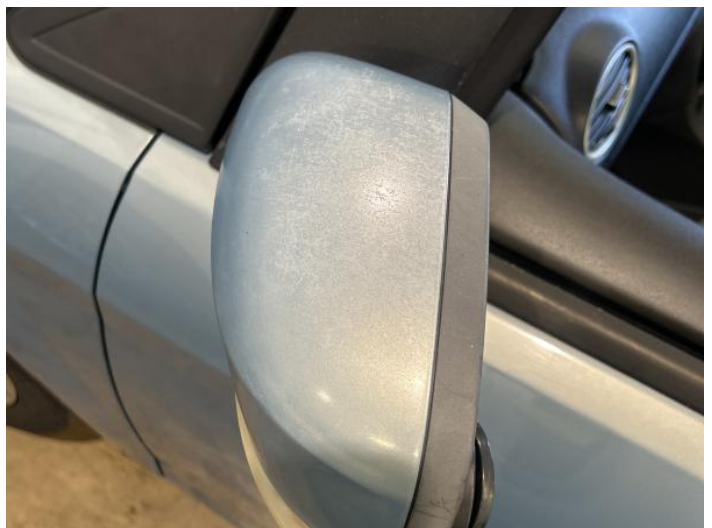
14: Door Mirror Assy nsf  
Scratched (Painted)  
Over 25mm Thru Paint

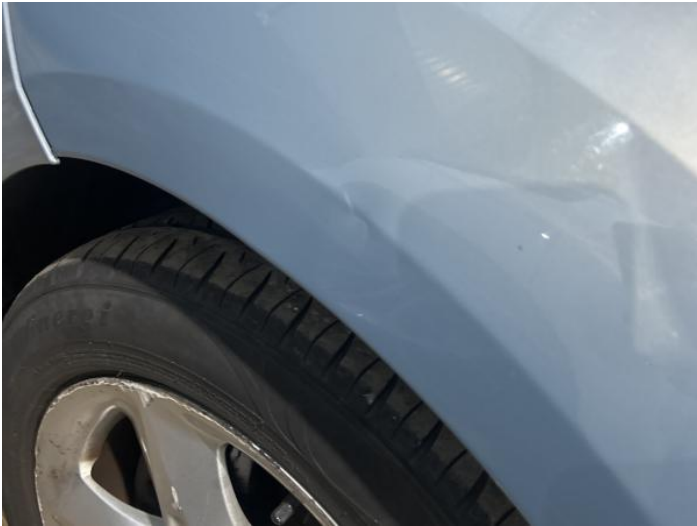
15: Wing nsf  
Dented  
Between 10mm + 30mm

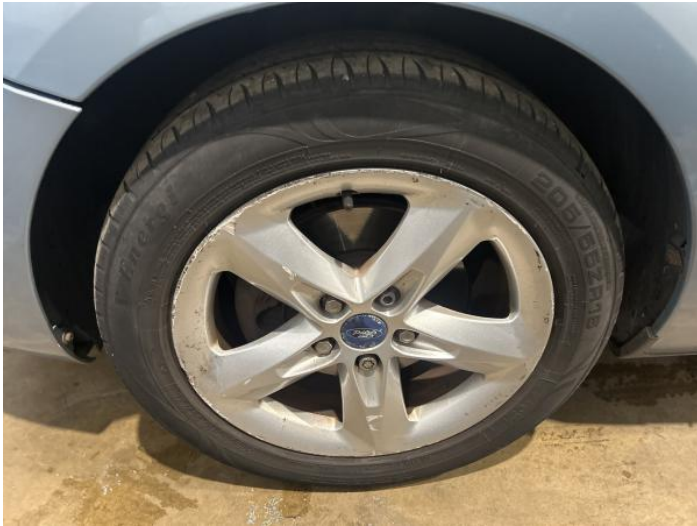
16: Wheel nsf  
Scratched  
Over 50mm

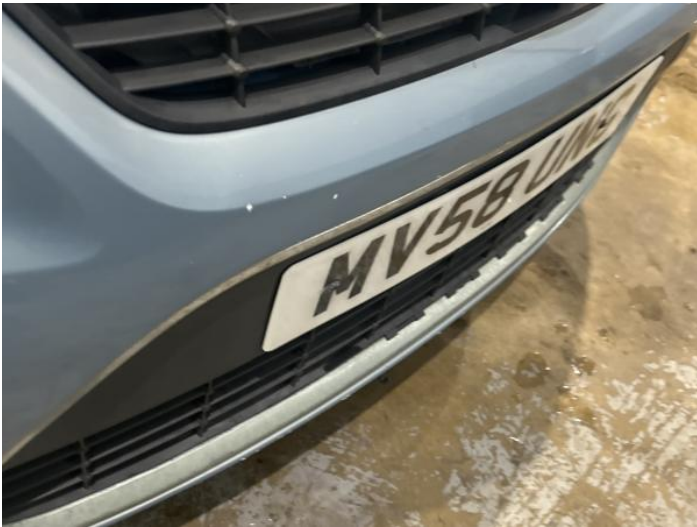
17: Bumper Front  
Chipped  
Multiple Chips
