# VEHICLE INSPECTION REPORT

**LK64XRE**

## Vauxhall Corsa 1.4T Black Edition 3dr

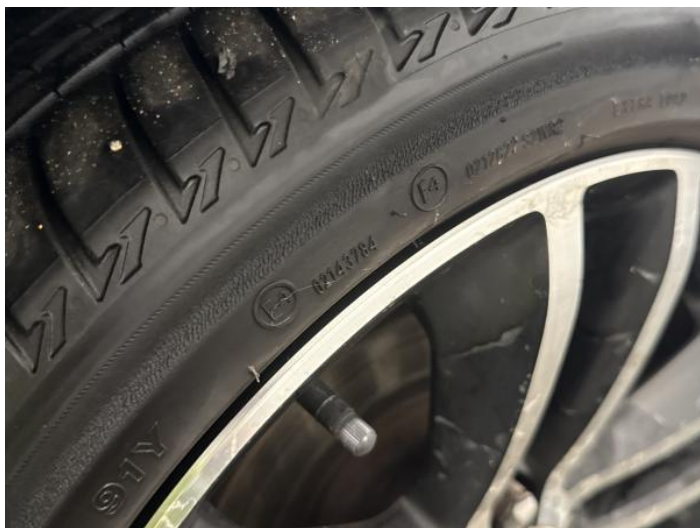
1: Tyre osr  
Damaged  
Replace

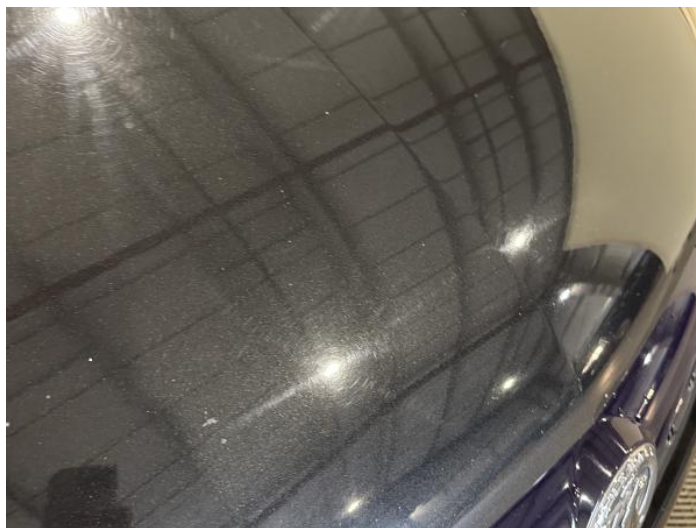
2: Bonnet  
Chipped  
Multiple Chips

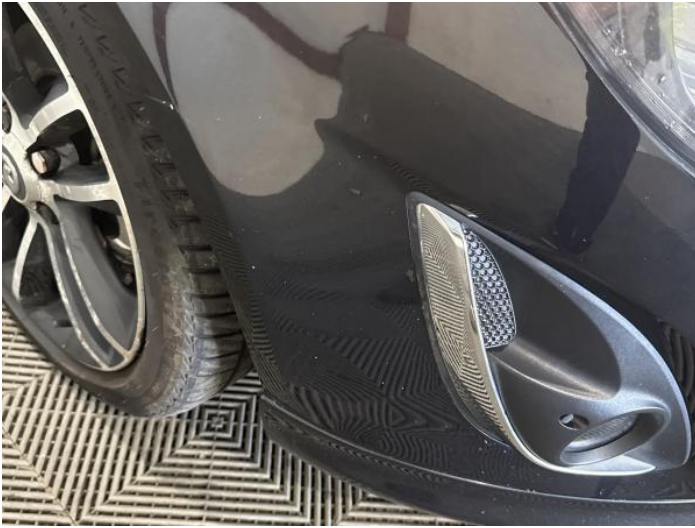
3: Bumper Front  
Scratched  
Over 100mm Thru Paint

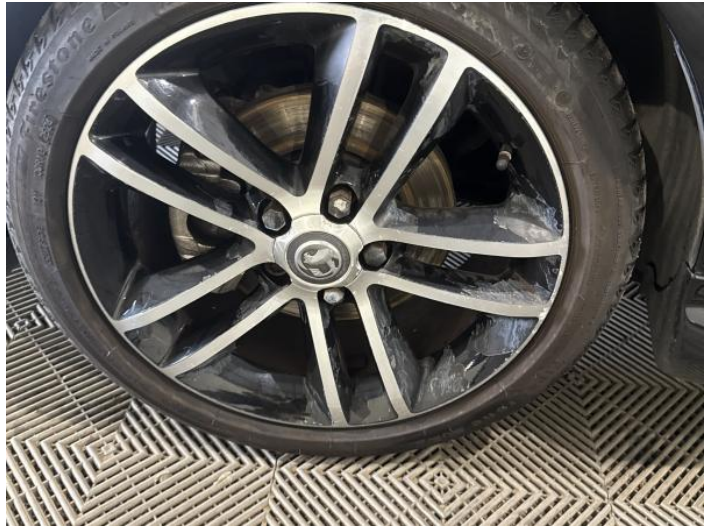
4: Wheel nsf  
Scratched  
Over 50mm

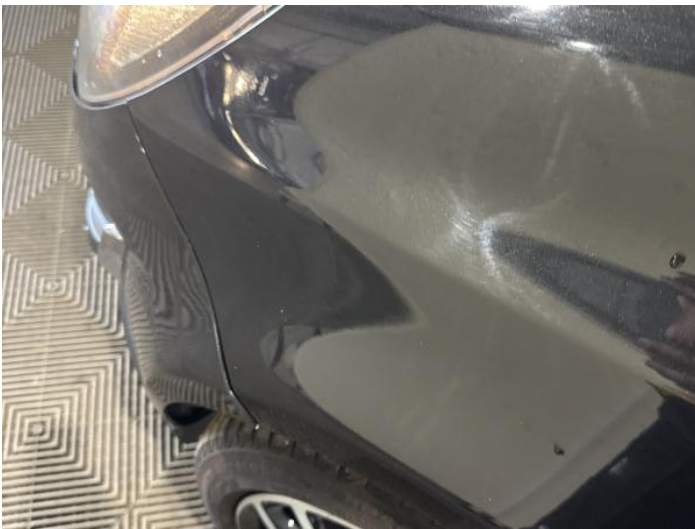
5: Wing nsf  
Chipped  
1 To 5

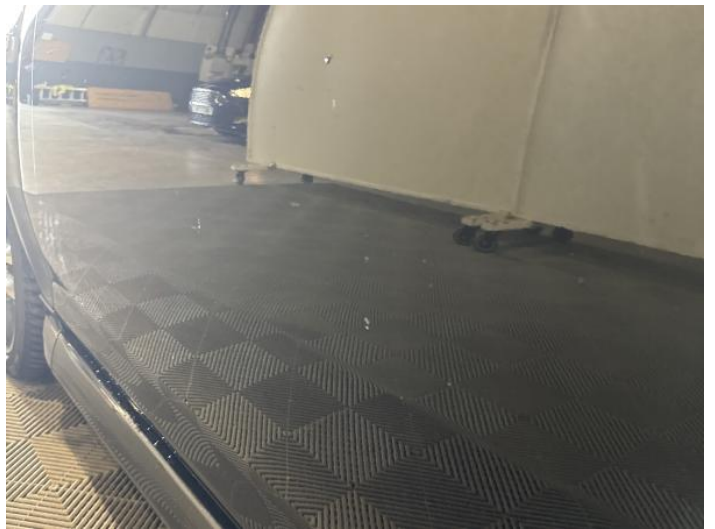
6: Door nsf  
Chipped  
Multiple Chips

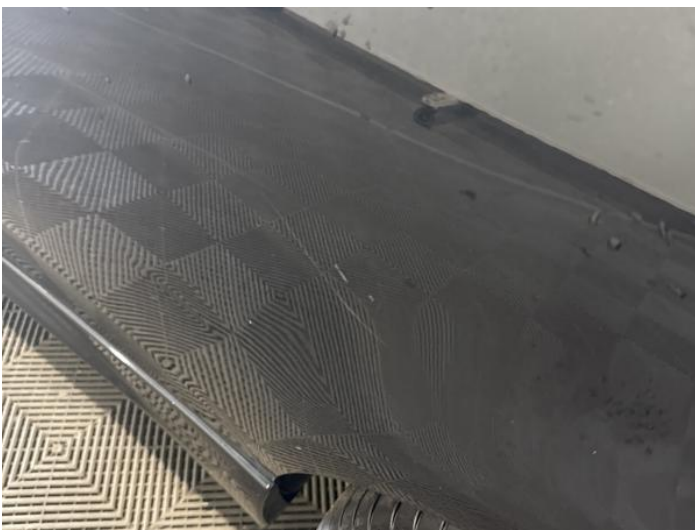
7: Qtr Panel nsr  
Scratched  
Over 25mm Thru Paint

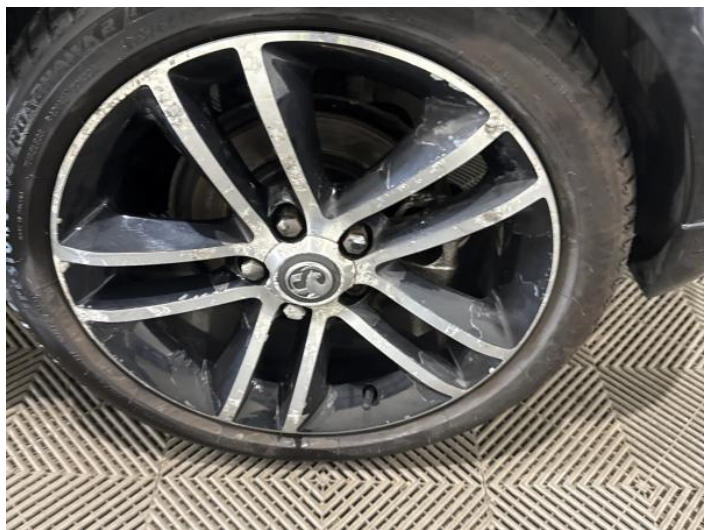
8: Wheel nsr  
Scratched  
Over 50mm

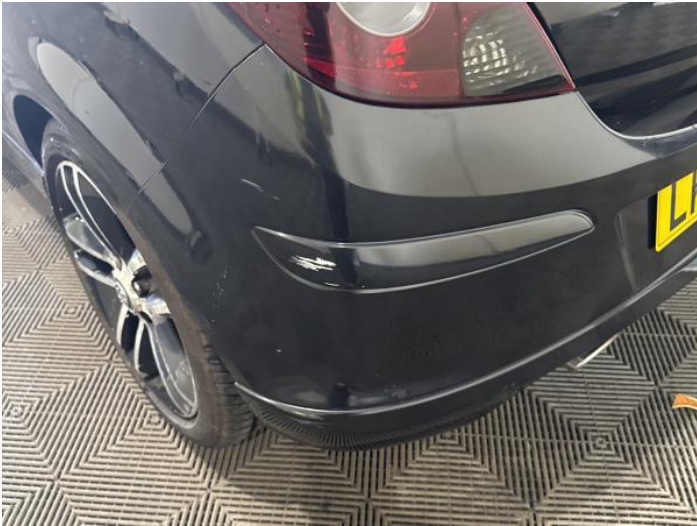
9: Bumper Rear  
Poor Previous Repair  
Poor Paint

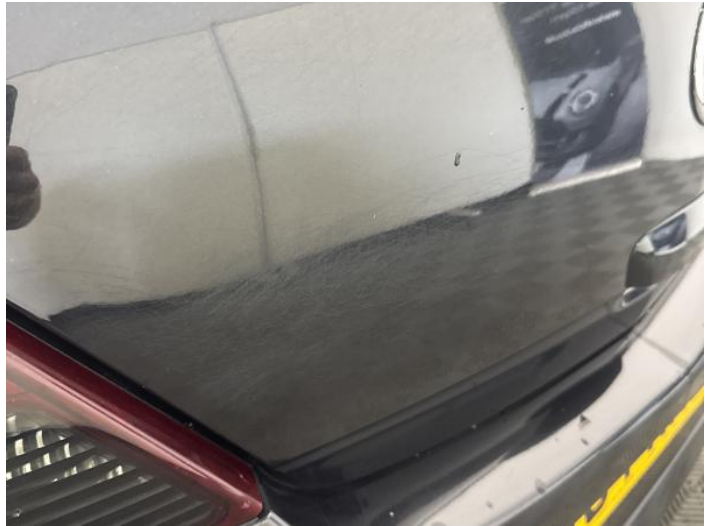
10: Tailgate  
Scratched  
Over 25mm Thru Paint

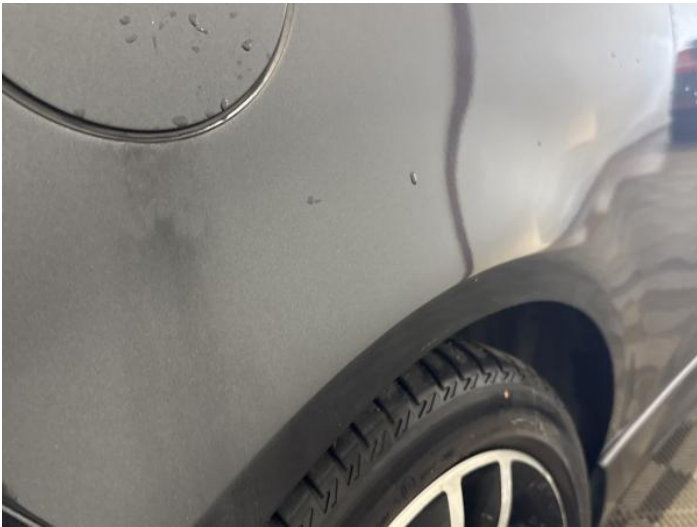
11: Qtr Panel osf  
Scratched  
Over 25mm Thru Paint

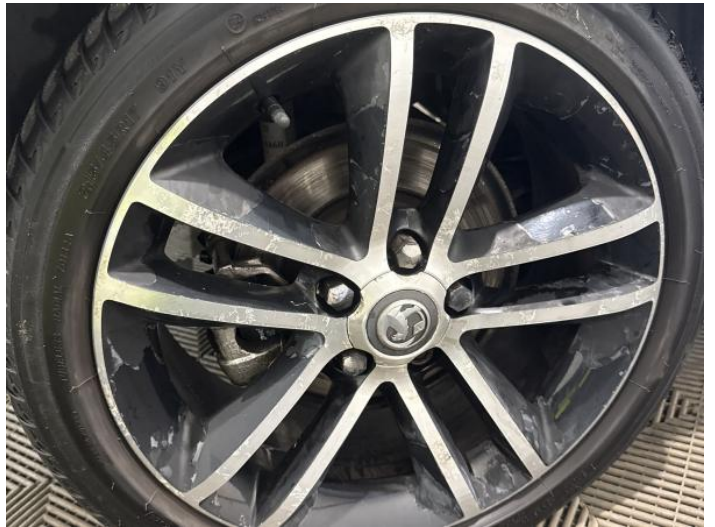
12: Wheel osf  
Scratched  
Over 50mm

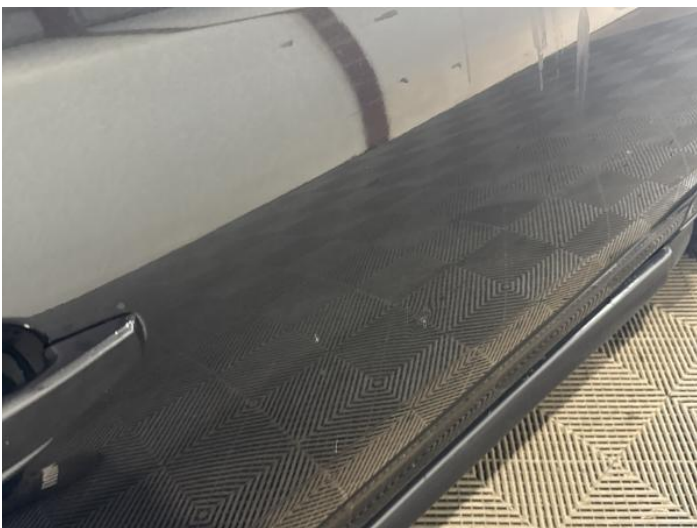
13: Door osf  
Dented  
With Paint Damage

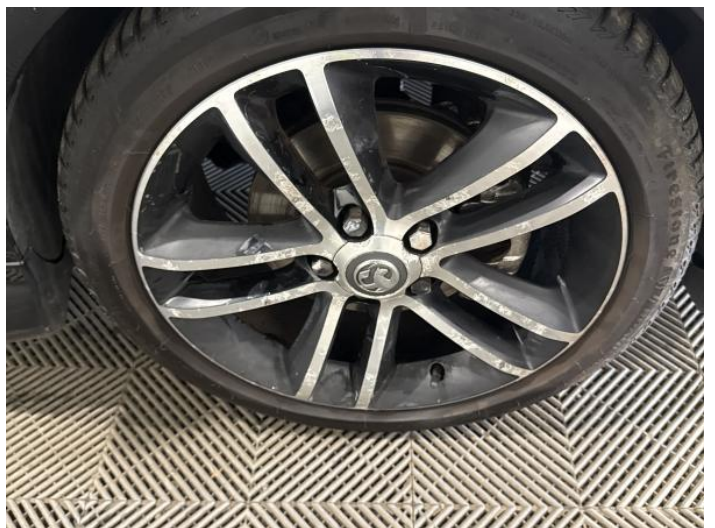
14: Wheel osf  
Scratched  
Over 50mm

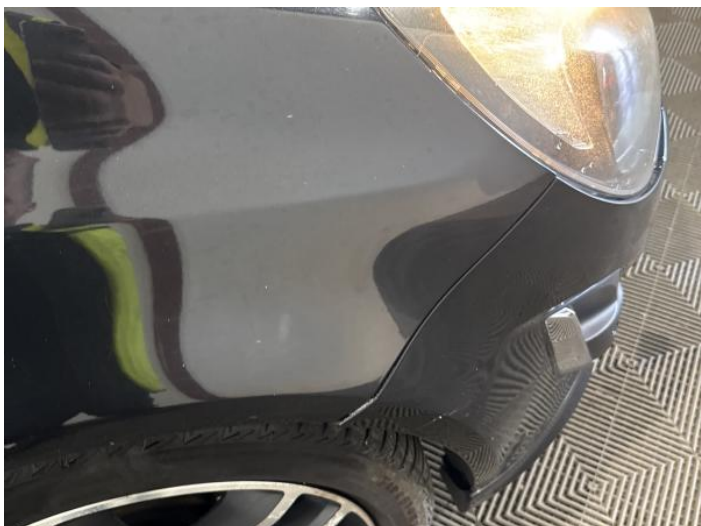
15: Wing osf  
Chipped  
1 To 5

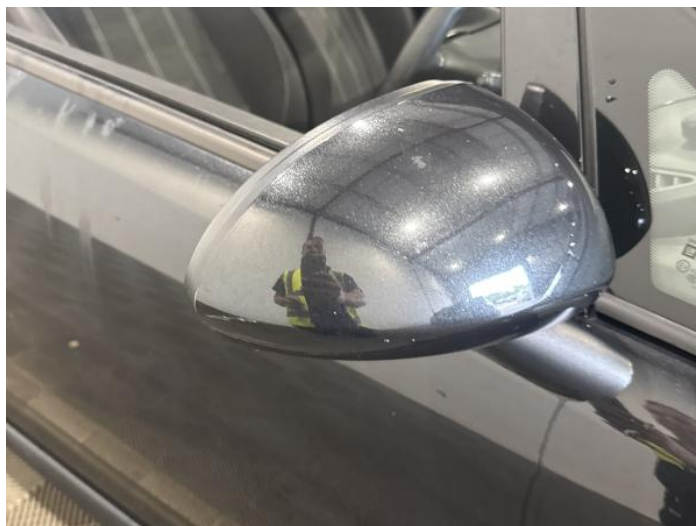
16: Door Mirror Assy osf  
Scratched (Painted)  
UpTo 25mm Thru Paint

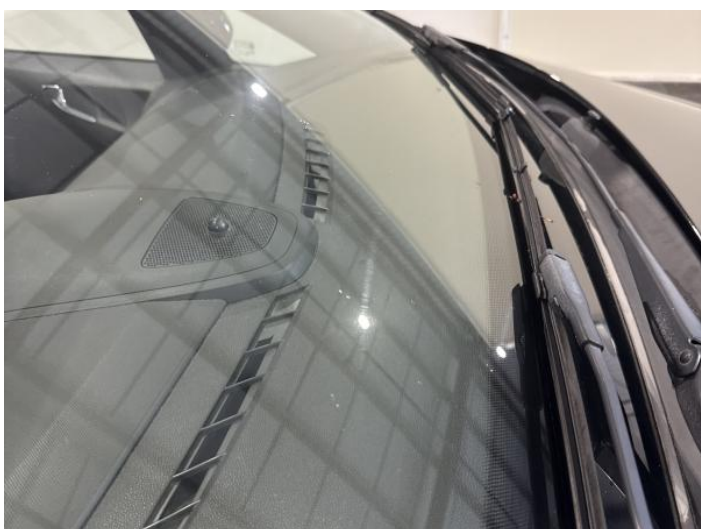
17: Screen Front  
Chipped  
UpTo 10mm

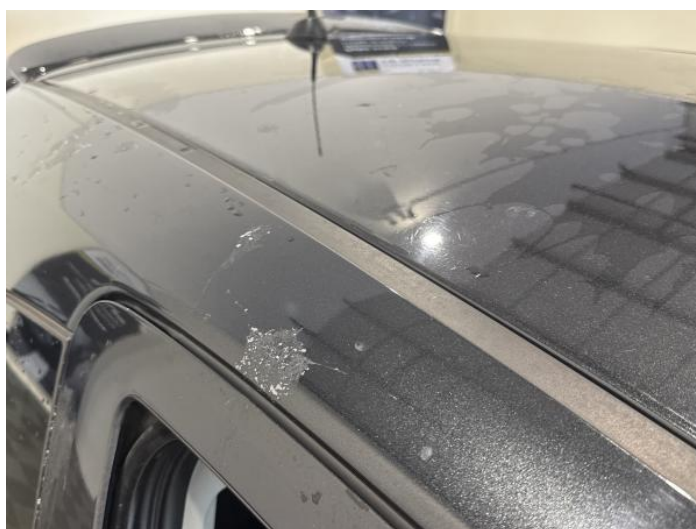
18: Roof  
Scratched  
Over 25mm Thru Paint
