# VEHICLE INSPECTION REPORT

**GY10WDS**

## Nissan Qashqai 1.6 Tekna 5dr

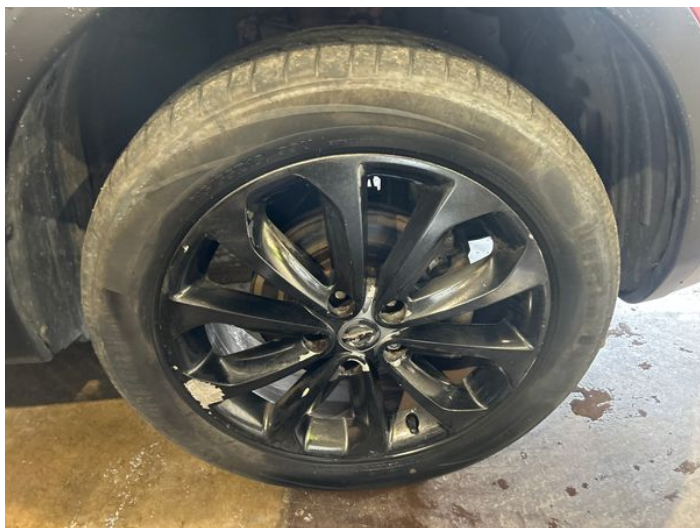
1: Wheel osf  
Scratched  
Over 50mm

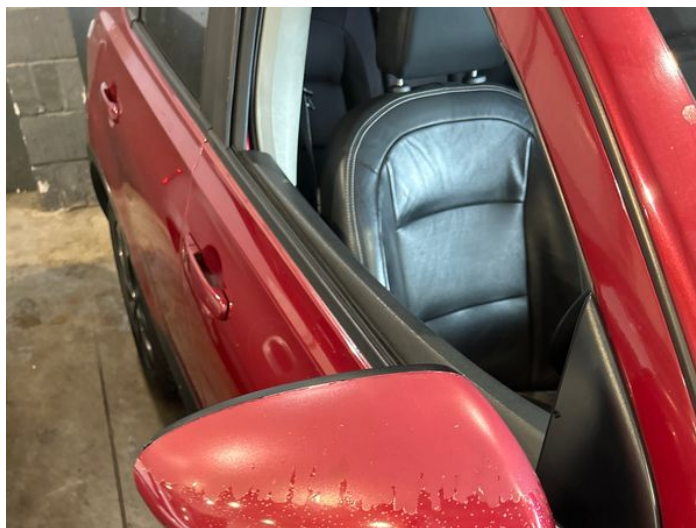
2: Door Mirror Assy osf  
Scratched (Painted)  
Over 25mm Thru Paint

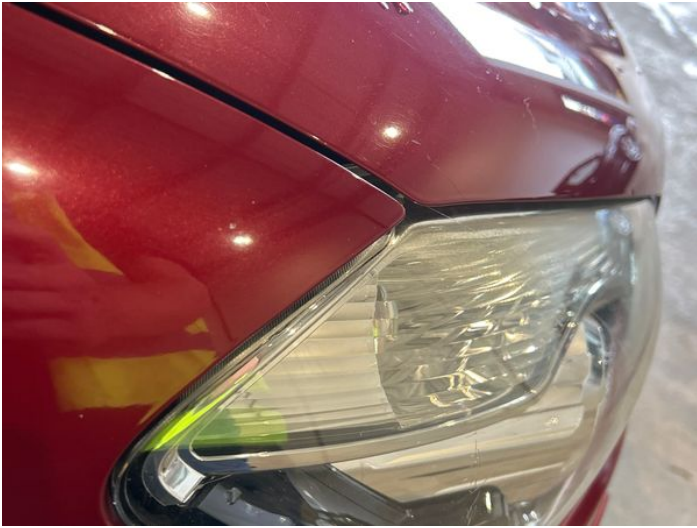
3: Wing osf  
Chipped  
1 To 5

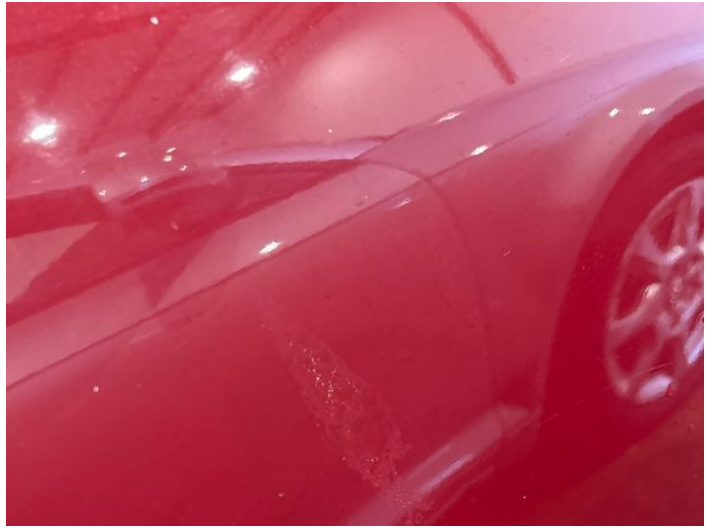
4: Door osf  
Poor Previous Repair  
Paint Flake

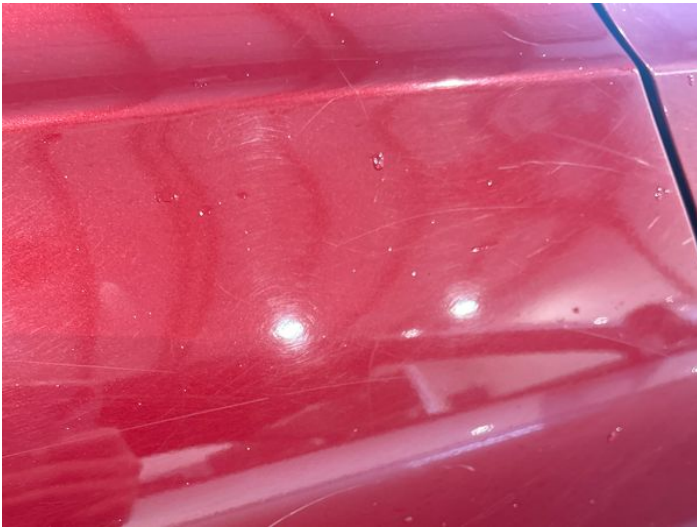
5: Door osr  
Scratched  
Over 25mm Thru Paint

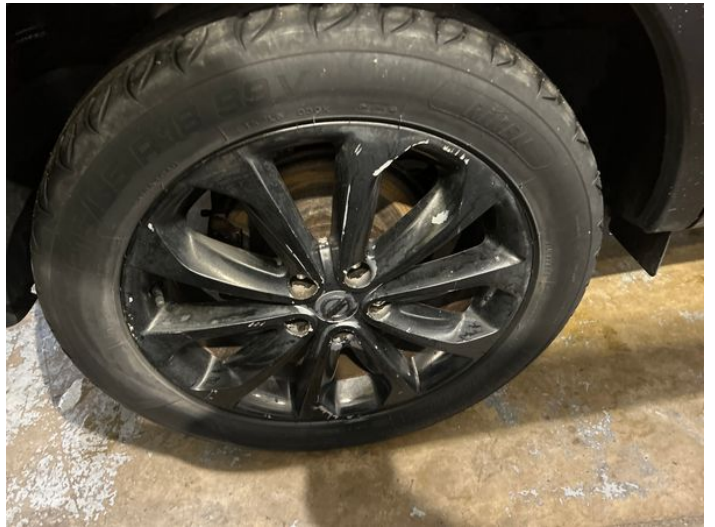
6: Wheel osr  
Scratched  
Over 50mm

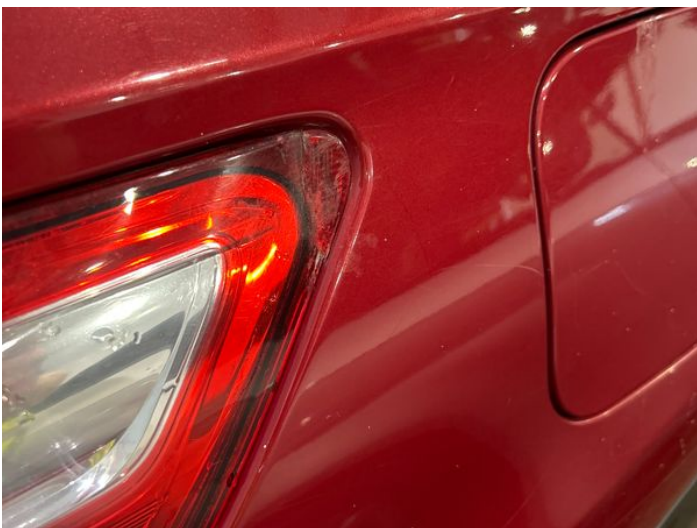
7: Lamp osr  
Broken  
Replace

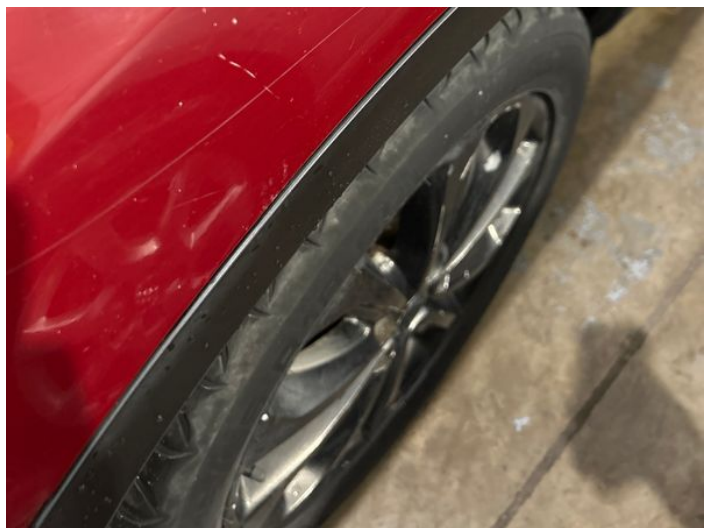
8: Qtr Panel osr  
Scratched  
Over 25mm Thru Paint

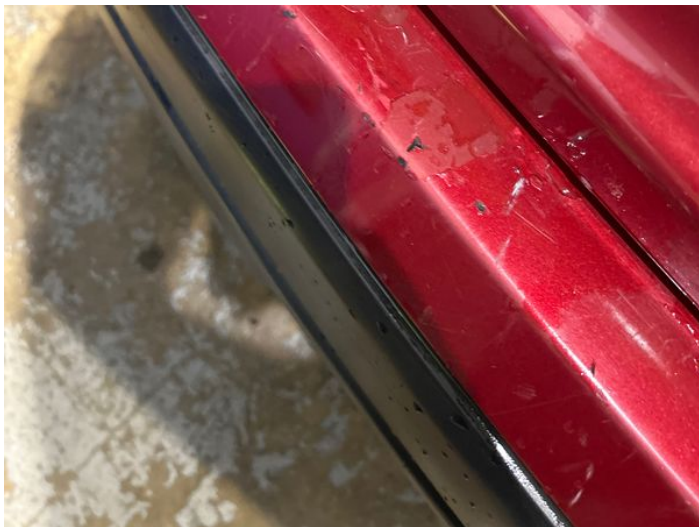
9: Bumper Rear  
Poor Previous Repair  
Paint Flake

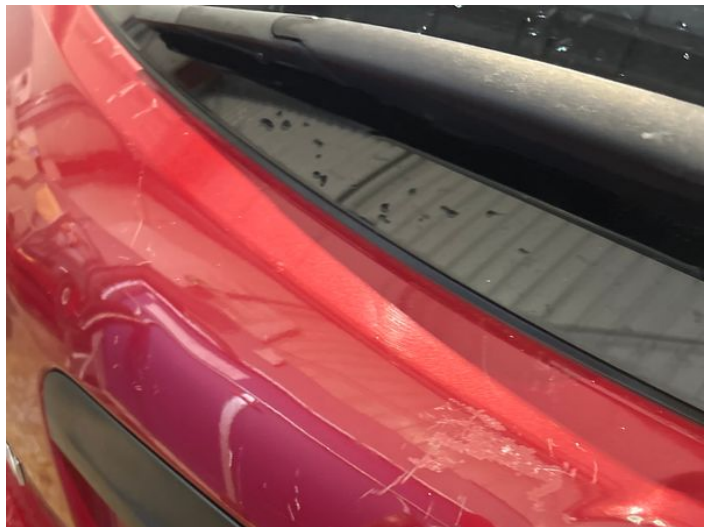
10: Tailgate  
Dented  
With Paint Damage

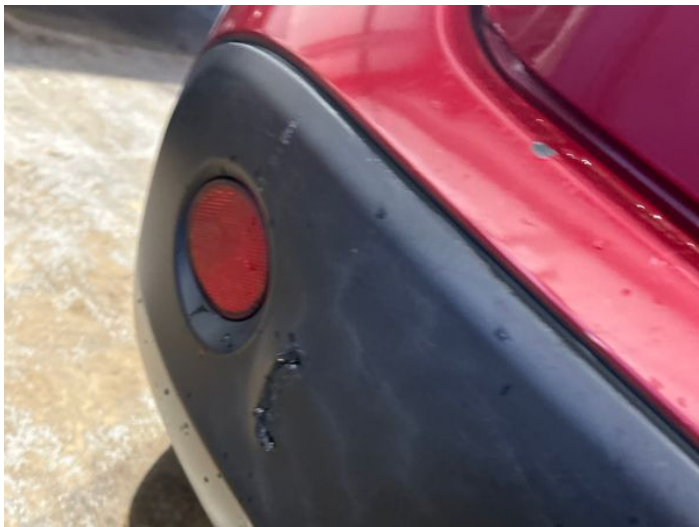
11: Bumper Rear Moulding  
Scuffed (Unpainted)  
UpTo 100mm

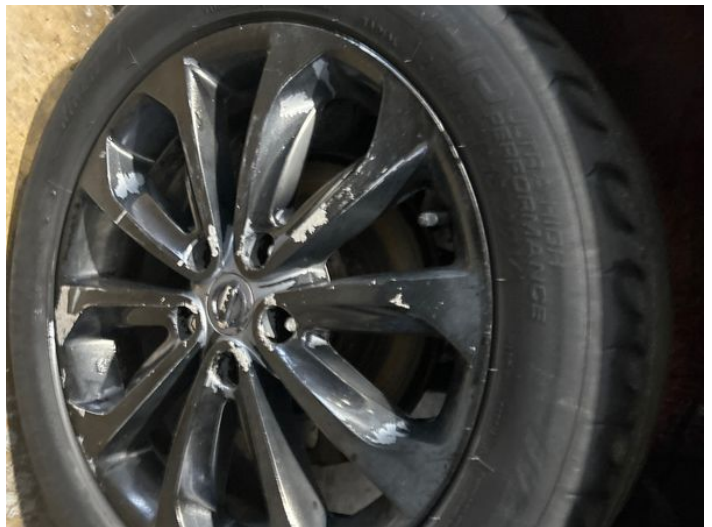
12: Wheel nsr  
Scratched  
Over 50mm

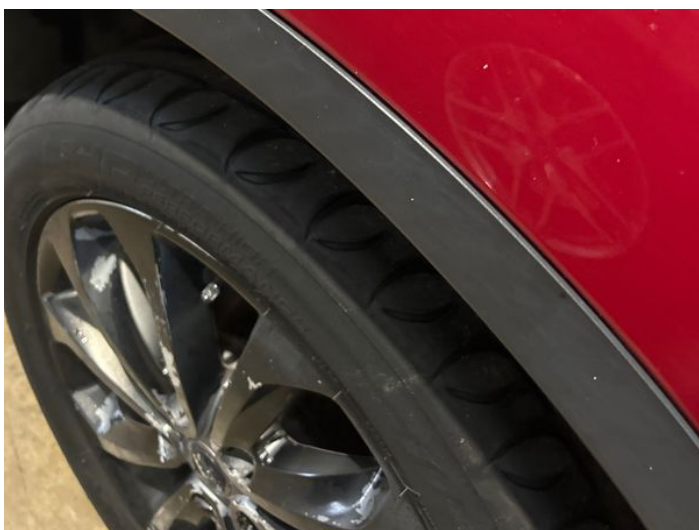
13: Qtr Panel nsr  
Chipped  
1 To 5

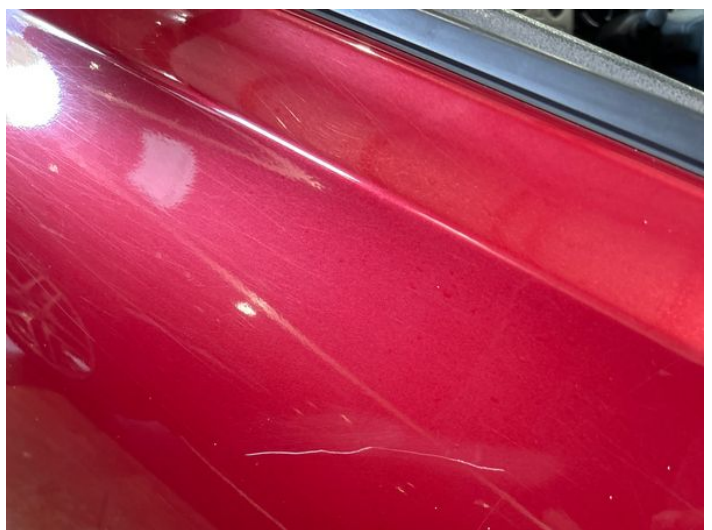
14: Door nsf  
Scratched  
Over 25mm Thru Paint

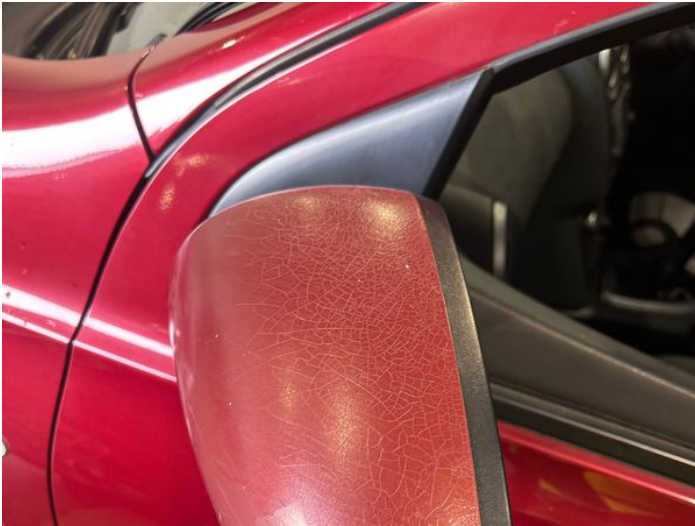
15: Door Mirror Assy nsf  
Scratched (Painted)  
Over 25mm Thru Paint

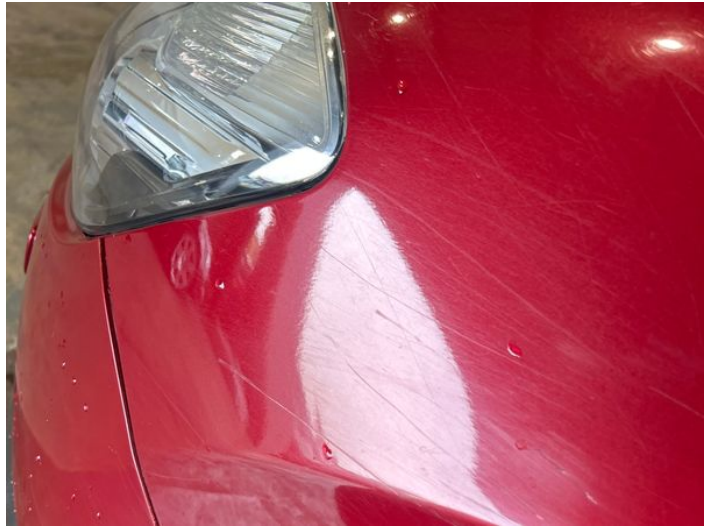
16: Wing nsf  
Scratched  
Over 25mm Thru Paint

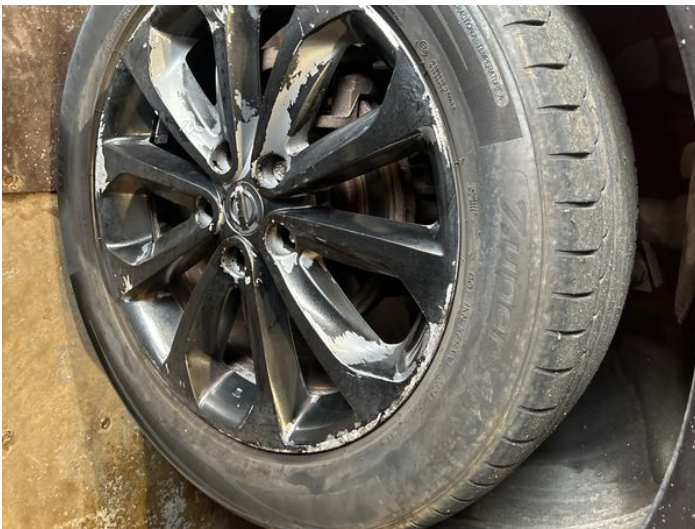
17: Wheel nsf  
Scratched  
Over 50mm

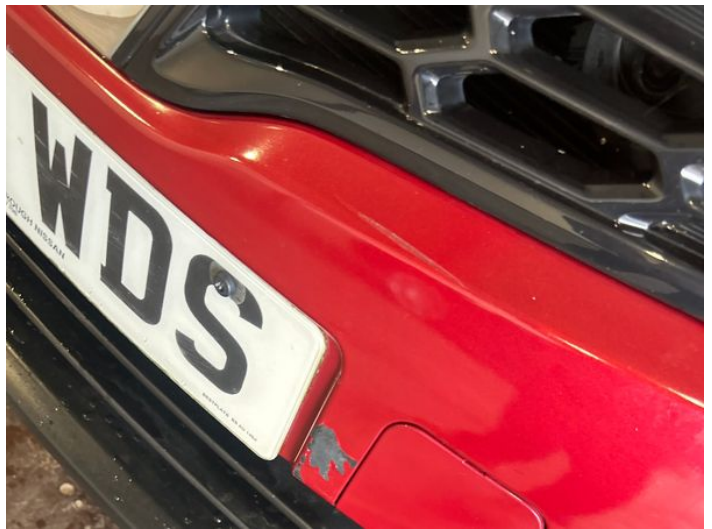
18: Bumper Front  
Poor Previous Repair  
Paint Flake

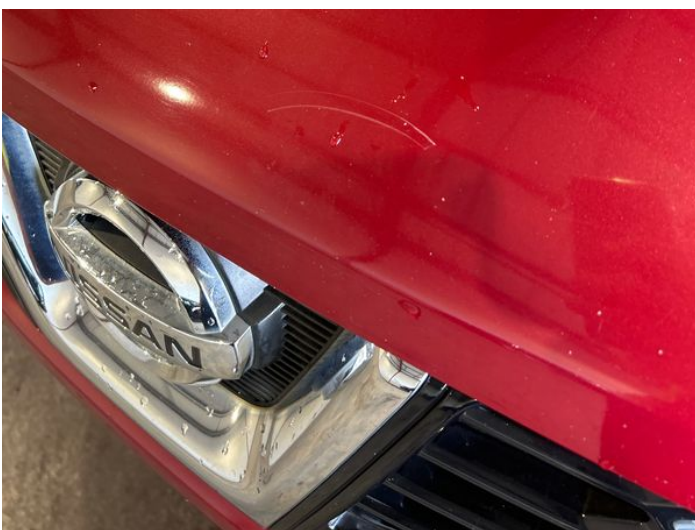
19: Bonnet  
Scratched  
Over 25mm Thru Paint

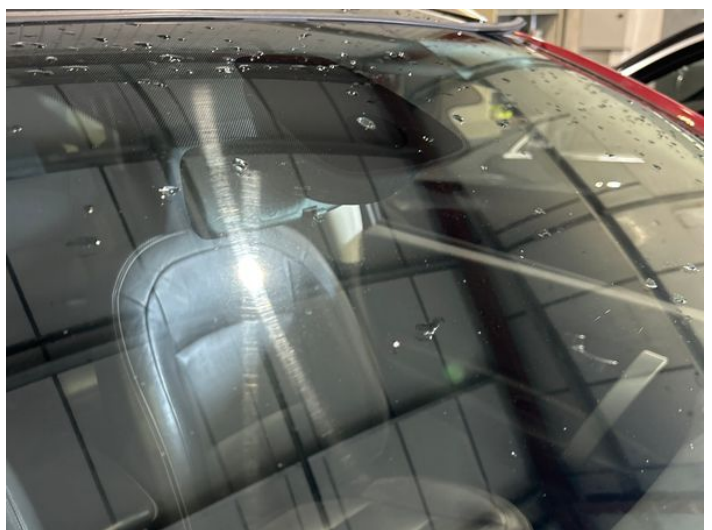
20: Screen Front  
Chipped  
UpTo 10mm

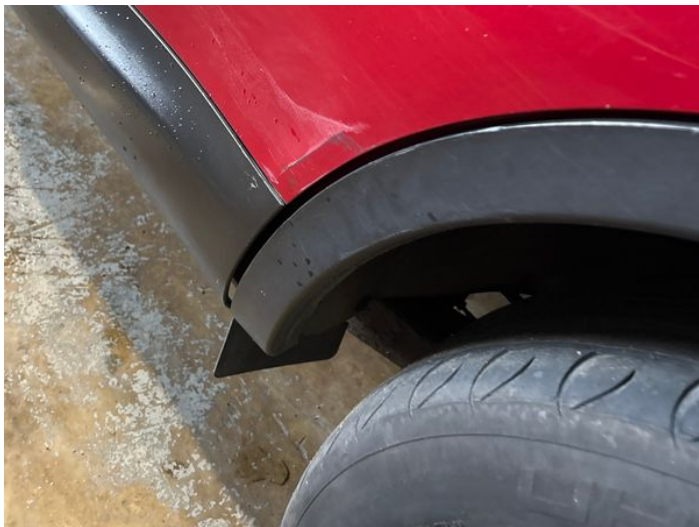
21: Door nsr  
Dented  
With Paint Damage
