## VEHICLE INSPECTION REPORT

**GX21LUF**

### Ford Fiesta 1.0 EcoBoost 95 Titanium 5dr

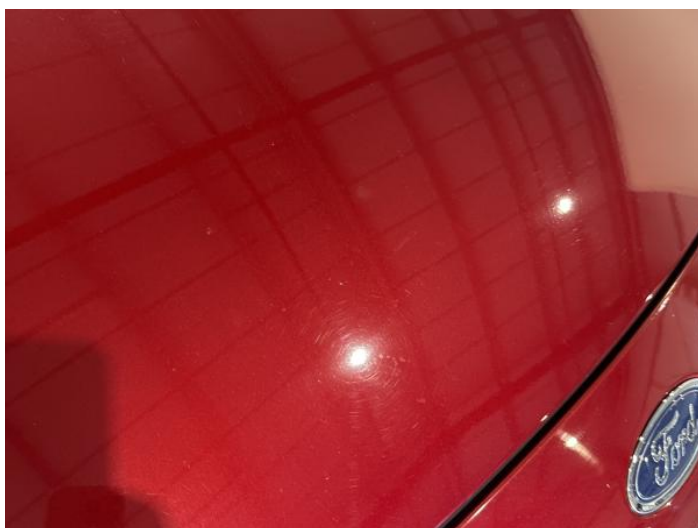
1: Bonnet  
Chipped  
1 To 5

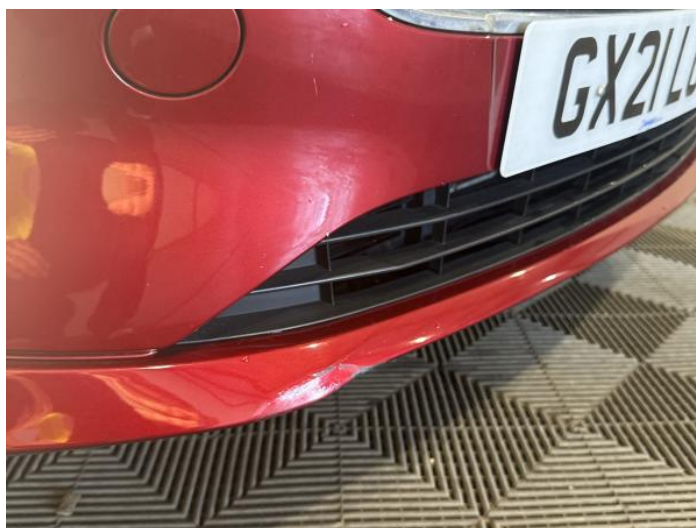
2: Bumper Front  
Dented  
With Paint Damage

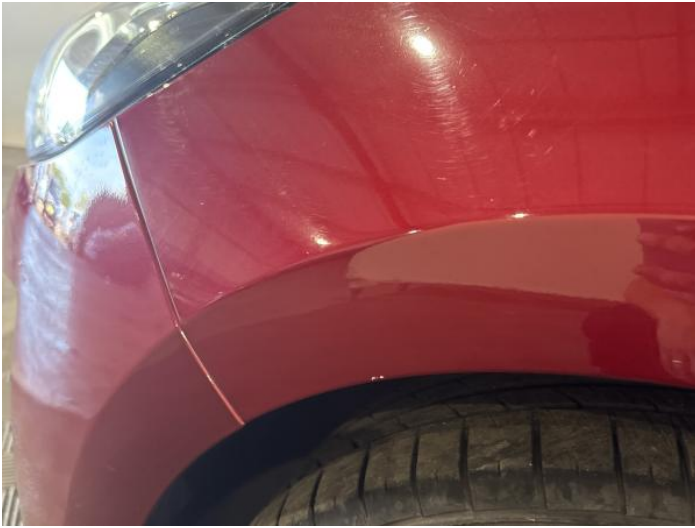
3: Wing nsf  
Chipped  
1 To 5

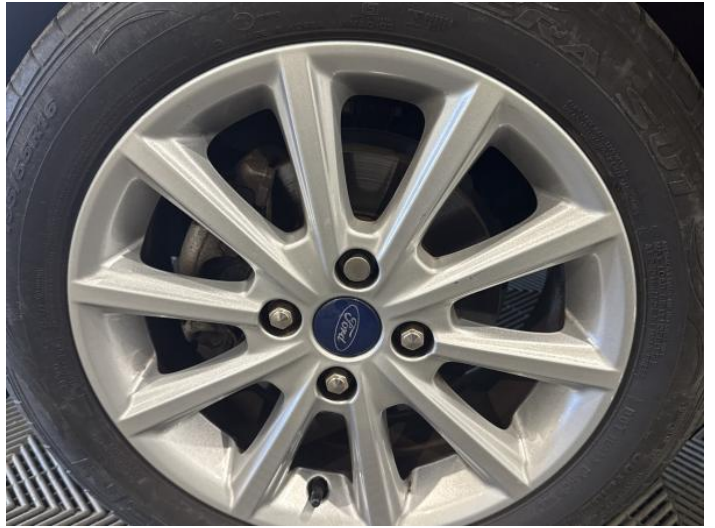
4: Wheel nsf  
Scratched  
Over 50mm

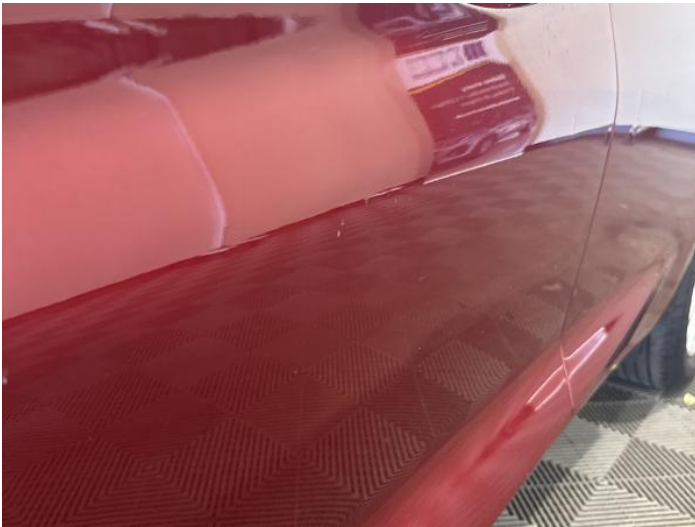
5: Door nsf  
Dented  
Over 30mm

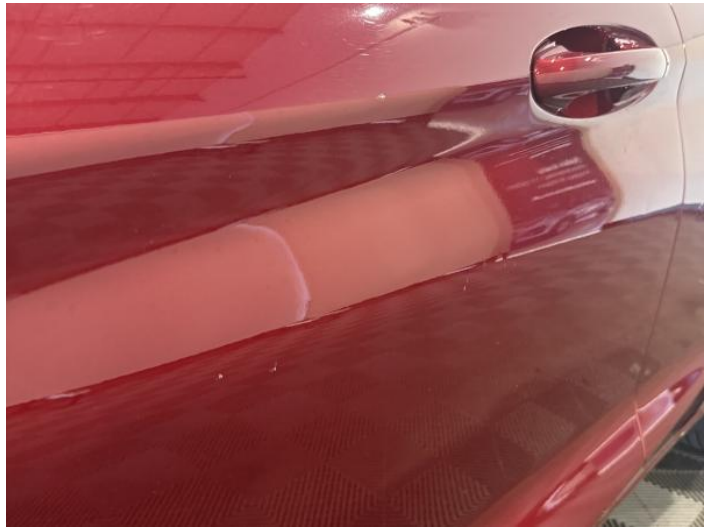
6: Door nsf  
Chipped  
Multiple Chips

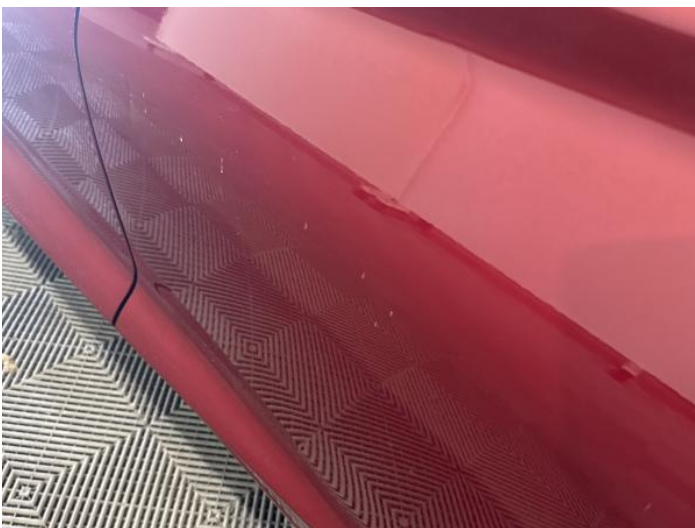
7: Door nsr  
Dented  
With Paint Damage

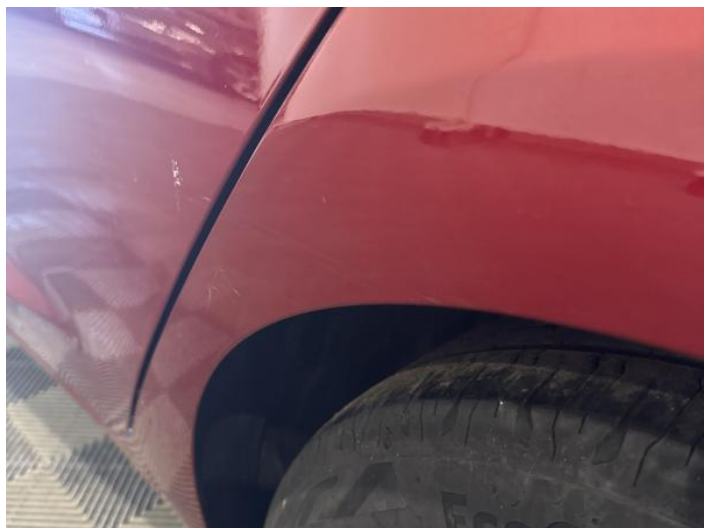
8: Qtr Panel nsr  
Scratched  
Over 25mm Thru Paint

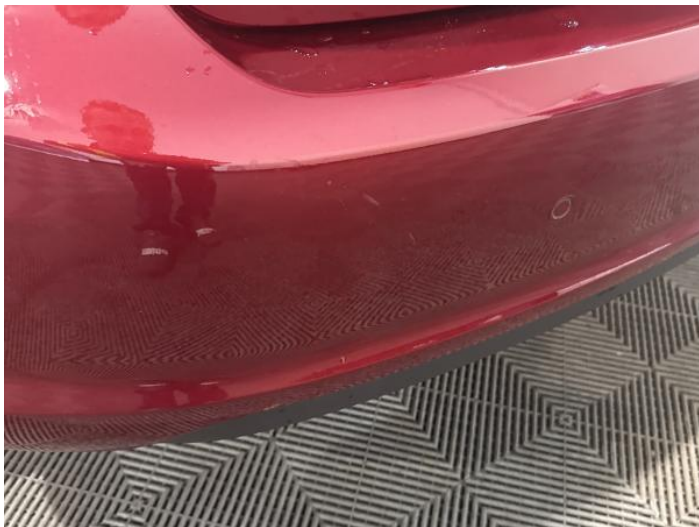
9: Bumper Rear  
Scratched  
25 to 100mm Thru Paint

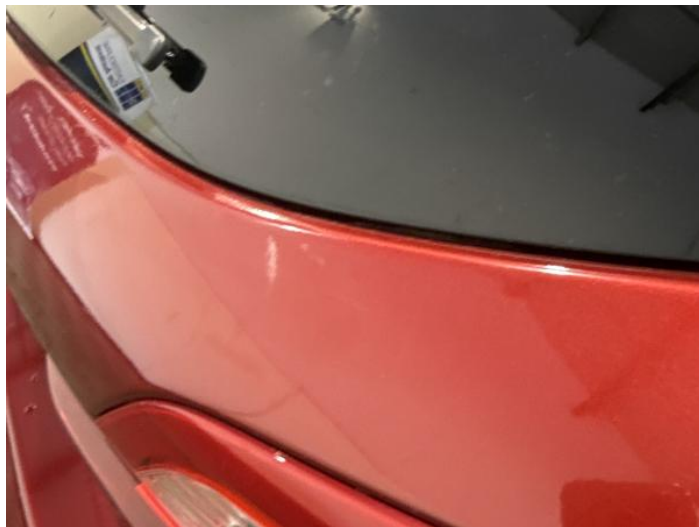
10: Tailgate  
Scratched  
Over 25mm Thru Paint

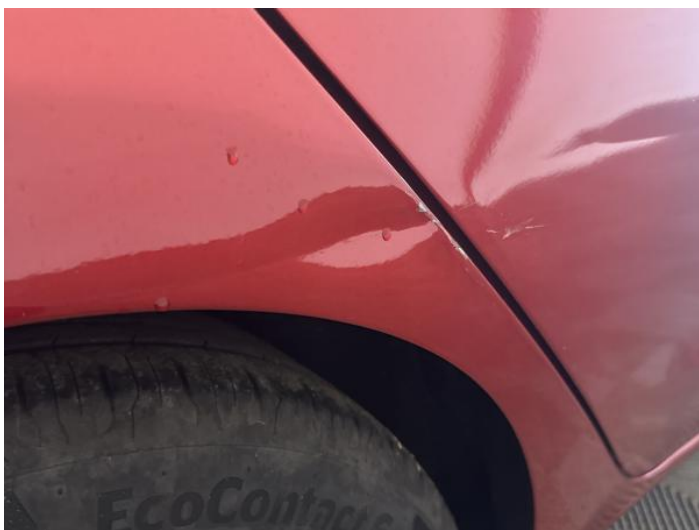
11: Qtr Panel osr  
Dented  
With Paint Damage

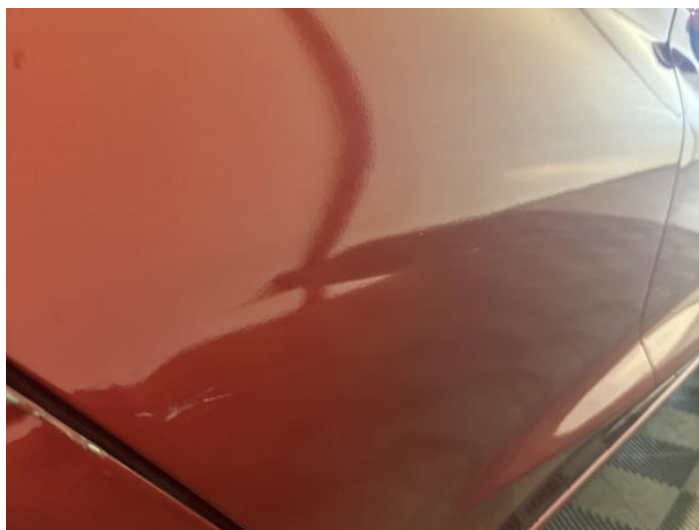
12: Door osr  
Dented  
With Paint Damage

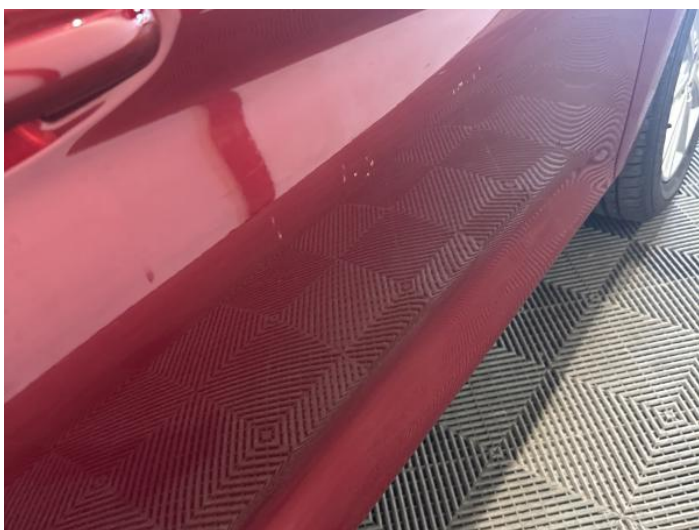
13: Door osf  
Dented  
With Paint Damage

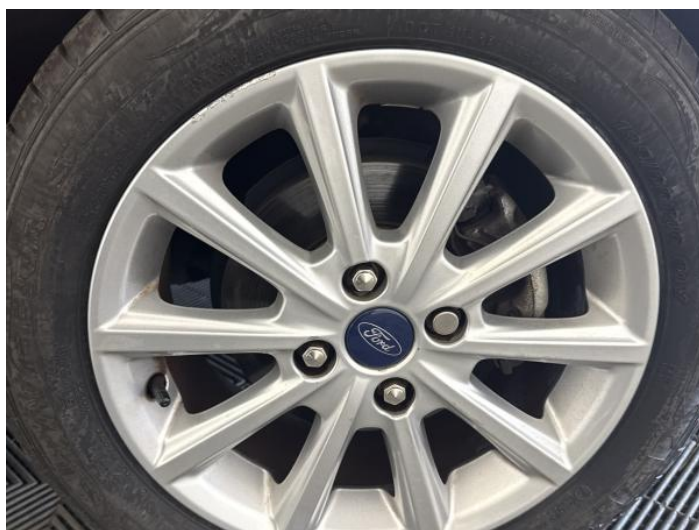
14: Wheel osf  
Scratched  
Over 50mm

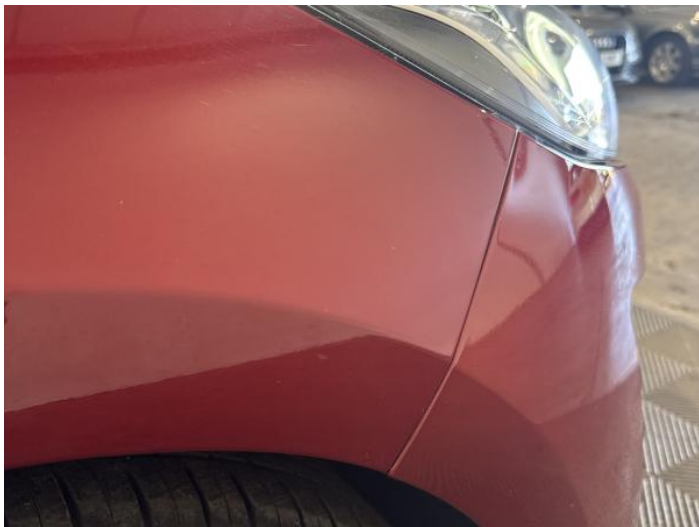
15: Wing osf  
Chipped  
1 To 5
