# VEHICLE INSPECTION REPORT

**LS70GZL**

## Renault Clio 1.0 TCe 100 Iconic 5dr

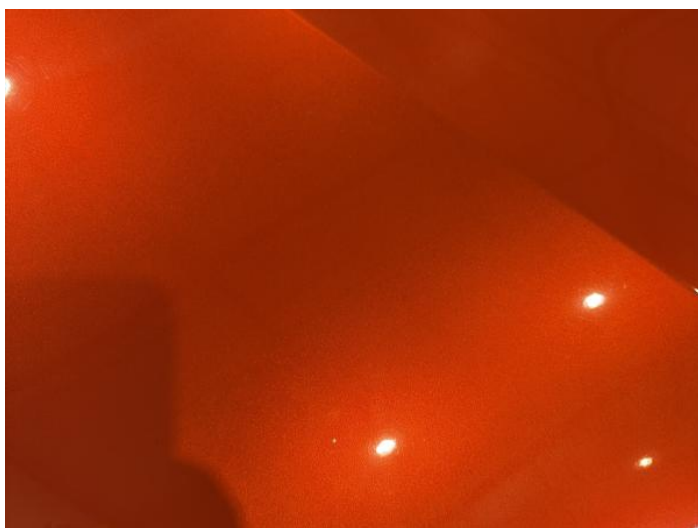
1: Bonnet  
Chipped  
1 To 5

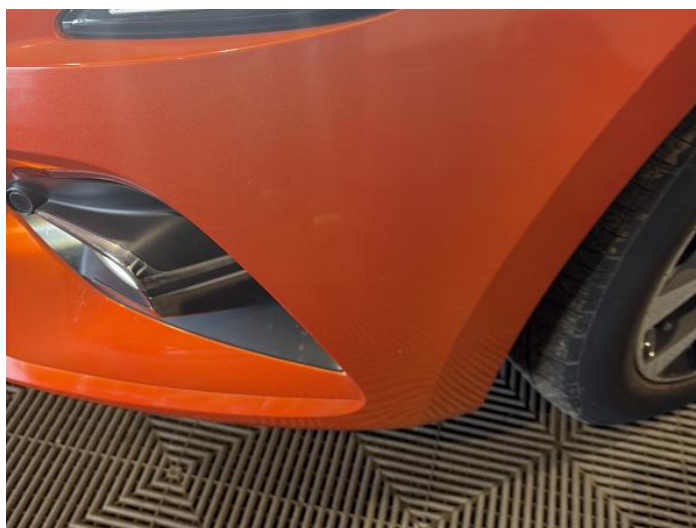
2: Bumper Front  
Poor Previous Repair  
Poor Paint

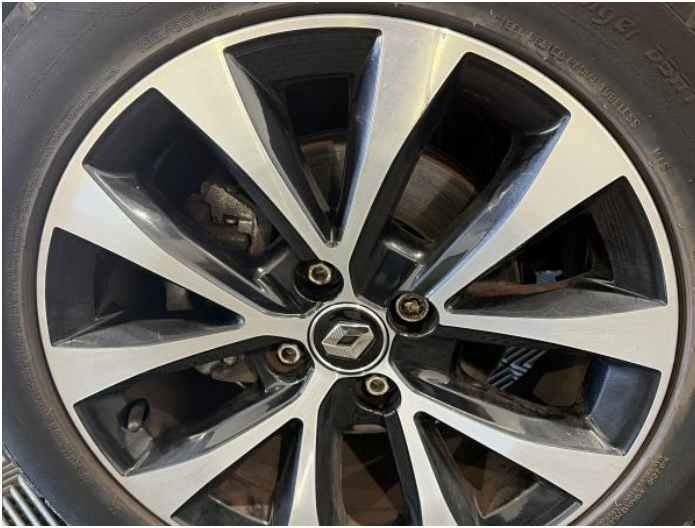
3: Wheel nsf  
Scratched  
Over 50mm

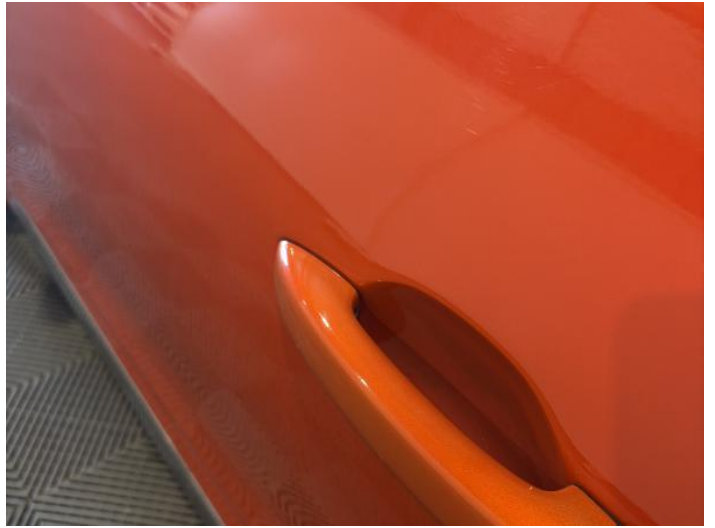
4: Door nsf  
Poor Previous Repair  
Poor Paint

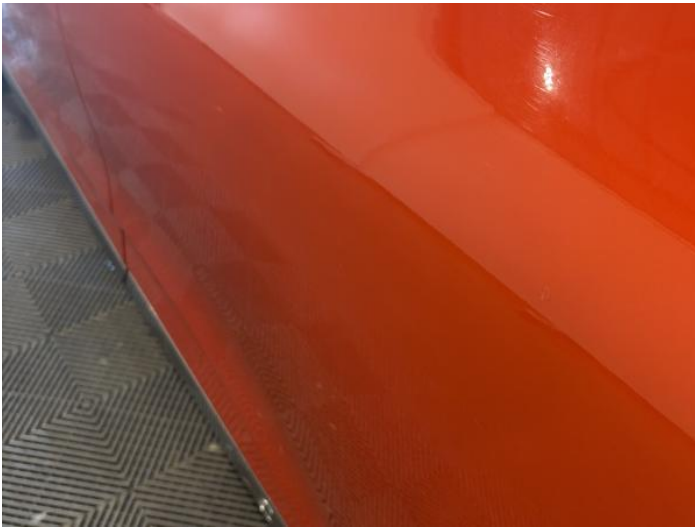
5: Door nsr  
Poor Previous Repair  
Poor Paint

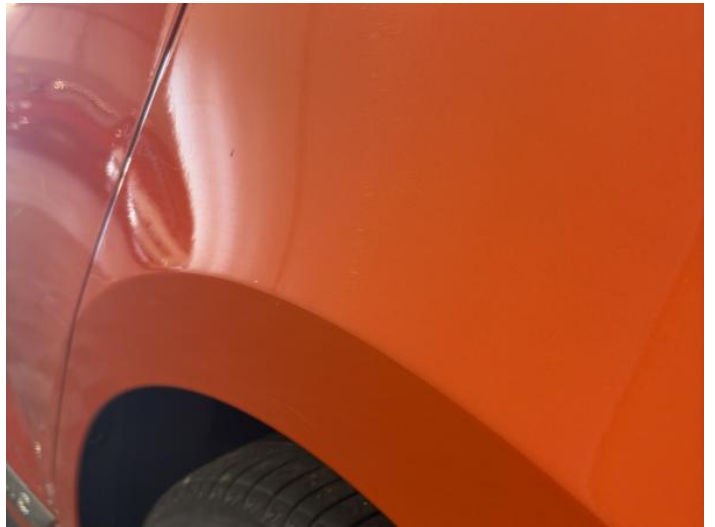
6: Qtr Panel nsr  
Chipped  
1 To 5

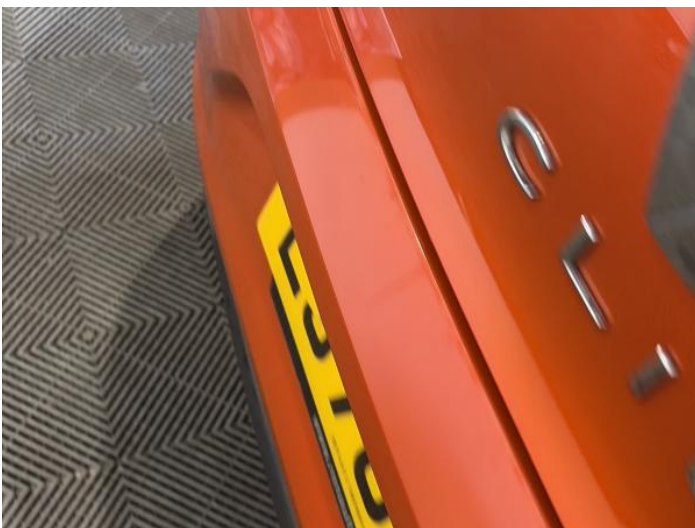
7: Bumper Rear  
Scratched  
25 to 100mm Thru Paint

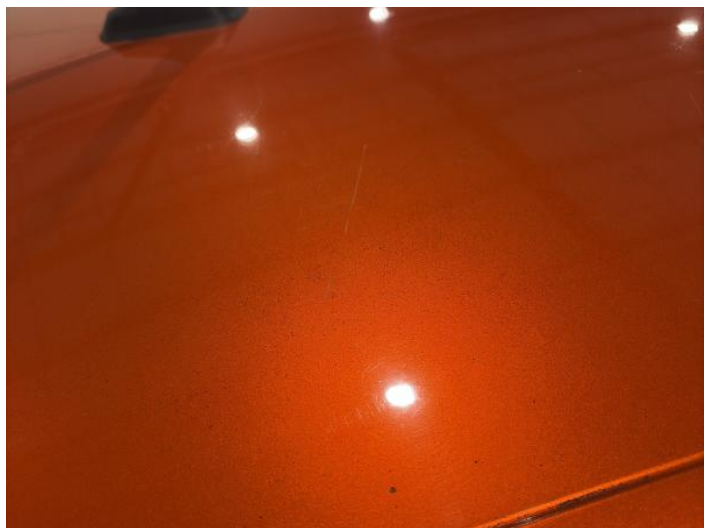
8: Roof  
Scratched  
Over 25mm Thru Paint

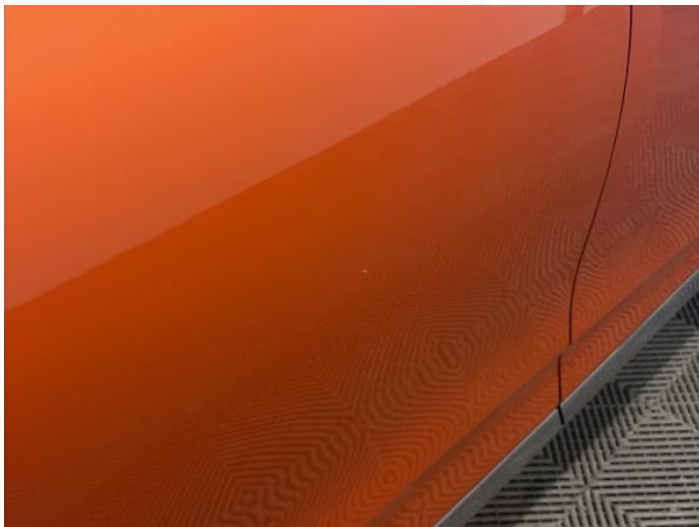
9: Door osr  
Chipped  
1 To 5

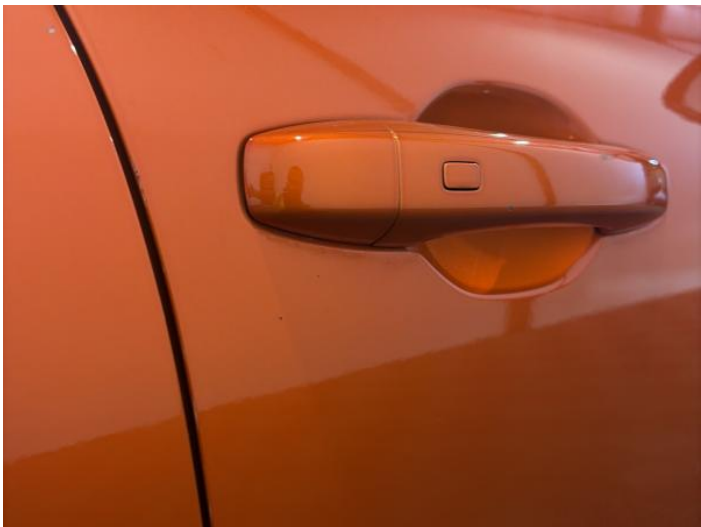
10: Door osf  
Chipped  
Edge Chip

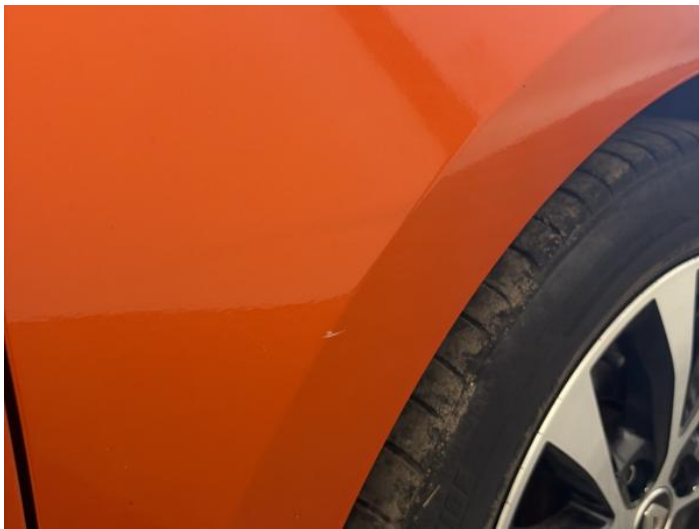
11: Wing osf  
Scratched  
UpTo 25mm Thru Paint

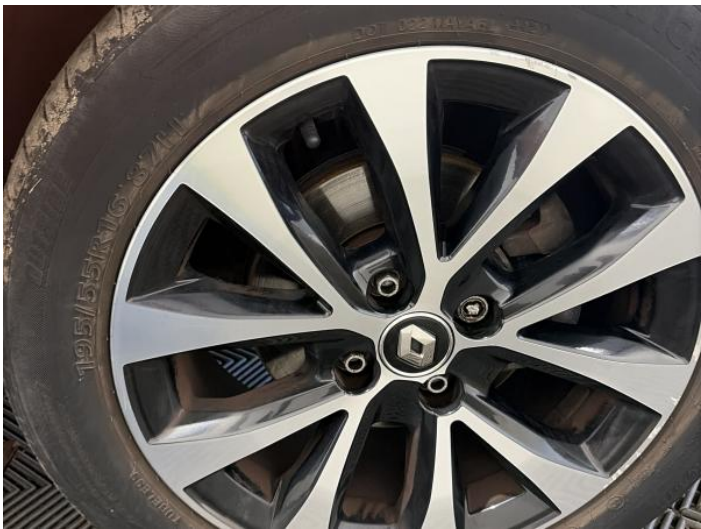
12: Wheel osf  
Scratched  
Over 50mm
