# VEHICLE INSPECTION REPORT

**GX72ZCO**

## Dacia Duster 1.3 TCe 130 Extreme SE 5dr

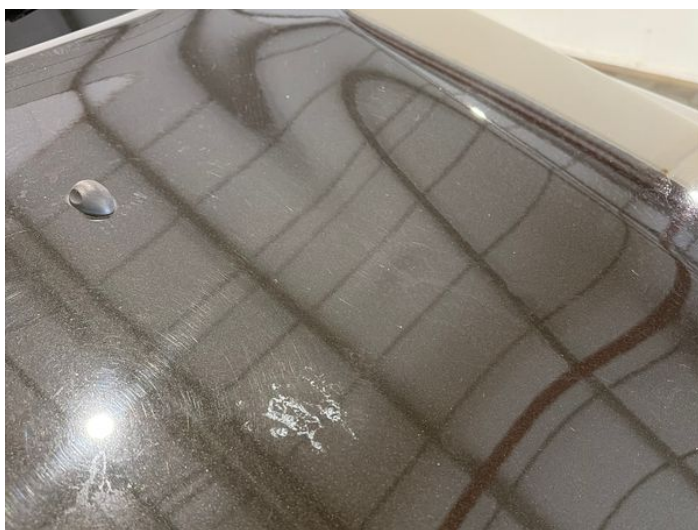
1: Bonnet  
Scratched  
Over 25mm Thru Paint

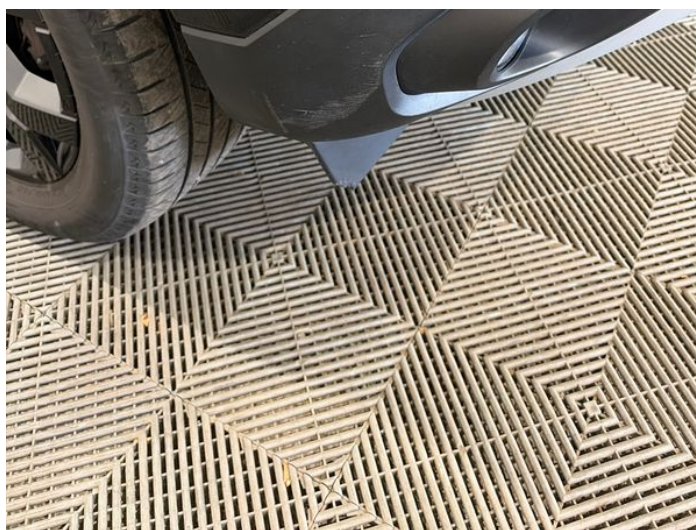
2: Bumper Front Moulding  
Scuffed (Unpainted)  
Over 100mm

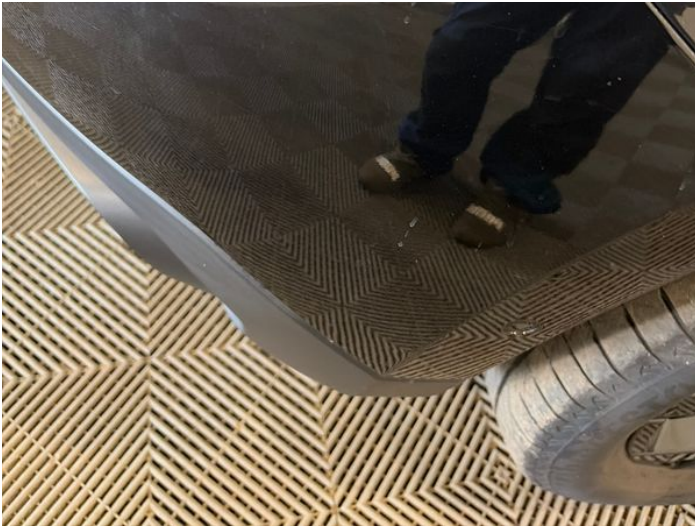
3: Bumper Front  
Scratched  
UpTo 25mm Thru Paint

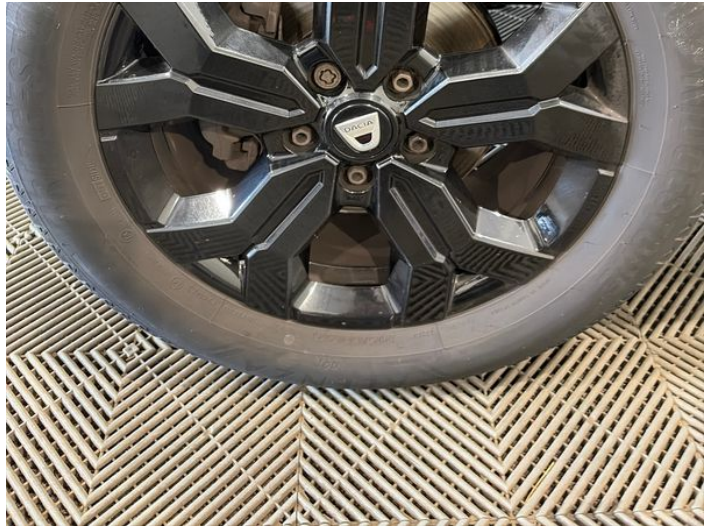
4: Wheel nsf  
Scratched  
Up To 50mm

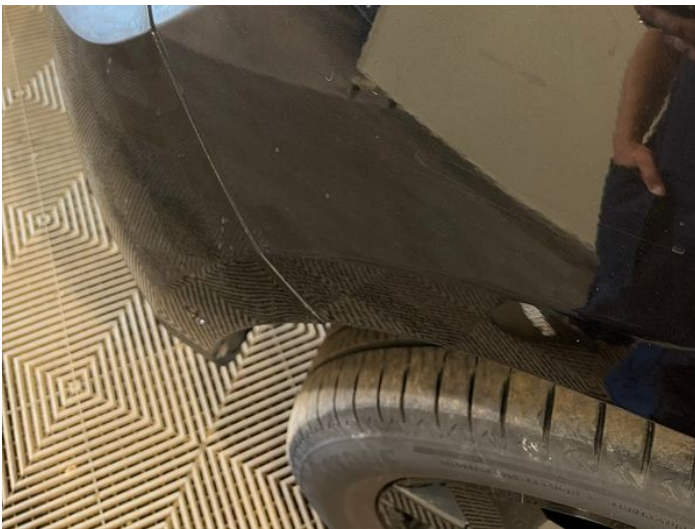
5: Wing nsf  
Scratched  
UpTo 25mm Thru Paint

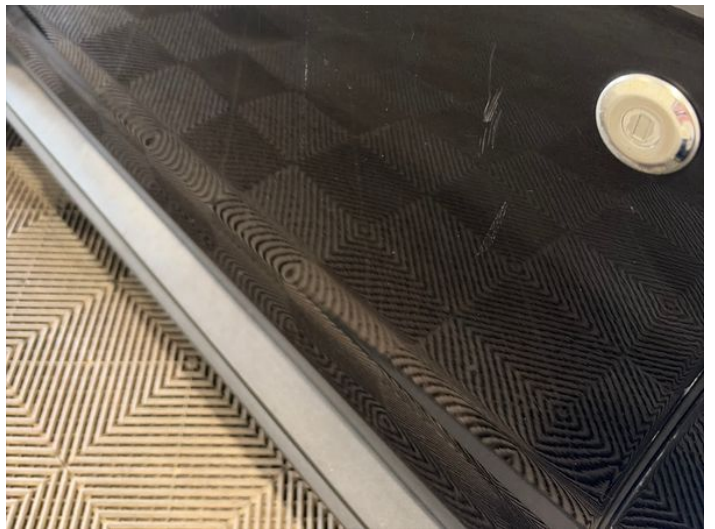
6: Door nsf  
Scratched  
Over 25mm Thru Paint

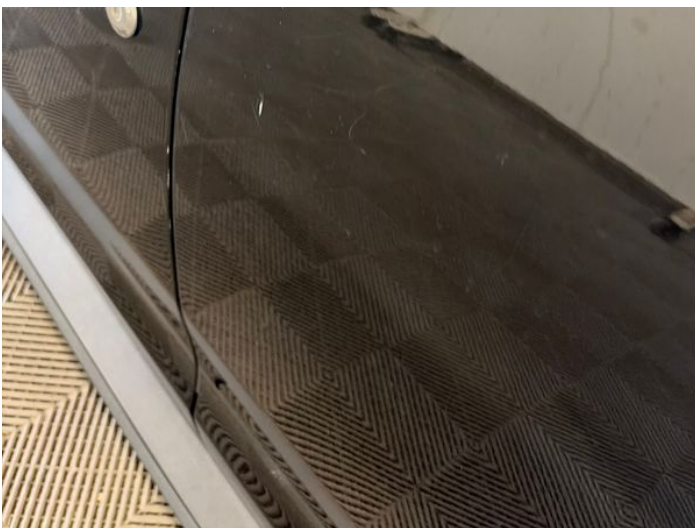
7: Door nsr  
Scratched  
Over 25mm Thru Paint

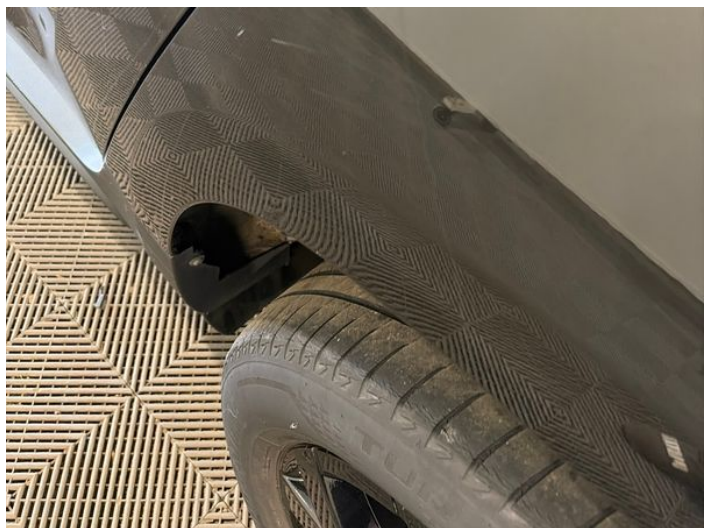
8: Qtr Panel nsr  
Scratched  
Over 25mm Thru Paint

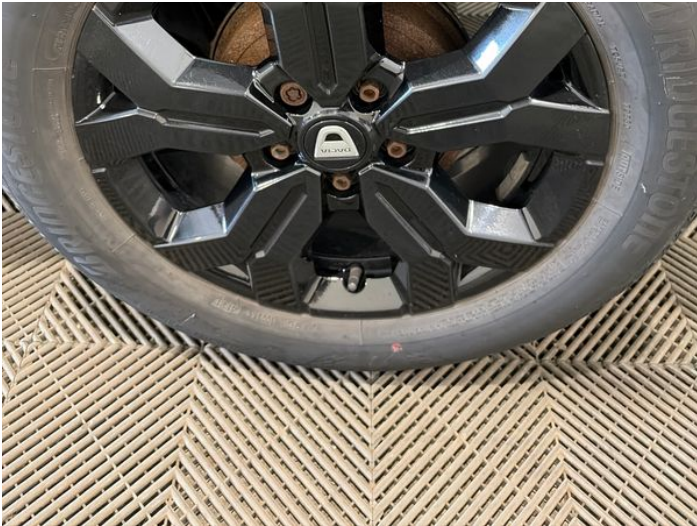
9: Wheel nsr  
Scratched  
Over 50mm

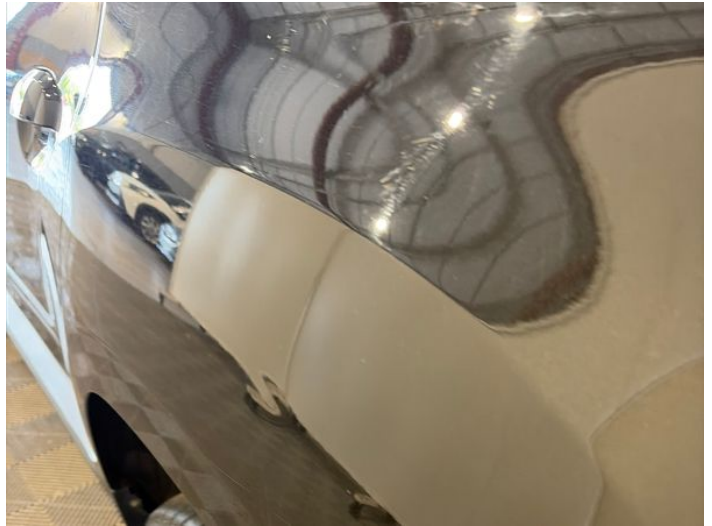
10: Qtr Panel nsr  
Dented  
Over 30mm

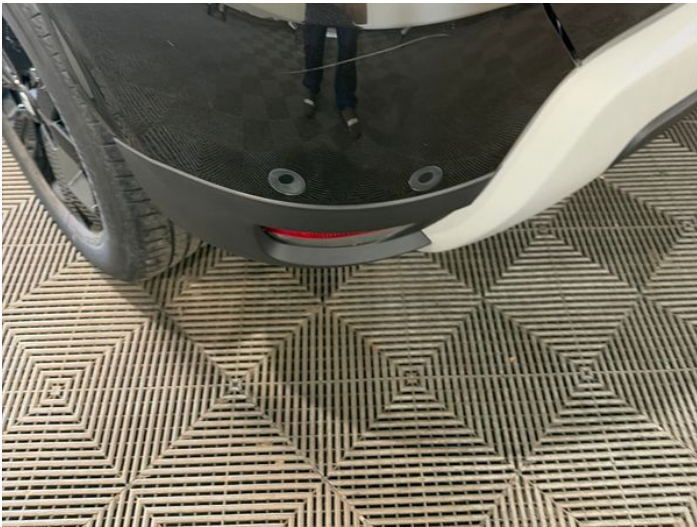
11: Bumper Rear  
Scratched  
25 to 100mm Thru Paint

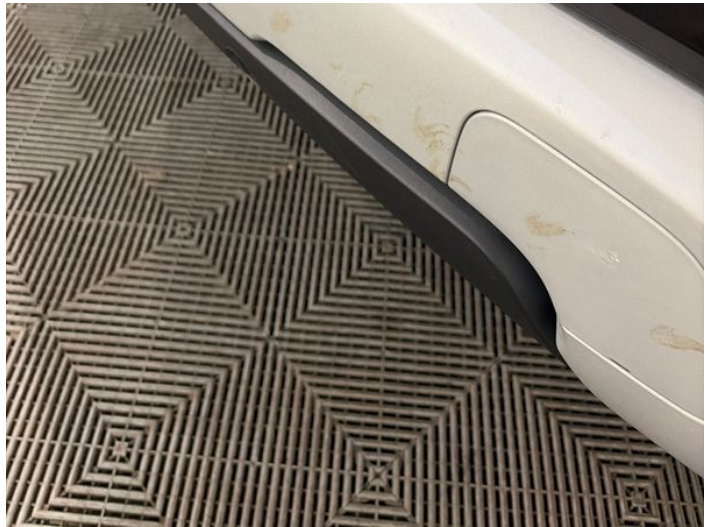
12: Bumper Rear Moulding  
Scratched (Painted)  
Over 25mm Thru Paint

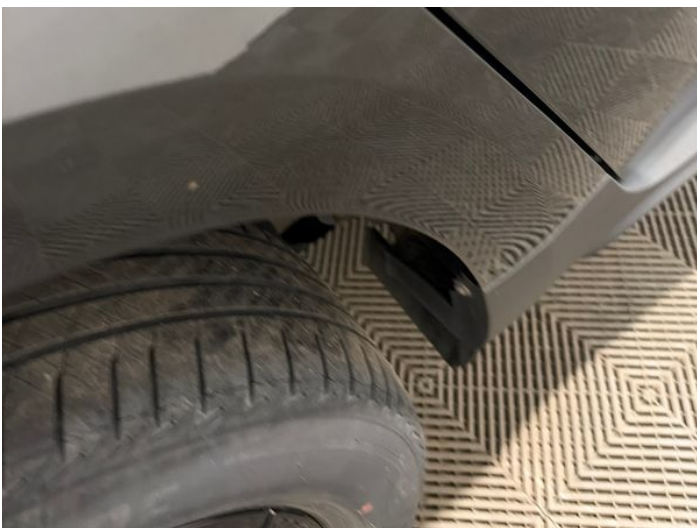
13: Qtr Panel osr  
Poor Previous Repair  
Poor Paint

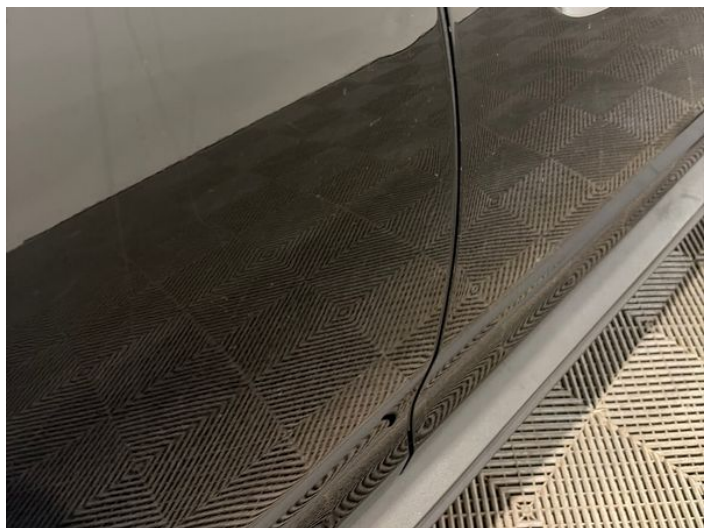
14: Door osr  
Poor Previous Repair  
Rippled UpTo 30%

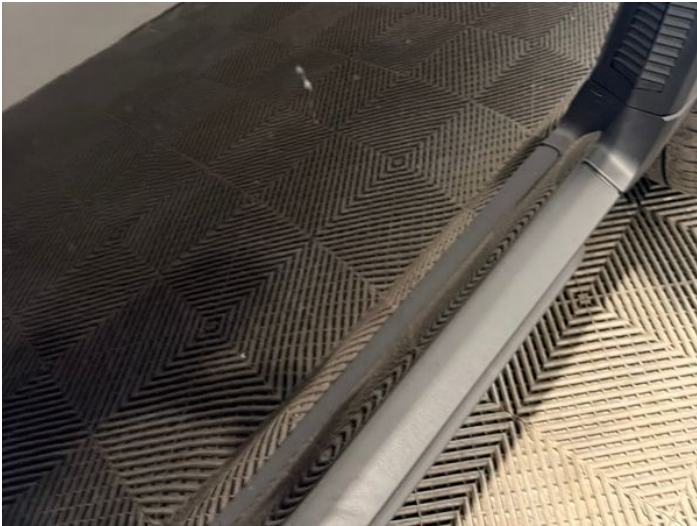
15: Door osf  
 Scratched  
 UpTo 25mm Thru Paint

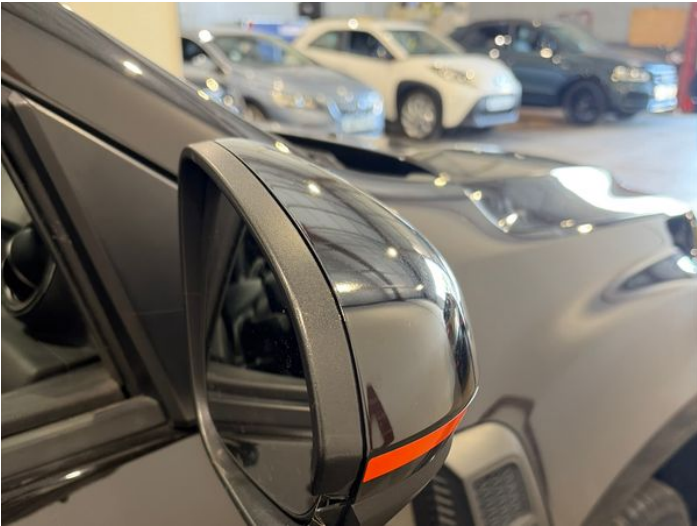
16: Door Mirror Assy osf  
 Broken  
 Replace

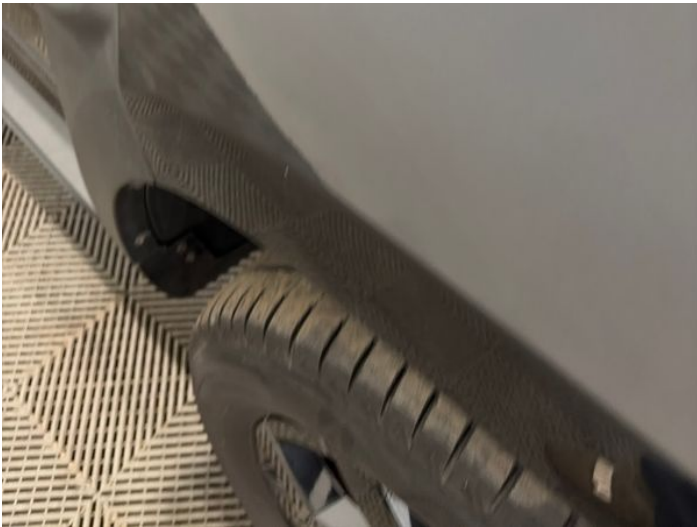
17: Wing osf  
 Chipped  
 1 To 5

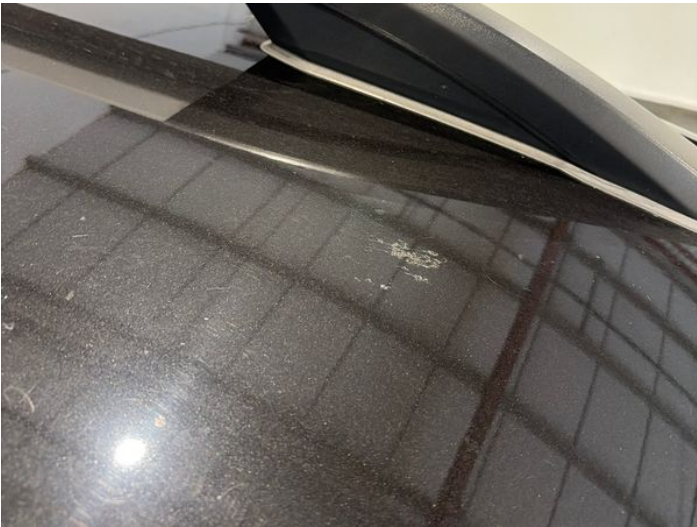
18: Roof  
 Scratched  
 Over 25mm Thru Paint
