## VEHICLE INSPECTION REPORT

**GU15MGV**

### Vauxhall Astra 1.4i 16V Excite 5dr

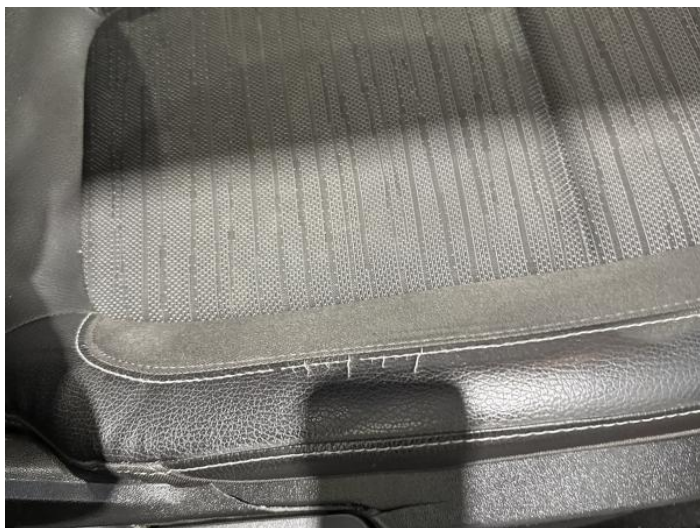
1: Seat Base Cover osf  
Scuffed  
Over 25mm

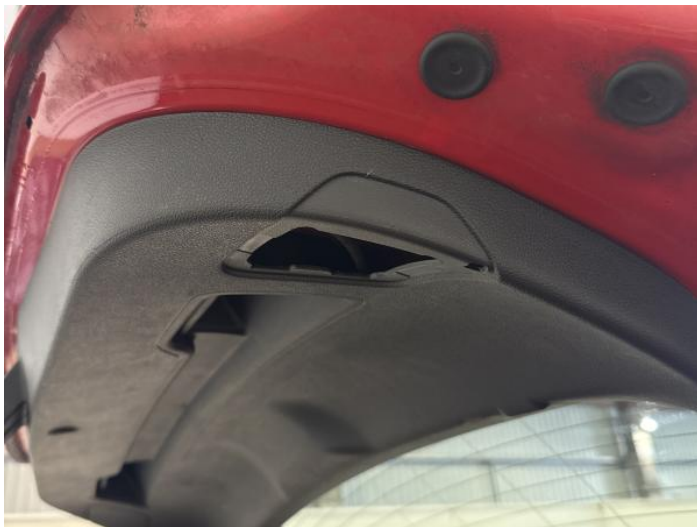
3: Fascia Trim  
Damaged  
Replace

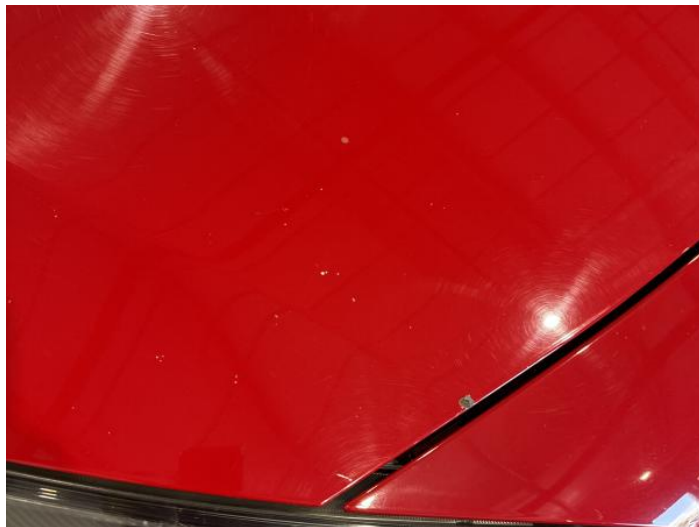
4: Bonnet  
Chipped  
Multiple Chips

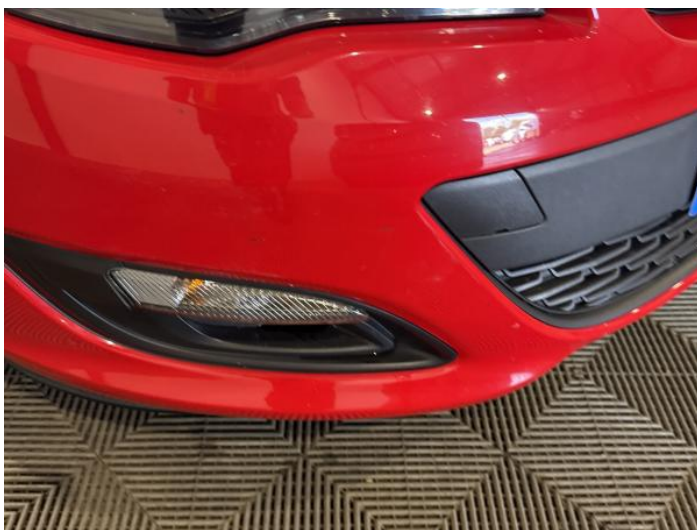
5: Bumper Front  
Scratched  
25 to 100mm Thru Paint

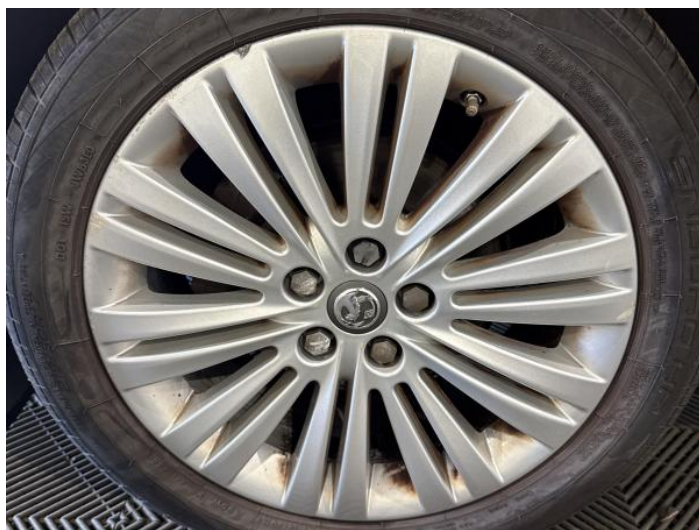
6: Wheel nsf  
Scratched  
Over 50mm

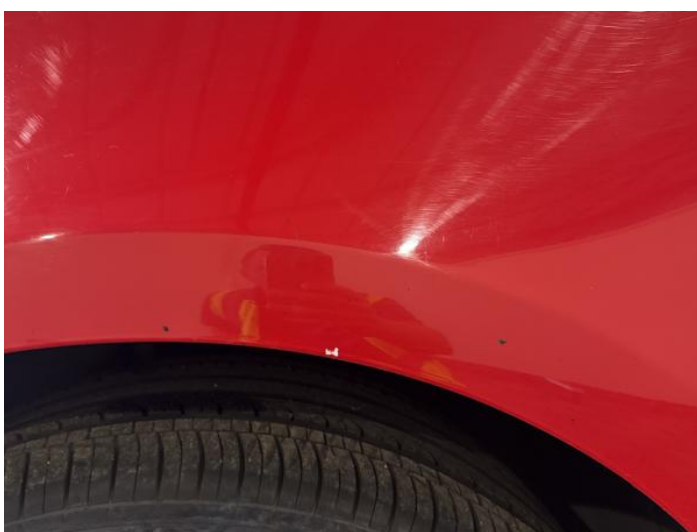
7: Wing nsf  
Chipped  
Over 5mm

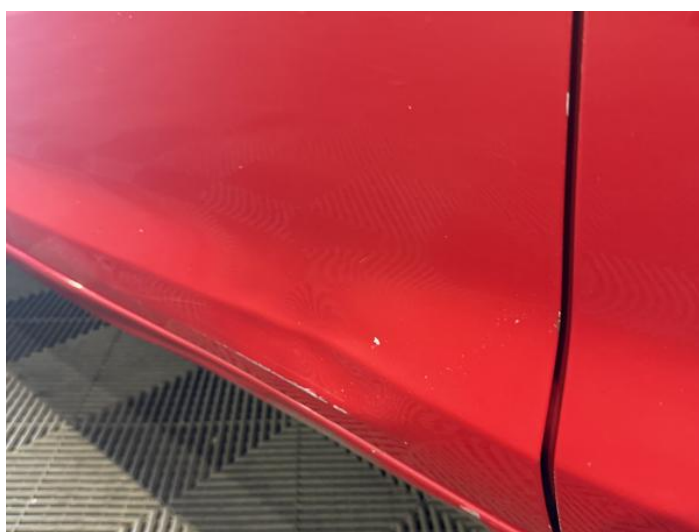
8: Door nsf  
Dented  
With Paint Damage

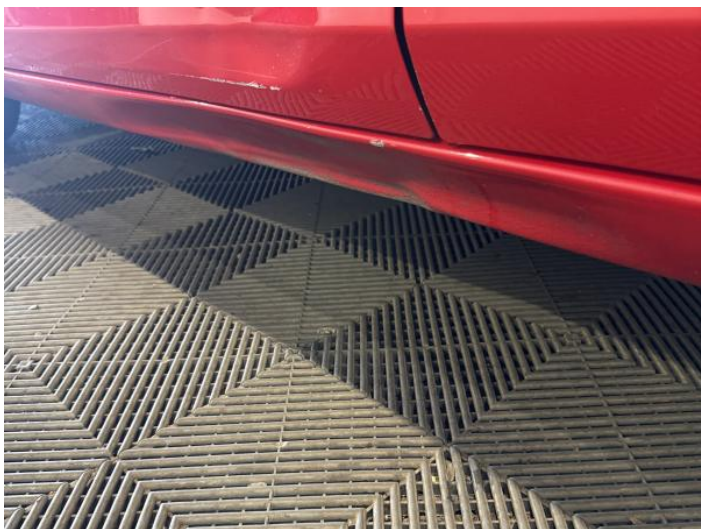
9: Sill ns  
Dented  
With Paint Damage

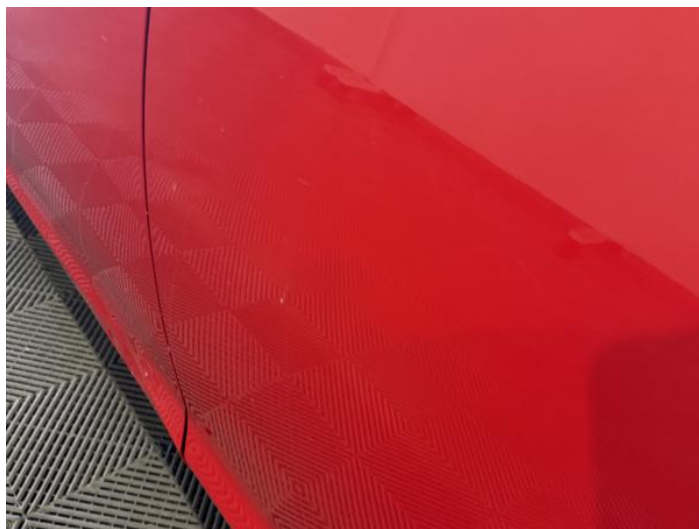
10: Door nsr  
Scratched  
Over 25mm Thru Paint

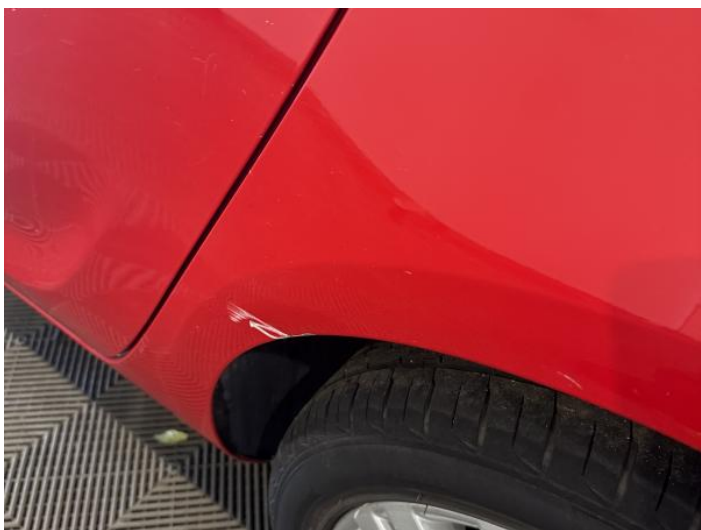
11: Qtr Panel nsr  
Dented  
With Paint Damage

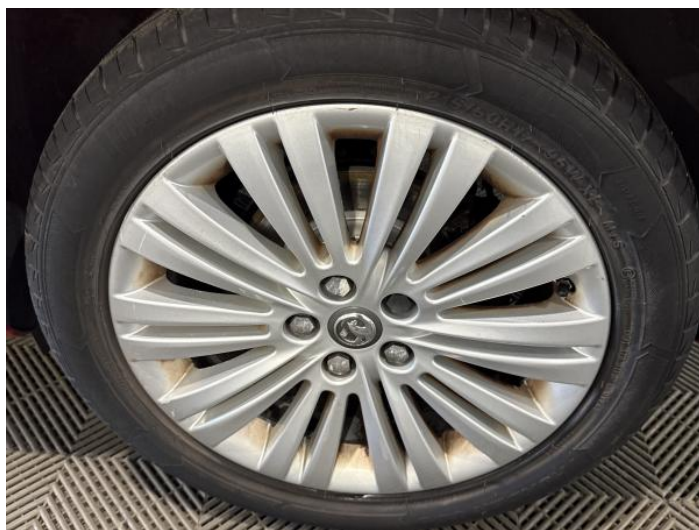
12: Wheel nsr  
Scratched  
Up To 50mm

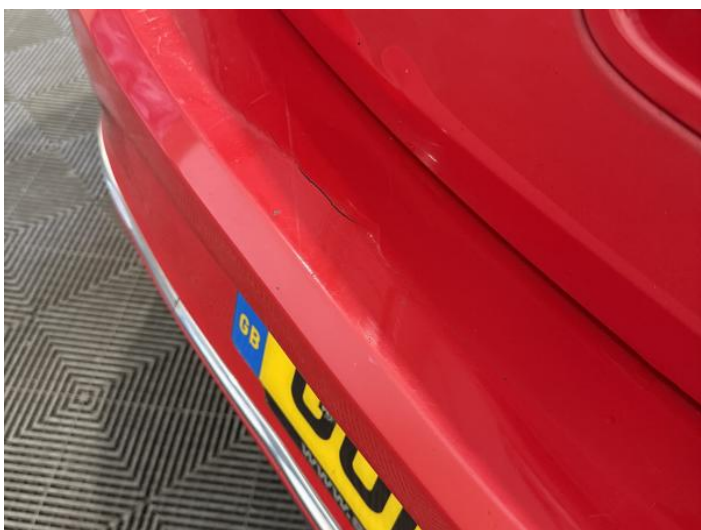
13: Bumper Rear  
Dented  
With Paint Damage

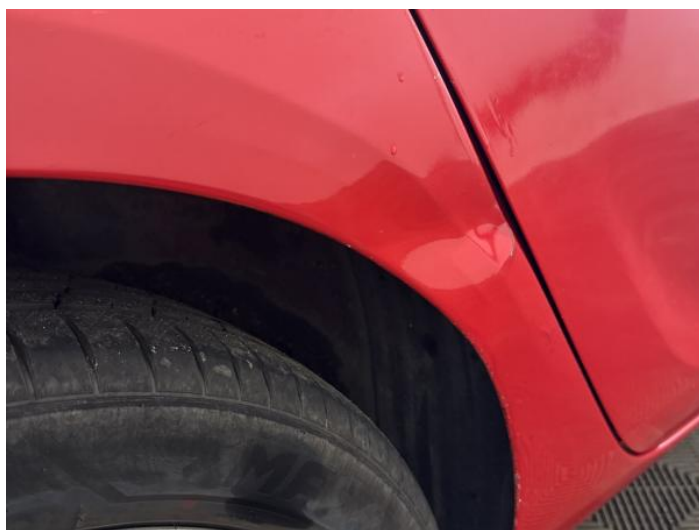
14: Qtr Panel osr  
Dented  
With Paint Damage

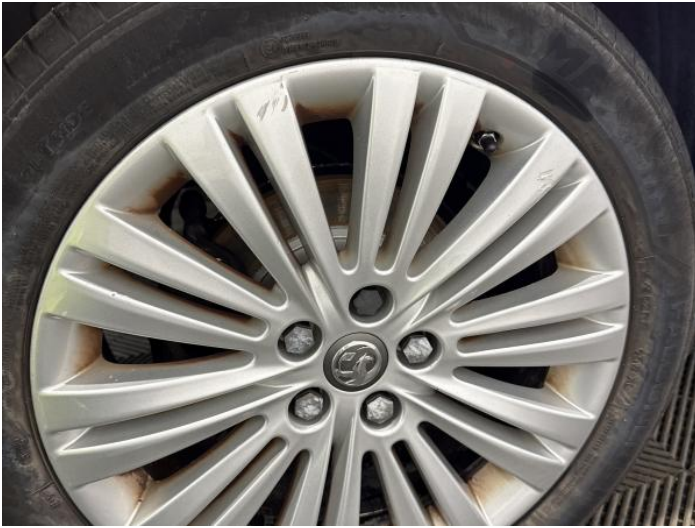
15: Wheel osf  
Scratched  
Over 50mm

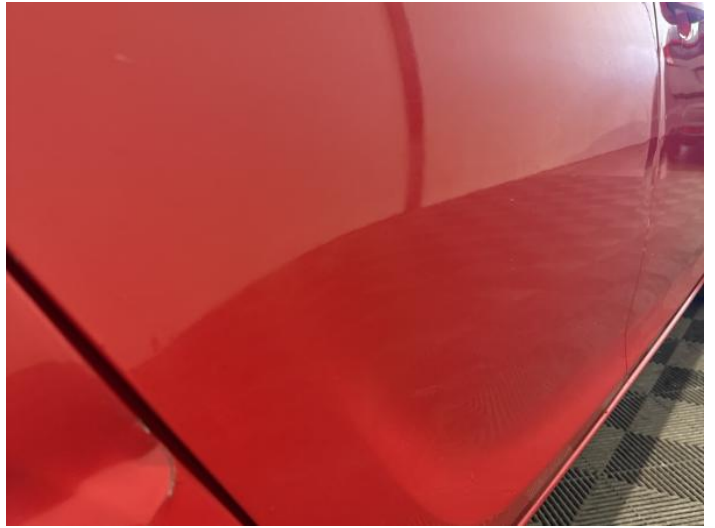
16: Door osf  
Dented  
With Paint Damage

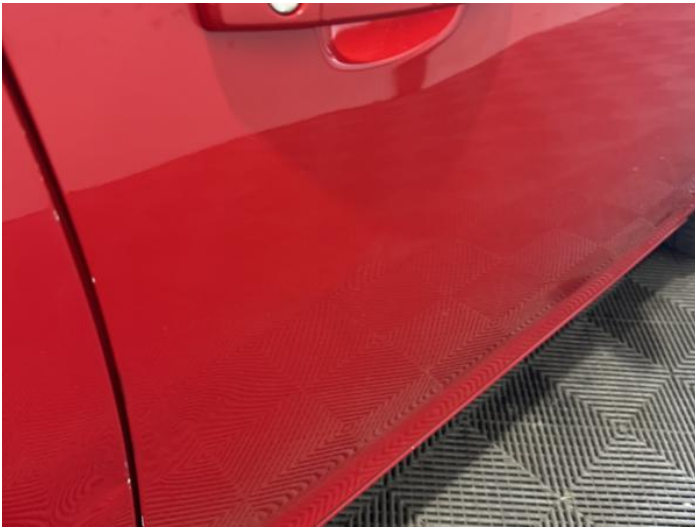
17: Door osf  
Dented  
With Paint Damage

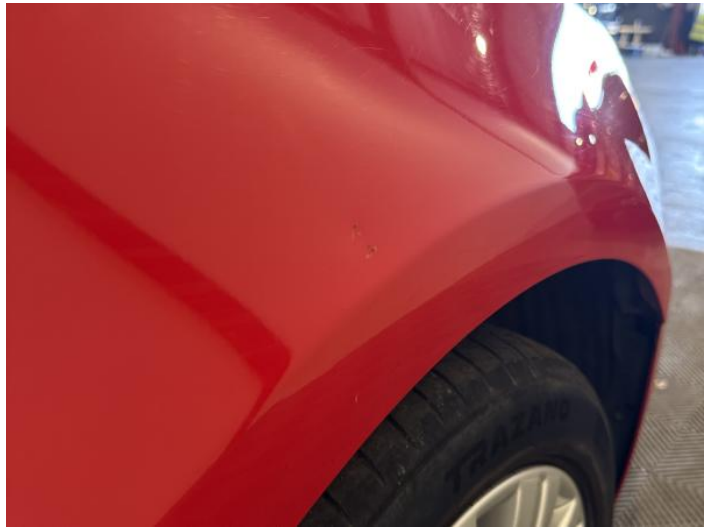
18: Wing osf  
Dented  
Between 10mm + 30mm

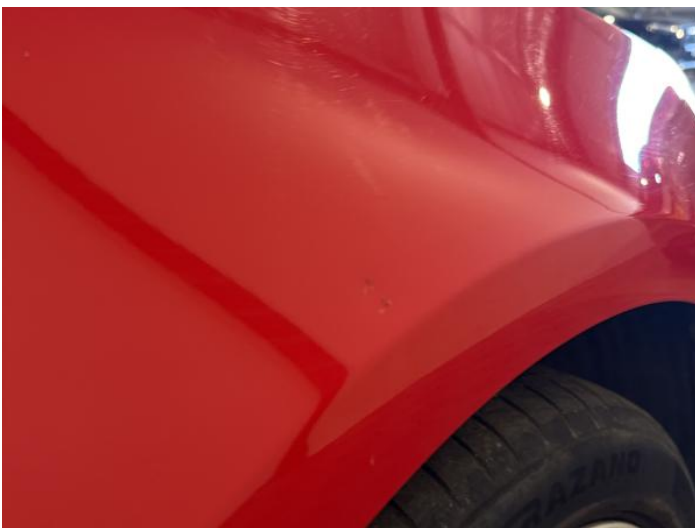
19: Wing osf  
Chipped  
1 To 5

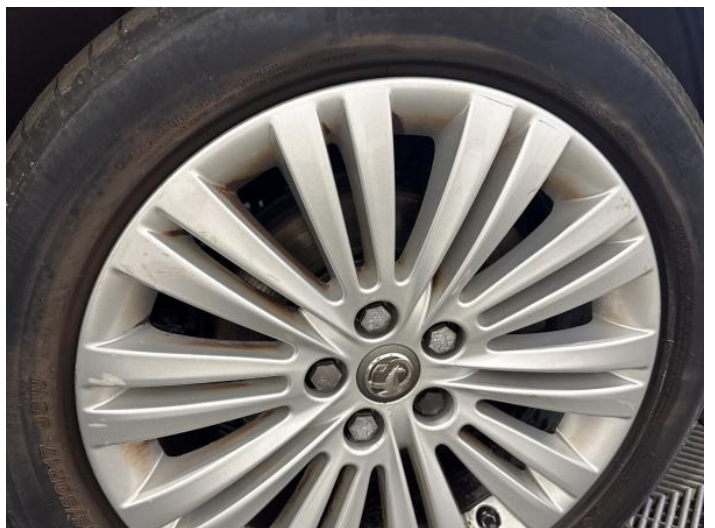
20: Wheel osf  
Scratched  
Over 50mm
