# VEHICLE INSPECTION REPORT

**FN65RUA**

## Vauxhall Astra 1.6 CDTi 16V ecoFLEX Design 5dr

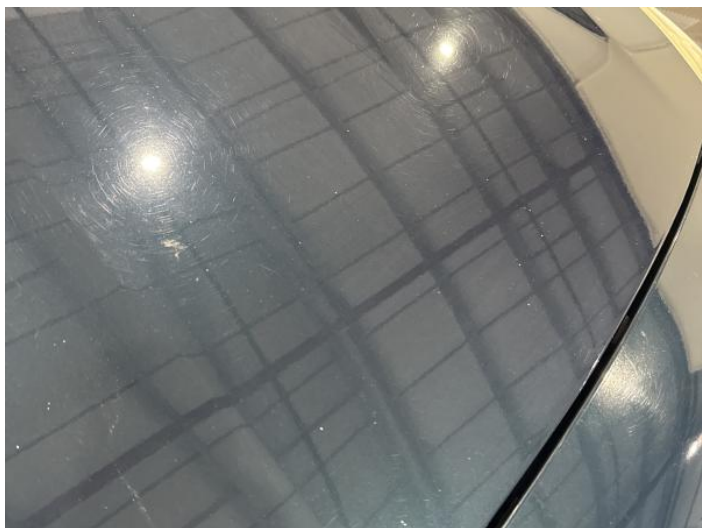
1: Bonnet  
Chipped  
Multiple Chips

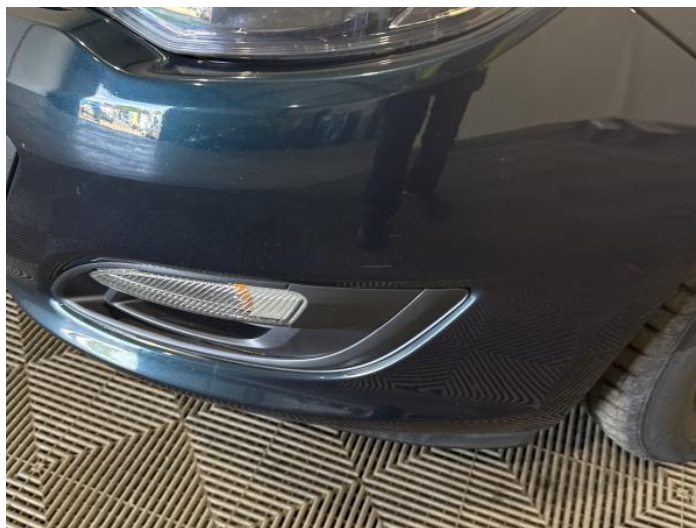
2: Bumper Front  
Scratched  
25 to 100mm Thru Paint

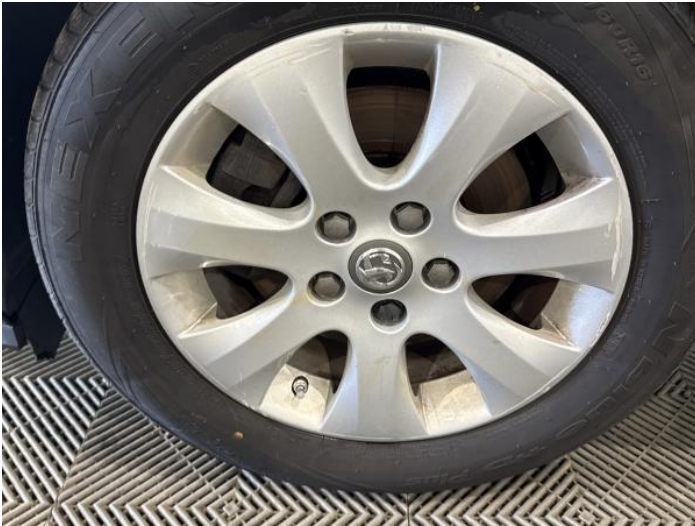
3: Wheel nsf  
Scratched  
Over 50mm

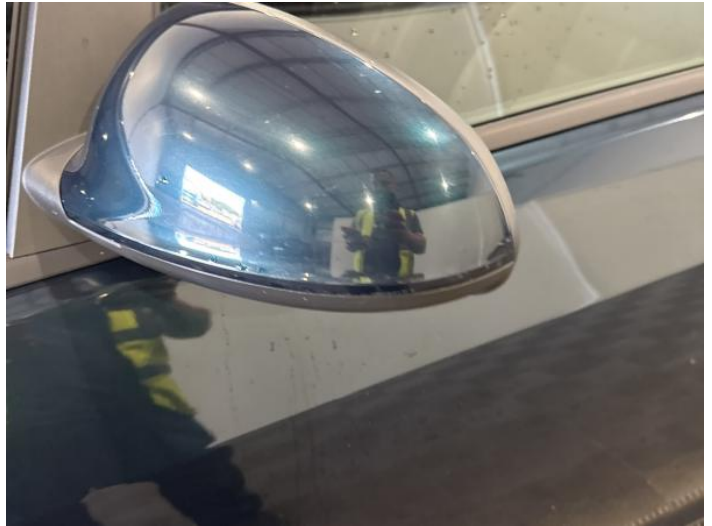
4: Door Mirror Assy nsf  
Scratched (Painted)  
UpTo 25mm Thru Paint

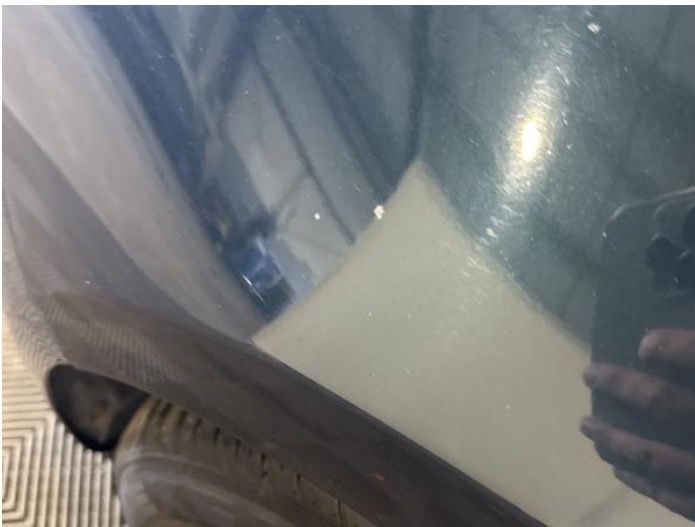
5: Wing nsf  
Scratched  
UpTo 25mm Thru Paint

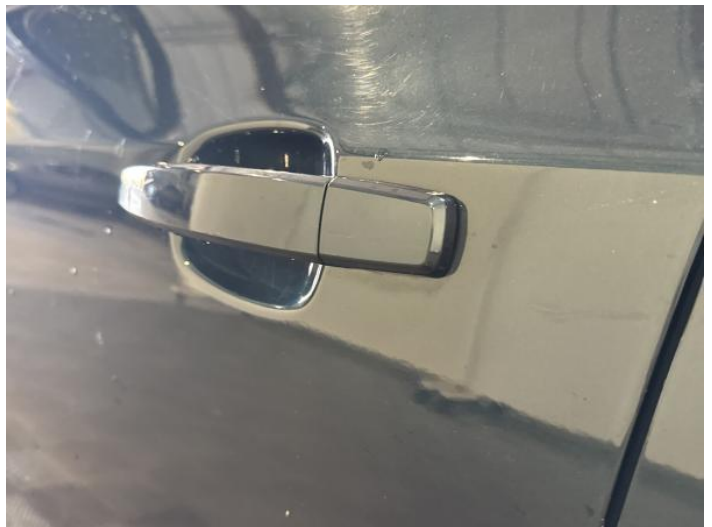
6: Door nsf  
Scratched  
Over 25mm Thru Paint

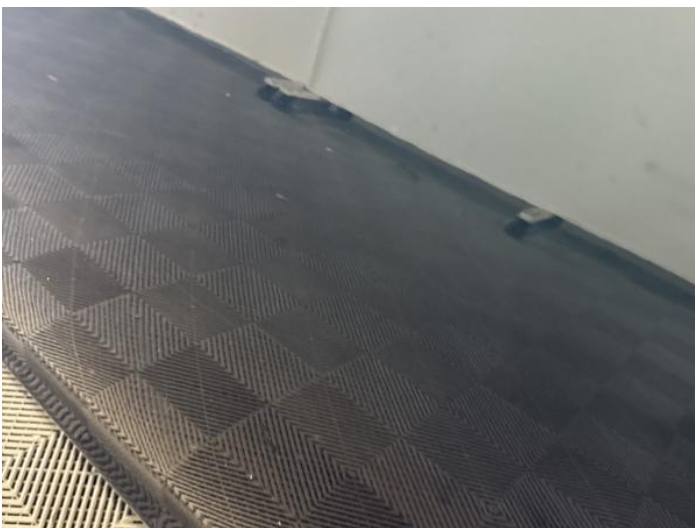
7: Door nsr  
Scratched  
Over 25mm Thru Paint

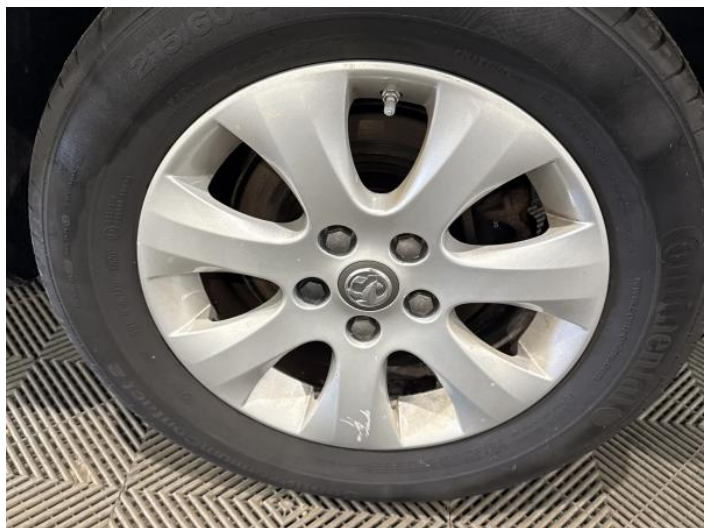
8: Wheel nsr  
Scratched  
Over 50mm

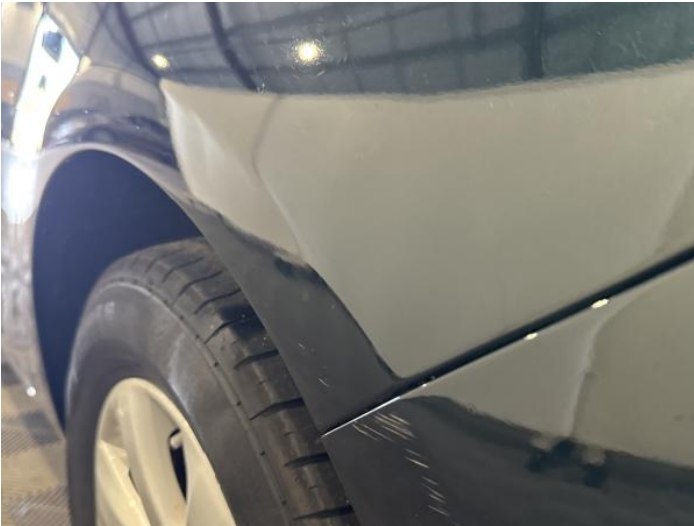
9: Qtr Panel nsr  
 Scratched  
 UpTo 25mm Thru Paint

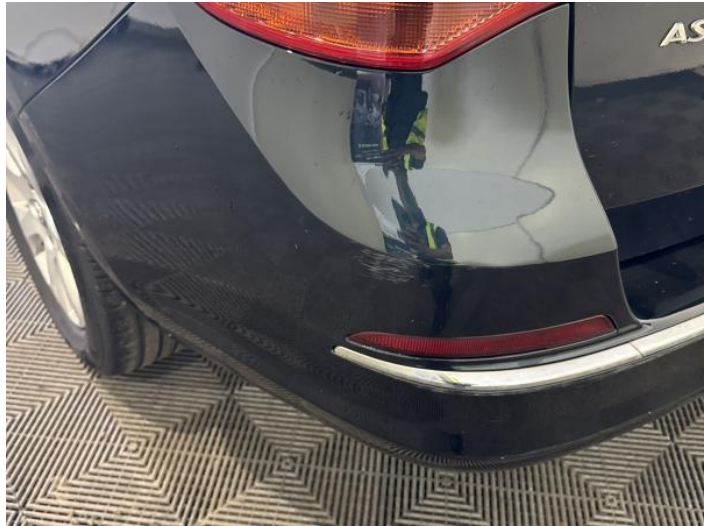
10: Bumper Rear  
 Scratched  
 Over 100mm Thru Paint

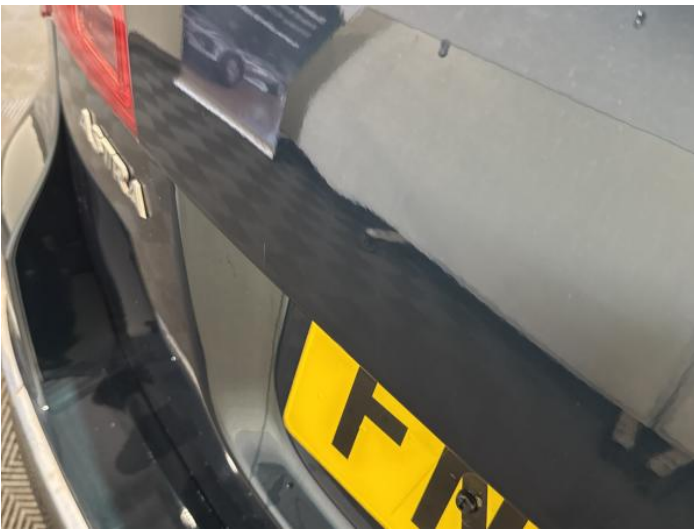
11: Tailgate  
 Scratched  
 UpTo 25mm Thru Paint

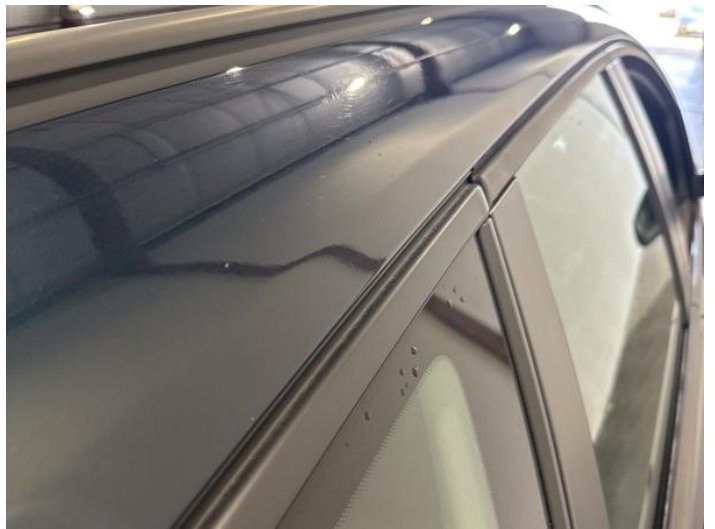
12: B Post os  
 Dented  
 Between 10mm + 30mm

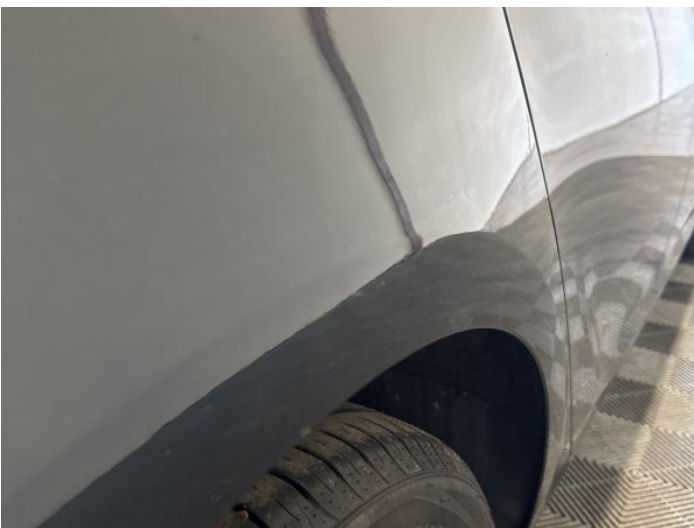
13: Qtr Panel osr  
 Dented  
 Between 10mm + 30mm

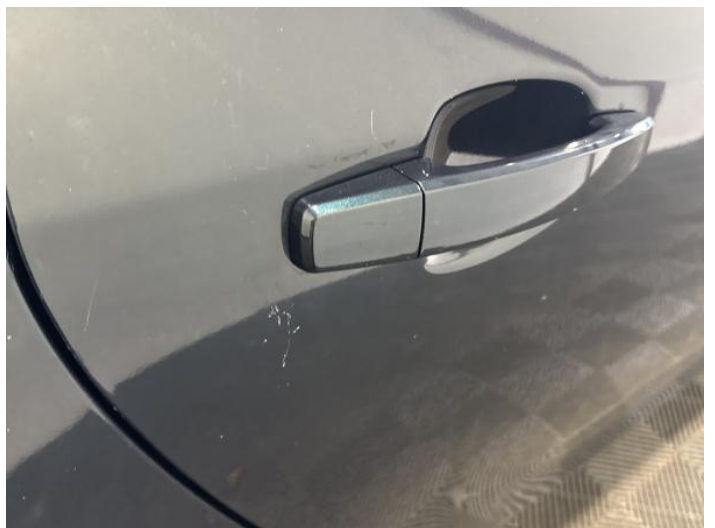
14: Door osr  
 Scratched  
 Over 25mm Thru Paint

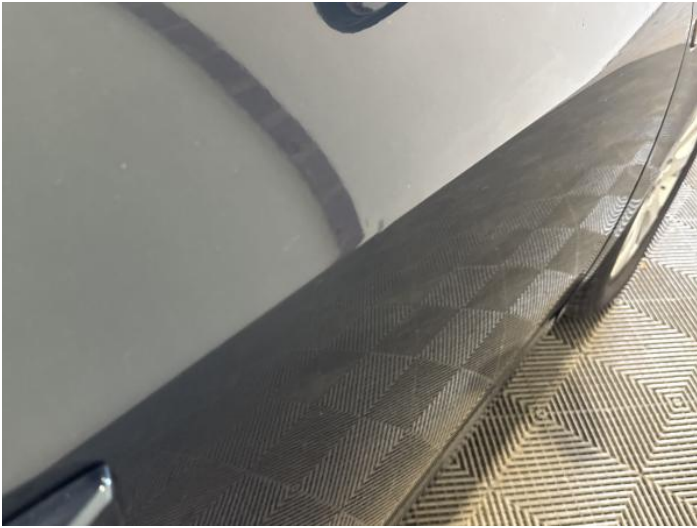
15: Door osf  
Dented  
Between 10mm + 30mm

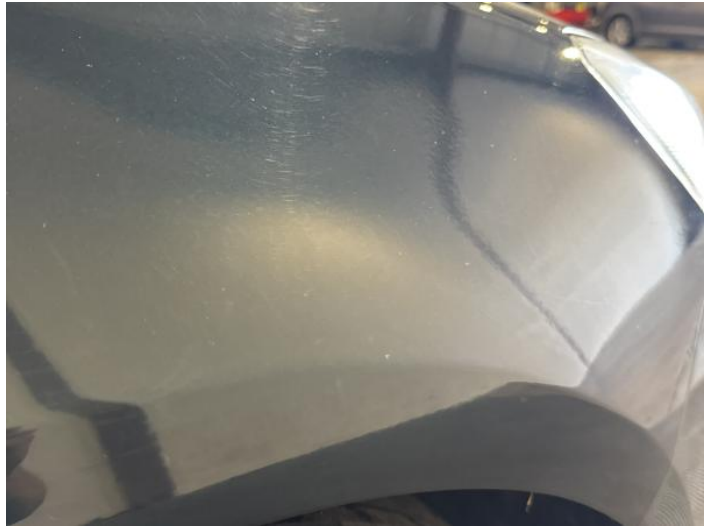
16: Wing osf  
Chipped  
1 To 5

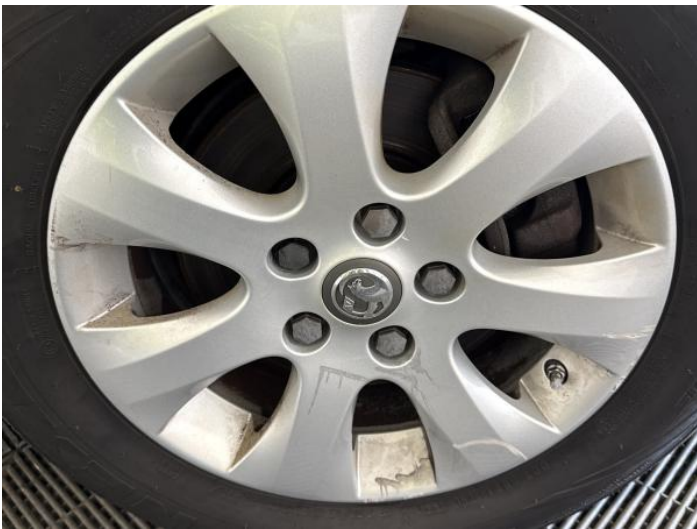
17: Wheel osf  
Scratched  
Over 50mm

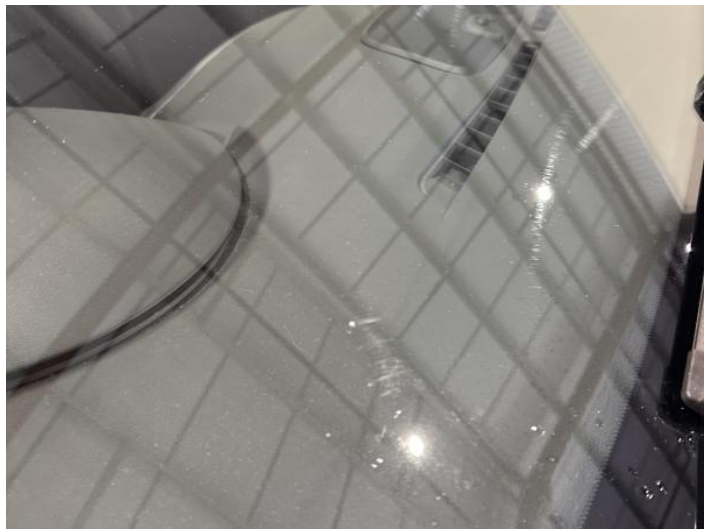
18: Screen Front  
Chipped  
UpTo 10mm

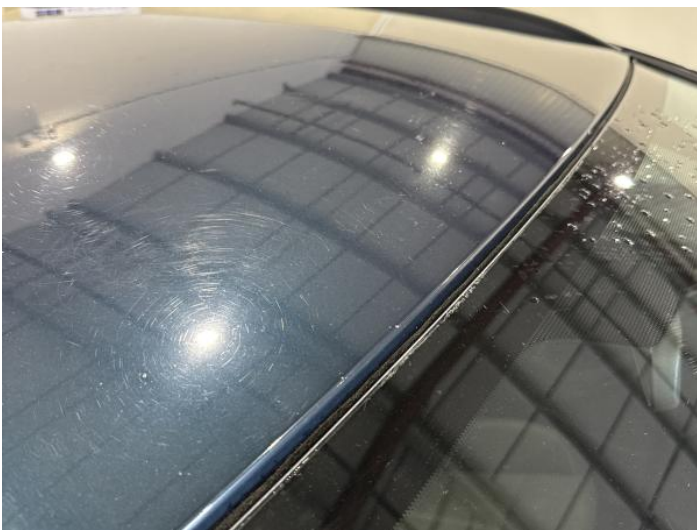
19: Roof  
Scratched  
Over 25mm Thru Paint
