# VEHICLE INSPECTION REPORT

RJ16RKE

## Kia Rio 1.4 CRDi 3 5dr

Non Runner  
Inspection

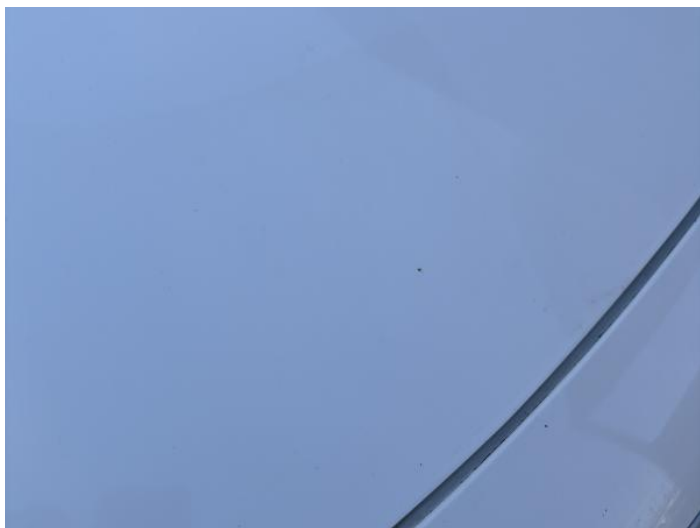
1: Bonnet  
Chipped  
1 To 5

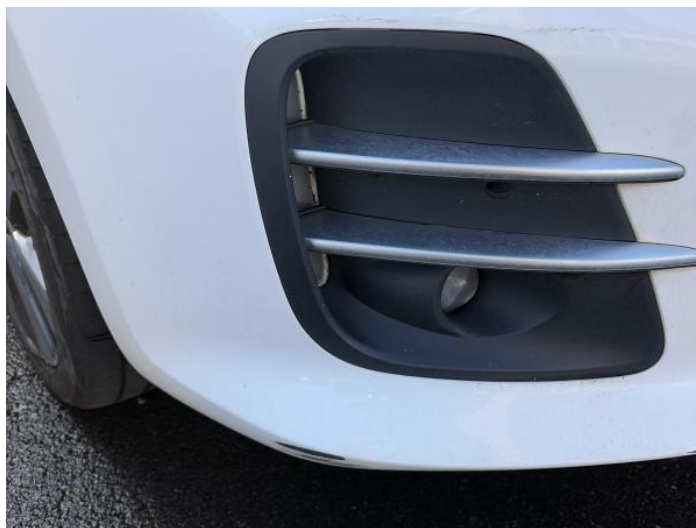
2: Bumper Front  
Scratched  
Over 100mm Thru Paint

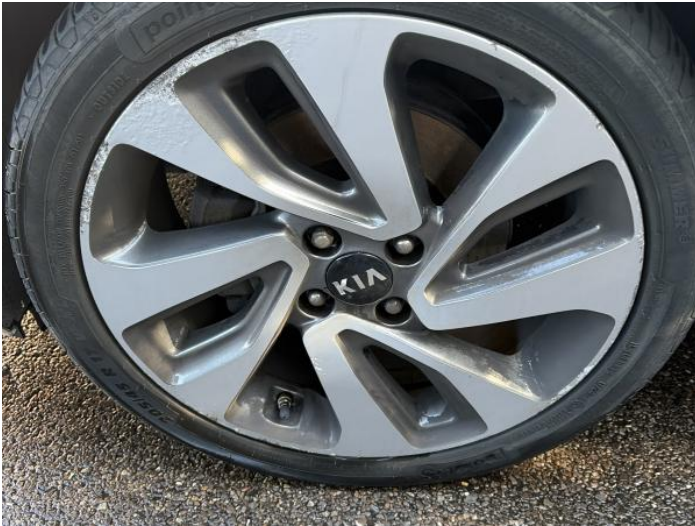
3: Wheel nsf  
Scratched  
Over 50mm

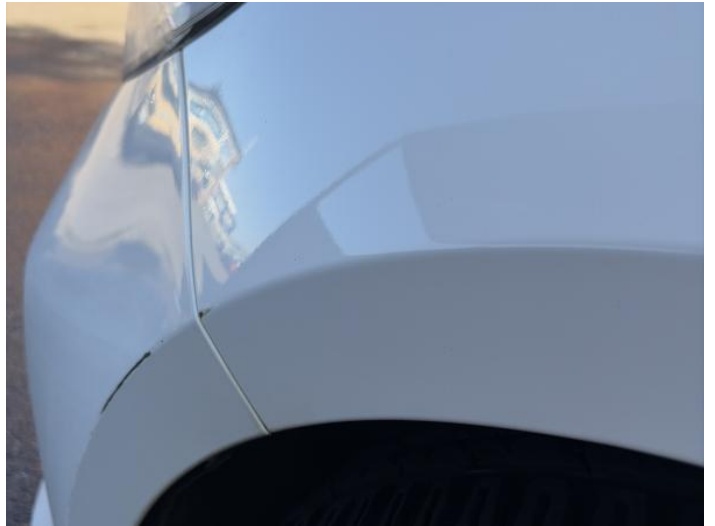
4: Wing nsf  
Scratched  
UpTo 25mm Thru Paint

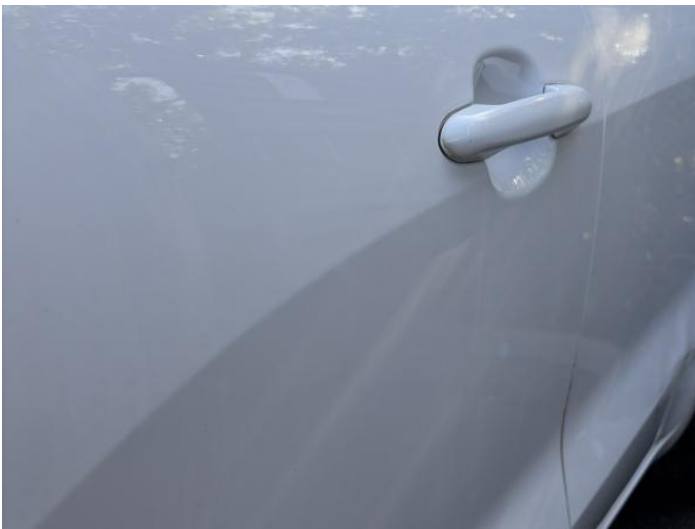
5: Door nsf  
Dented  
Between 10mm + 30mm

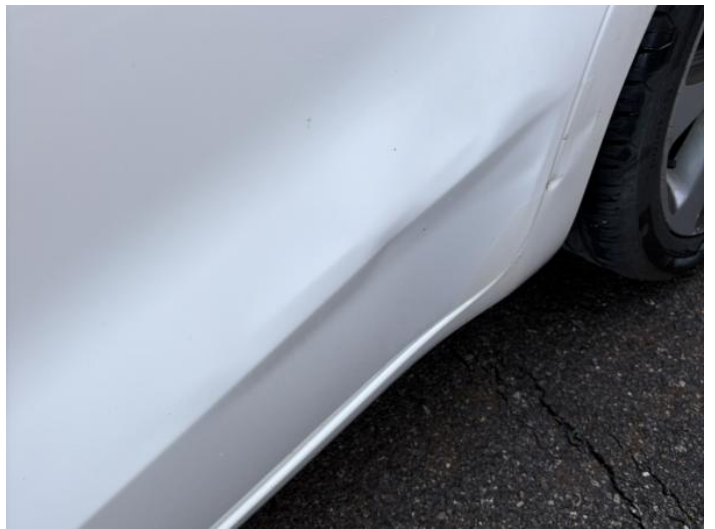
6: Door nsr  
Dented  
Over 30mm

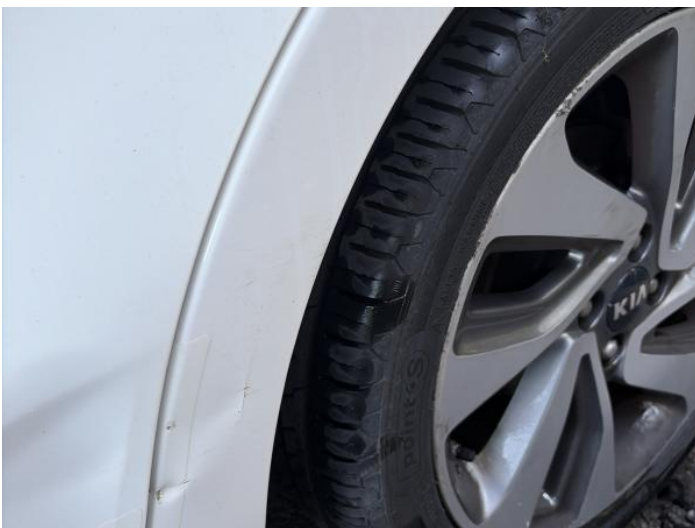
7: Qtr Panel nsr  
Dented  
With Paint Damage

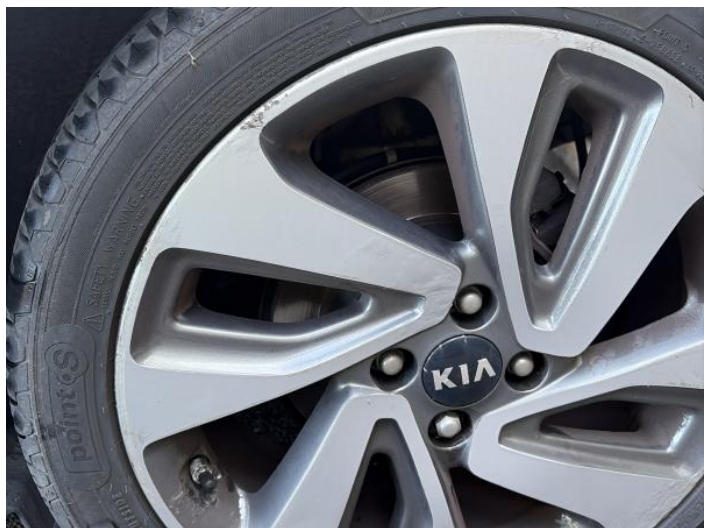
8: Wheel nsr  
Scratched  
Up To 50mm

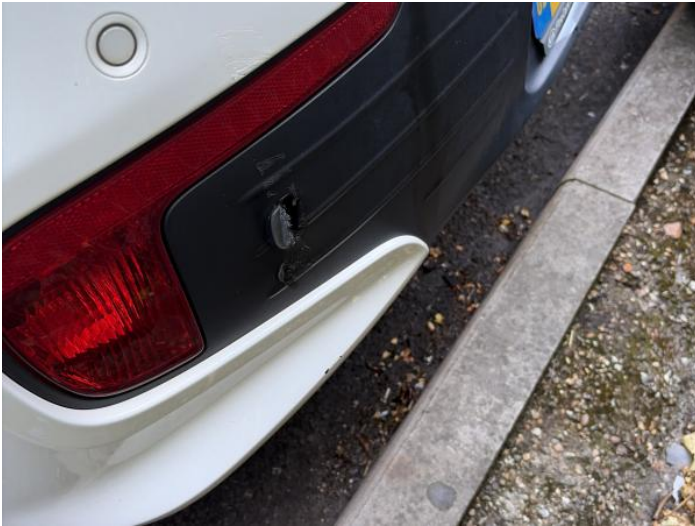
9: Bumper Rear Moulding  
Broken  
Replace

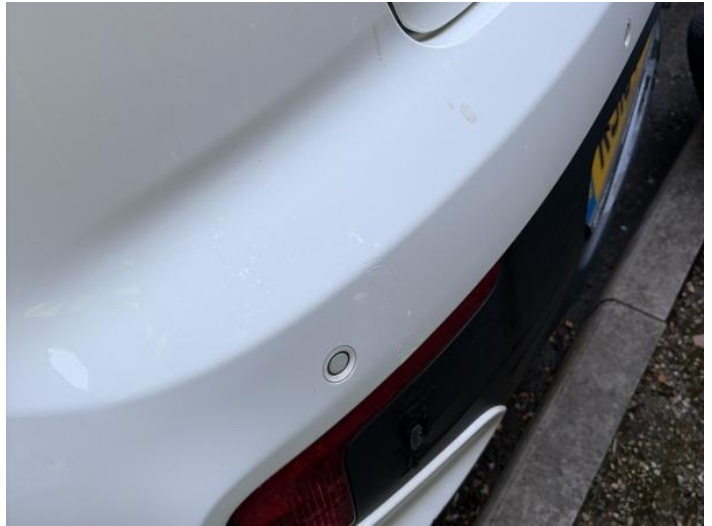
10: Bumper Rear  
Scratched  
25 to 100mm Thru Paint

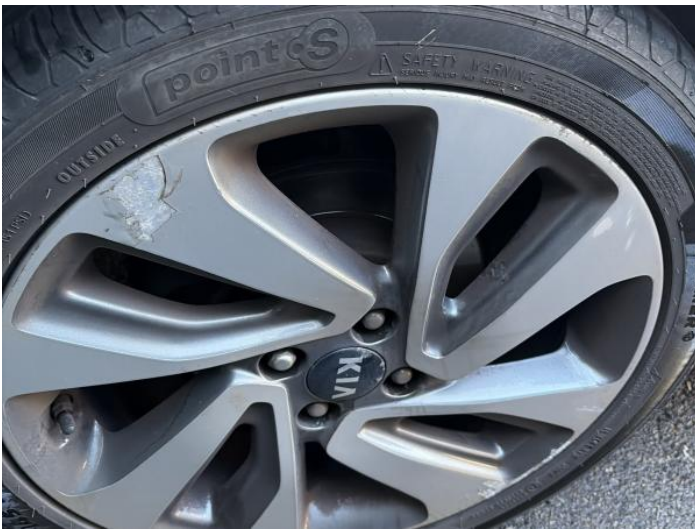
11: Wheel osr  
Scratched  
Over 50mm

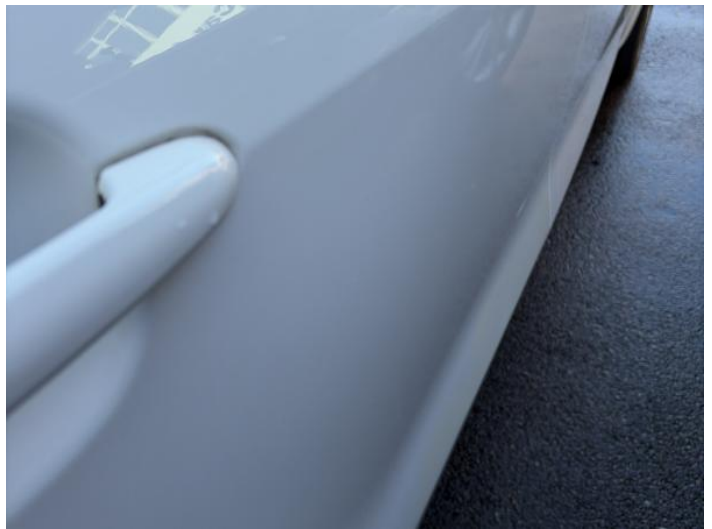
12: Door osr  
Dented  
Between 10mm + 30mm

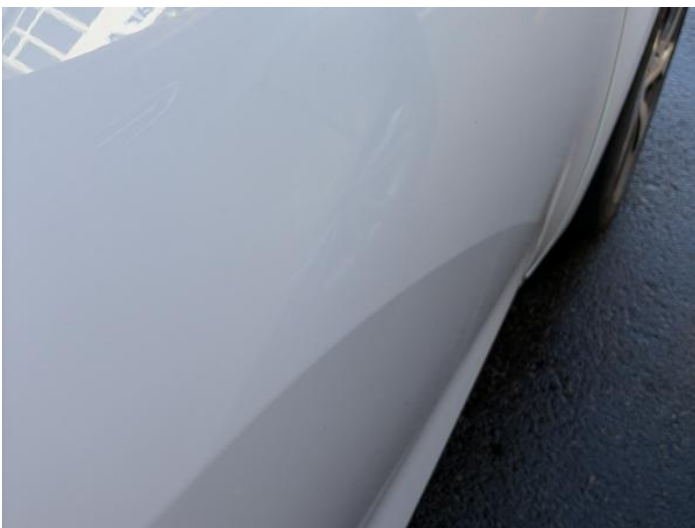
13: Door osf  
Dented  
Between 10mm + 30mm

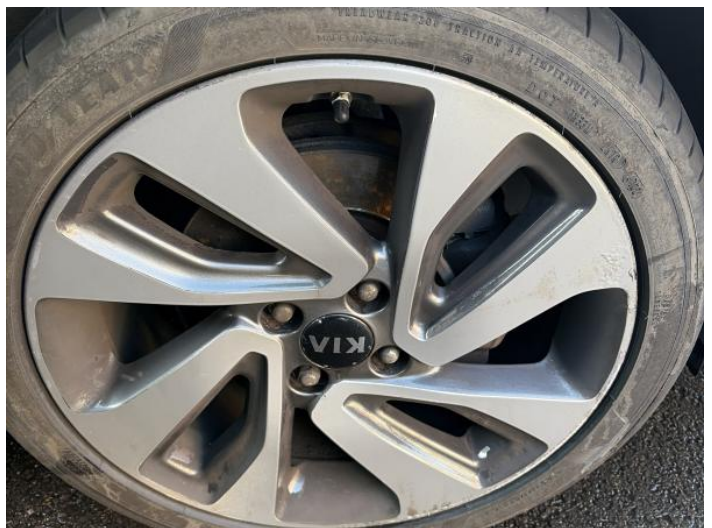
14: Wheel osf  
Scratched  
Over 50mm

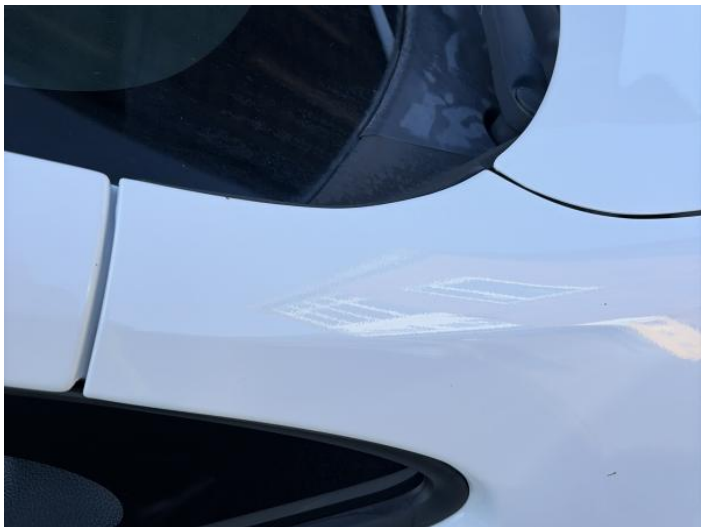
15: Wing osf  
Chipped  
1 To 5
