# VEHICLE INSPECTION REPORT

**HG63LSC**

## Honda Civic 1.8 i-VTEC ES 5dr

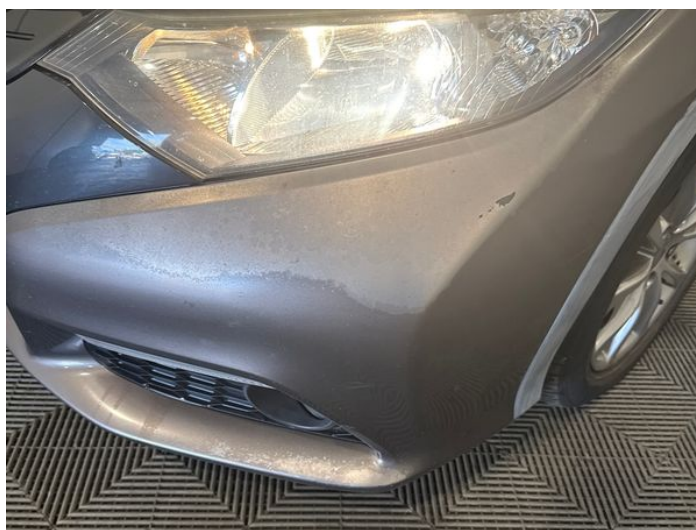
2: Bumper Front  
Dented  
With Paint Damage

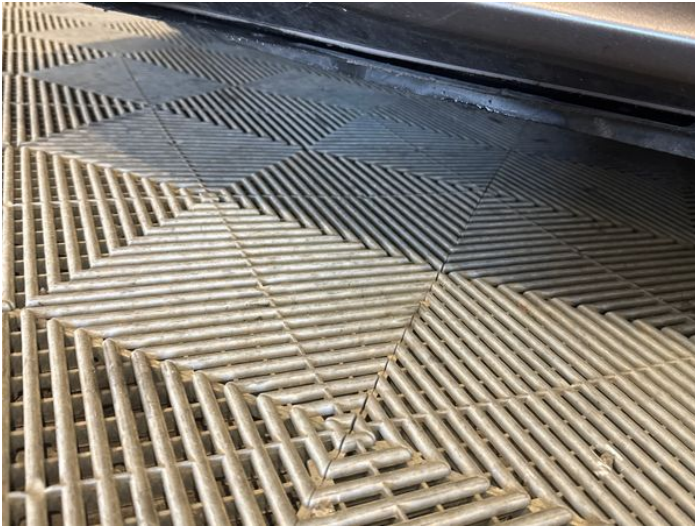
3: Bumper Front Moulding  
Broken  
Replace

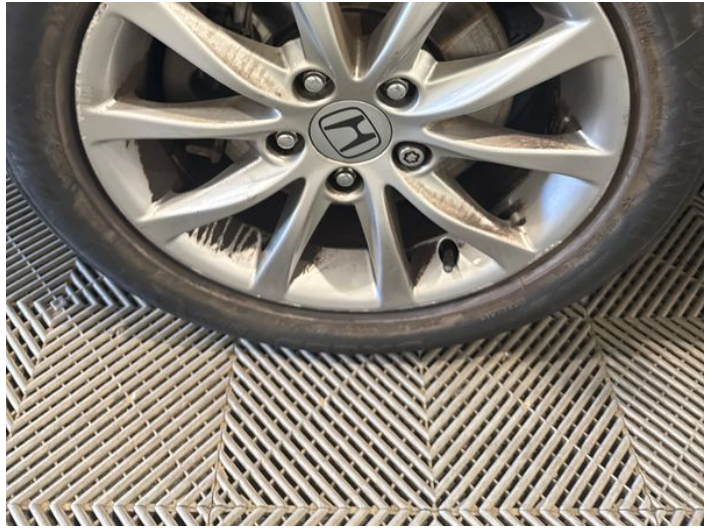
4: Wheel nsf  
Scratched  
Over 50mm

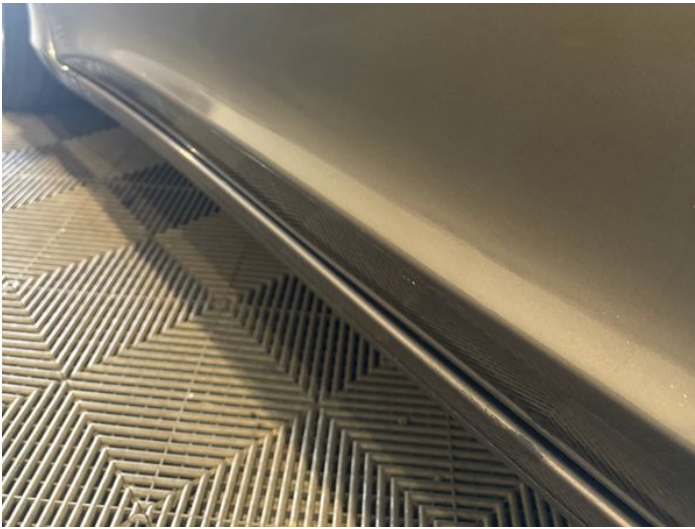
5: Door nsf  
Dented  
With Paint Damage

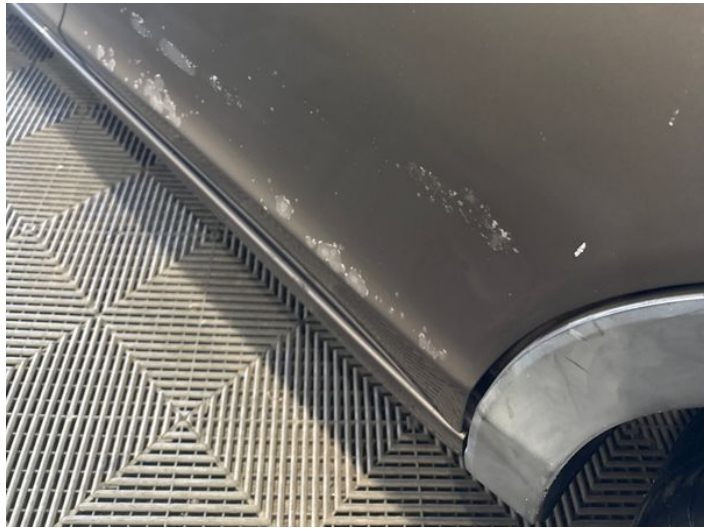
6: Door nsr  
Poor Previous Repair  
Paint Flake

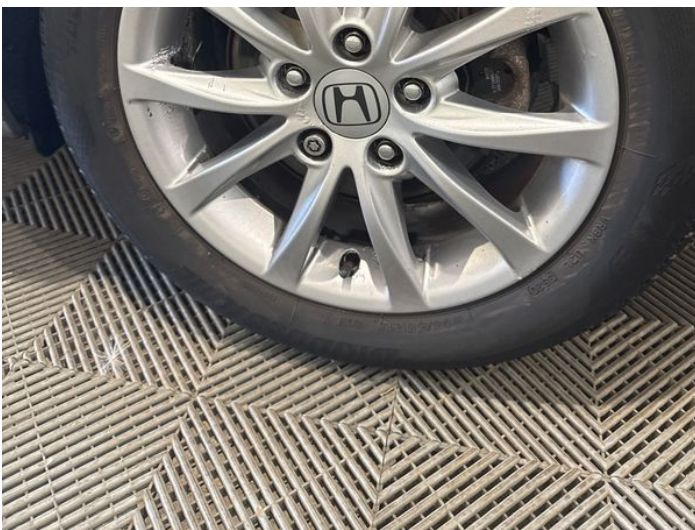
7: Wheel nsr  
Scratched  
Up To 50mm

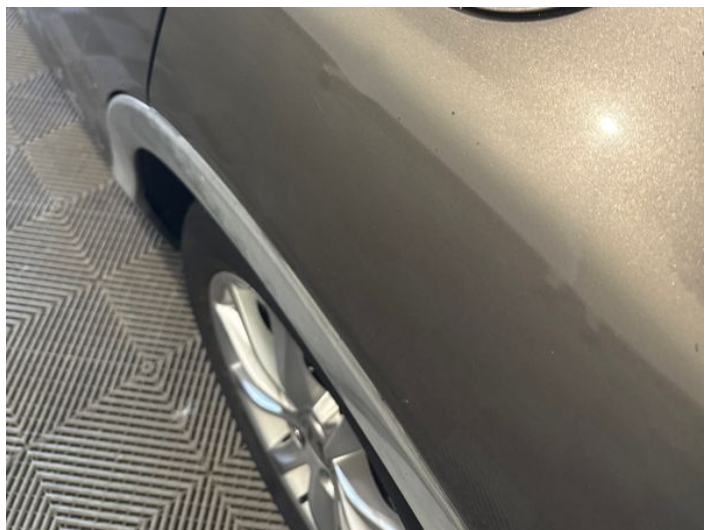
8: Qtr Panel nsr  
Dented  
Between 10mm + 30mm

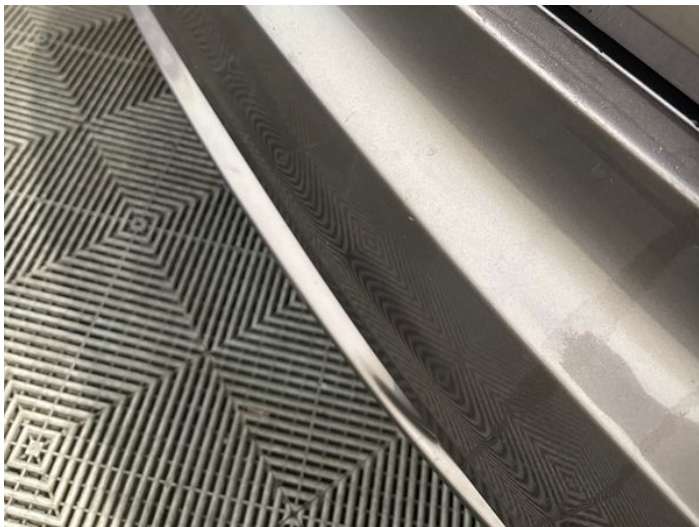
9: Bumper Rear  
Scratched  
25 to 100mm Thru Paint

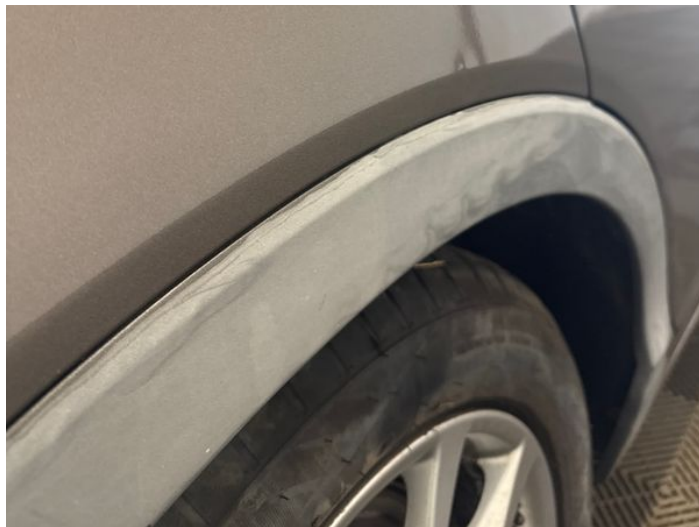
10: Qtr Panel osr  
Dented  
Between 10mm + 30mm

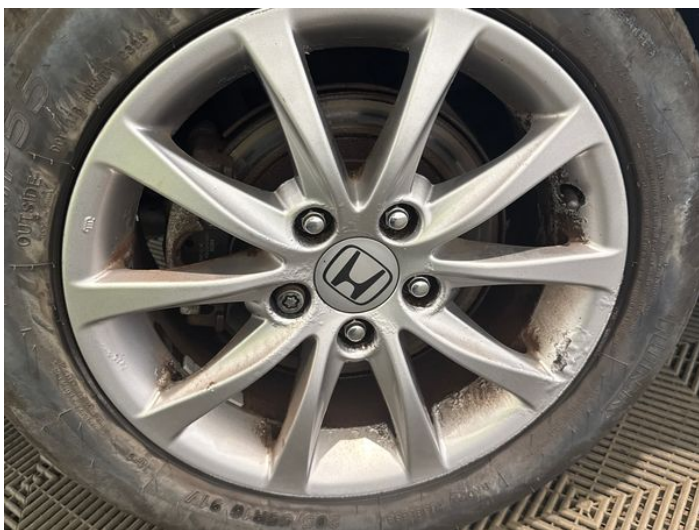
11: Wheel osr  
Scratched  
Over 50mm

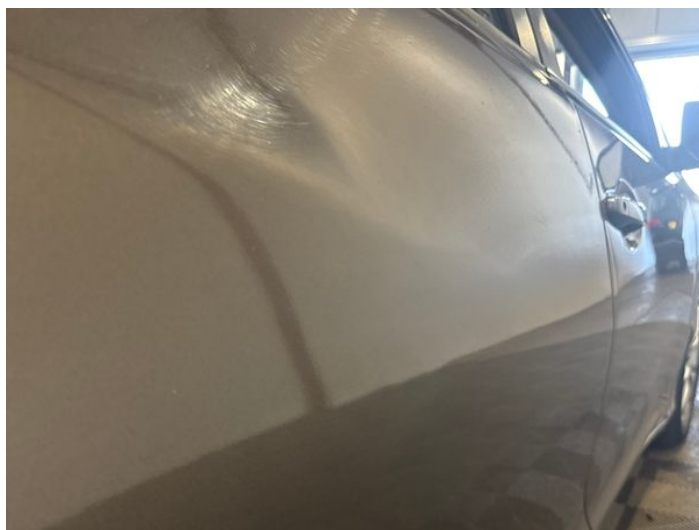
12: Door osr  
Poor Previous Repair  
Rippled UpTo 30%

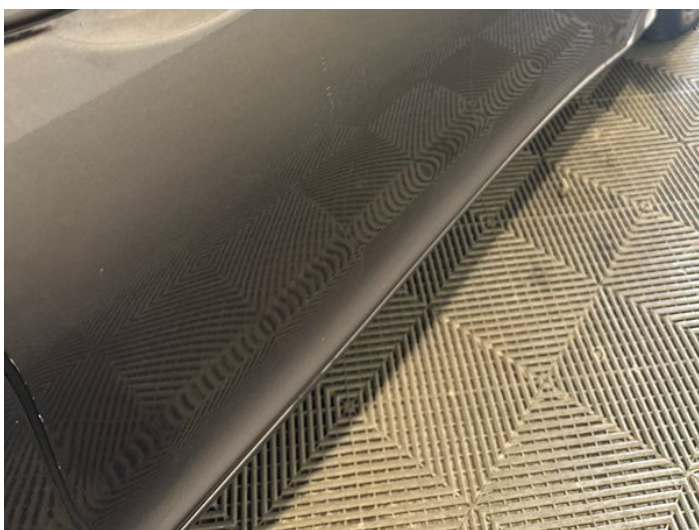
13: Door osf  
Dented  
With Paint Damage

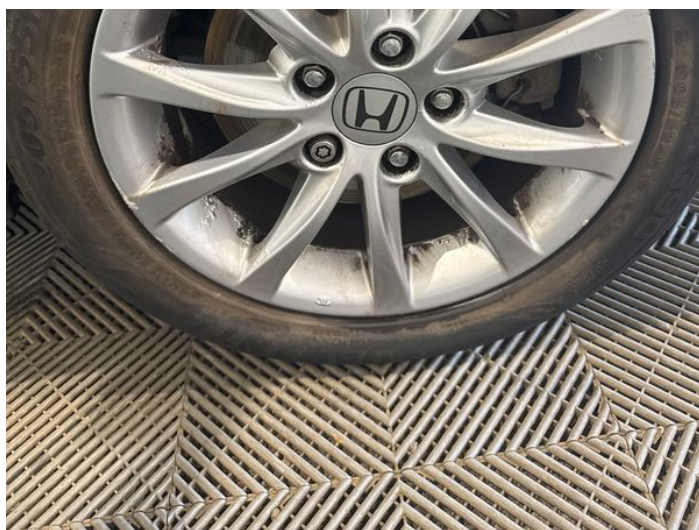
14: Wheel osf  
Scratched  
Over 50mm

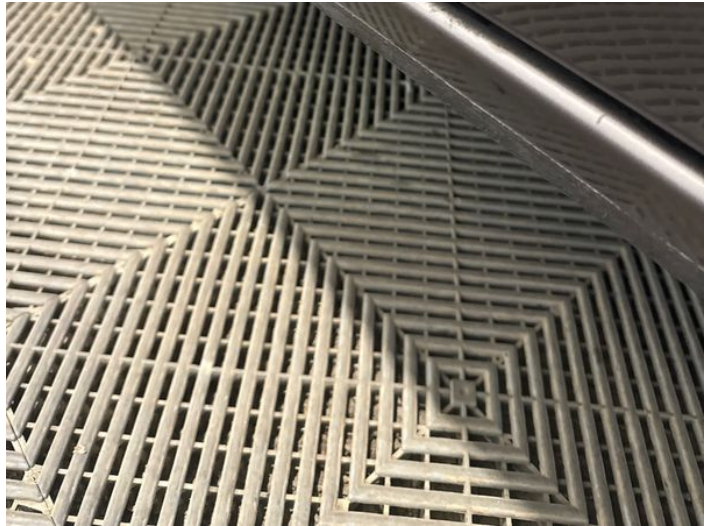
16: Sill os  
Scratched  
Over 25mm Thru Paint

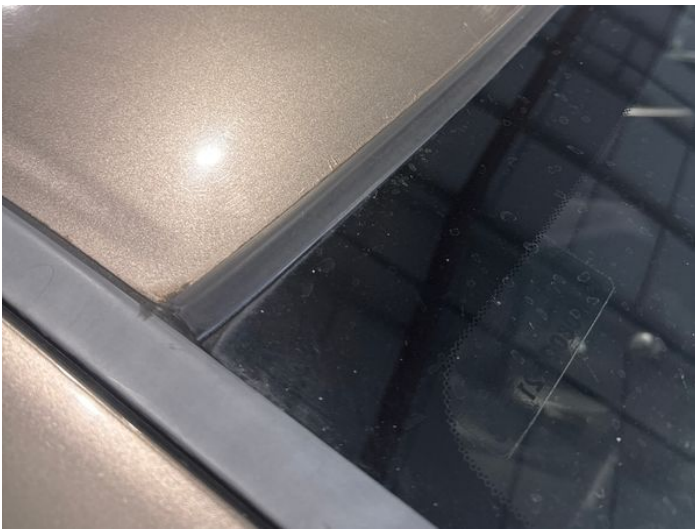
17: Roof  
Rusted  
Over 5mm

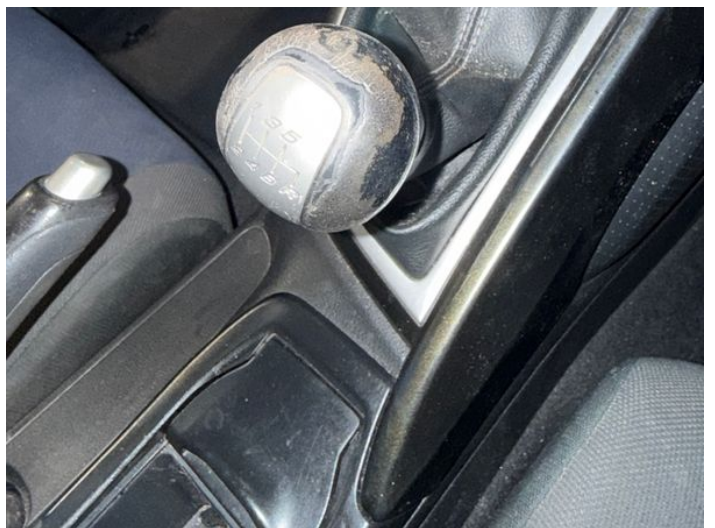
20: Switches And Controls  
Broken  
Replace
