# VEHICLE INSPECTION REPORT

**MJ62VDV**

## Mercedes-Benz B Class B180 CDI BlueEFFICIENCY SE 5dr

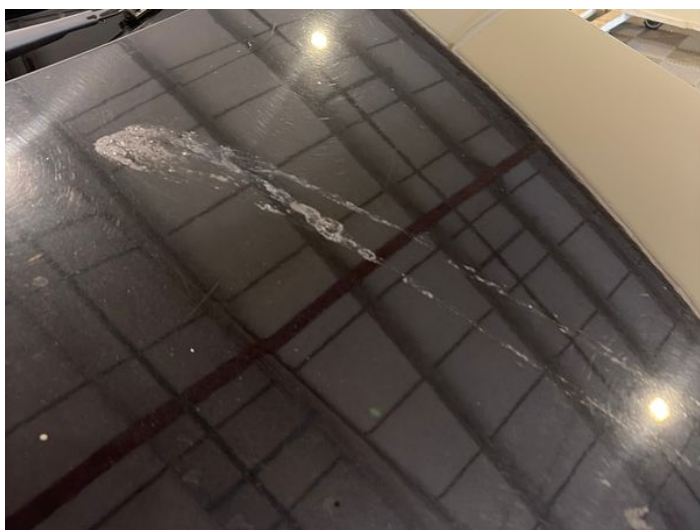
1: Bonnet  
Scratched  
Over 25mm Thru Paint

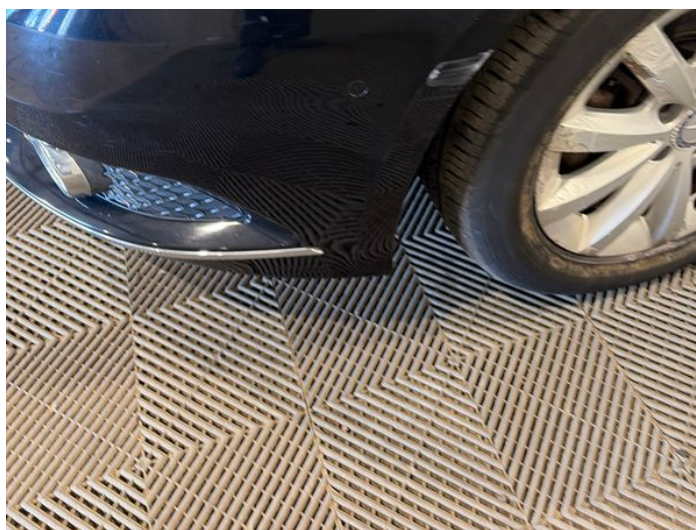
2: Bumper Front  
Scratched  
25 to 100mm Thru Paint

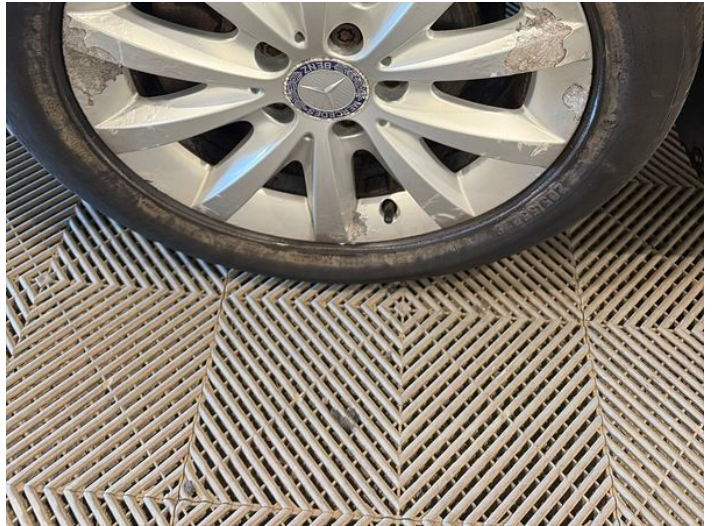
4: Wheel nsf  
Scratched  
Over 50mm

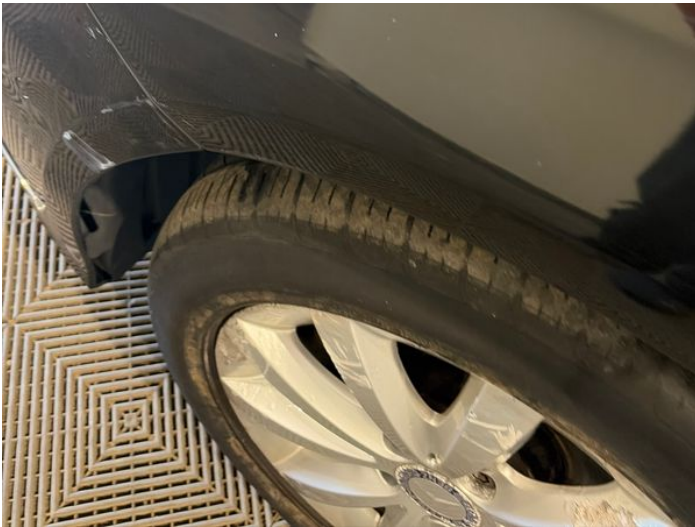
5: Wing nsf  
Scratched  
Over 25mm Thru Paint

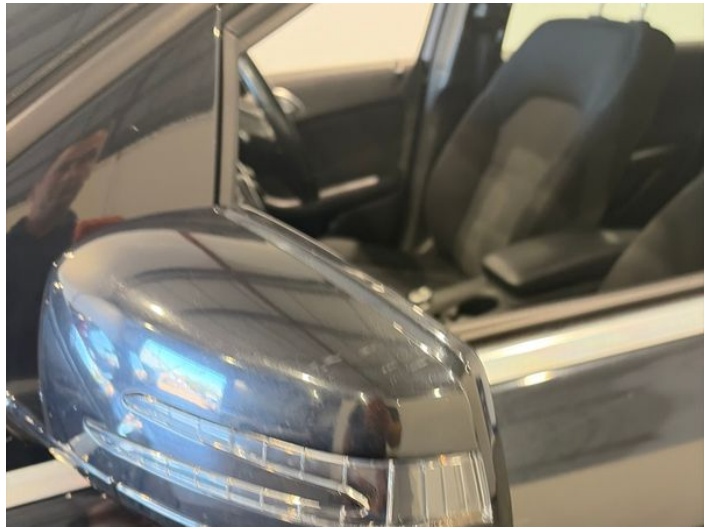
6: Door Mirror Assy nsf  
Scratched (Painted)  
UpTo 25mm Thru Paint

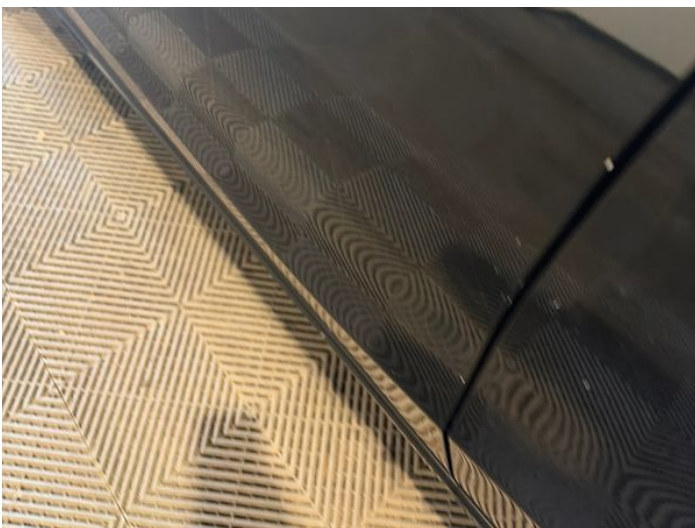
7: Door nsf  
Chipped  
Multiple Chips

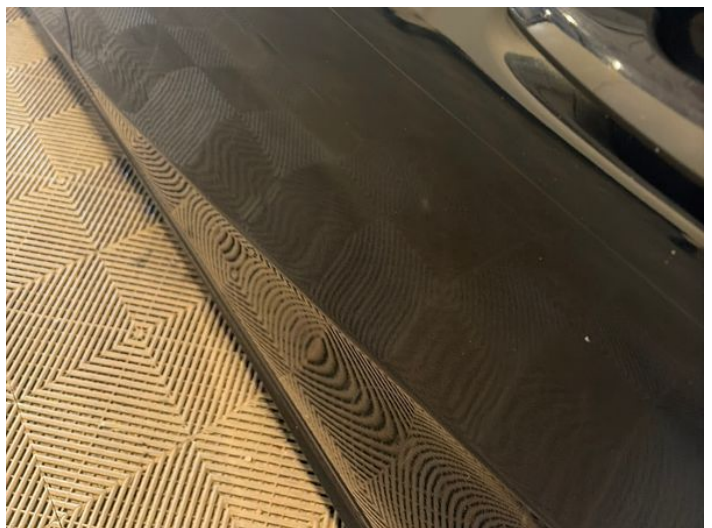
8: Door nsr  
Scratched  
Over 25mm Thru Paint

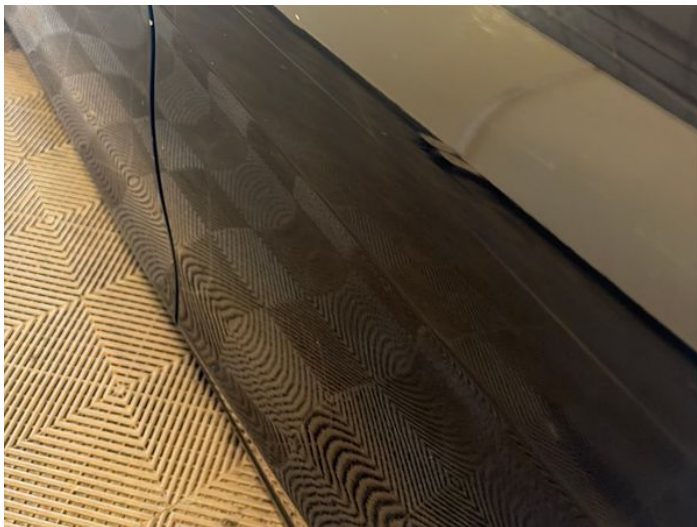
9: Door nsr  
Dented  
Between 10mm + 30mm

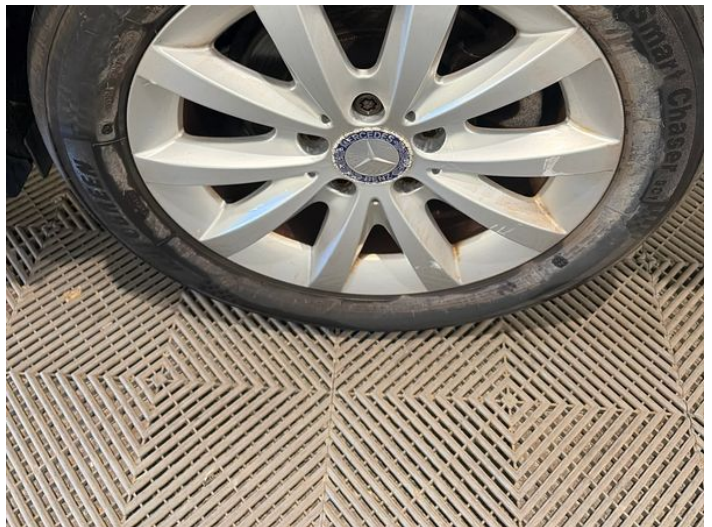
10: Wheel nsr  
Scratched  
Over 50mm

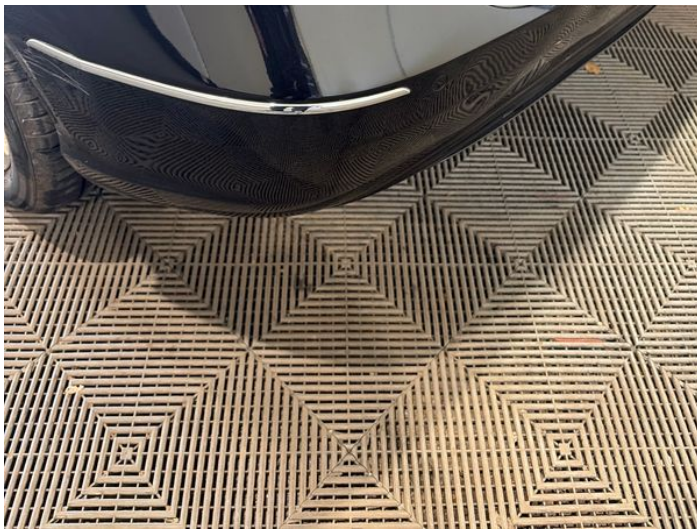
11: Bumper Rear  
Dented  
With Paint Damage

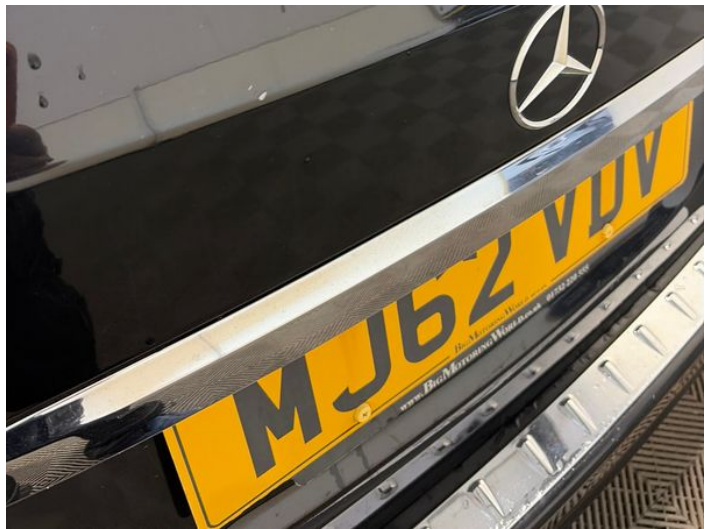
12: Tailgate  
Chipped  
1 To 5

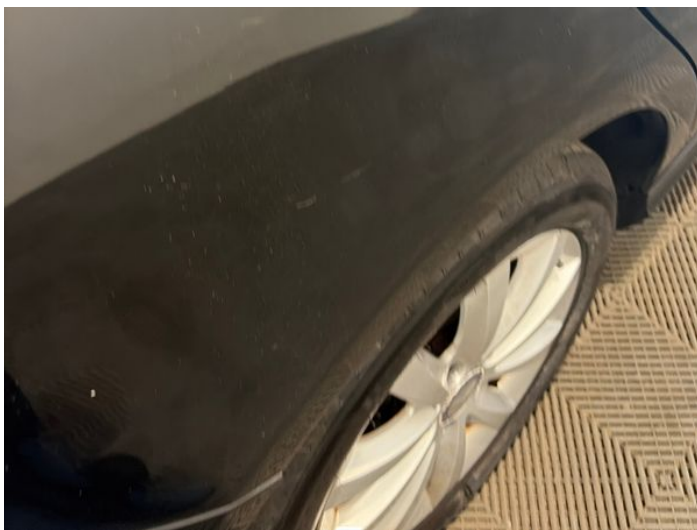
13: Qtr Panel osr  
Scratched  
Over 25mm Thru Paint

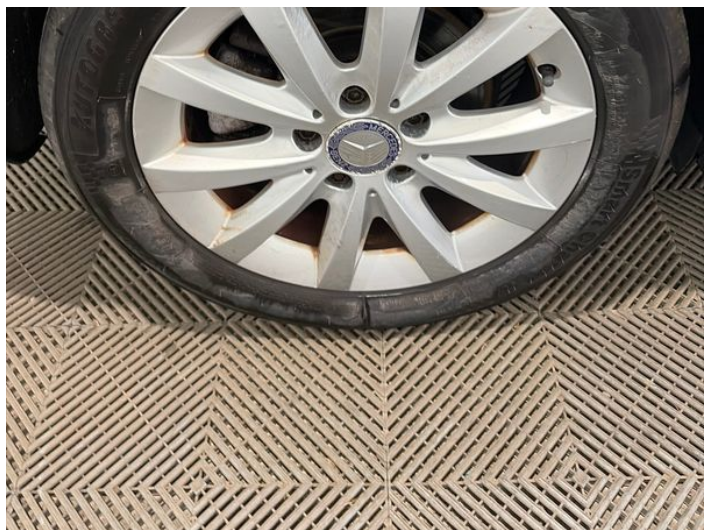
14: Wheel osr  
Scratched  
Up To 50mm

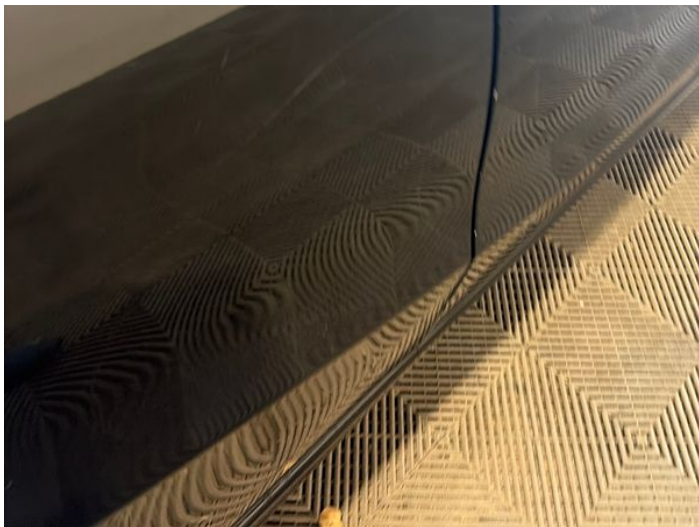
15: Door osr  
Scratched  
Over 25mm Thru Paint

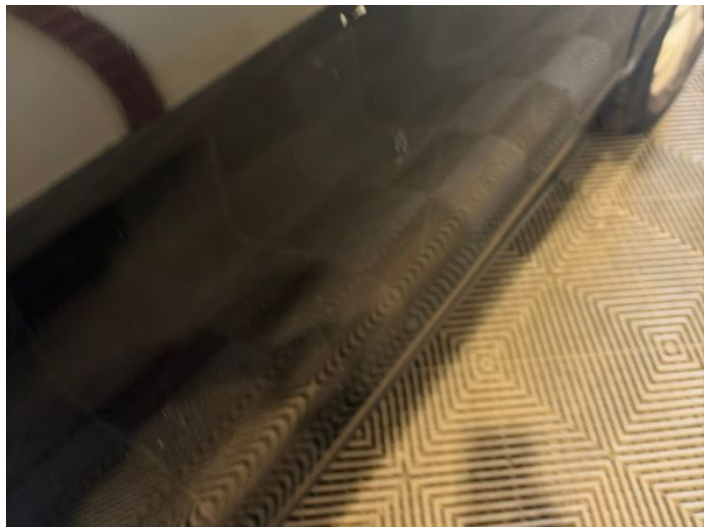
16: Door osf  
Dented  
Between 10mm + 30mm

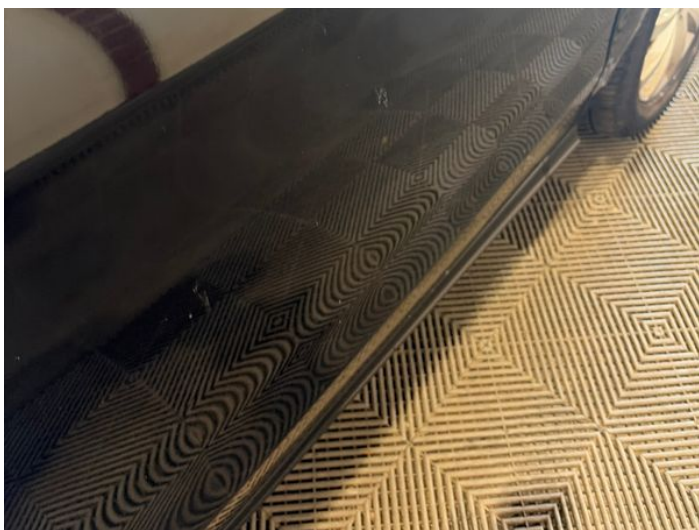
17: Door osf  
Scratched  
Over 25mm Thru Paint

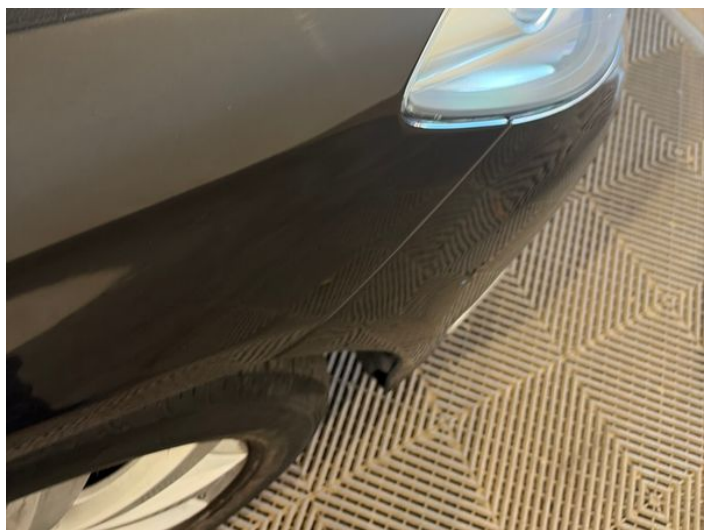
18: Wing osf  
Chipped  
1 To 5
