# VEHICLE INSPECTION REPORT

DA70RZM

## Toyota RAV4 2.5 VVT-i Hybrid Dynamic 5dr CVT 2WD

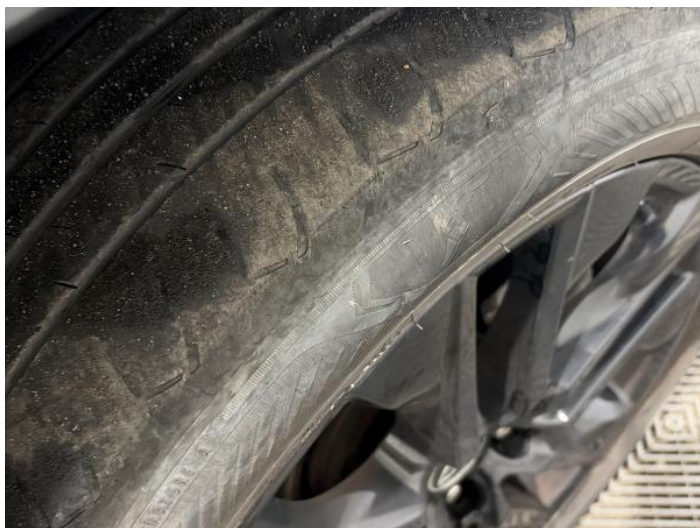
| OSF | GOODYEAR | Damaged |

1: Tyre osf  
Damaged  
Replace

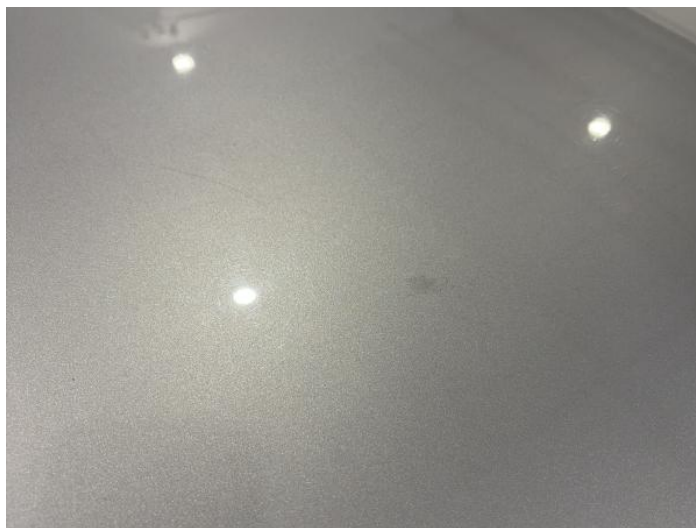
2: Bonnet  
Scratched  
Over 25mm Thru Paint

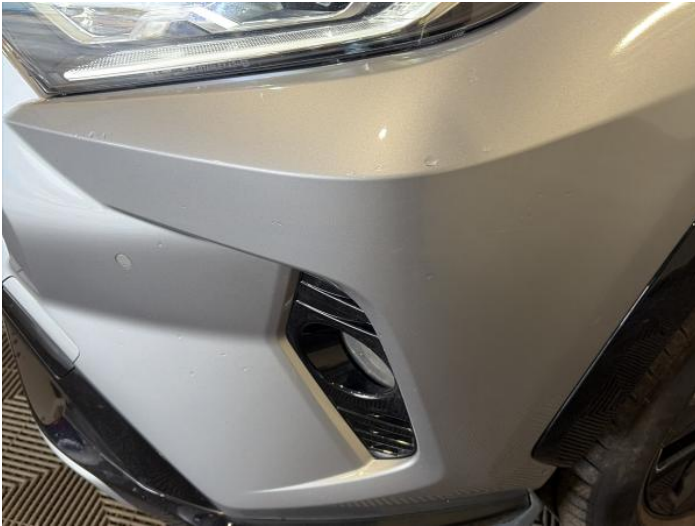
3: Bumper Front  
Scratched  
25 to 100mm Thru Paint

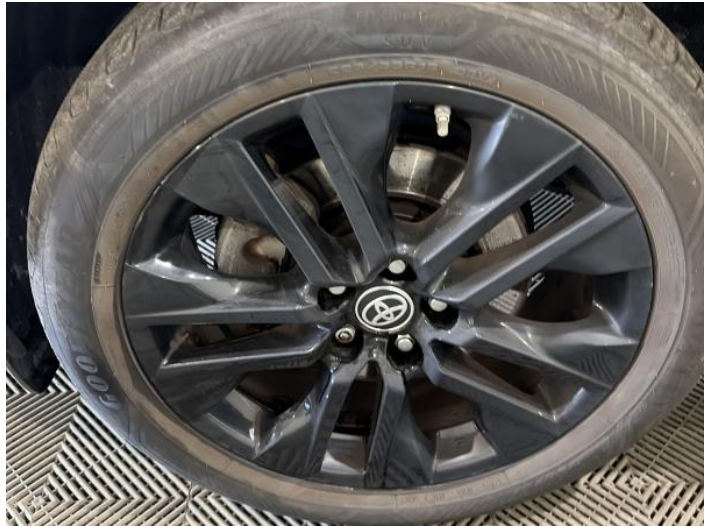
4: Wheel nsf  
Scratched  
Up To 50mm

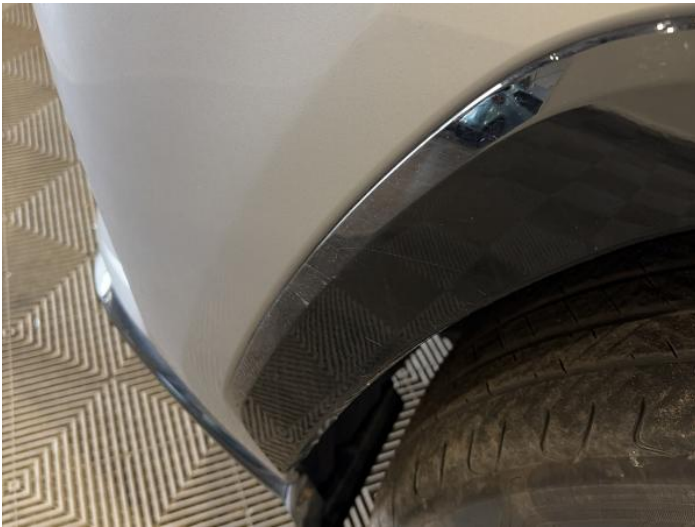
5: Wing Front Arch Extension ns  
Scratched (Painted)  
UpTo 25mm Thru Paint

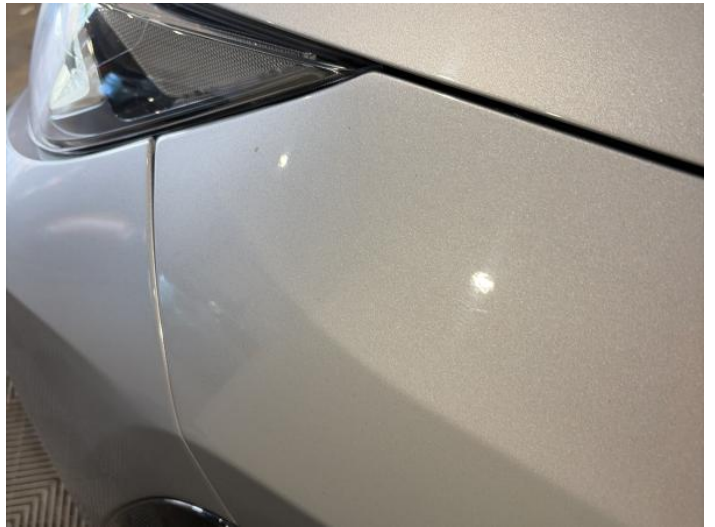
6: Wing nsf  
Chipped  
1 To 5

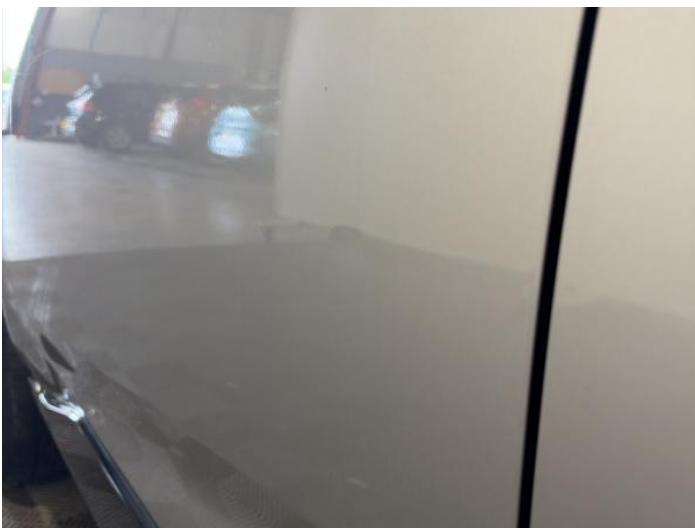
7: Door nsf  
Dented  
Between 10mm + 30mm

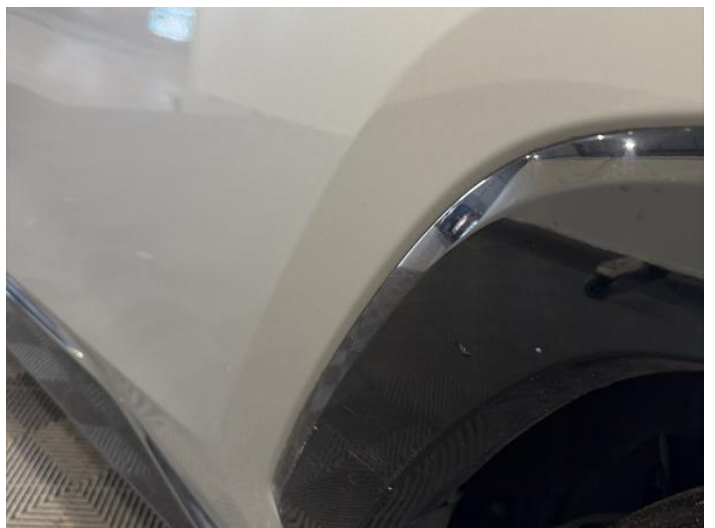
8: Door nsr  
Scratched  
Over 25mm Thru Paint

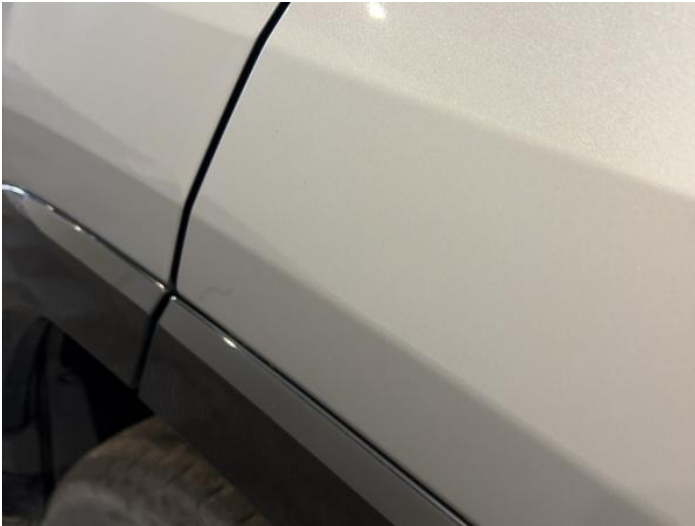
9: Qtr Panel nsr  
Scratched  
Over 25mm Thru Paint

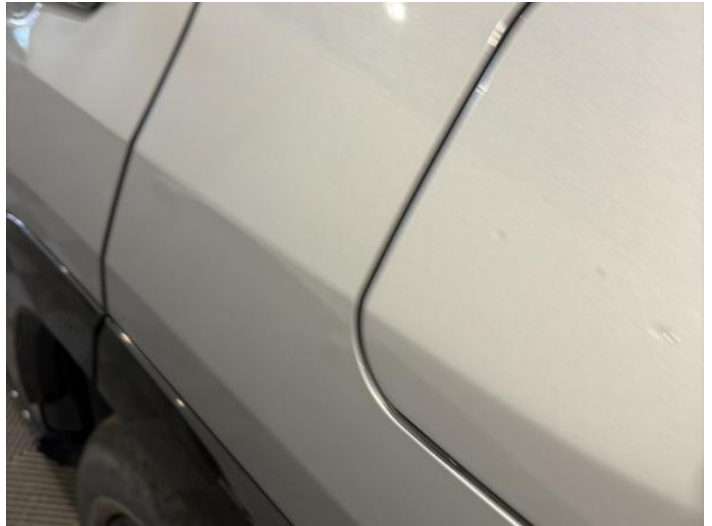
10: Qtr Panel nsr  
Dented  
Between 10mm + 30mm

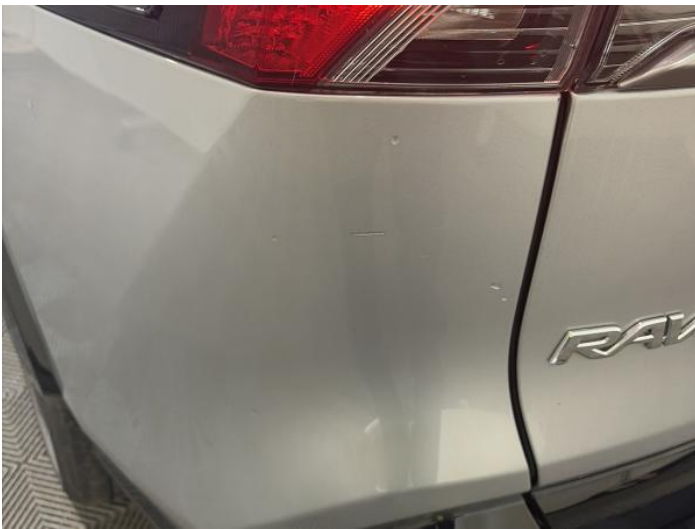
11: Bumper Rear  
Scratched  
Up To 25mm Thru Paint

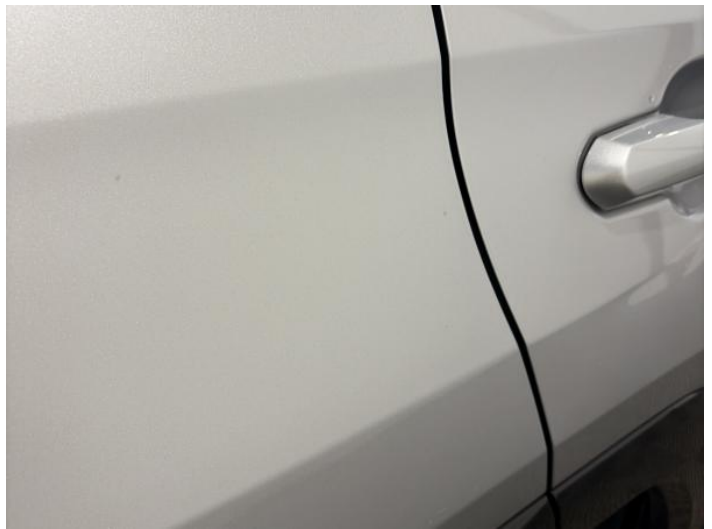
12: Qtr Panel osr  
Chipped  
1 To 5

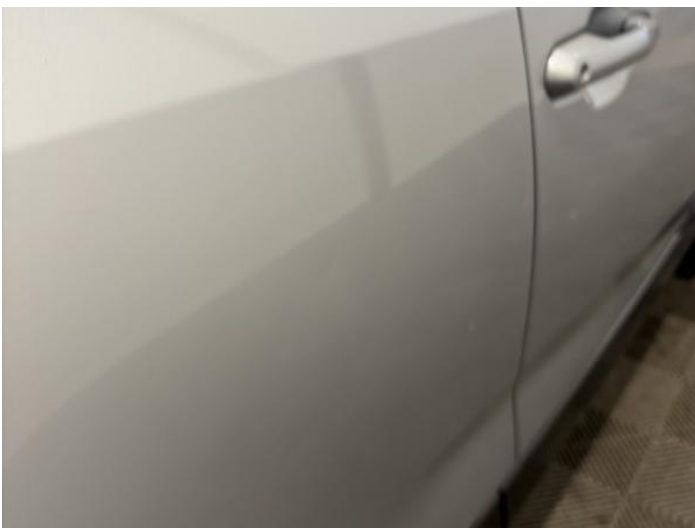
13: Door osr  
Dented  
Between 10mm + 30mm

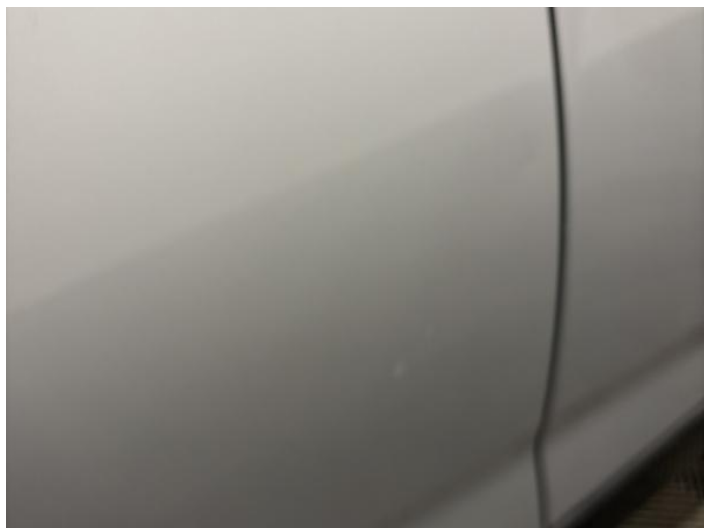
14: Door osr  
Chipped  
1 To 5

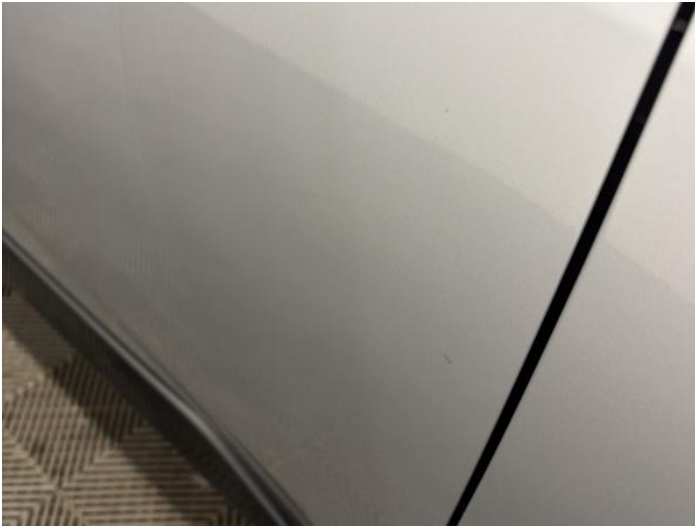
15: Door osf  
Chipped  
1 To 5

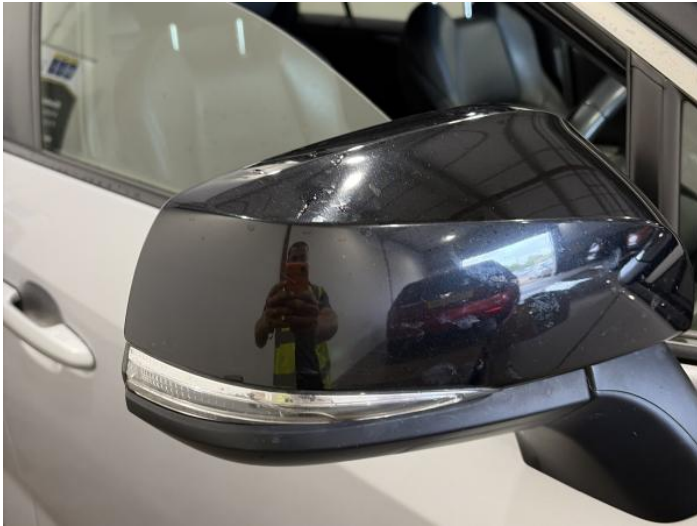
16: Flasher Side Repeater os  
Broken  
Replace

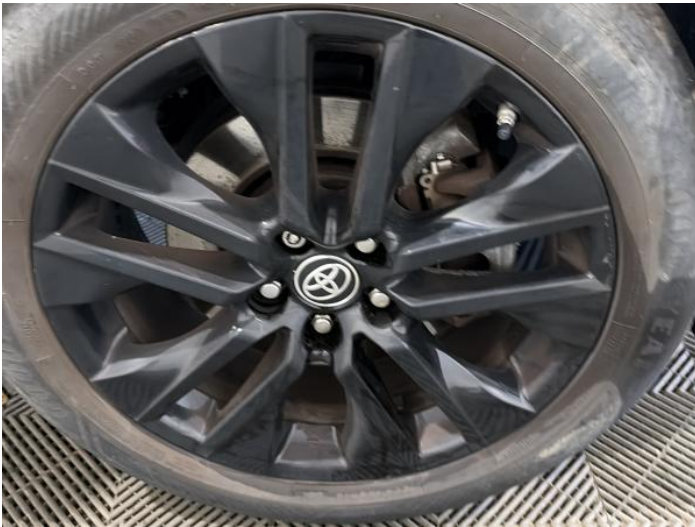
17: Wheel osf  
Scratched  
Over 50mm

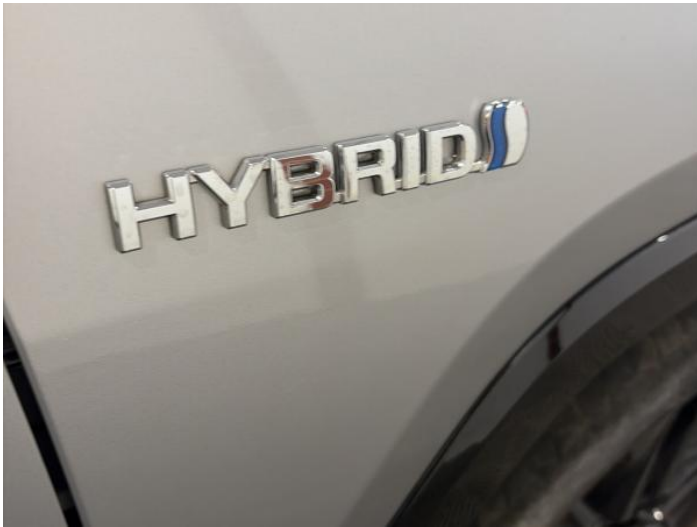
18: Wing osf  
Scratched  
UpTo 25mm Thru Paint
