# VEHICLE INSPECTION REPORT

**HN67EUV**

## Peugeot 2008 1.2 PureTech Allure 5dr

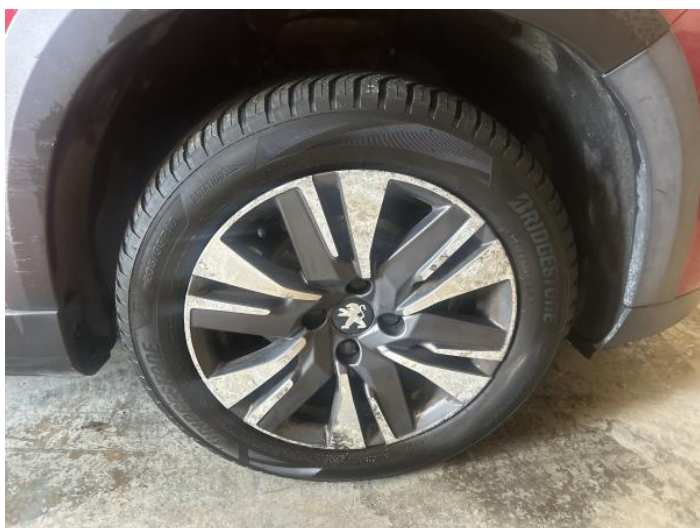
1: Wheel osf  
Corroded  
Light

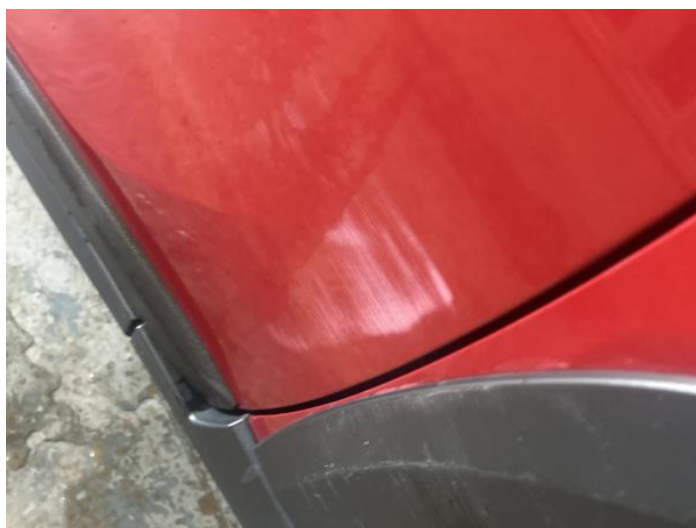
2: Door osf  
Scratched  
Over 25mm Thru Paint

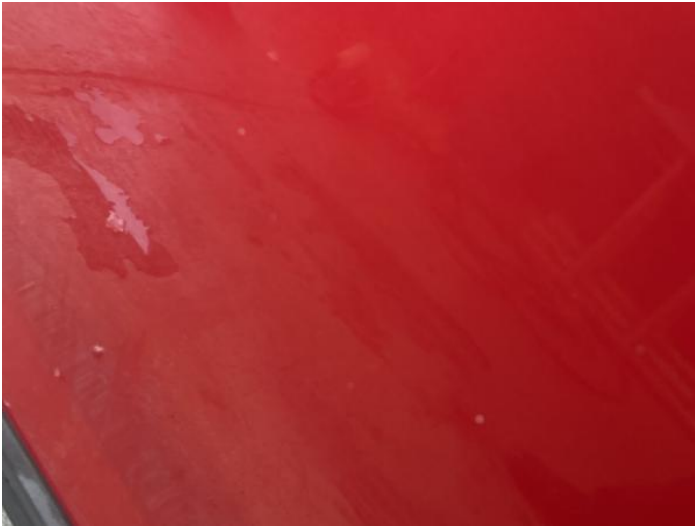
3: Door osr  
Chipped  
1 To 5

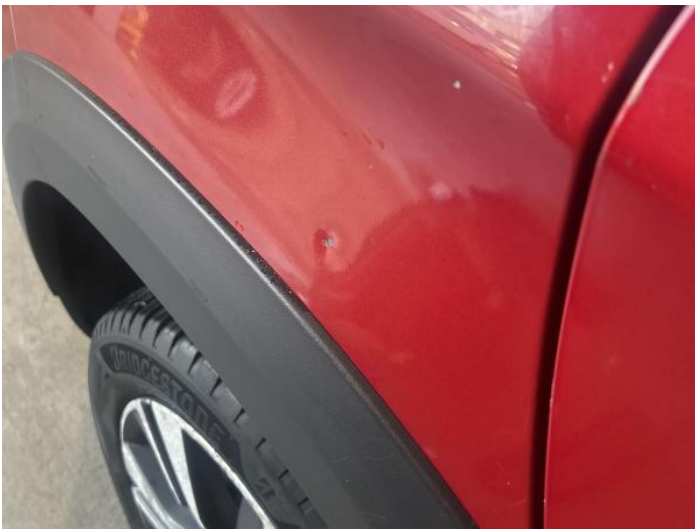
5: Qtr Panel osr  
Dented  
With Paint Damage

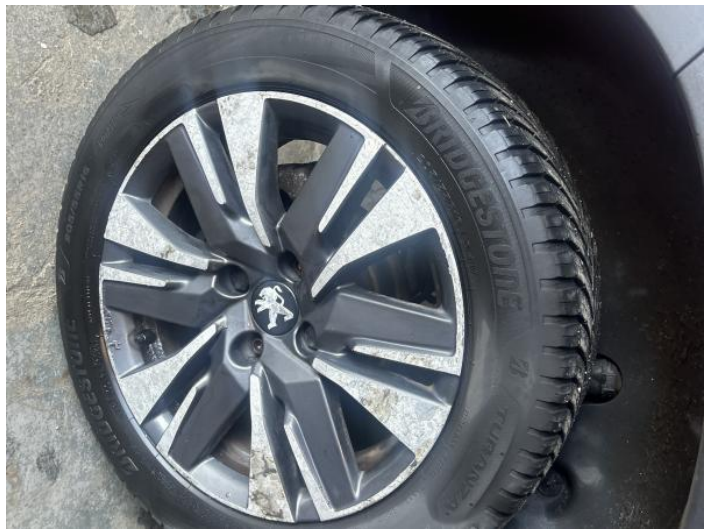
6: Wheel osr  
Corroded  
Light

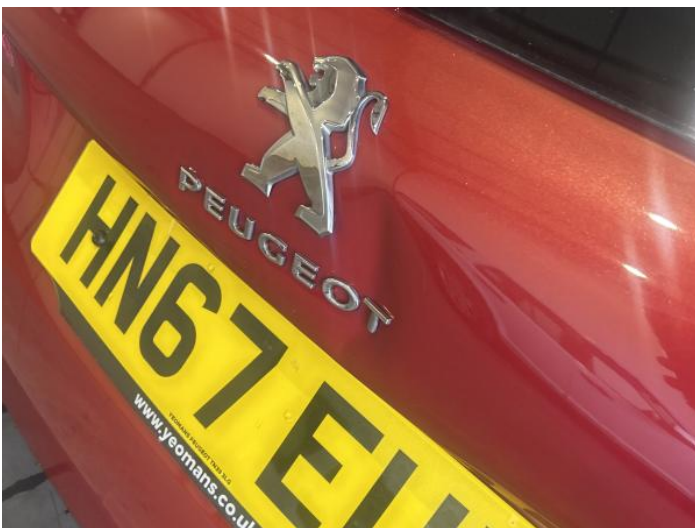
7: Tailgate  
Dented  
Over 30mm

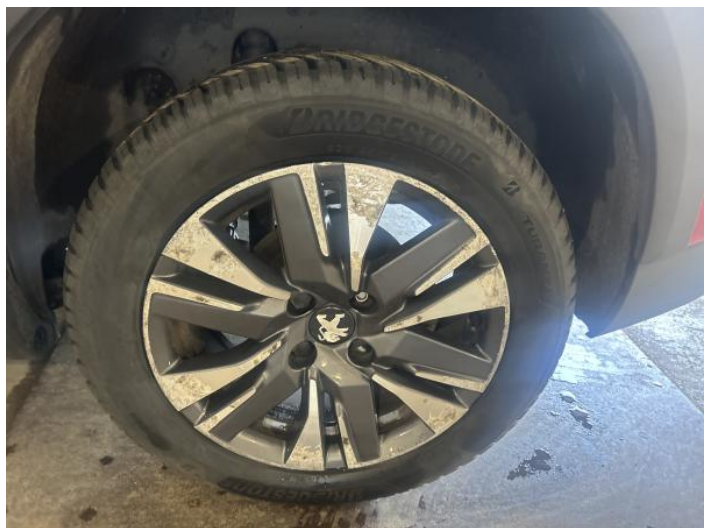
8: Wheel nsr  
Corroded  
Light

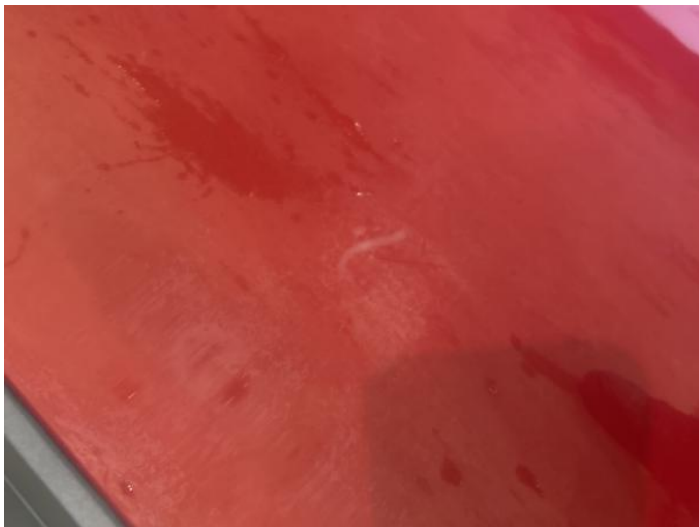
9: Door nsr  
Scratched  
UpTo 25mm Thru Paint

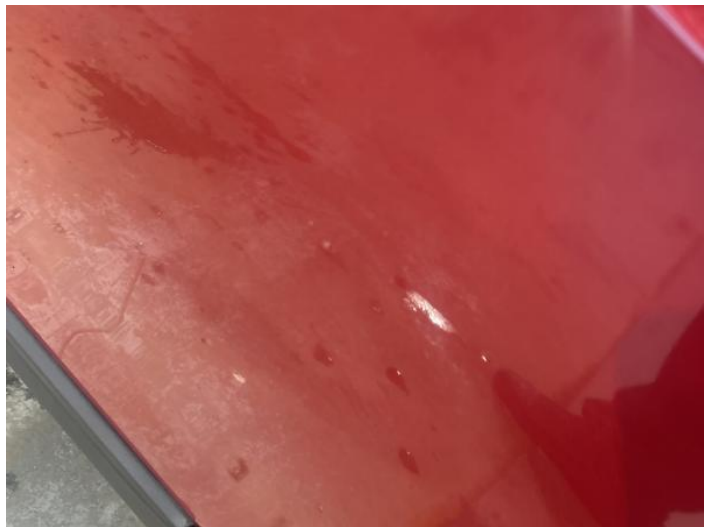
10: Door nsr  
Chipped  
1 To 5

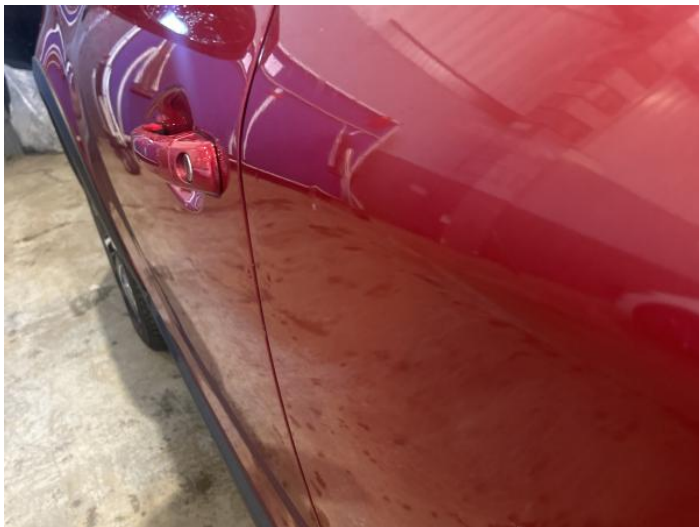
11: Door nsr  
Dented  
2 Or Less UpTo 10mm

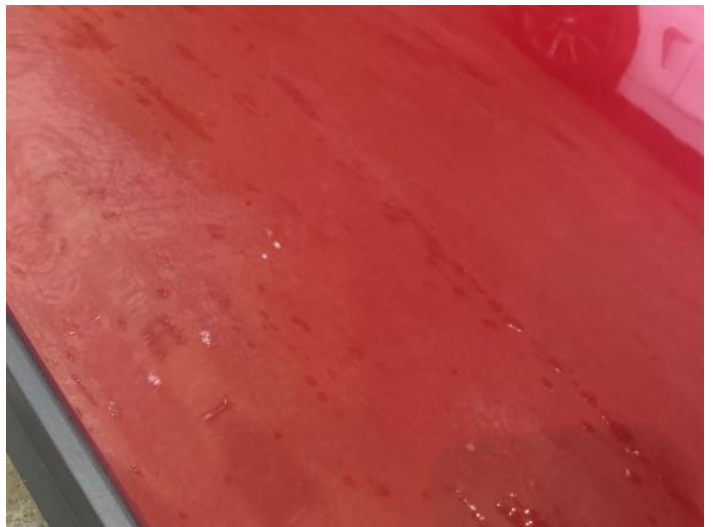
12: Door nsf  
Chipped  
1 To 5

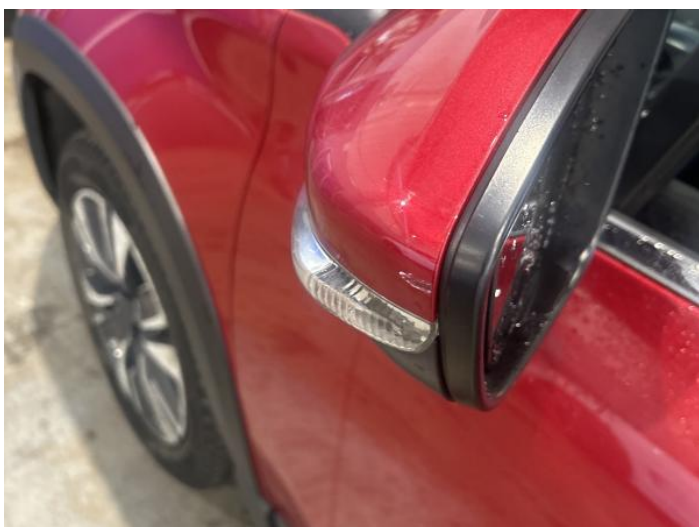
13: Door Mirror Assy nsf  
Scratched (Painted)  
UpTo 25mm Thru Paint

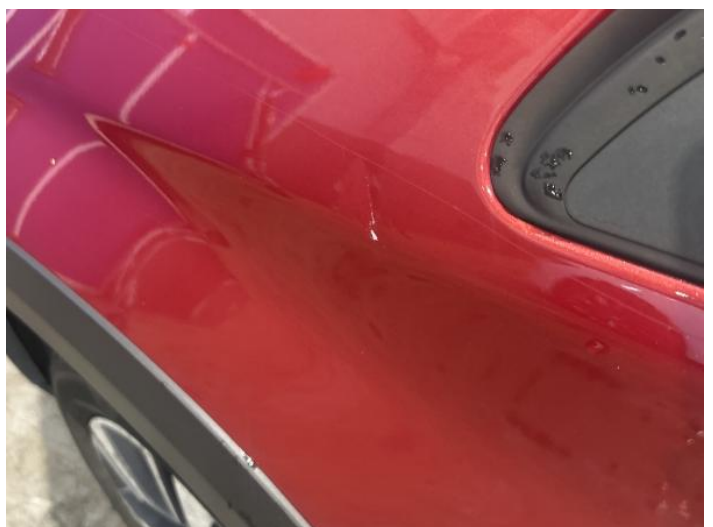
14: Wing nsf  
Dented  
With Paint Damage

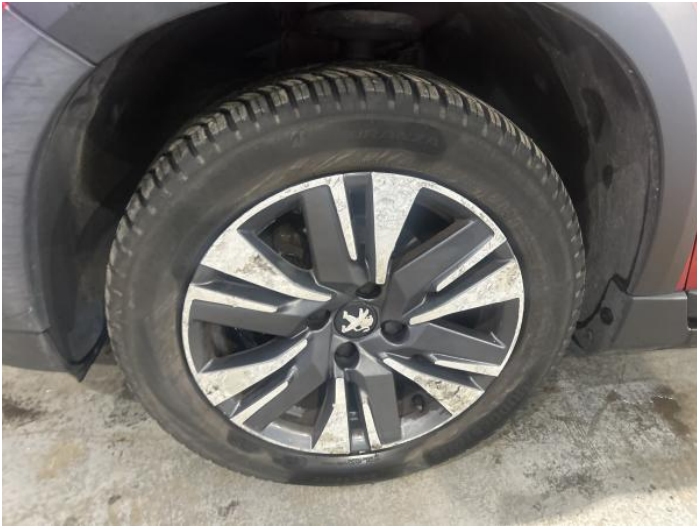
15: Wheel nsf  
Corroded  
Light

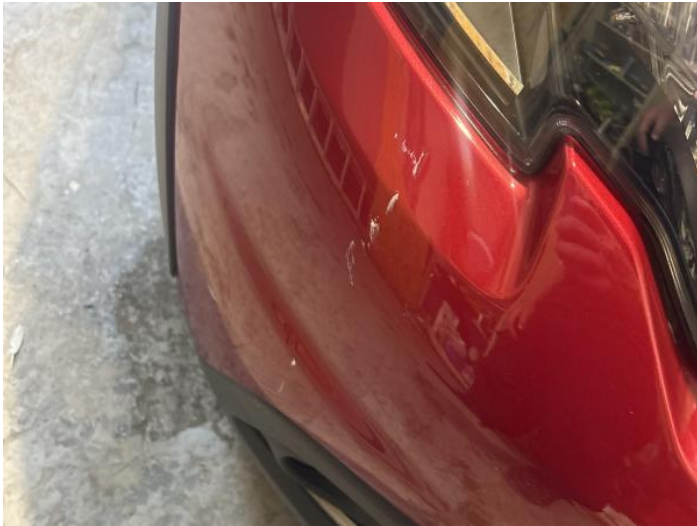
16: Bumper Front  
Scratched  
25 to 100mm Thru Paint

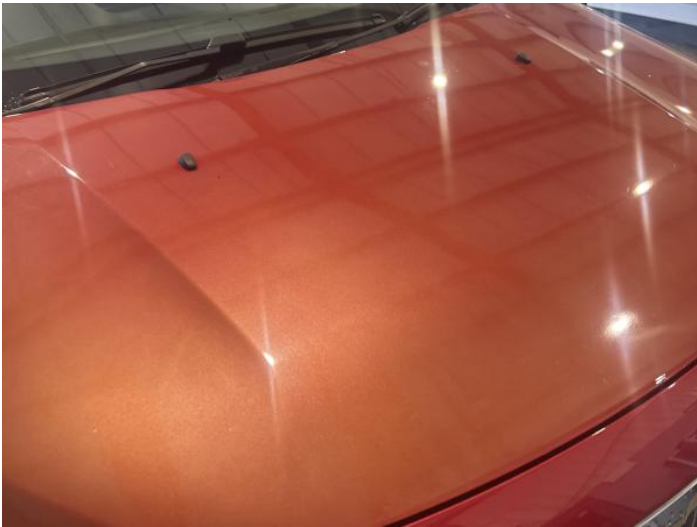
17: Bonnet  
Poor Previous Repair  
Poor Colour

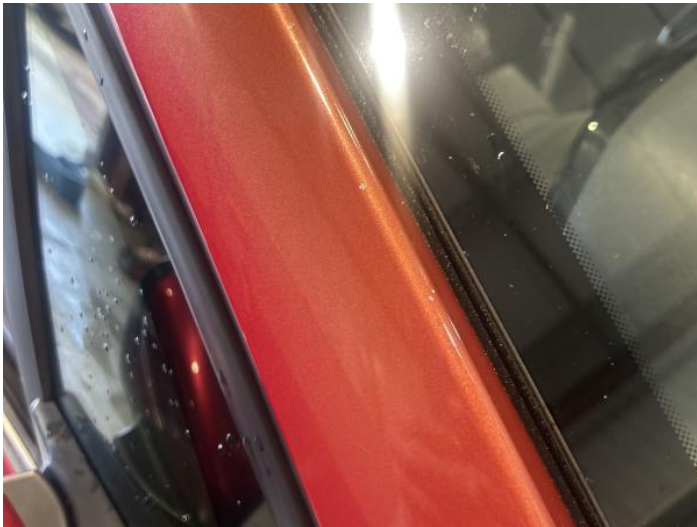
18: A Post os  
Chipped  
1 To 5
