# VEHICLE INSPECTION REPORT

**GY66NFM**

## Renault Clio 0.9 TCE 90 Dynamique Nav 5dr

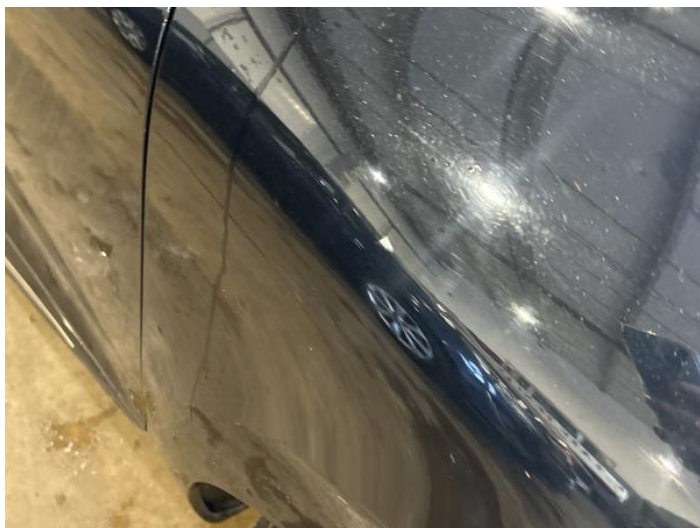
1: Wing osf  
Chipped  
1 To 5

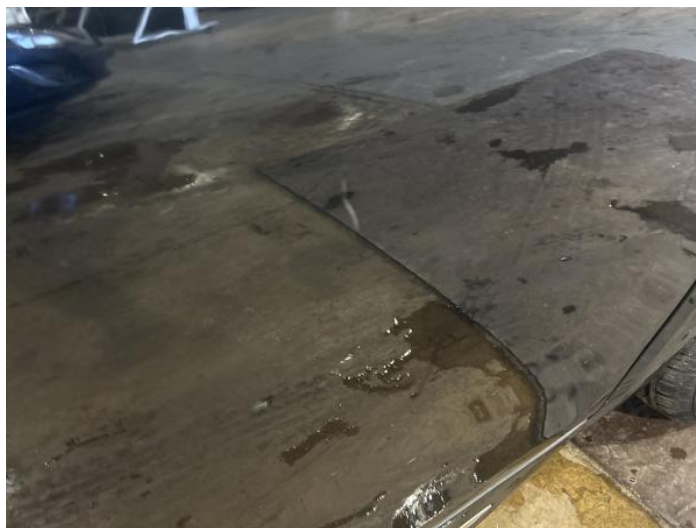
2: Door osf  
Scratched  
UpTo 25mm Thru Paint

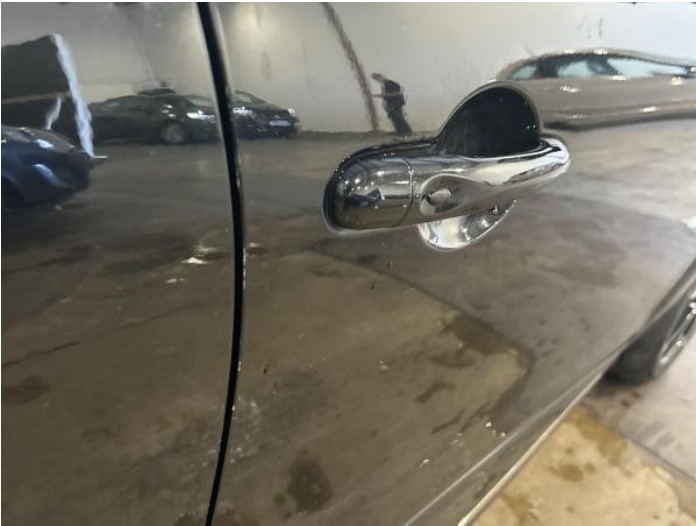
3: Door osf  
Chipped  
Edge Chip

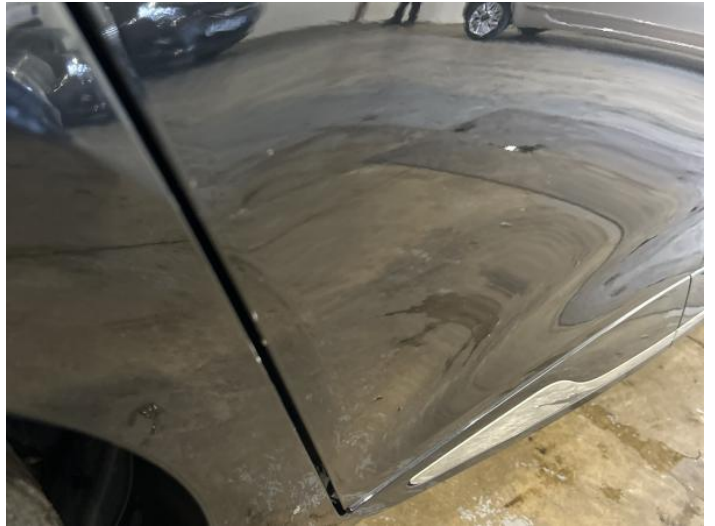
4: Door osr  
Chipped  
Edge Chip

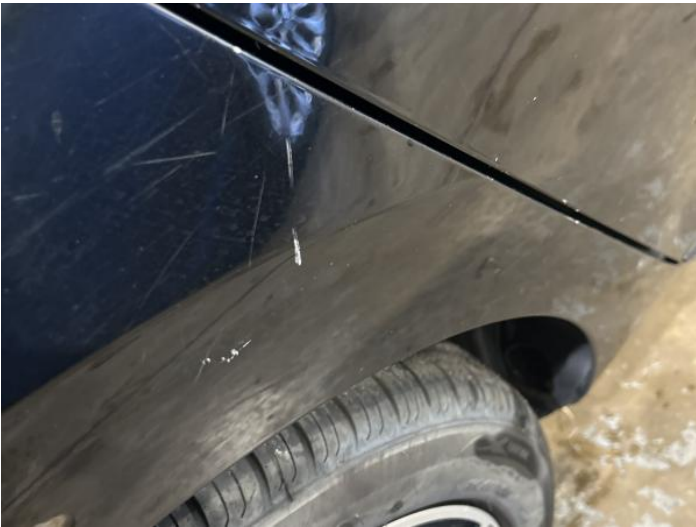
5: Qtr Panel osr  
Chipped  
1 To 5

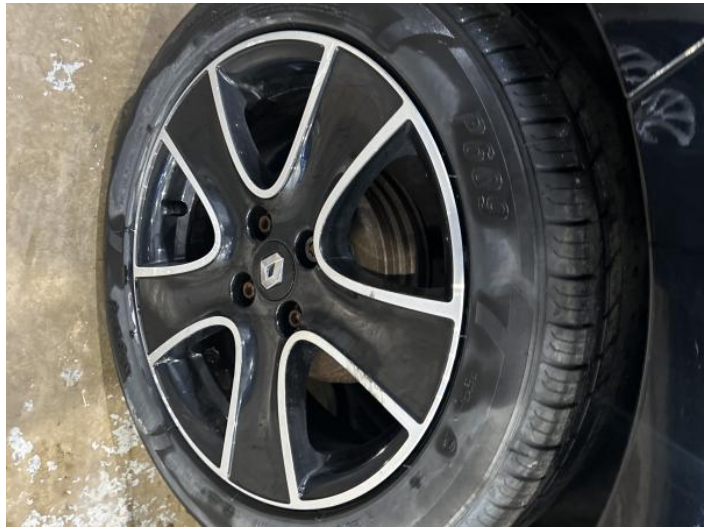
6: Wheel osr  
Corroded  
Light

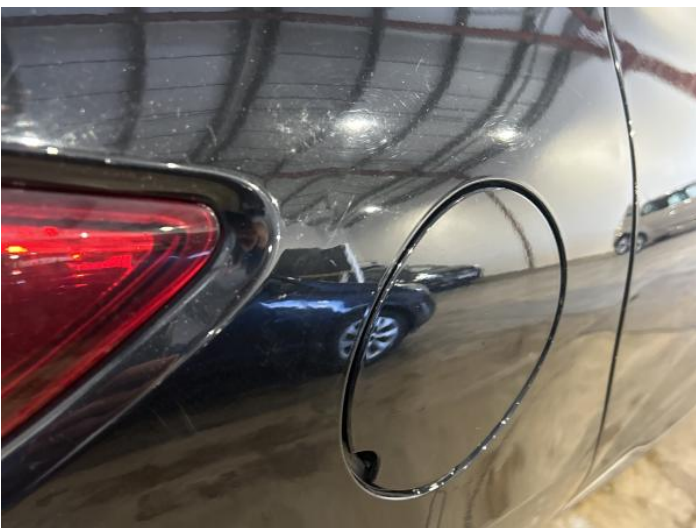
7: Qtr Panel osr  
Dented  
Between 10mm + 30mm

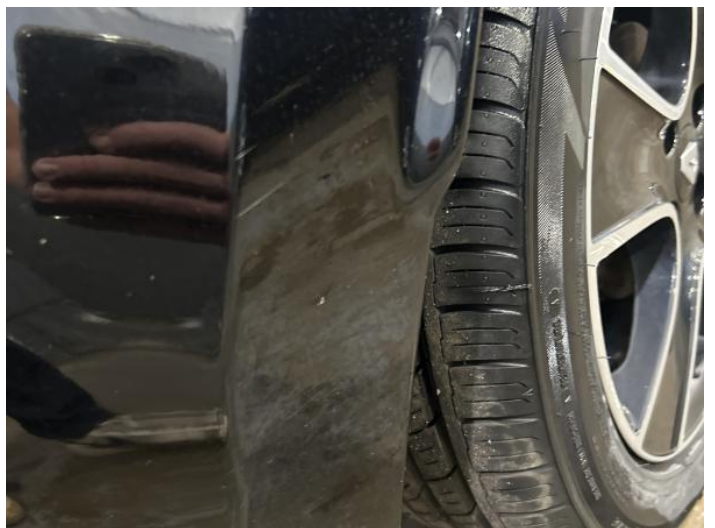
8: Bumper Rear  
Scratched  
Up To 25mm Thru Paint

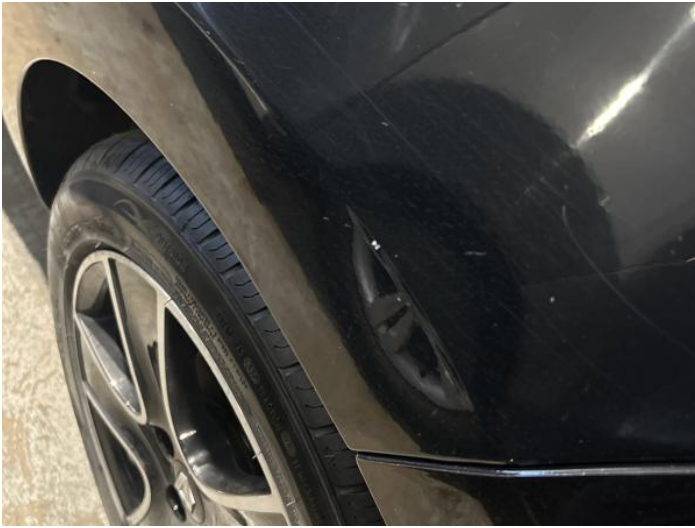
9: Qtr Panel nsr  
Chipped  
1 To 5

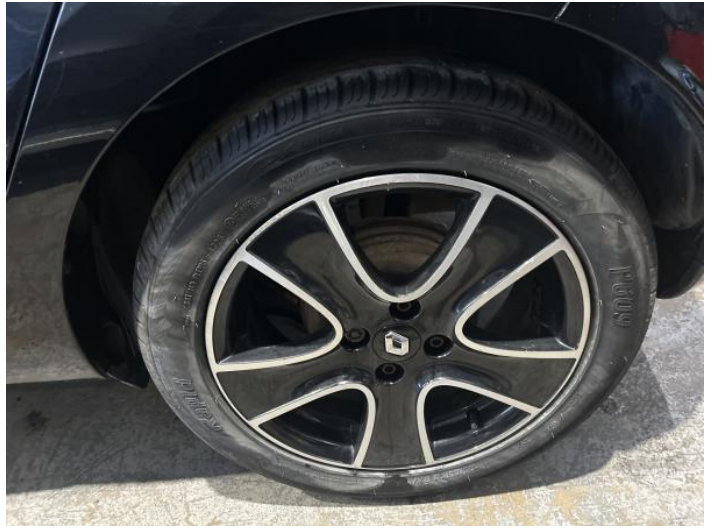
10: Wheel nsr  
Scratched  
Over 50mm

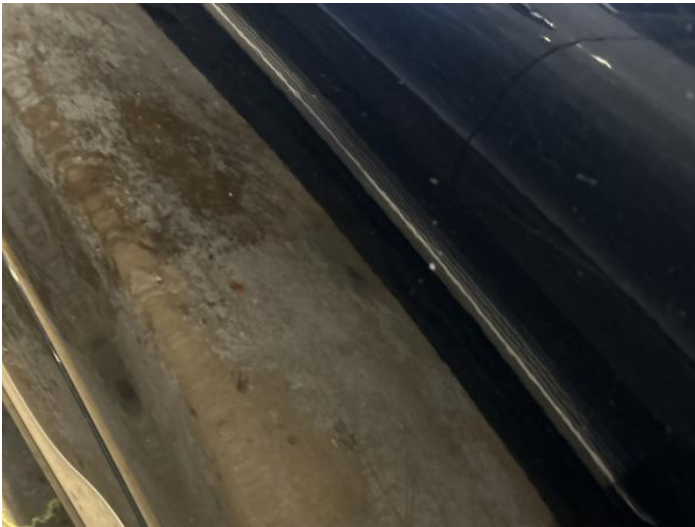
11: Door nsr  
Chipped  
1 To 5

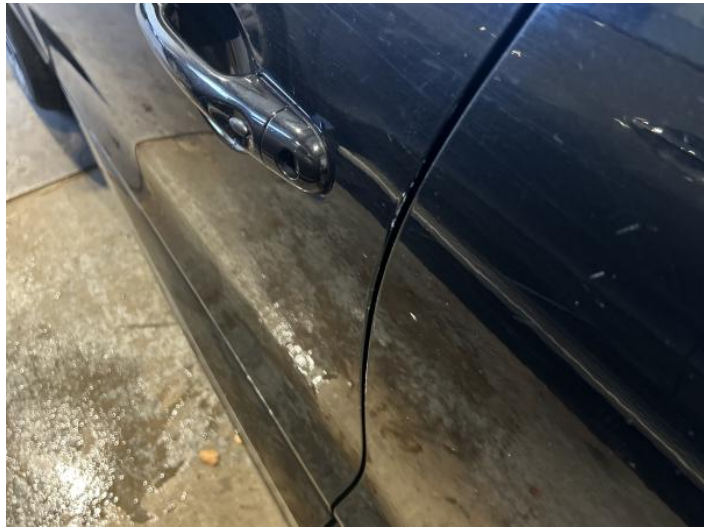
12: Door nsf  
Chipped  
Edge Chip

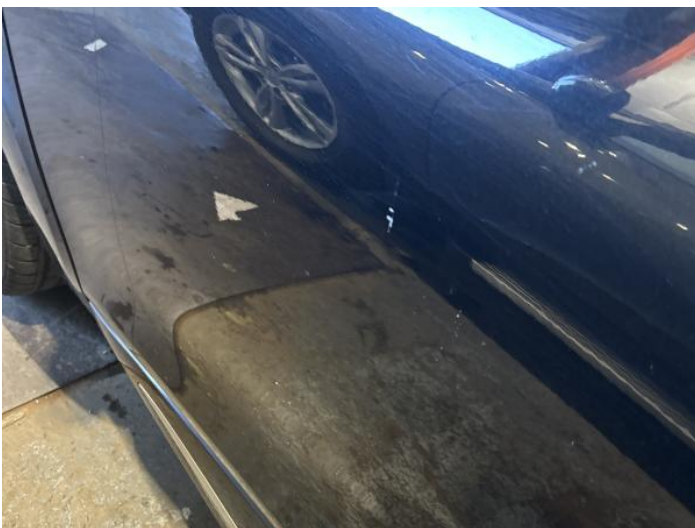
13: Door nsf  
Chipped  
1 To 5

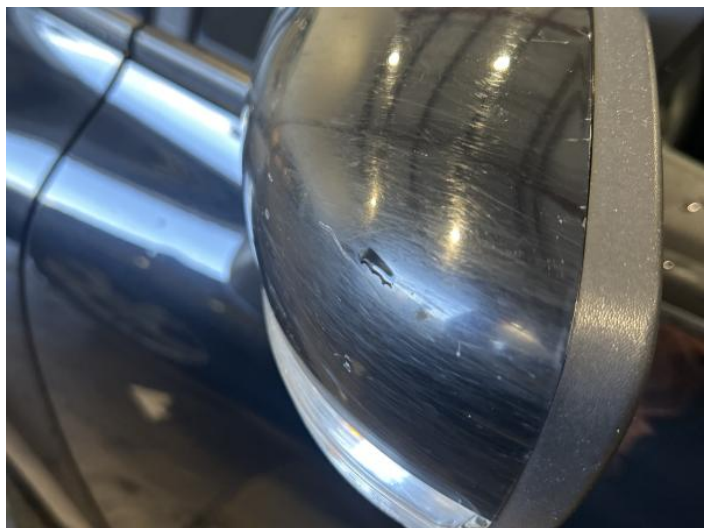
14: Door Mirror Assy nsf  
Scratched (Painted)  
UpTo 25mm Thru Paint

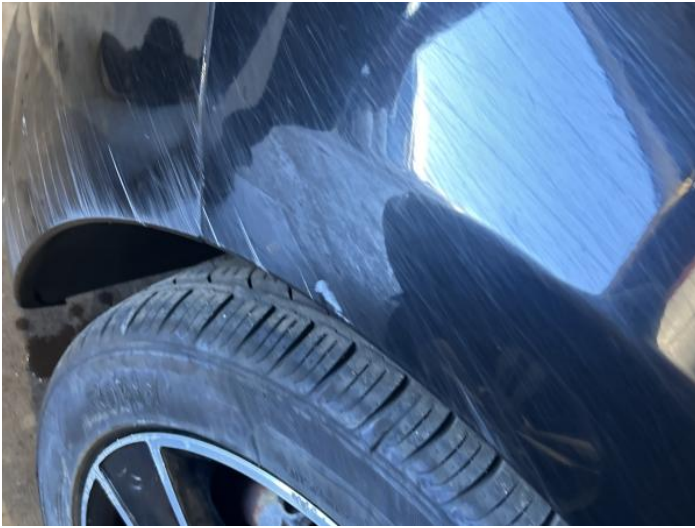
15: Wing nsf  
Scratched  
Over 25mm Thru Paint

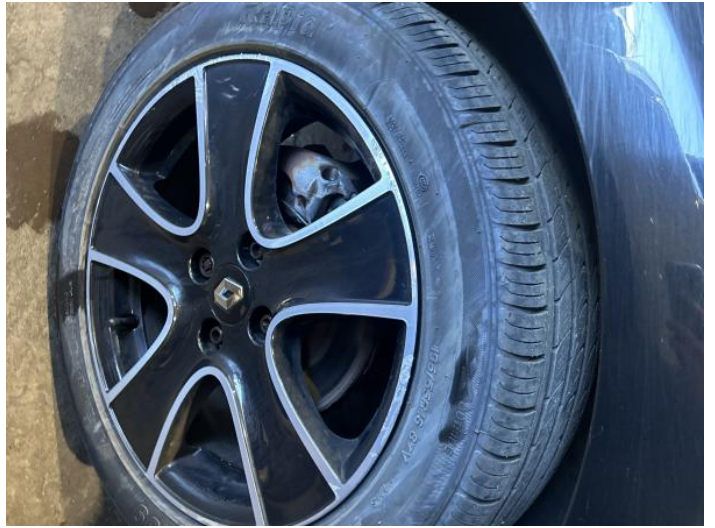
16: Wheel nsf  
Scratched  
Over 50mm

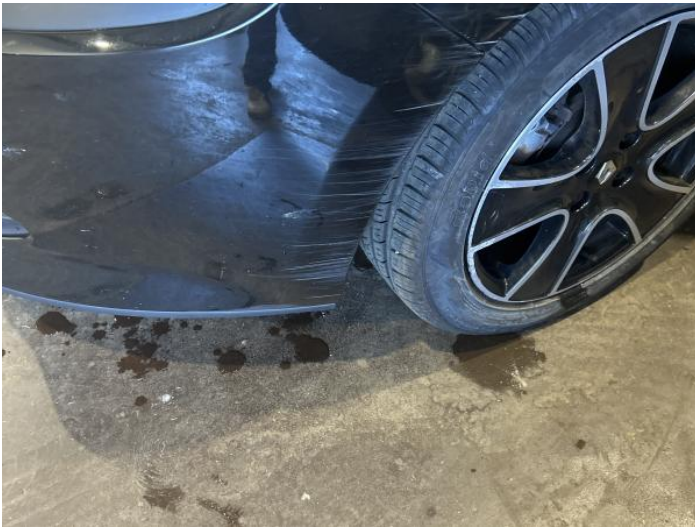
17: Bumper Front  
Scratched  
25 to 100mm Thru Paint

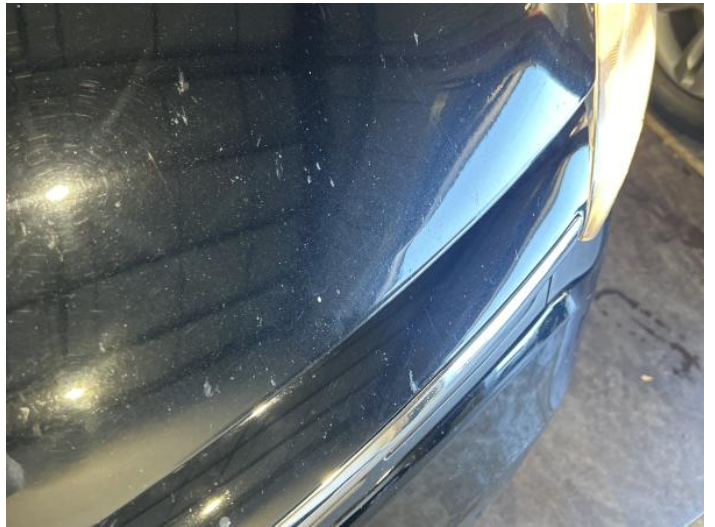
18: Bonnet  
Chipped  
1 To 5

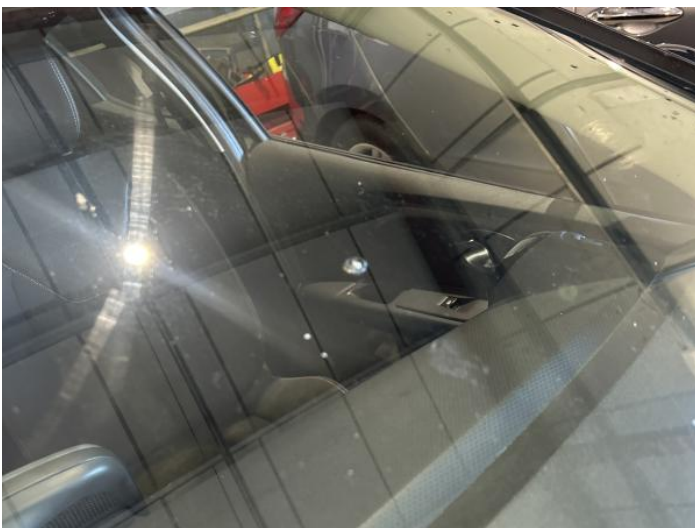
19: Screen Front  
Chipped  
UpTo 10mm

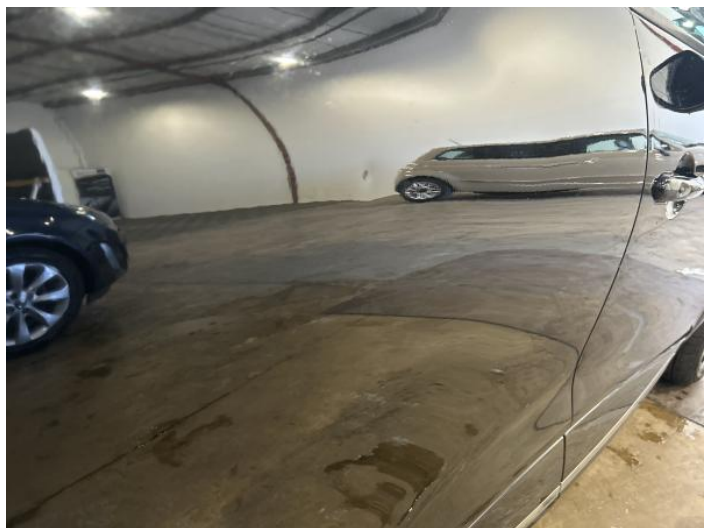
20: Door osr  
Dented  
2 Or Less UpTo 10mm

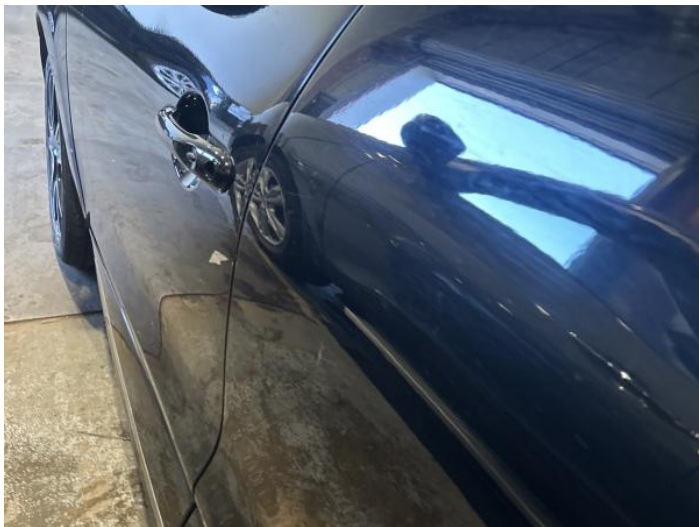
21: Door nsr  
Dented  
2 Or Less UpTo 10mm
