VEHICLE INSPECTION REPORT

GU15AHK

Skoda Fabia 1.2 TSI 90 SE 5dr

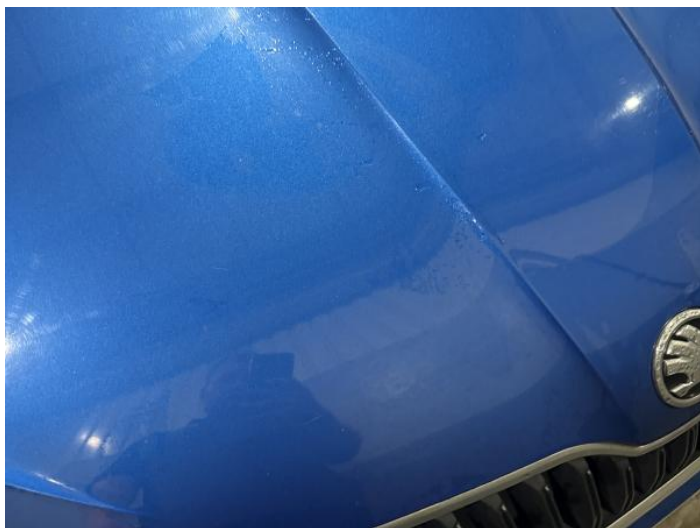
1: Bonnet
Chipped
1 To 5

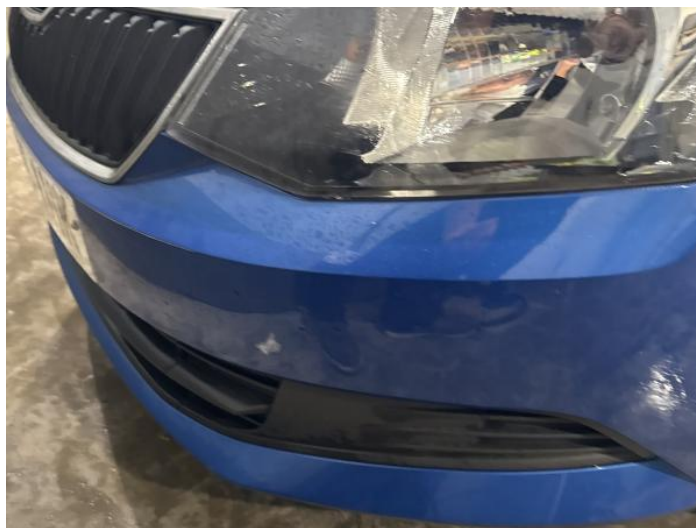
2: Bumper Front
Chipped
Multiple Chips

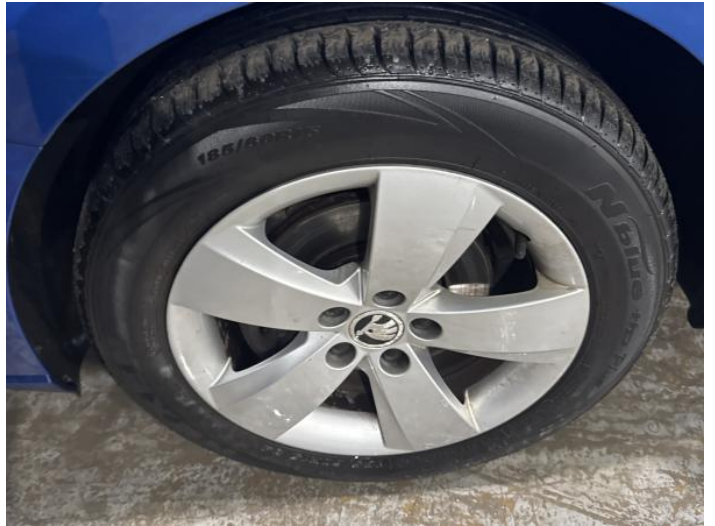
4: Wheel nsf
Scratched
Up To 50mm

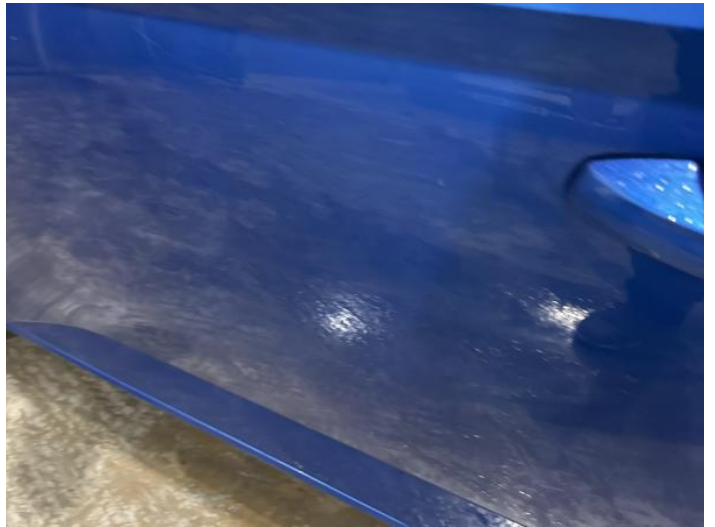
6: Door nsf
Chipped
1 To 5

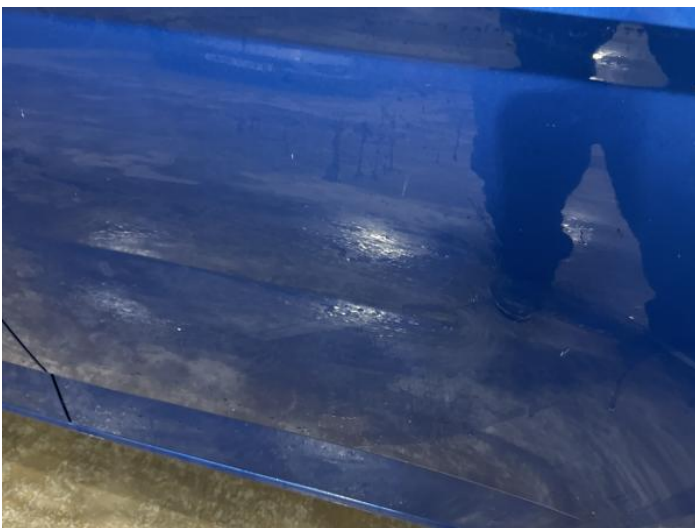
7: Door nsr
Dented
Over 30mm

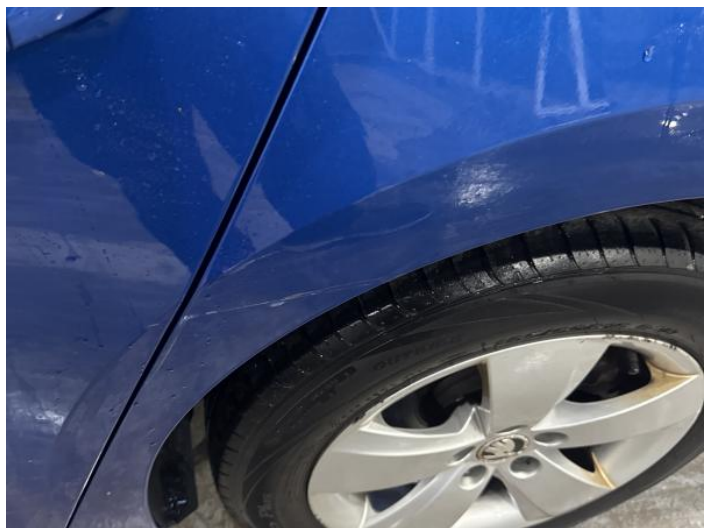
8: Qtr Panel nsr
Scratched
Over 25mm Thru Paint

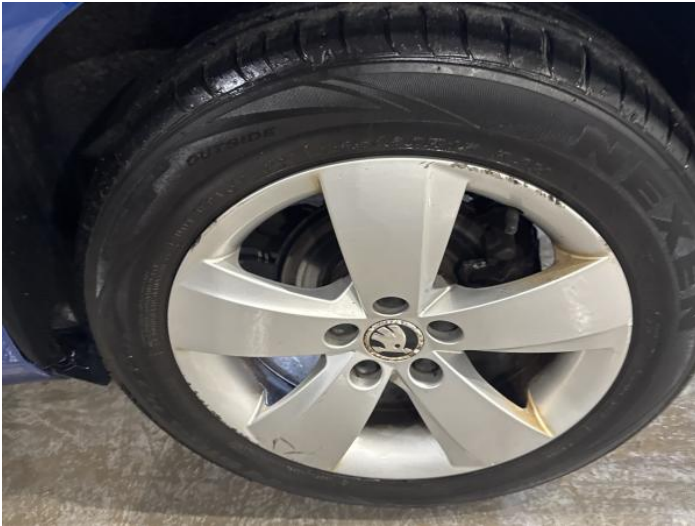
9: Wheel nsr
Scratched
Over 50mm

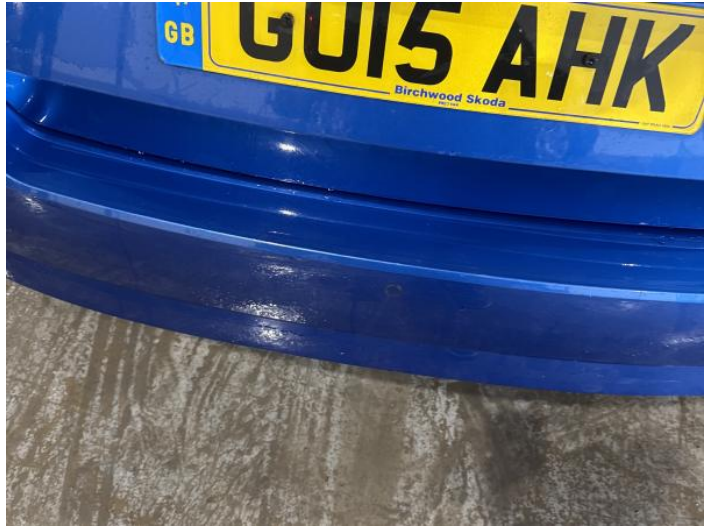
10: Bumper Rear
Chipped
Multiple Chips

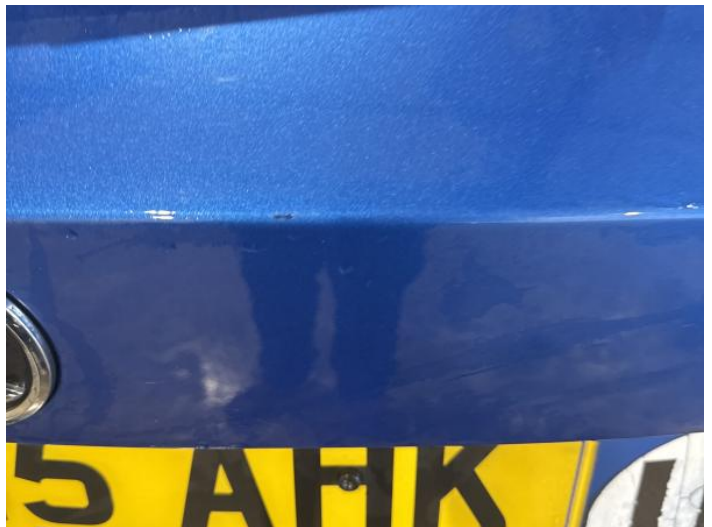
12: Boot Lid
Chipped
1 To 5

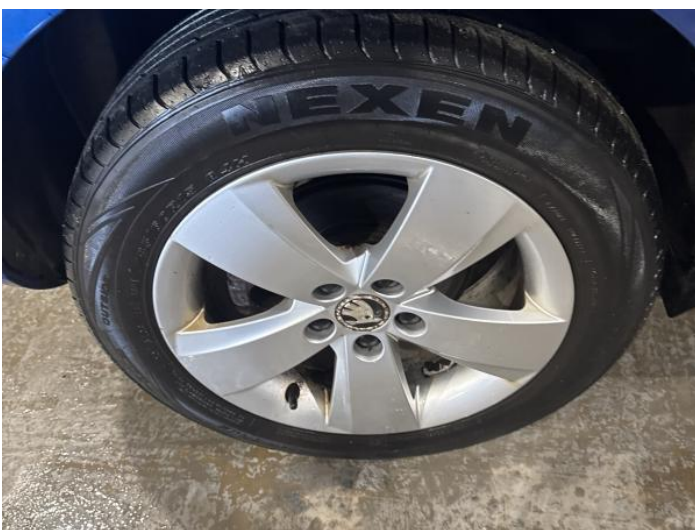
13: Wheel osr
Scratched
Up To 50mm

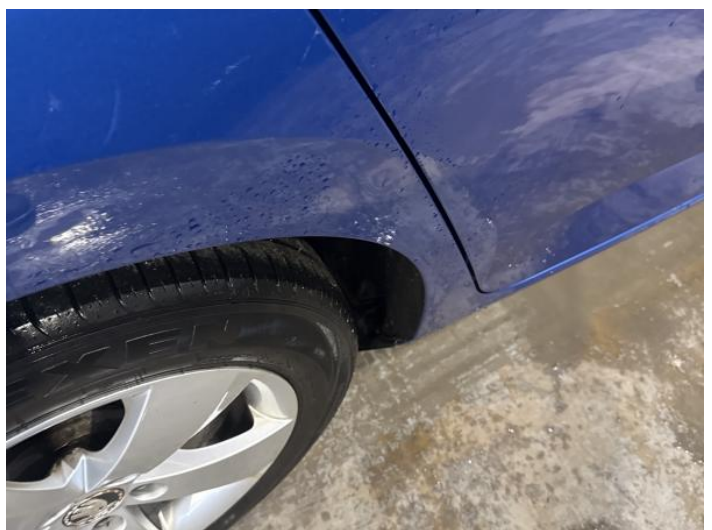
14: Qtr Panel osr
Dented
2 Or Less UpTo 10mm

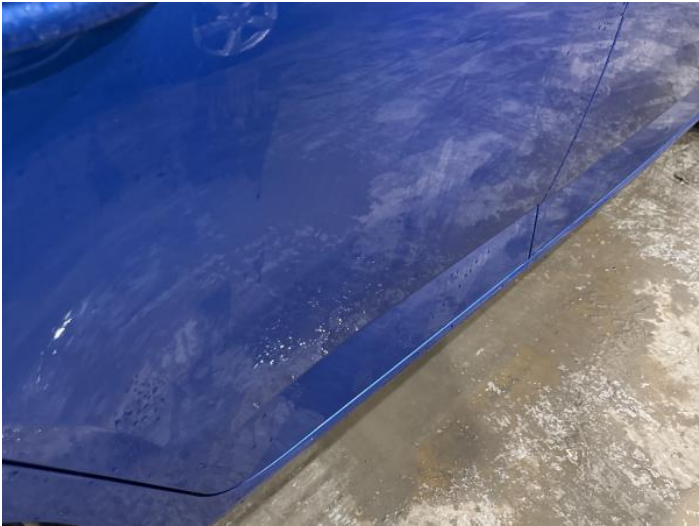
15: Door osr
Scratched
Over 25mm Not Thru Paint

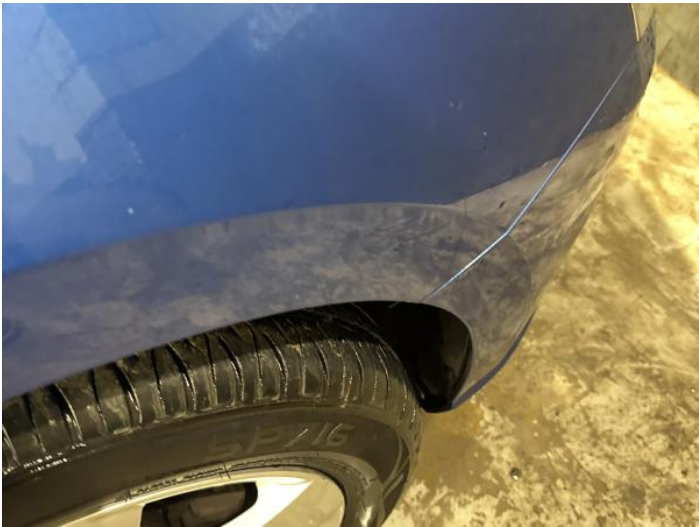
17: Wing osf
Chipped
1 To 5

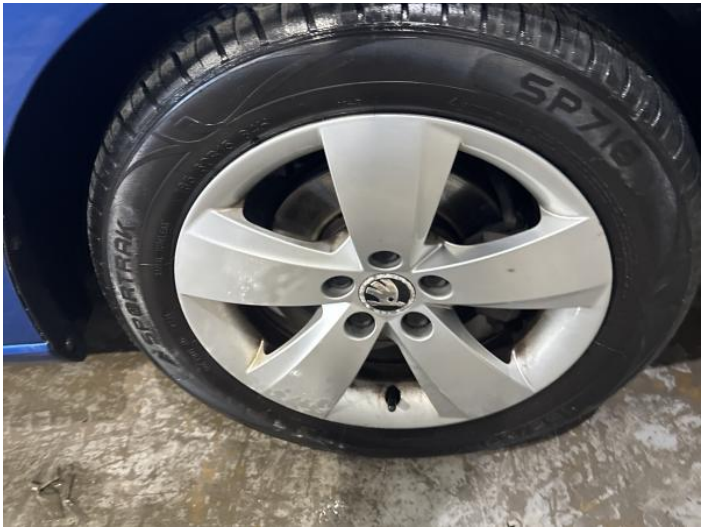
18: Wheel osf
Scratched
Up To 50mm
