VEHICLE INSPECTION REPORT

PN64ZZT

Nissan Qashqai 1.5 dCi Acenta Premium 5dr

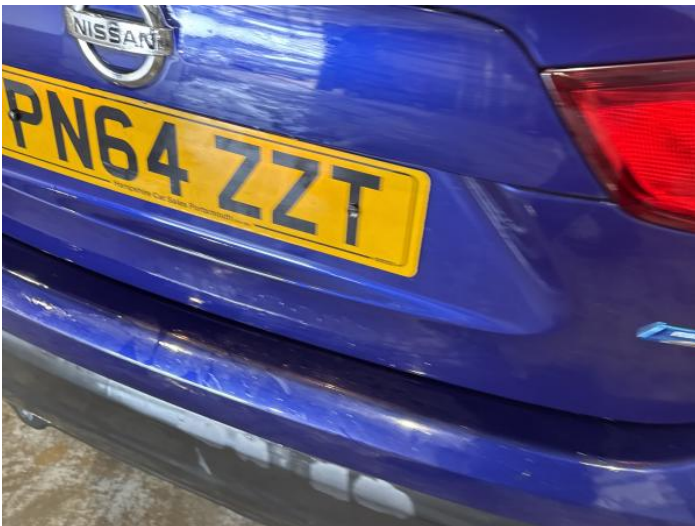
1: Bumper Rear
Scratched
25 to 100mm Thru Paint

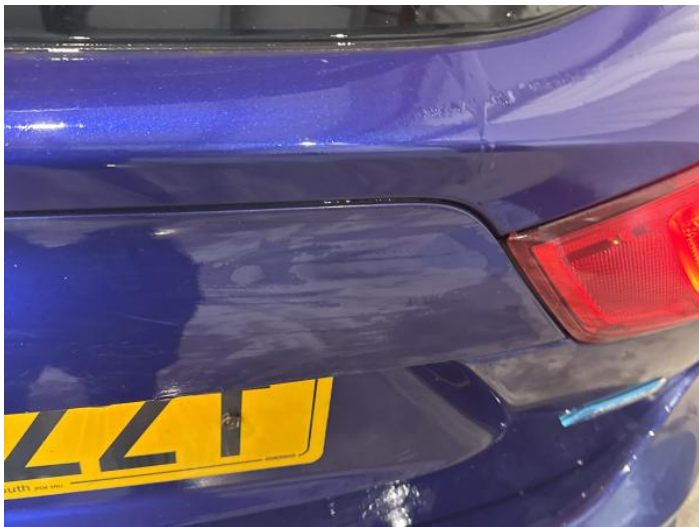
3: Boot Lid
Chipped
1 To 5

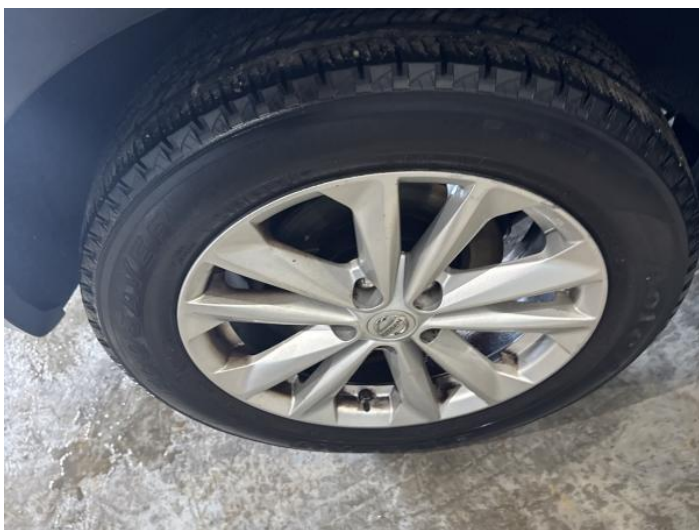
5: Wheel osr
Scratched
Over 50mm

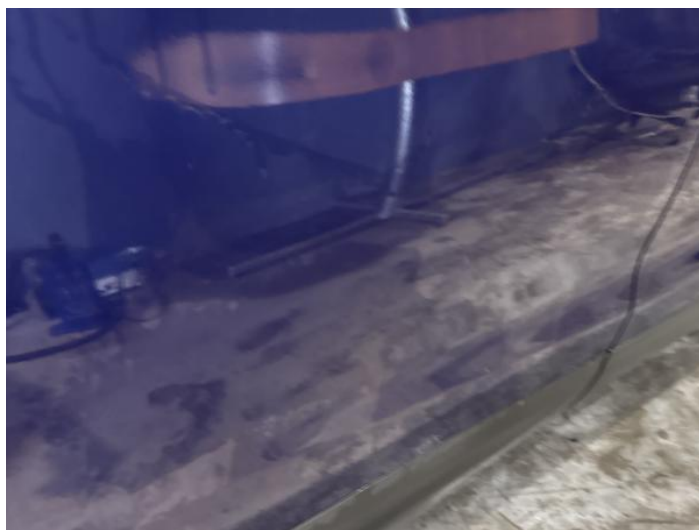
6: Door osr
Chipped
1 To 5

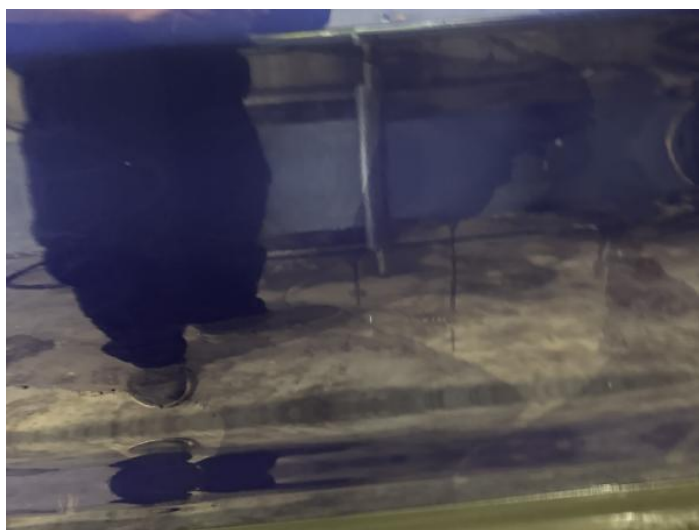
8: Door osf
Chipped
Multiple Chips

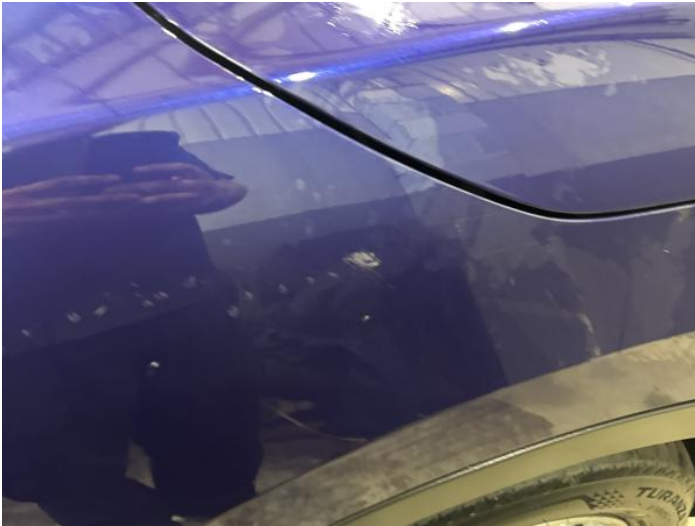
9: Wing osf
Chipped
1 To 5

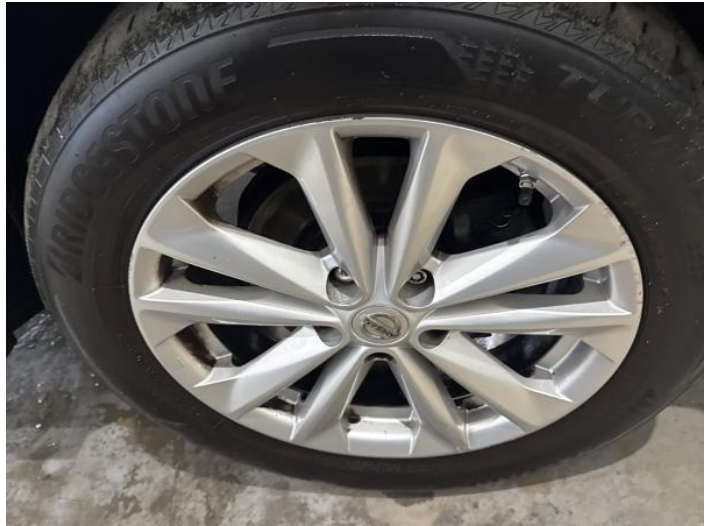
10: Wheel osf
Scratched
Over 50mm

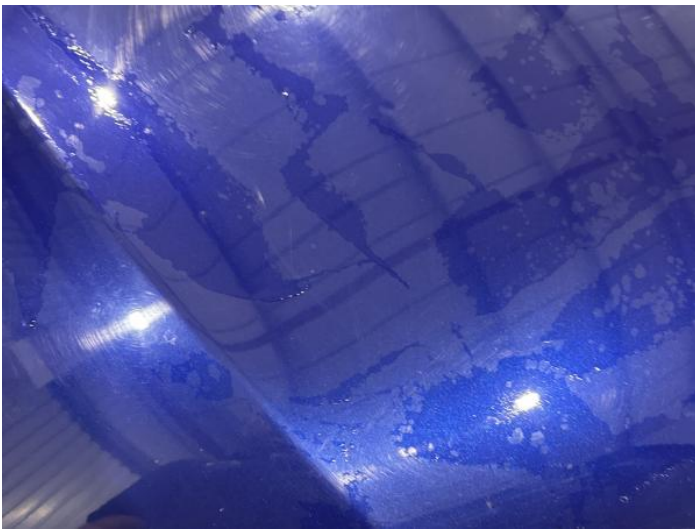
11: Bonnet
Chipped
1 To 5

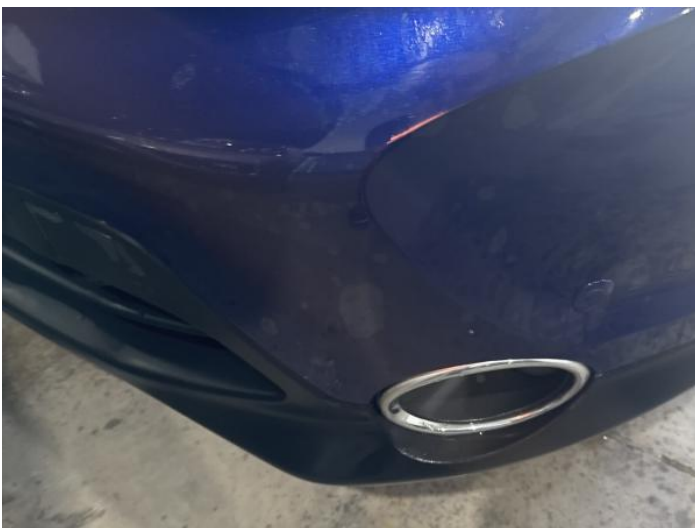
13: Bumper Front
Chipped
Multiple Chips

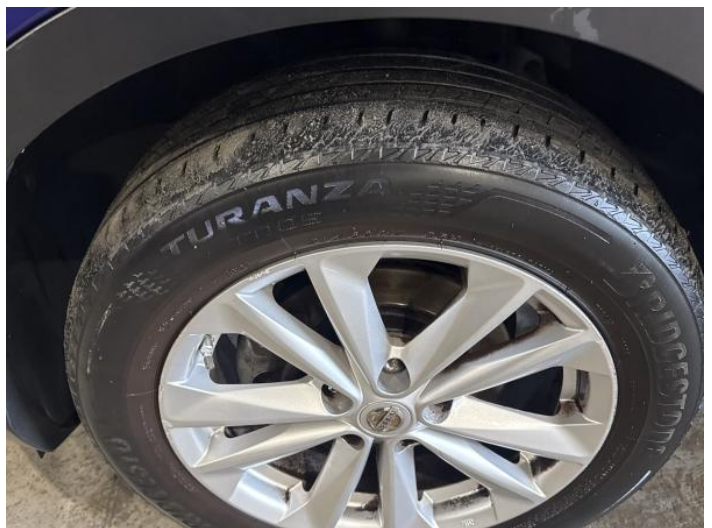
14: Wheel nsf
Scratched
Over 50mm

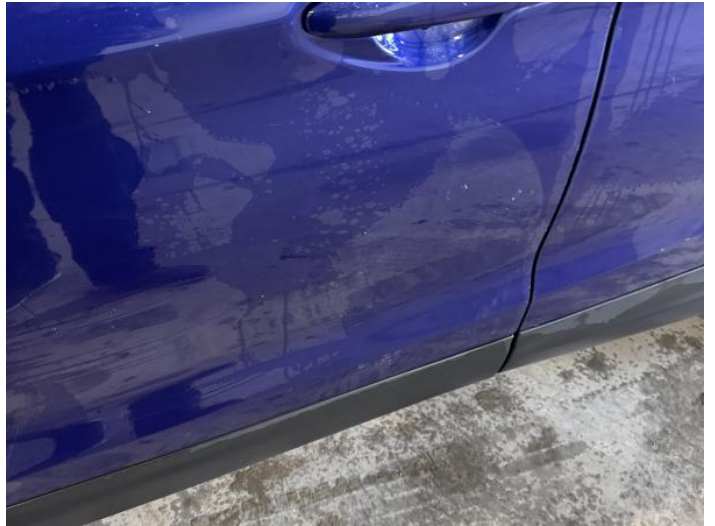
15: Wing nsf
Scratched
Over 25mm Not Thru Paint

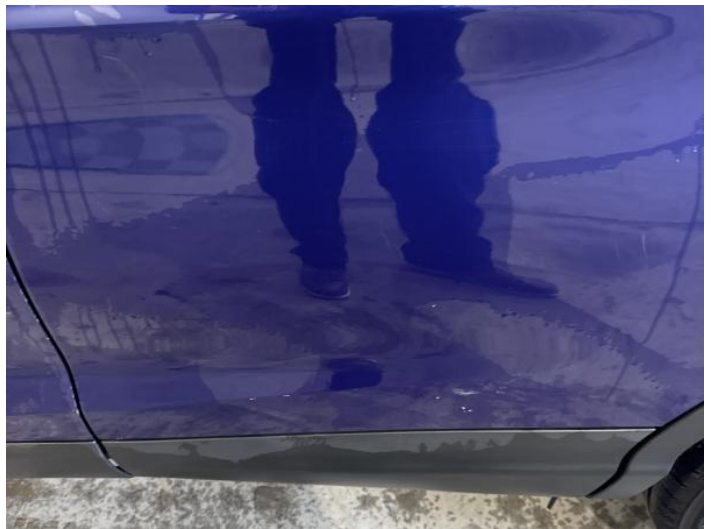
17: Door nsf
Scratched
Over 25mm Not Thru Paint

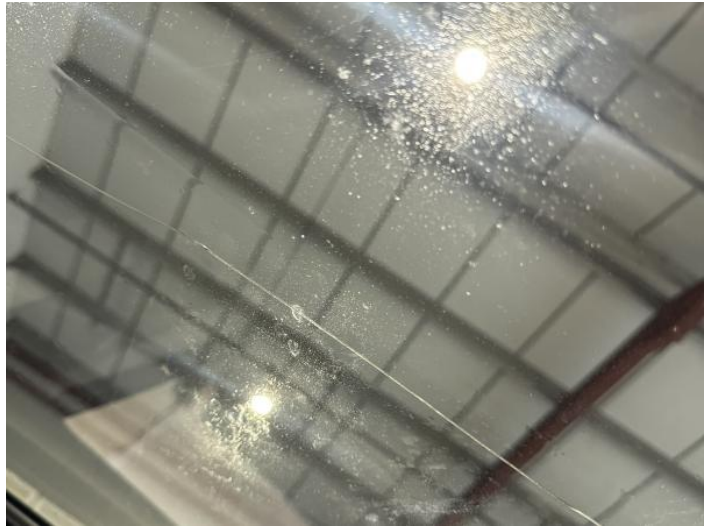
22: Glass Roof
Scratched
Over 30mm

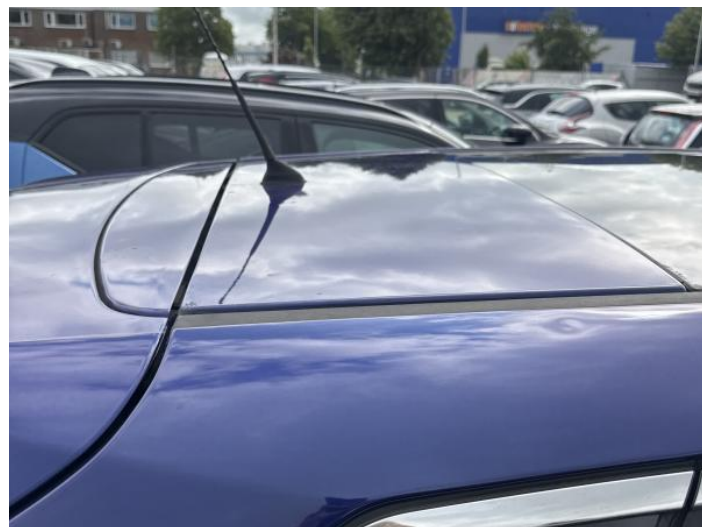
25: Roof
Dented
Hail - Moderate
