# VEHICLE INSPECTION REPORT

**GU10RVE**

## Toyota Verso 1.6 V-matic TR 5dr

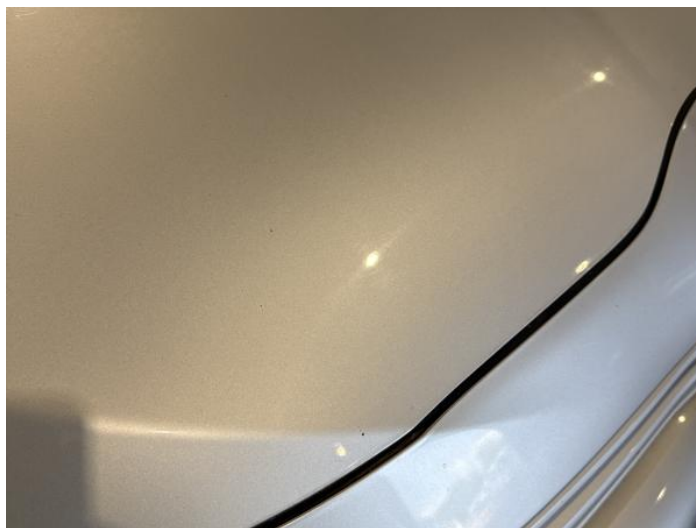
2: Bonnet  
Chipped  
1 To 5

1: Seat Base Cover of  
Torn  
Over 3mm

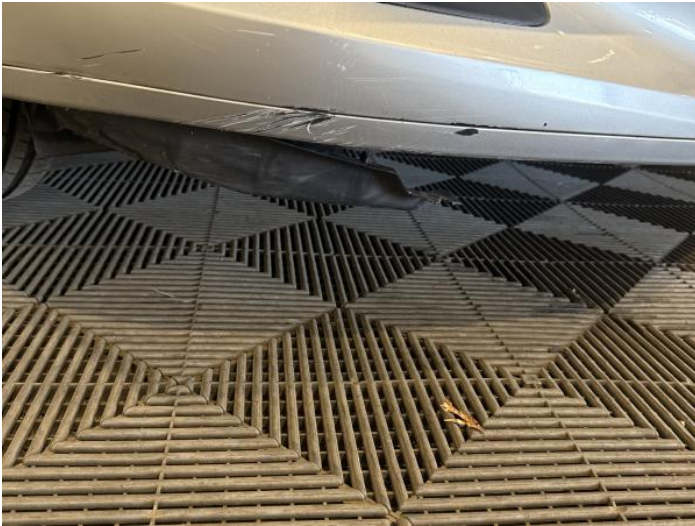
3: Bumper Front Moulding  
Broken  
Replace

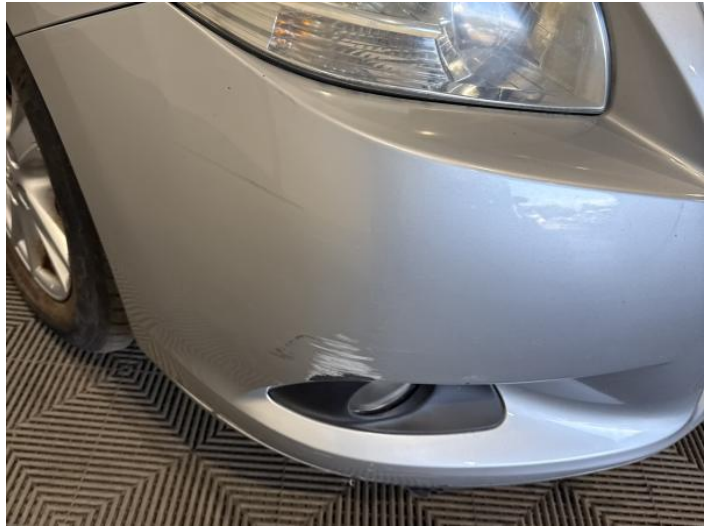
4: Bumper Front  
Scratched  
Over 100mm Thru Paint

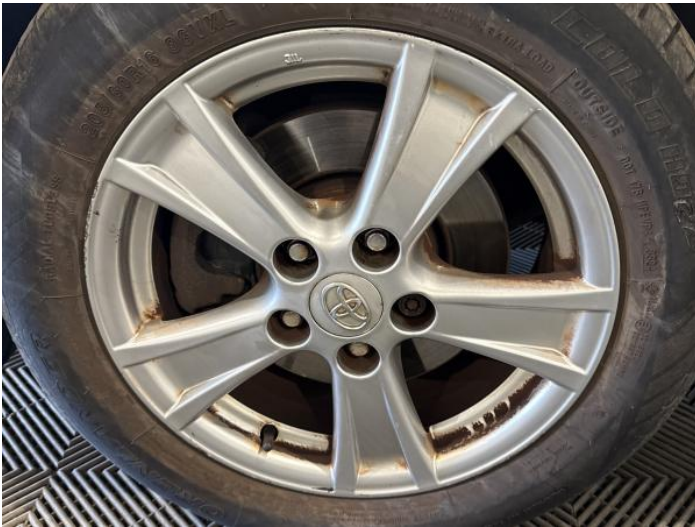
5: Wheel nsf  
Scratched  
Over 50mm

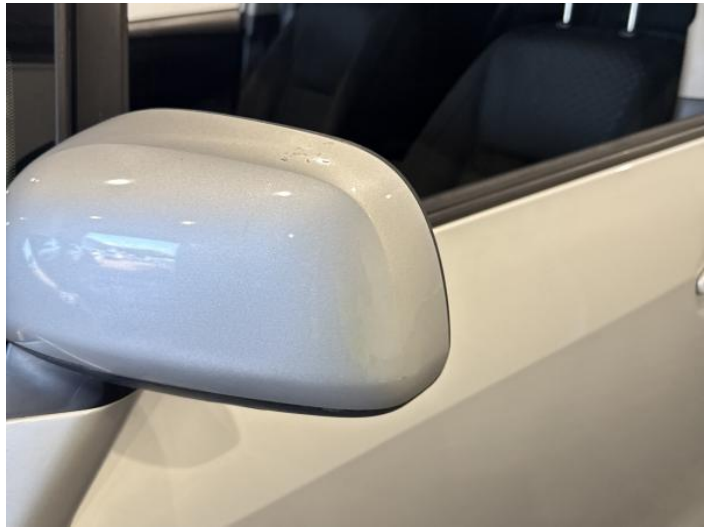
6: Door Mirror Assy nsf  
Scratched (Painted)  
UpTo 25mm Thru Paint

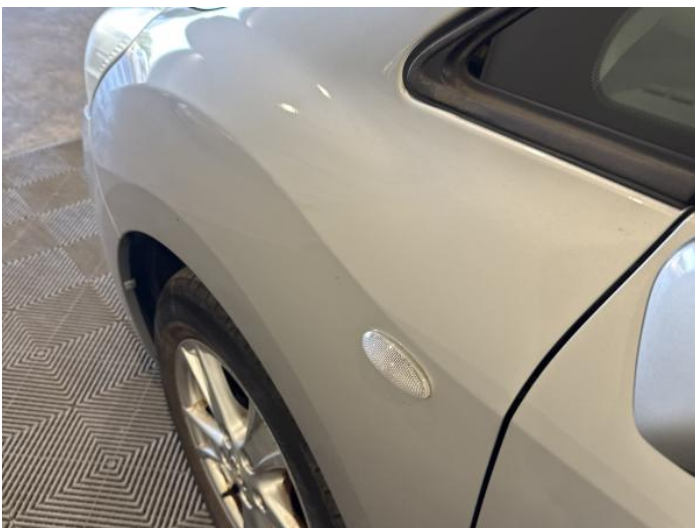
7: Wing nsf  
Poor Previous Repair  
Rippled UpTo 30%

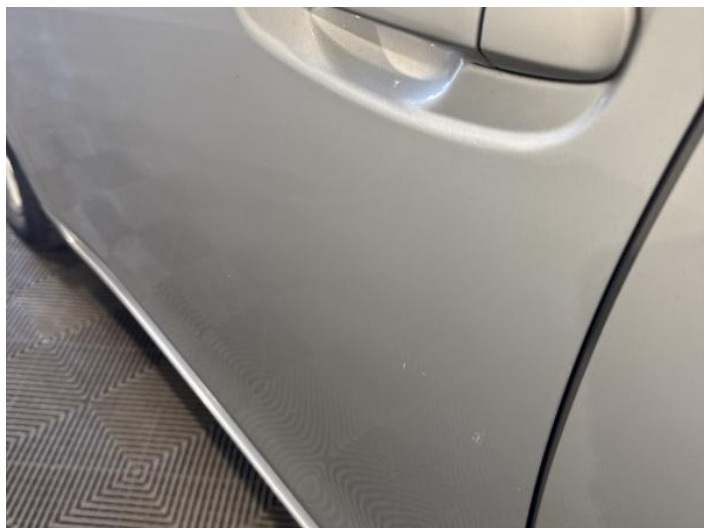
8: Door nsf  
Poor Previous Repair  
Poor Paint

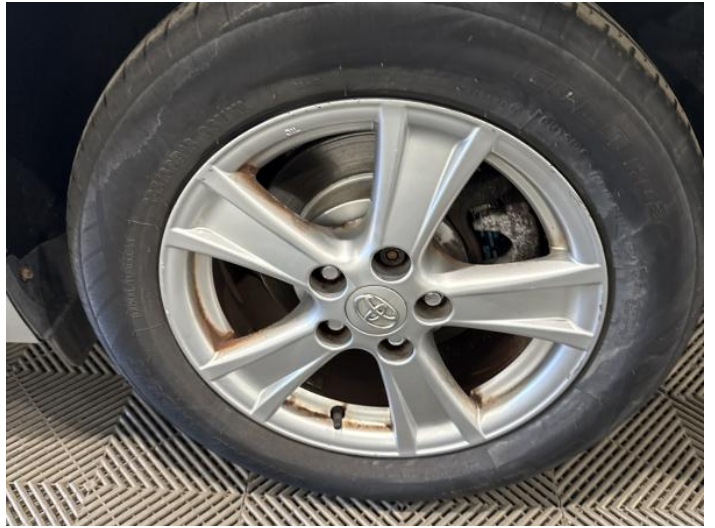
10: Wheel nsr  
Scratched  
Over 50mm

9: Door nsr  
Scratched  
UpTo 25mm Thru Paint

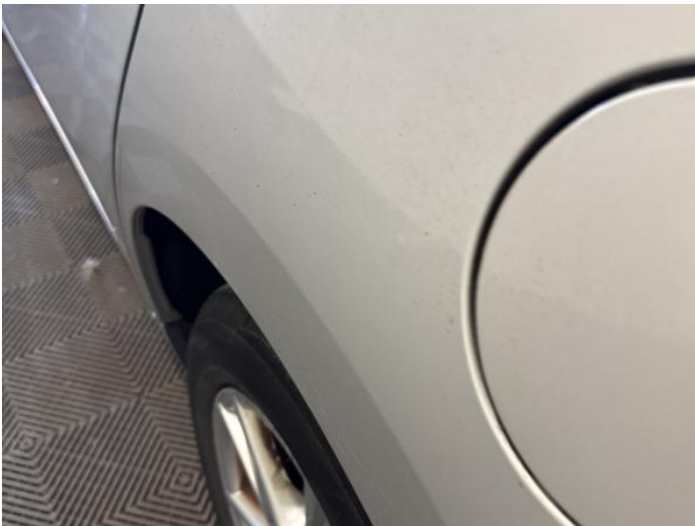
11: Qtr Panel nsr  
Dented  
Between 10mm + 30mm

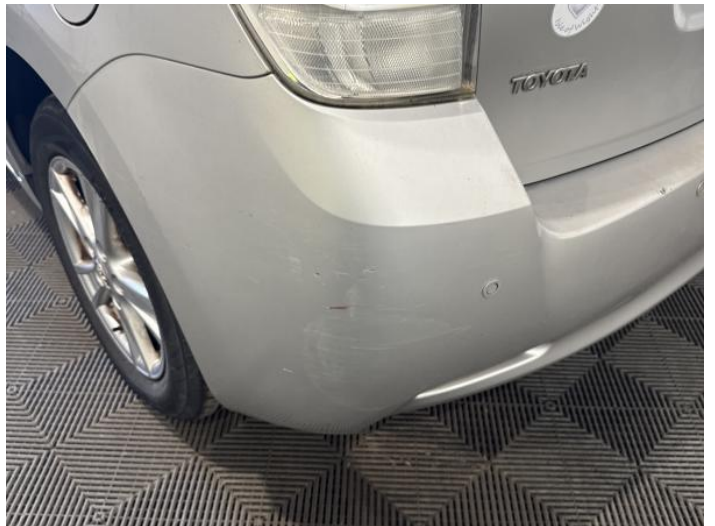
12: Bumper Rear  
Scratched  
Over 100mm Thru Paint

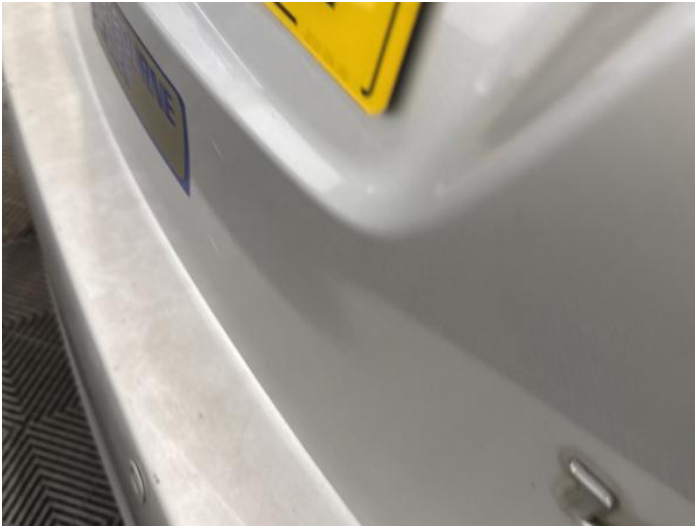
13: Tailgate  
Scratched  
UpTo 25mm Thru Paint

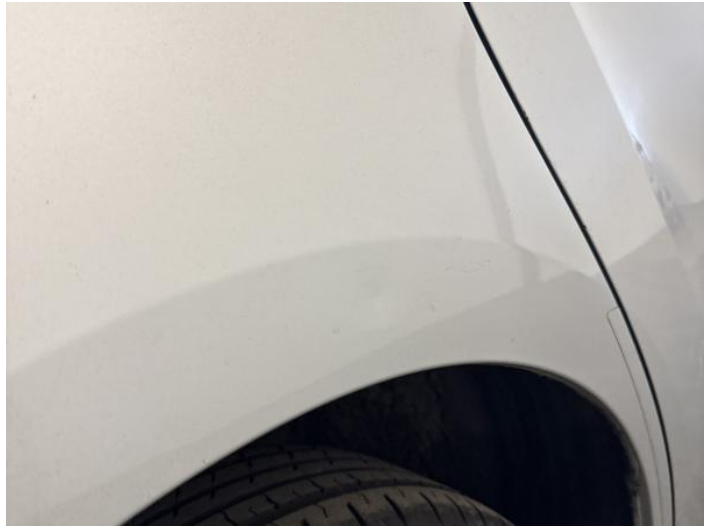
14: Qtr Panel osr  
Dented  
Between 10mm + 30mm

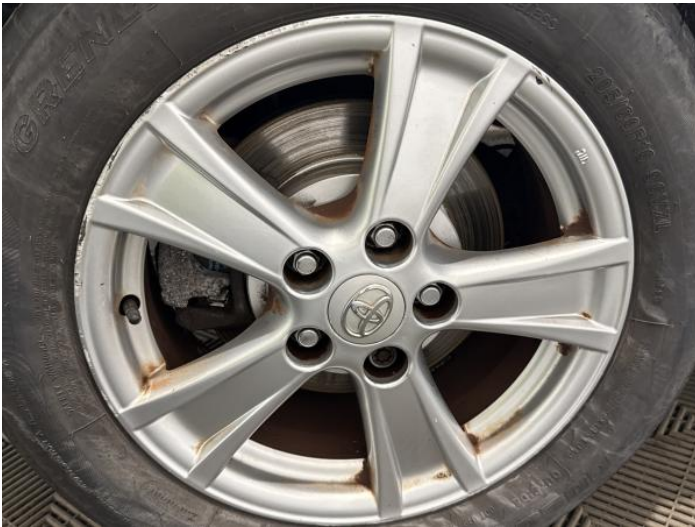
15: Wheel osr  
Scratched  
Over 50mm

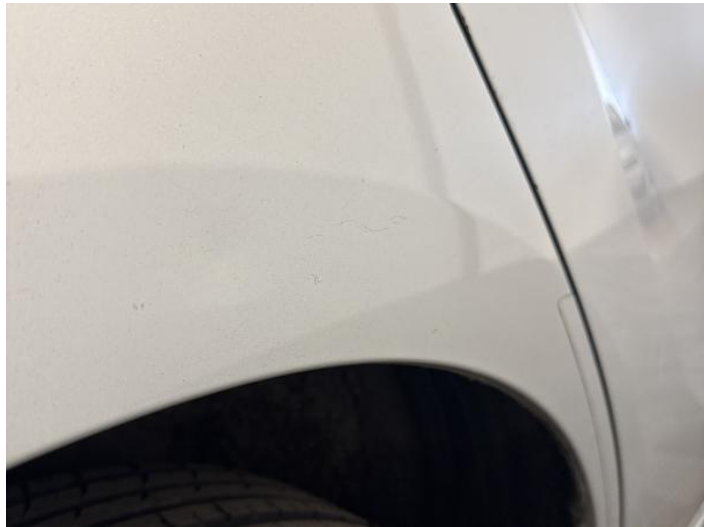
16: Qtr Panel osr  
Scratched  
UpTo 25mm Thru Paint

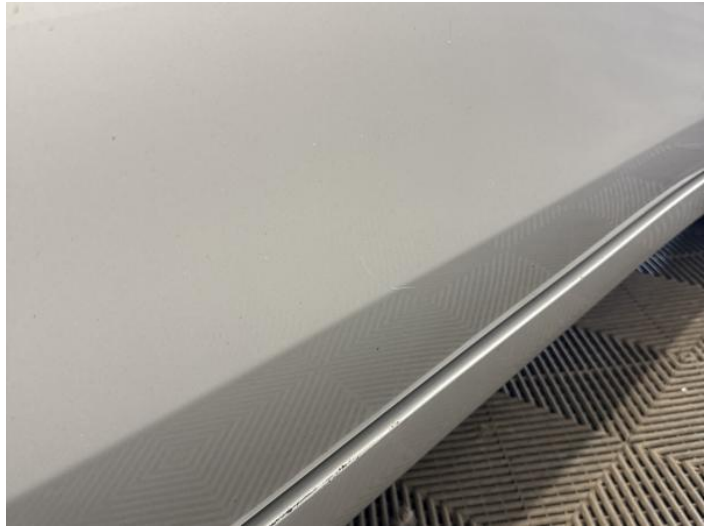
18: Door osf  
Scratched  
Over 25mm Thru Paint

17: Door osr  
Dented  
With Paint Damage

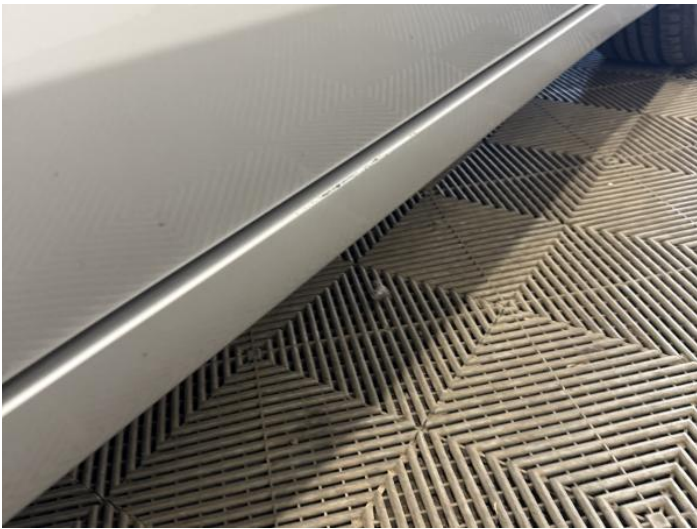
19: Sill Panel Trim os  
Scratched (Painted)  
Over 25mm Thru Paint

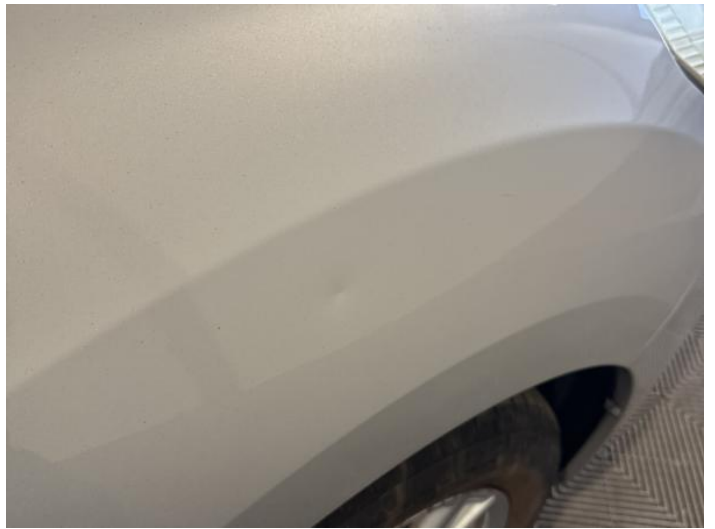
20: Wing osf  
Dented  
Between 10mm + 30mm

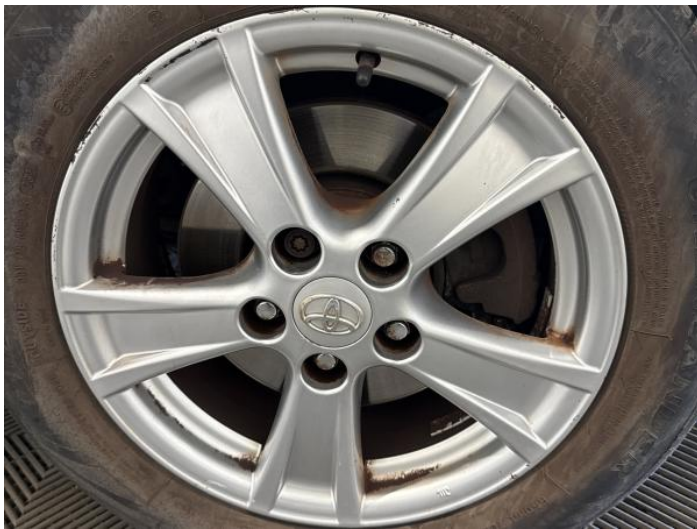
21: Wheel osf  
Scratched  
Up To 50mm

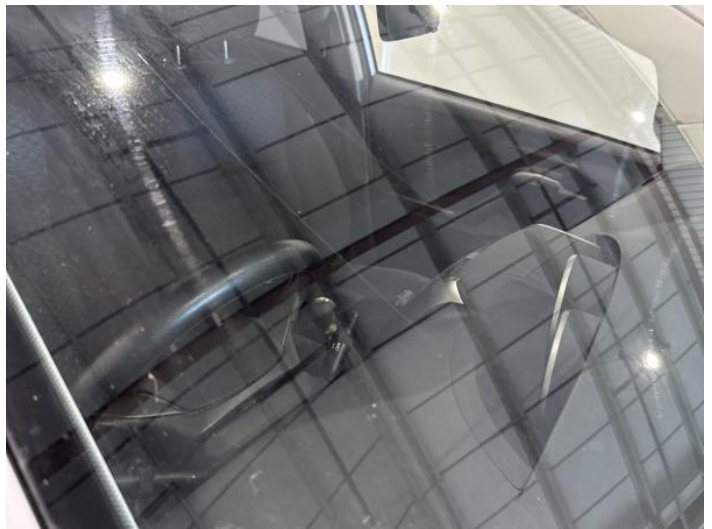
22: Screen Front  
Scratched  
Over 30mm
