# VEHICLE INSPECTION REPORT

**LS56PXN**

## BMW X3 2.0d SE 5dr

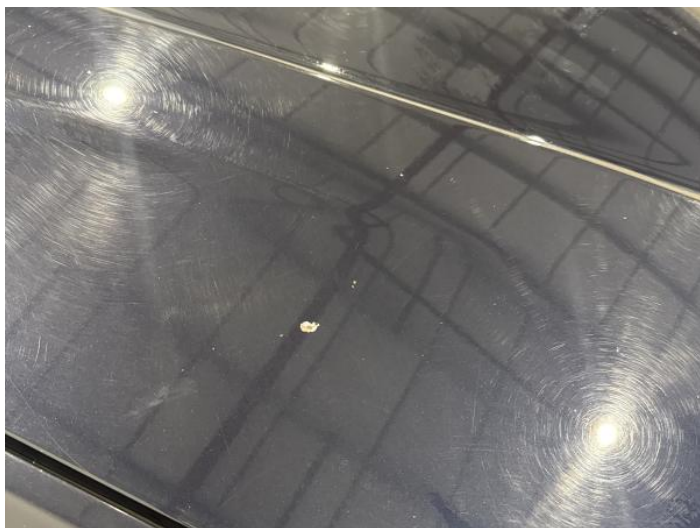
1: Bonnet  
Chipped  
Over 5mm

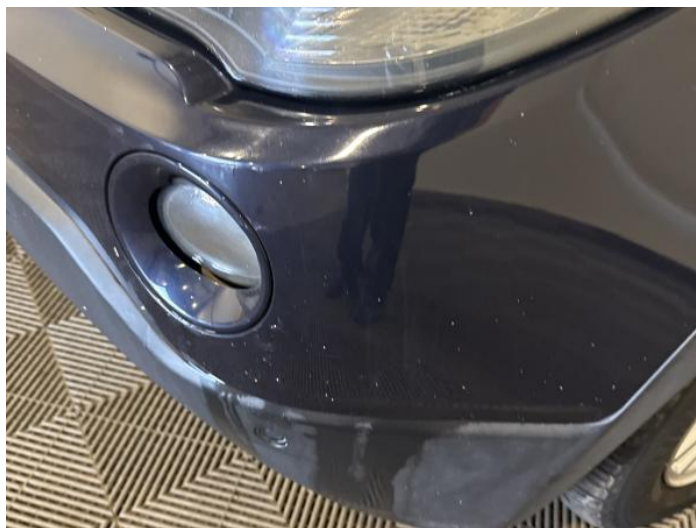
2: Bumper Front  
Chipped  
Multiple Chips

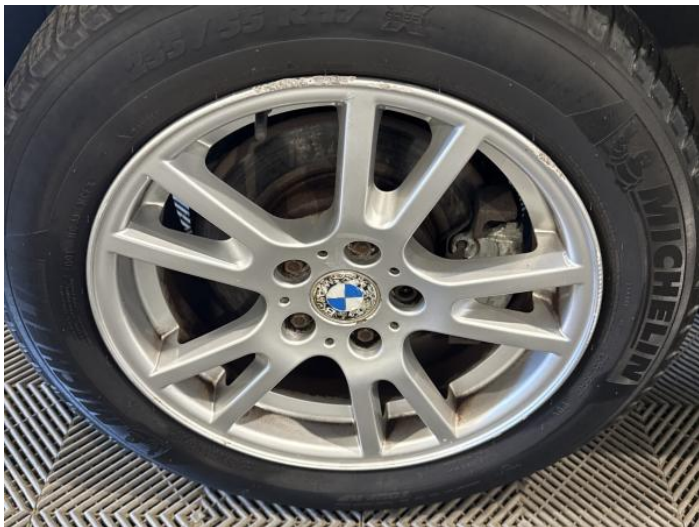
3: Wheel nsf  
Scratched  
Over 50mm

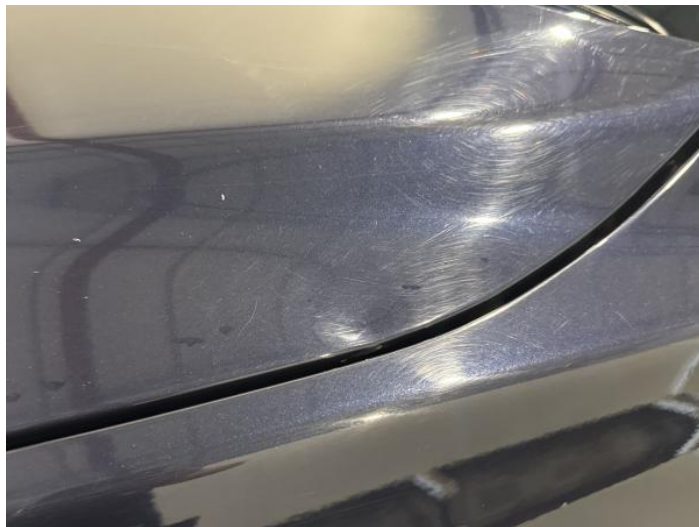
4: Bonnet  
Dented  
With Paint Damage

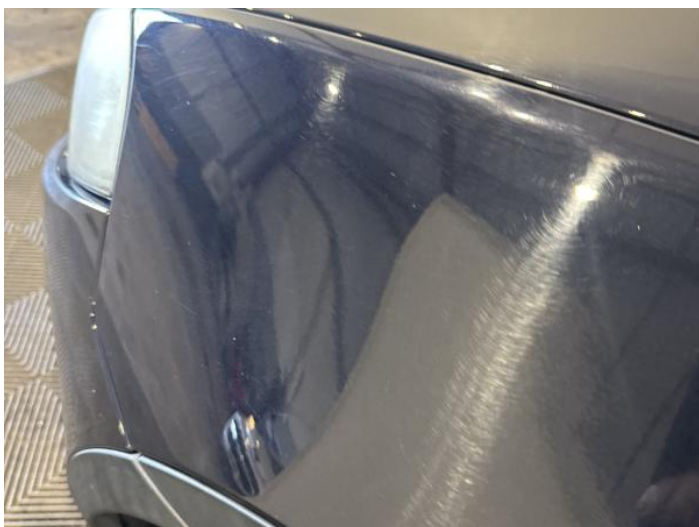
5: Wing nsf  
Chipped  
1 To 5

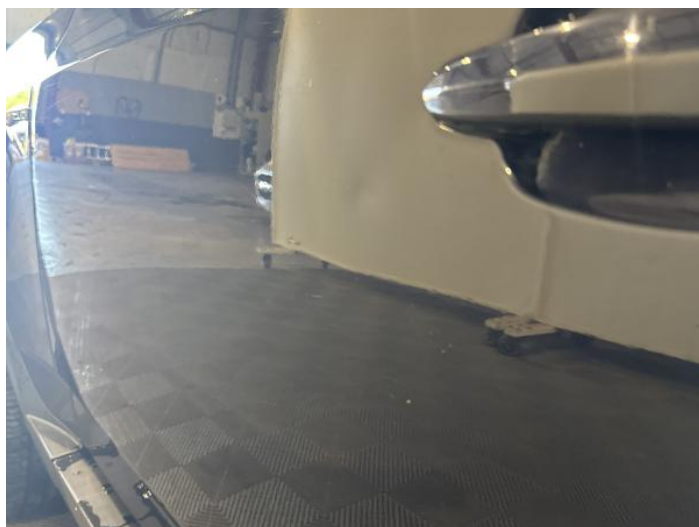
6: Door nsf  
Dented  
With Paint Damage

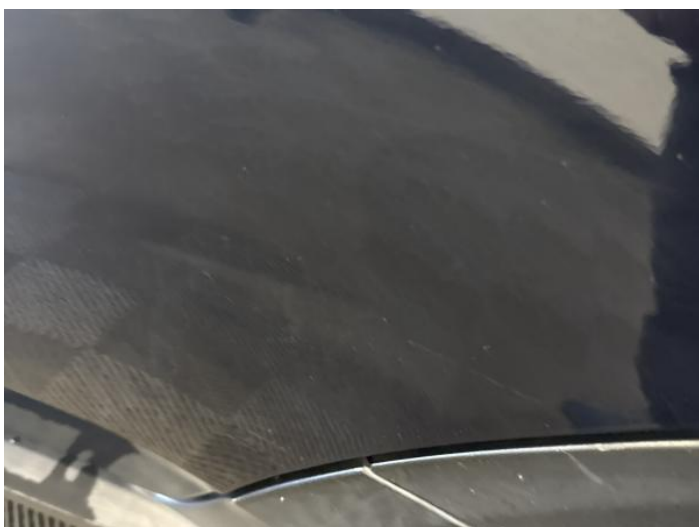
7: Door nsr  
Scratched  
Over 25mm Thru Paint

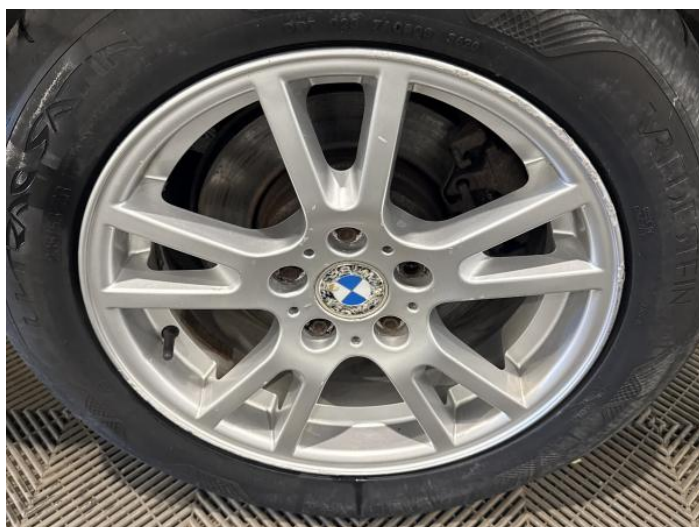
8: Wheel nsr  
Scratched  
Over 50mm

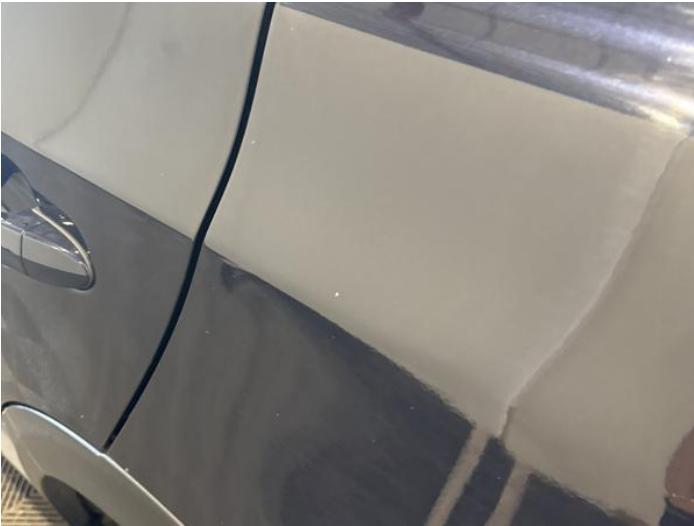
9: Qtr Panel nsr  
Chipped  
1 To 5

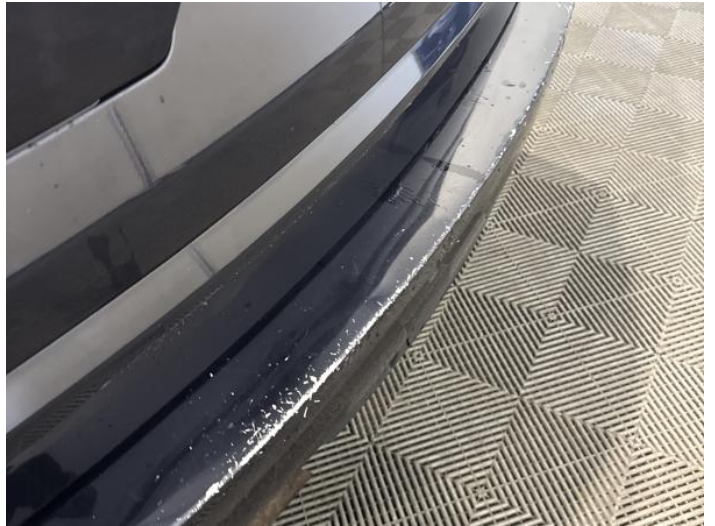
10: Bumper Rear  
Scratched  
Over 100mm Thru Paint

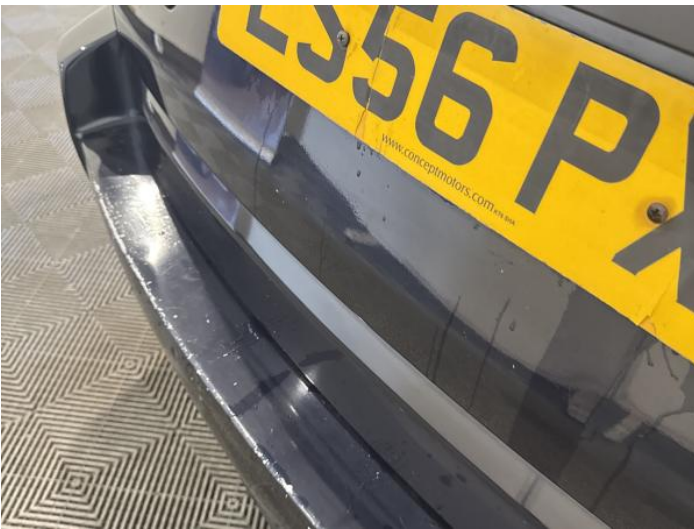
11: Tailgate  
Chipped  
1 To 5

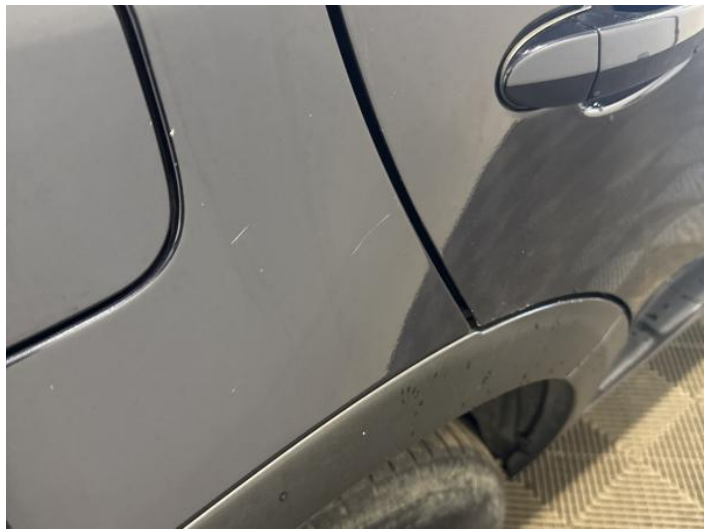
12: Qtr Panel osr  
Scratched  
UpTo 25mm Thru Paint

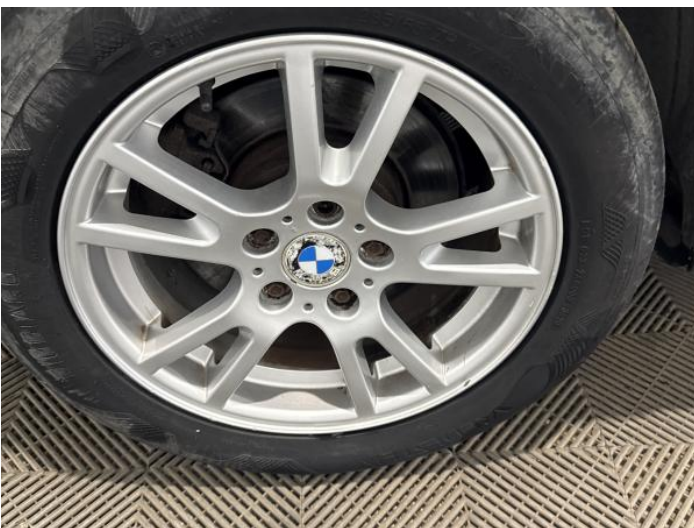
13: Wheel osr  
Scratched  
Over 50mm

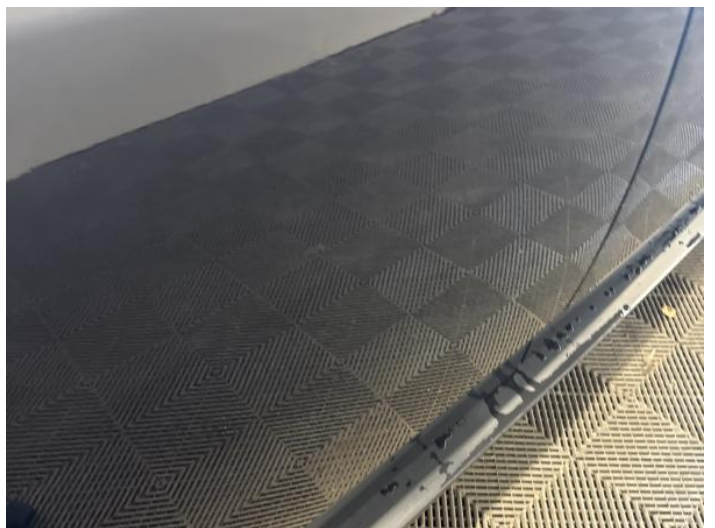
14: Door osr  
Scratched  
Over 25mm Thru Paint

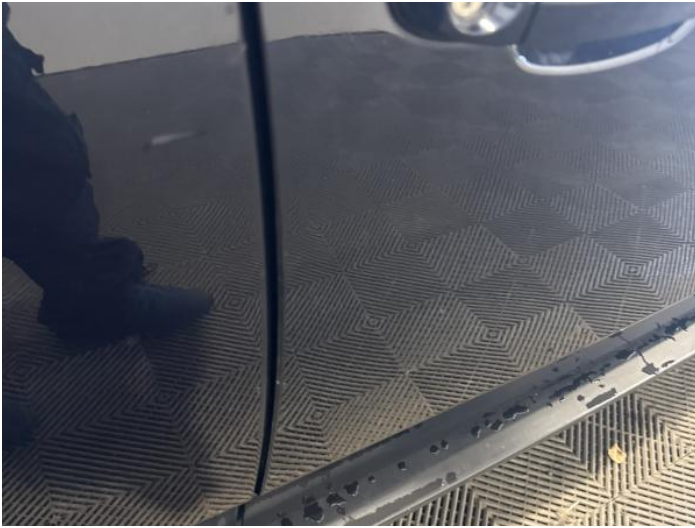
15: Door osf  
Chipped  
Edge Chip

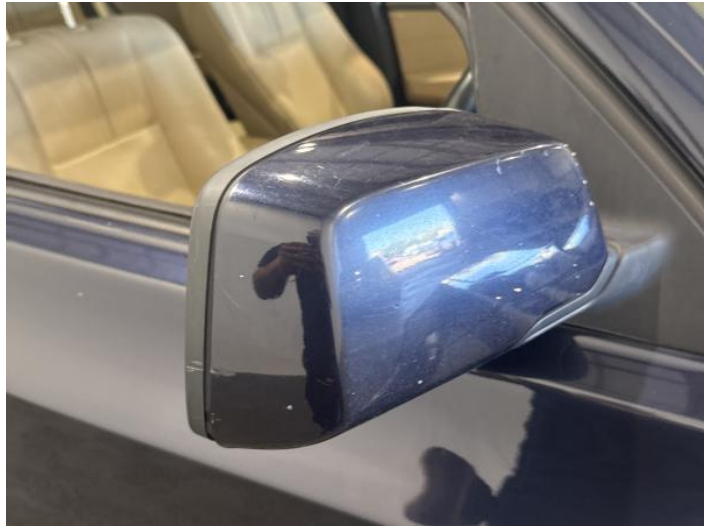
16: Door Mirror Assy osf  
Scratched (Painted)  
UpTo 25mm Thru Paint

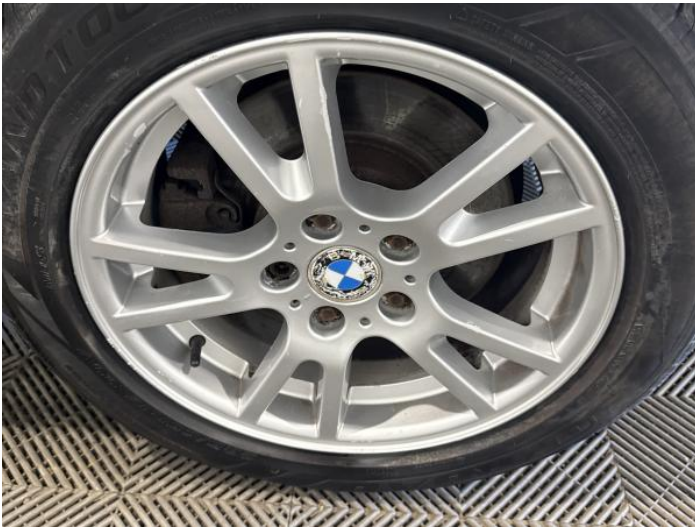
17: Wheel osf  
Scratched  
Over 50mm

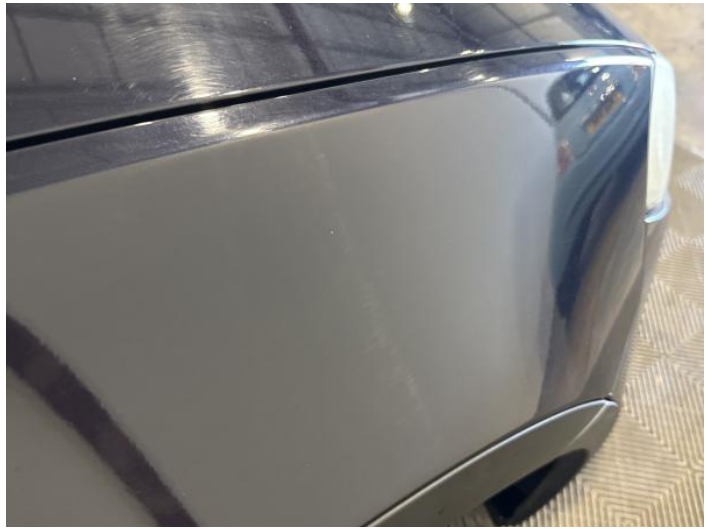
18: Wing osf  
Scratched  
UpTo 25mm Thru Paint

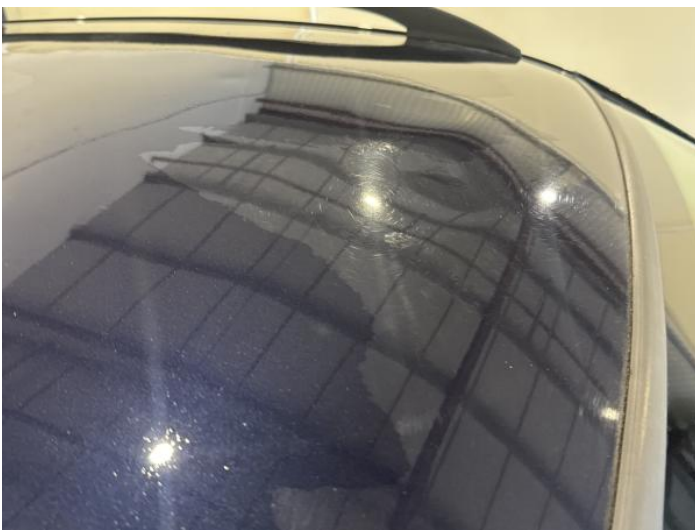
19: Roof  
Dented  
Over 30mm
