VEHICLE INSPECTION REPORT

LB66OYM

Peugeot 2008 1.2 PureTech 110 GT Line 5dr EAT6

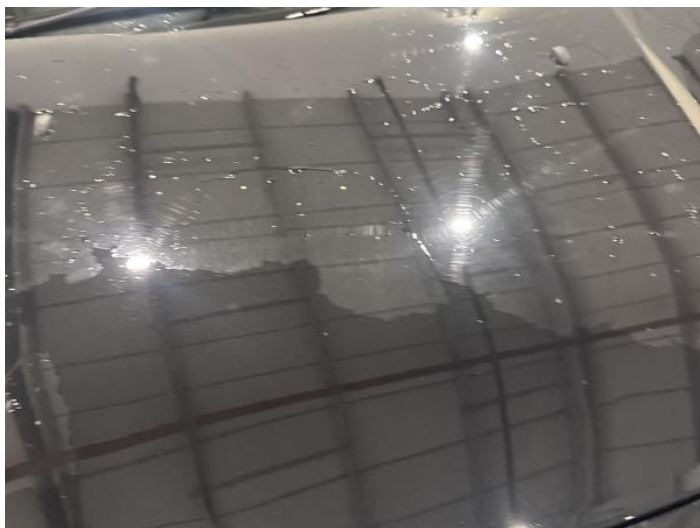
1: Bonnet
Chipped
1 To 5

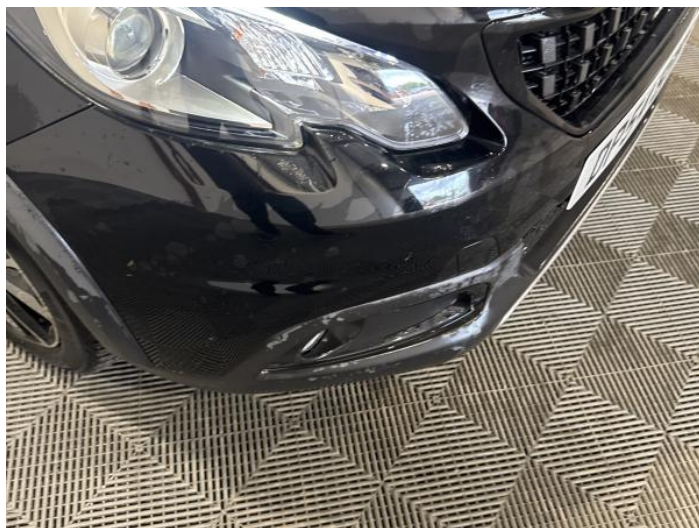
2: Bumper Front
Scratched
25 to 100mm Thru Paint

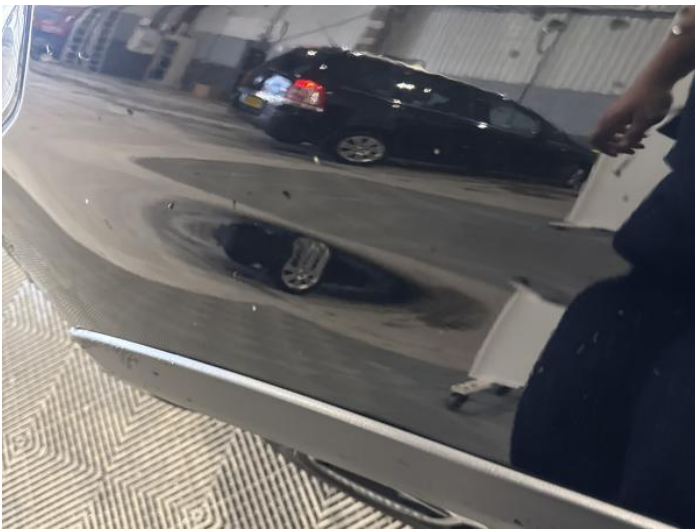
5: Wing nsf
Chipped
1 To 5

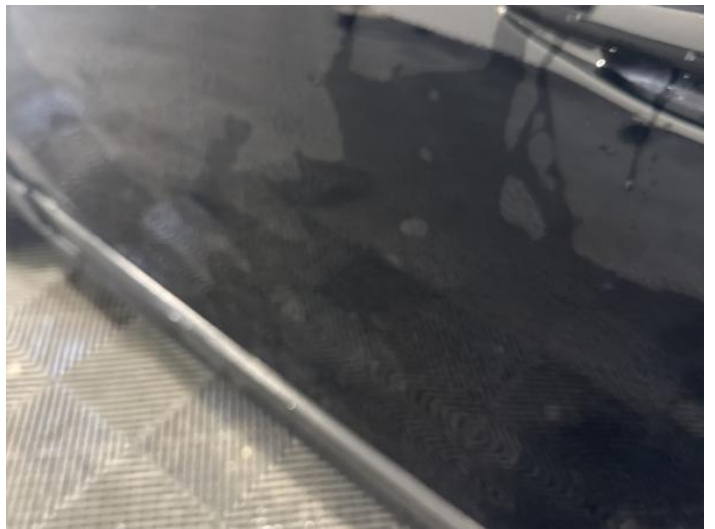
6: Door nsf
Dented
Over 2 UpTo 10mm

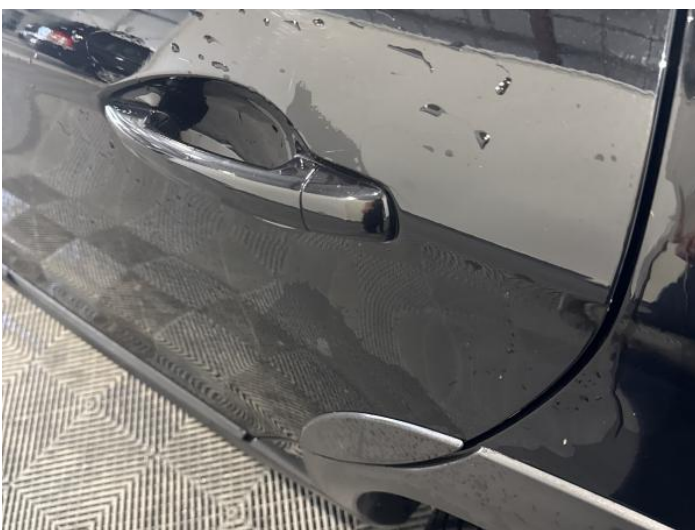
7: Door nsr
Scratched
Over 25mm Not Thru Paint

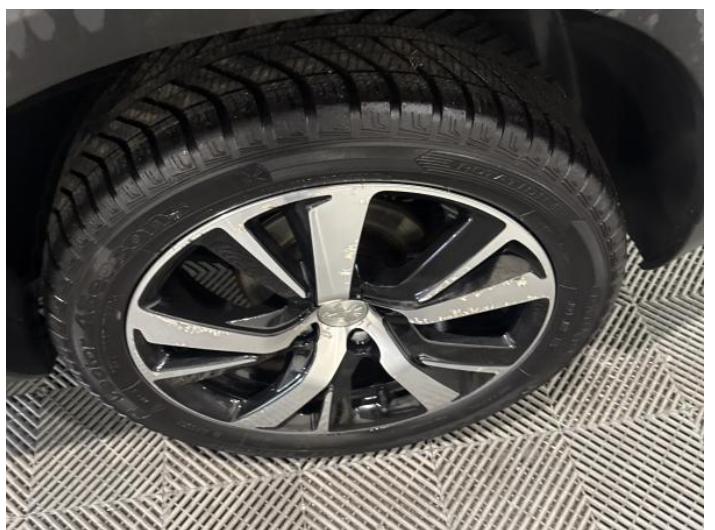
8: Wheel nsr
Scratched
Over 50mm

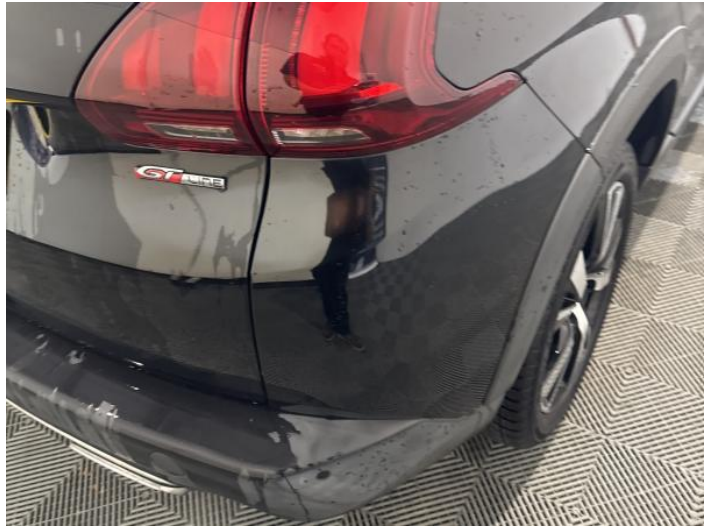
9: Qtr Panel nsr
Scratched
Over 25mm Not Thru Paint

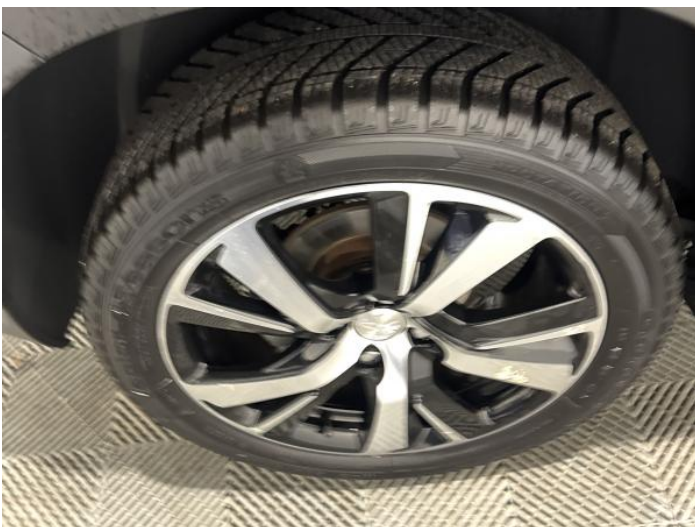
13: Wheel osr
Scratched
Over 50mm

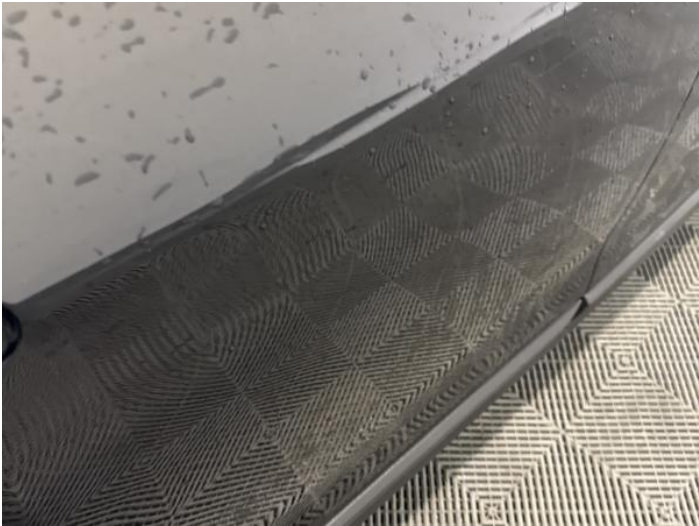
15: Door osr
Dented
Over 30mm

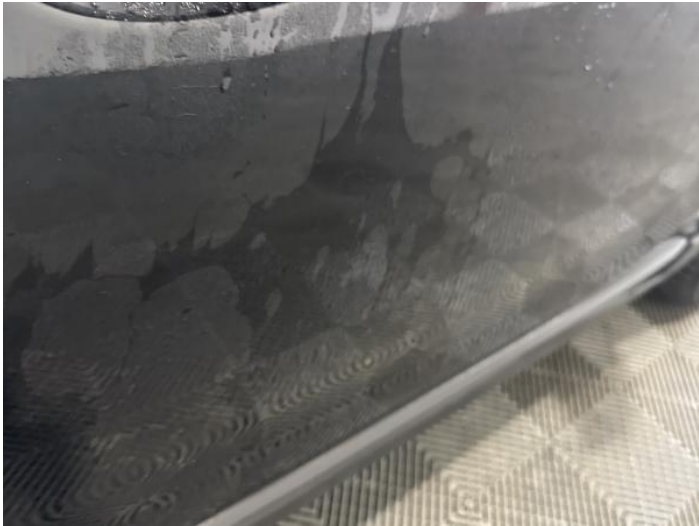
16: Door osf
Dented
2 Or Less UpTo 10mm

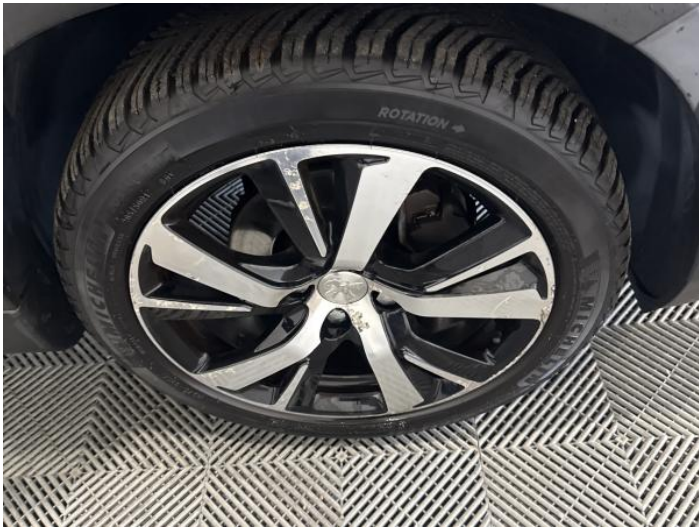
18: Wheel osf
Scratched
Over 50mm
