## VEHICLE INSPECTION REPORT

**AE70AVM**

### Mitsubishi Shogun Sport 2.4 DI-DC 4 5dr Auto 4WD

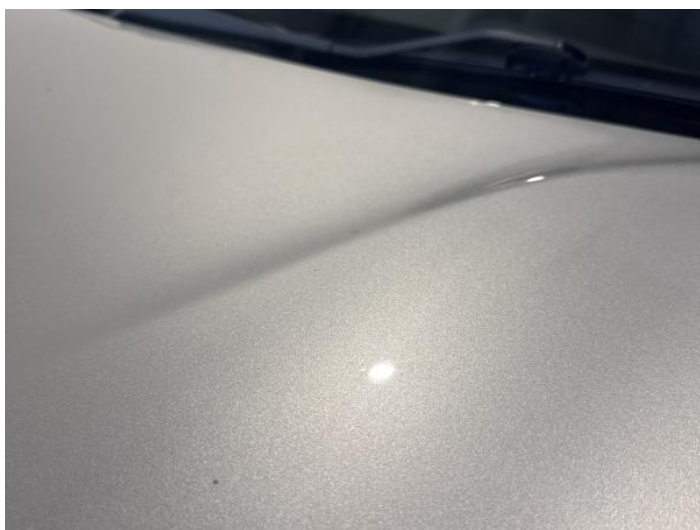
1: Bonnet  
Dented  
Between 10mm + 30mm

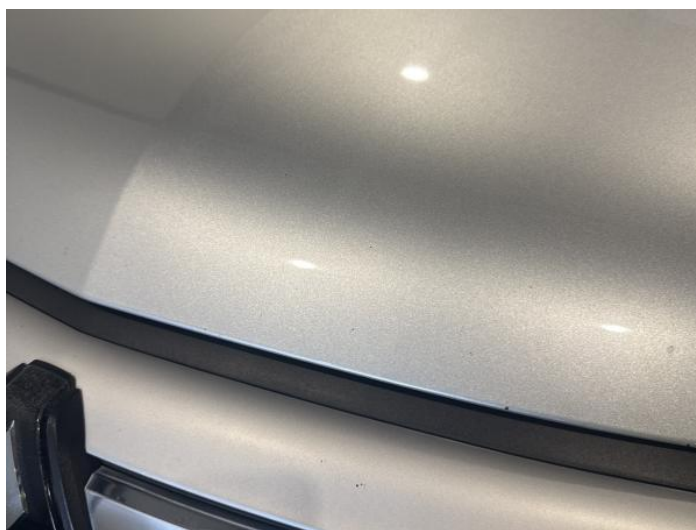
2: Bonnet  
Chipped  
Multiple Chips

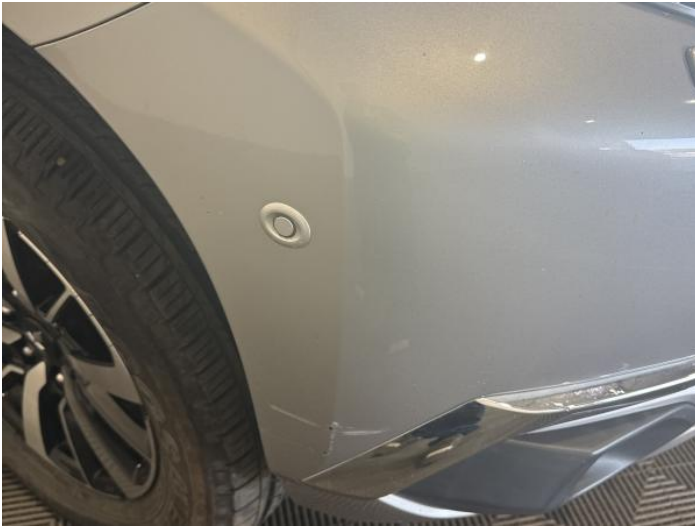
3: Bumper Front  
Scratched  
25 to 100mm Thru Paint

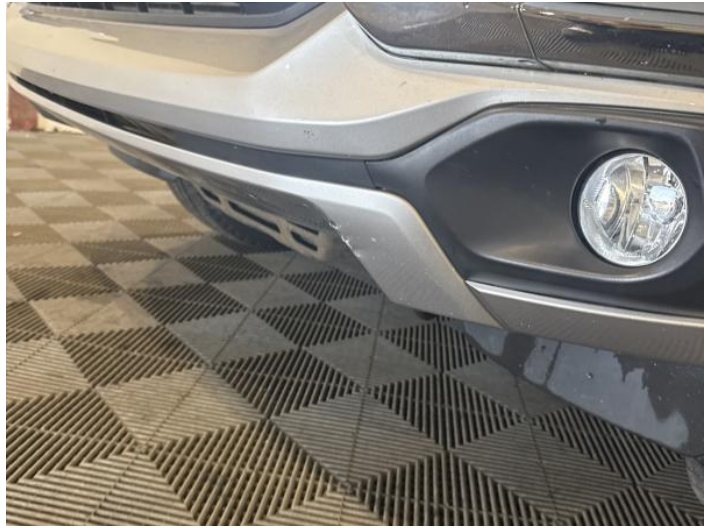
4: Bumper Front Moulding  
Scratched (Painted)  
Over 25mm Thru Paint

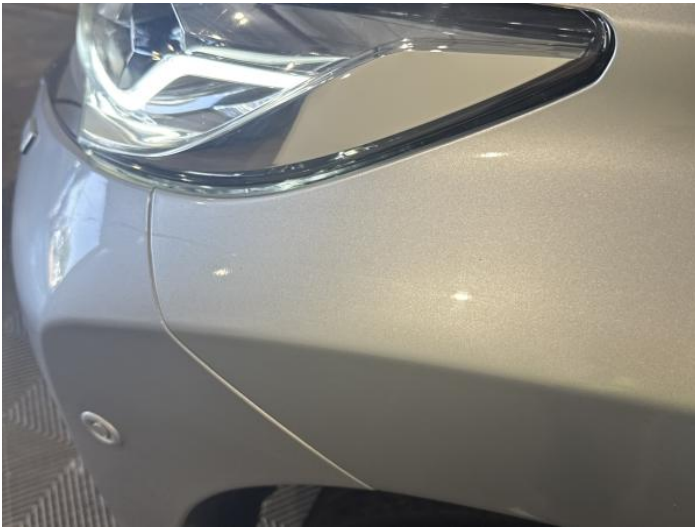
5: Wing nsf  
Scratched  
UpTo 25mm Thru Paint

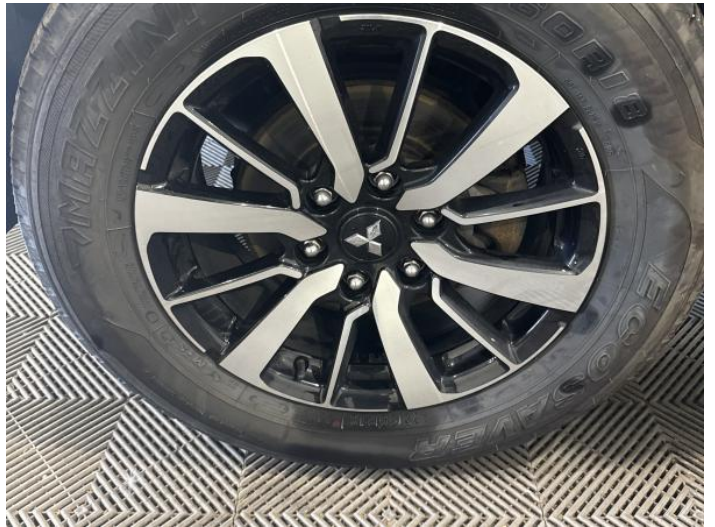
6: Wheel nsf  
Scratched  
Up To 50mm

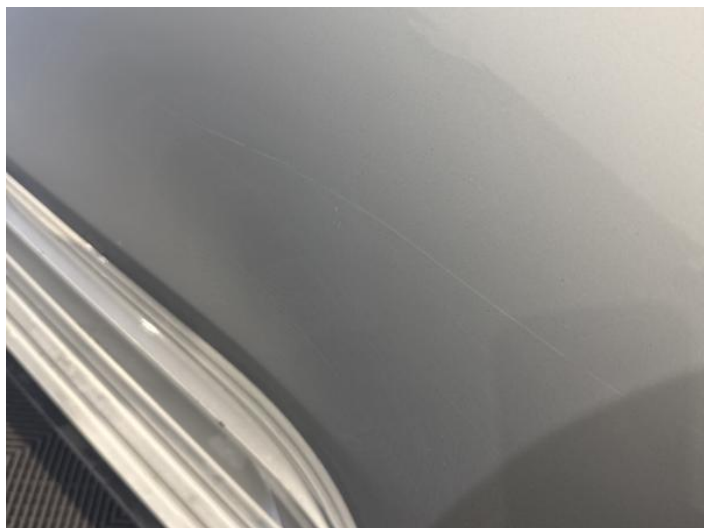
8: Door nsr  
Scratched  
Over 25mm Thru Paint

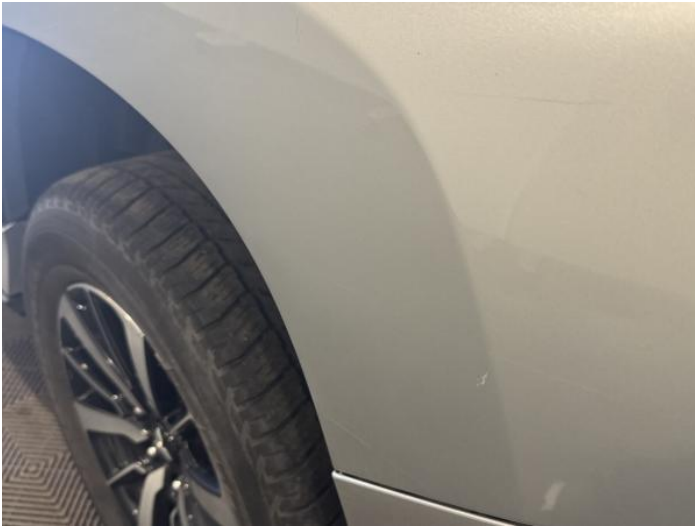
9: Qtr Panel nsr  
Scratched  
UpTo 25mm Thru Paint

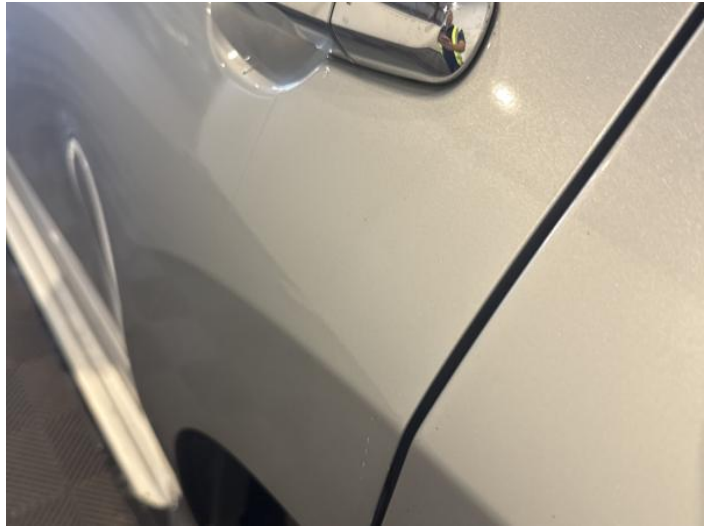
10: Door nsr  
Dented  
Between 10mm + 30mm

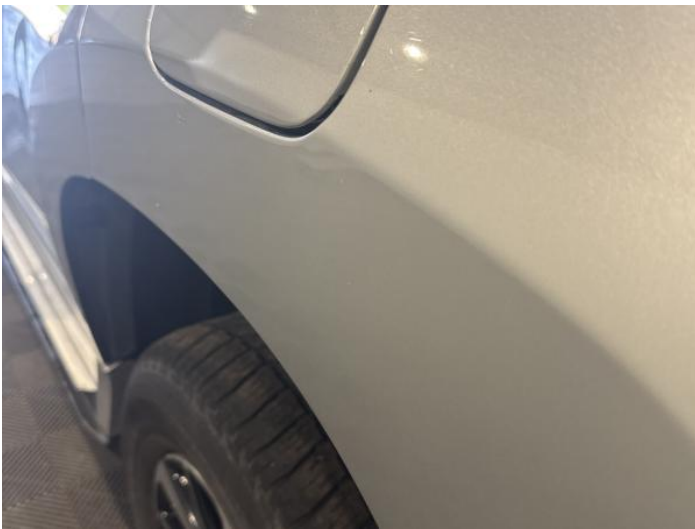
11: Qtr Panel nsr  
Dented  
Over 30mm

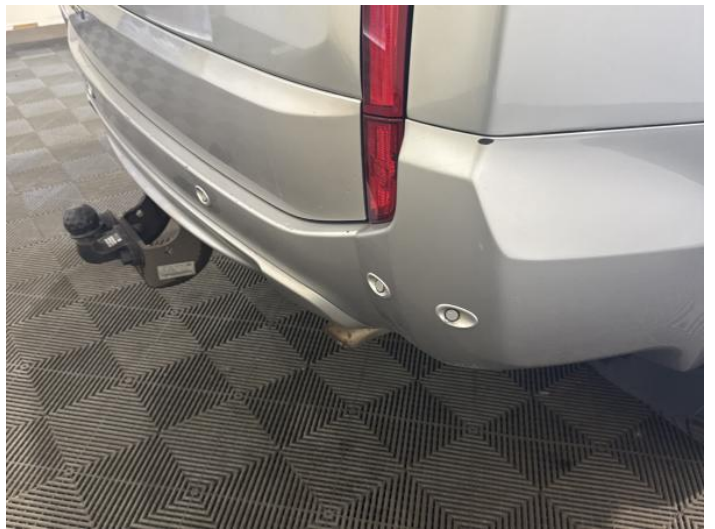
12: Bumper Rear  
Scratched  
Over 100mm Thru Paint

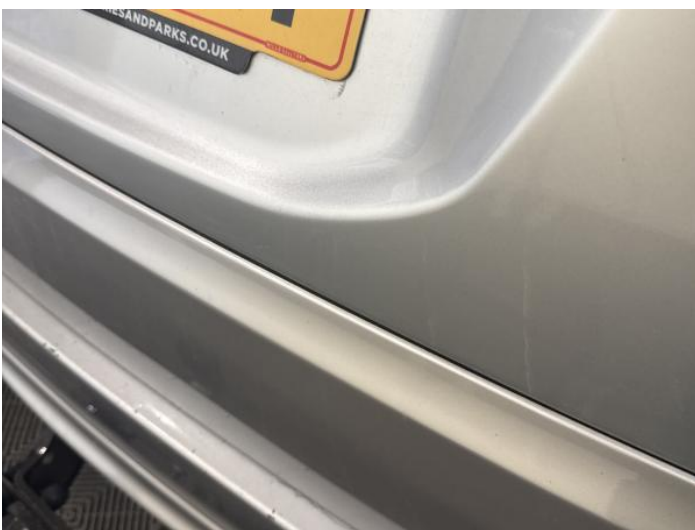
13: Tailgate  
Scratched  
UpTo 25mm Thru Paint

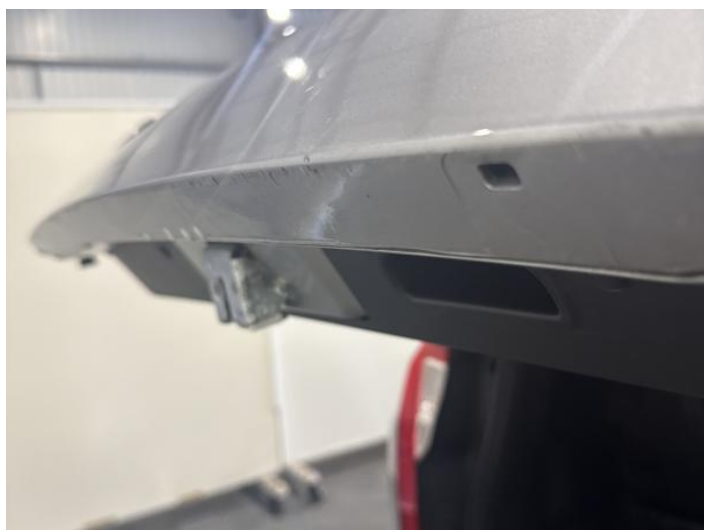
14: Tailgate Trim Panel  
Scratched (Painted)  
Over 25mm Thru Paint

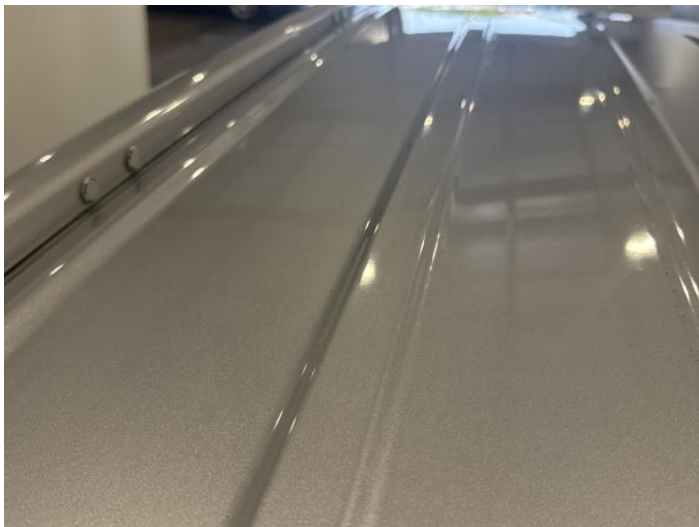
15: Roof  
Dented  
Between 10mm + 30mm

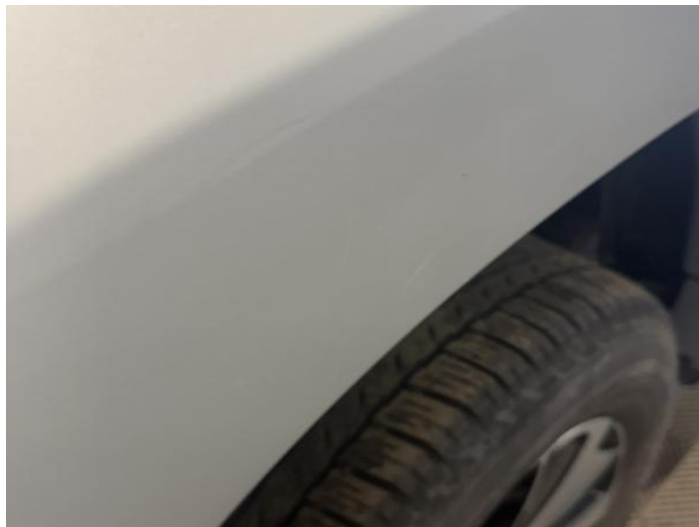
16: Qtr Panel osr  
Scratched  
UpTo 25mm Thru Paint

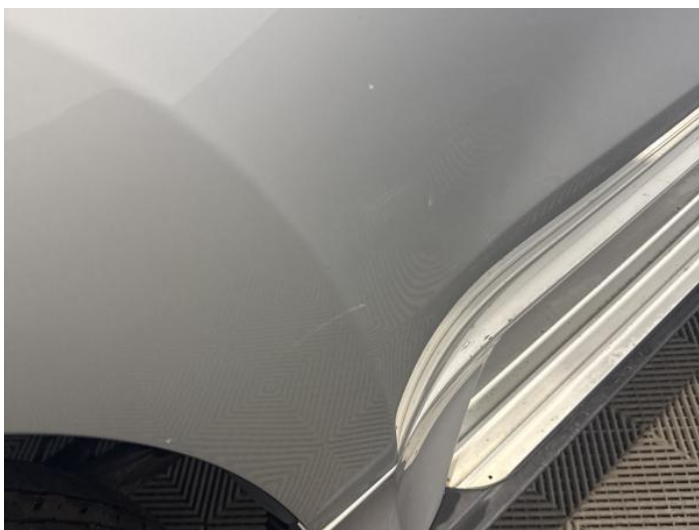
17: Door osr  
Scratched  
Over 25mm Thru Paint

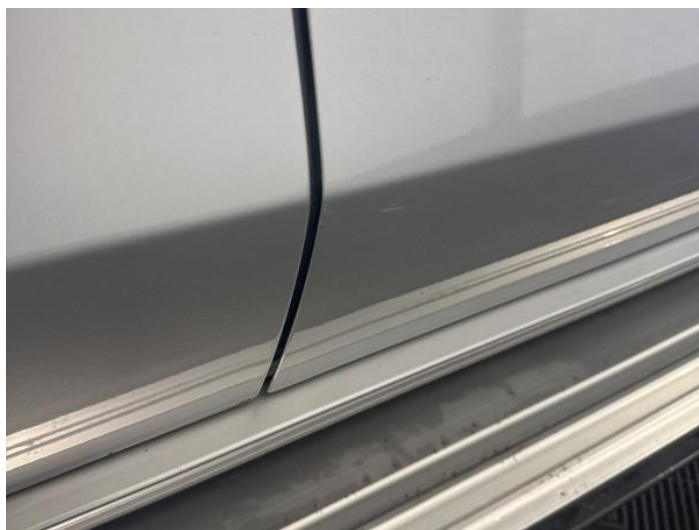
18: Door osf  
Scratched  
UpTo 25mm Thru Paint

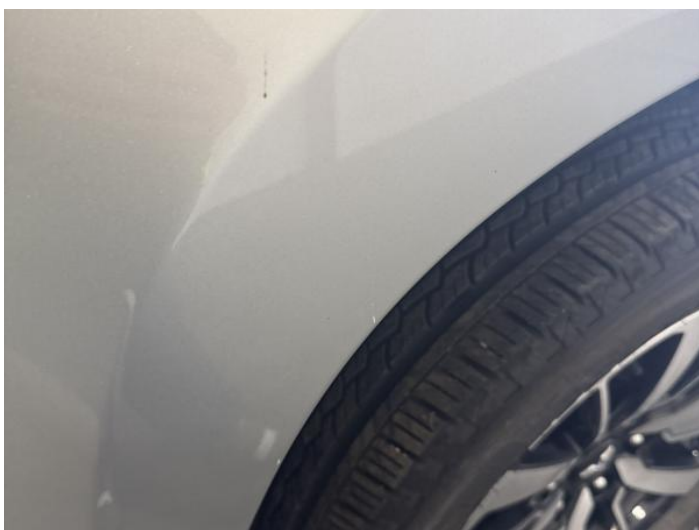
19: Wing osf  
Scratched  
UpTo 25mm Thru Paint
