VEHICLE INSPECTION REPORT

ET12AXX

Nissan Qashqai+2 2.0 Tekna 5dr 4WD CVT

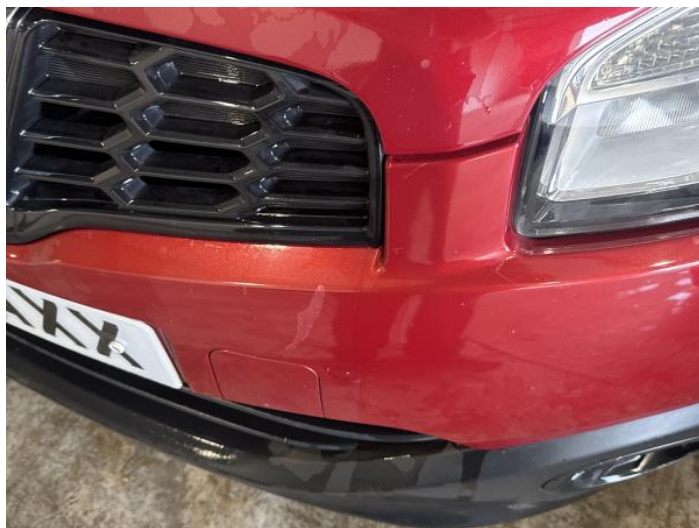
2: Bumper Front
Poor Previous Repair
Paint Flake

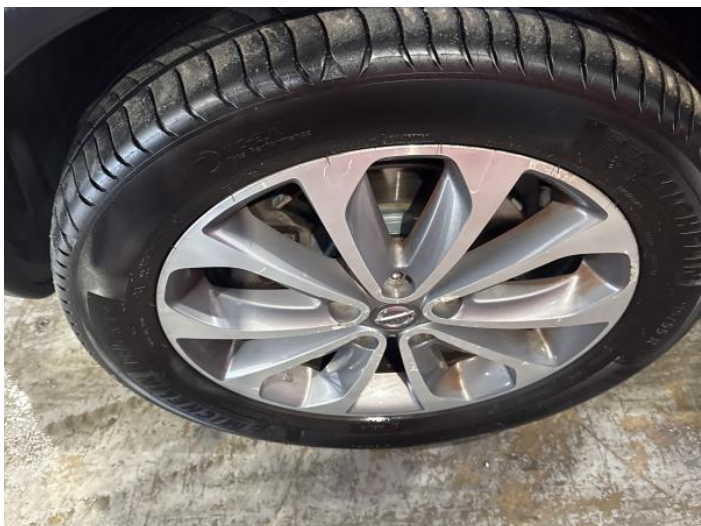
3: Wheel nsf
Scratched
Over 50mm

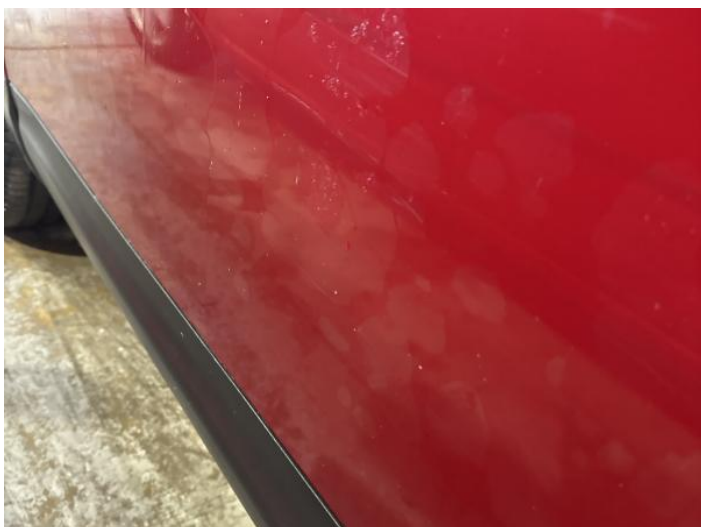
5: Door nsf
Chipped
Multiple Chips

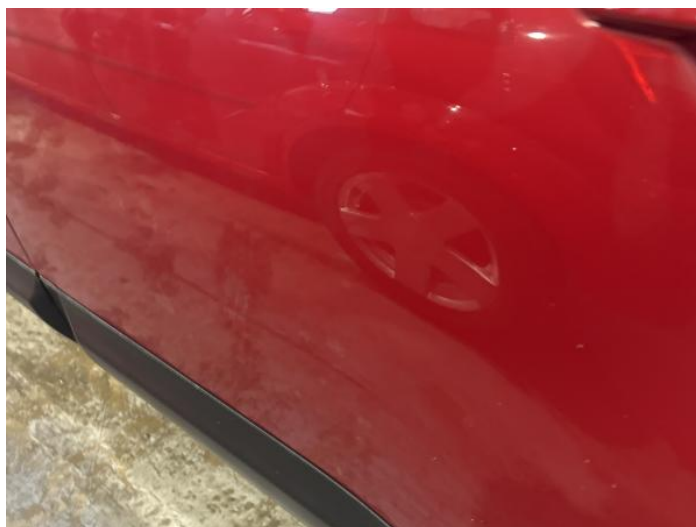
6: Door nsr
Dented
With Paint Damage

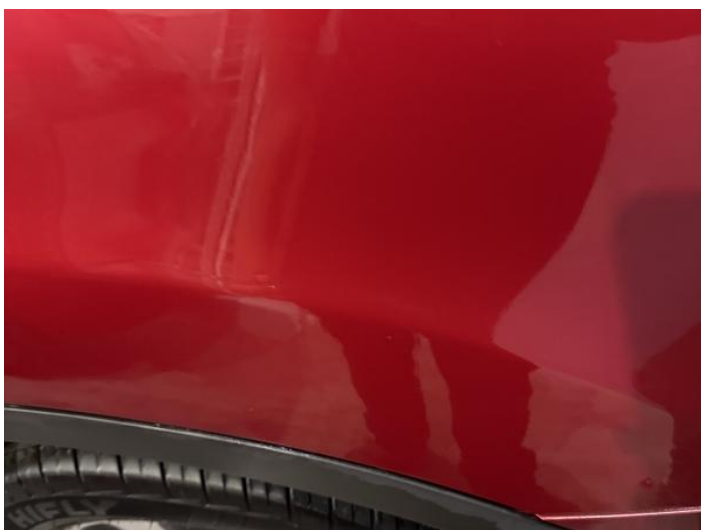
7: Qtr Panel nsr
Chipped
1 To 5

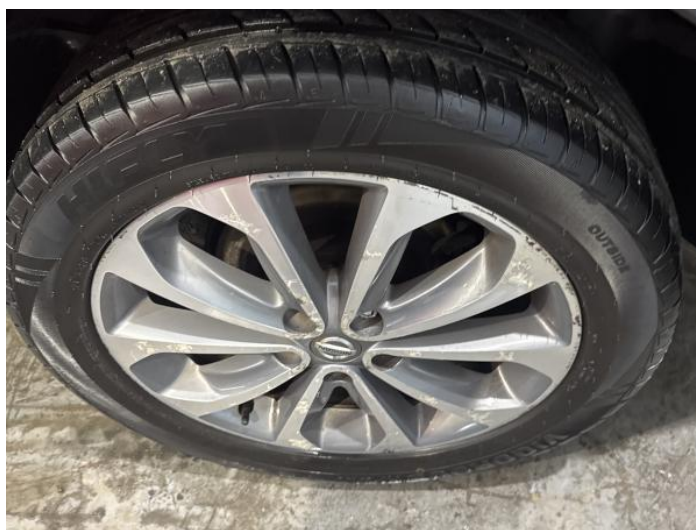
8: Wheel nsf
Scratched
Over 50mm

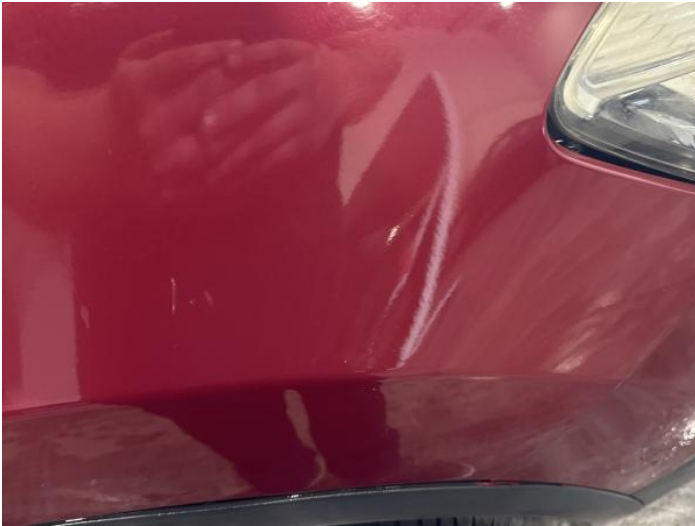
9: Wing osf
Chipped
1 To 5

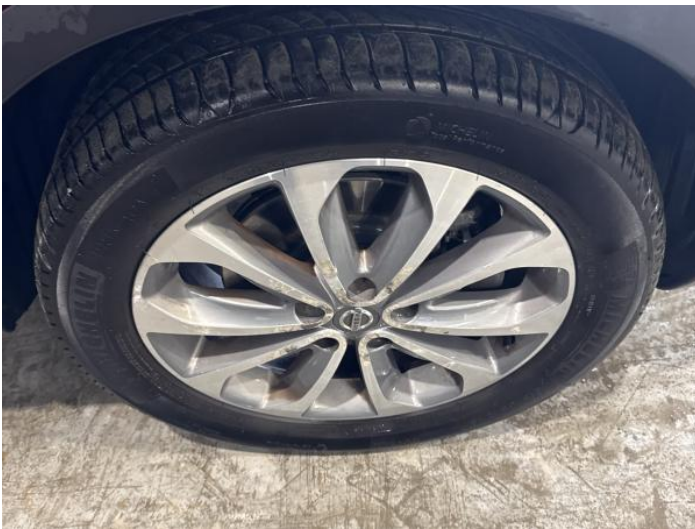
11: Wheel osf
Scratched
Over 50mm

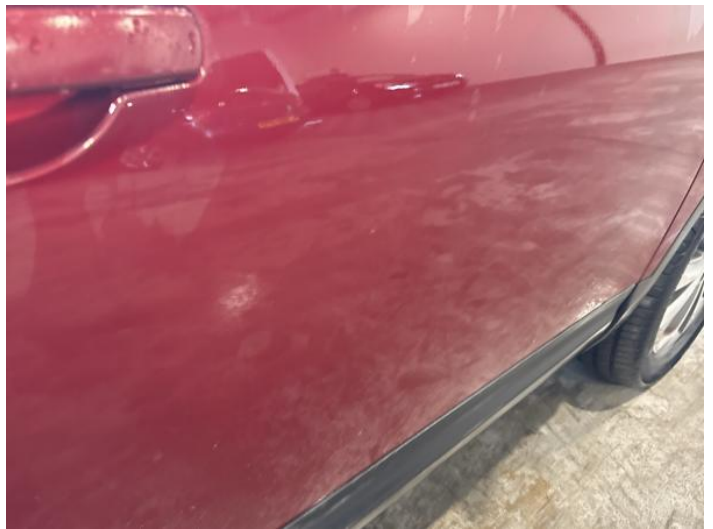
12: Door osf
Dented
Over 2 UpTo 10mm

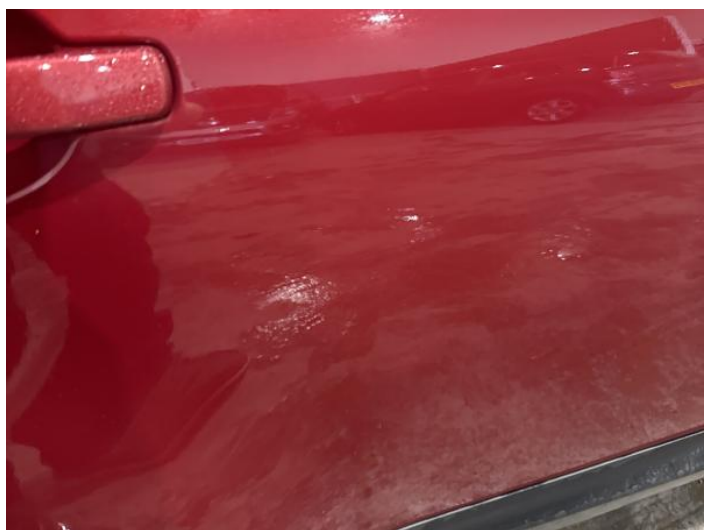
14: Door osr
Chipped
1 To 5

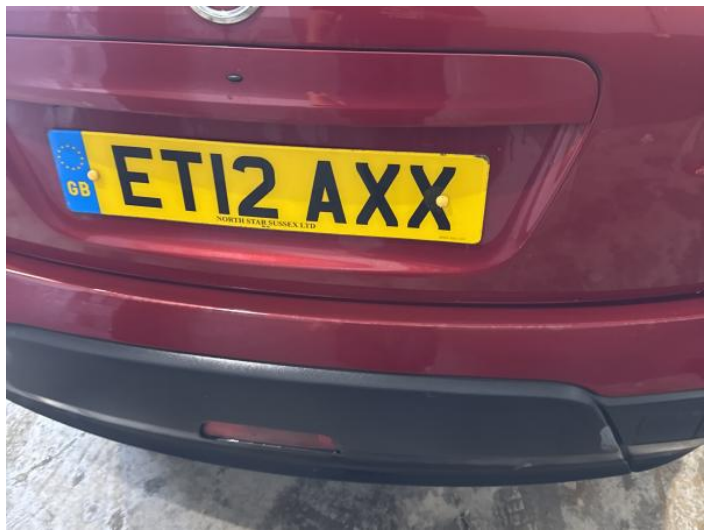
18: Bumper Rear
Chipped
Multiple Chips
