## VEHICLE INSPECTION REPORT

**RK63OCE**

### Dacia Sandero Stepway 0.9 TCe Laureate 5dr

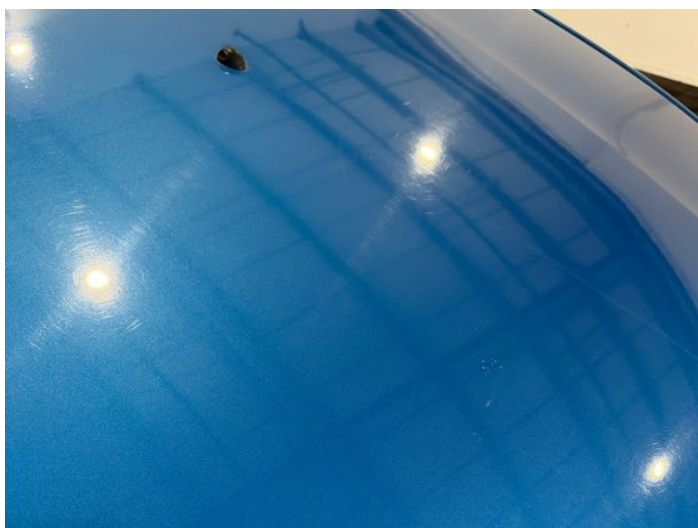
1: Bonnet  
Chipped  
Multiple Chips

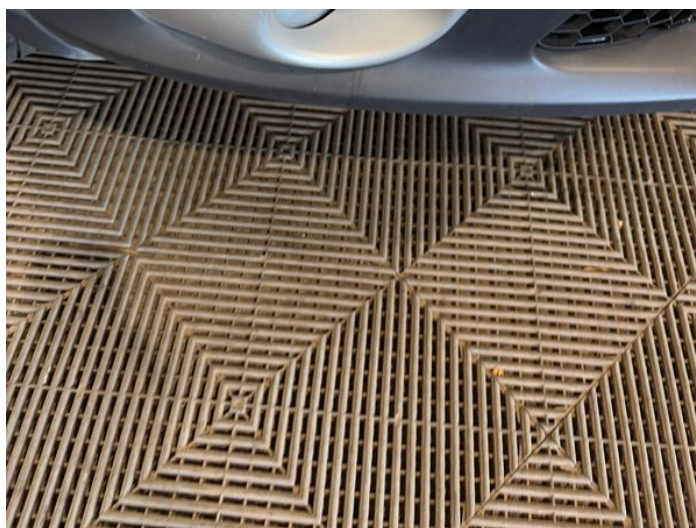
2: Fog Lamp Surround is  
Scratched (Painted)  
Over 25mm Thru Paint

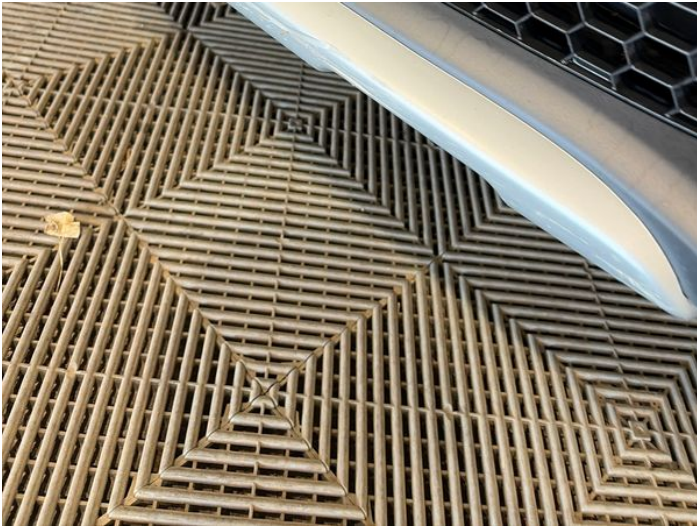
3: Bumper Front Moulding  
Scratched (Painted)  
Over 25mm Thru Paint

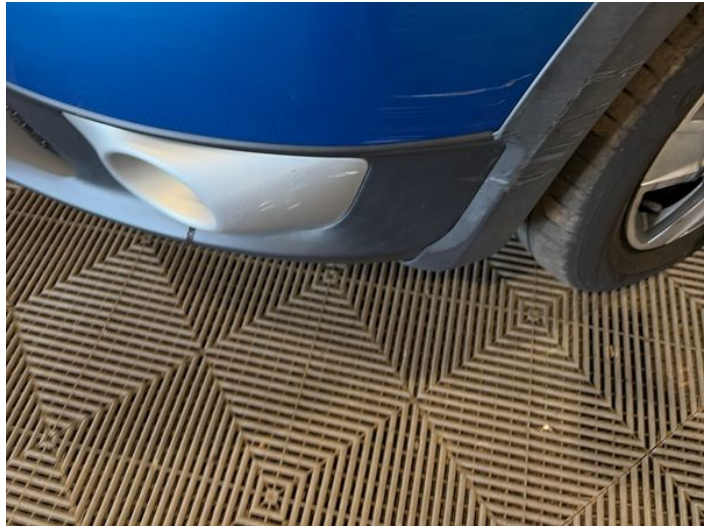
4: Bumper Front  
Scratched  
25 to 100mm Thru Paint

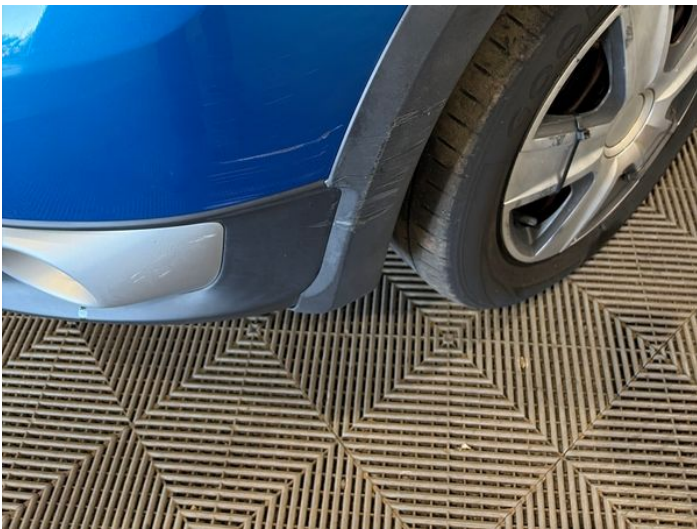
5: Wing Front Arch Extension nsf  
Scuffed (Unpainted)  
Over 100mm

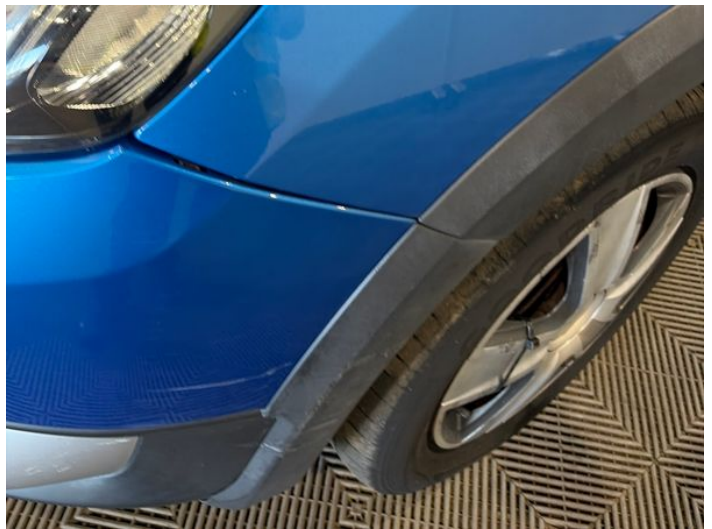
6: Wing nsf  
Chipped  
1 To 5

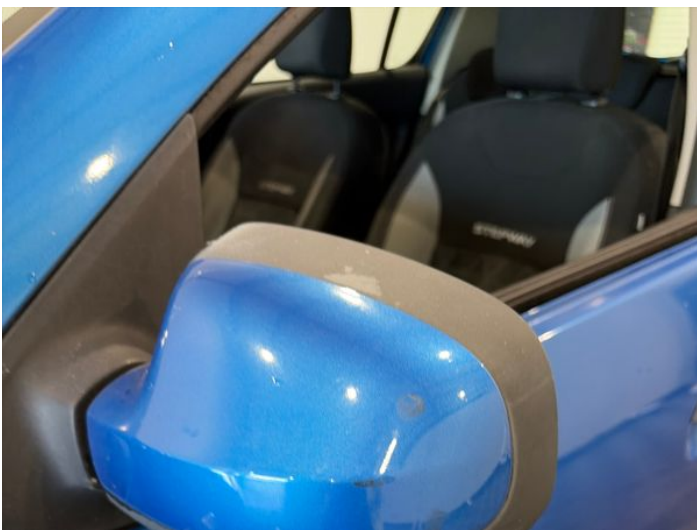
7: Door Mirror Assy nsf  
Scratched (Painted)  
UpTo 25mm Thru Paint

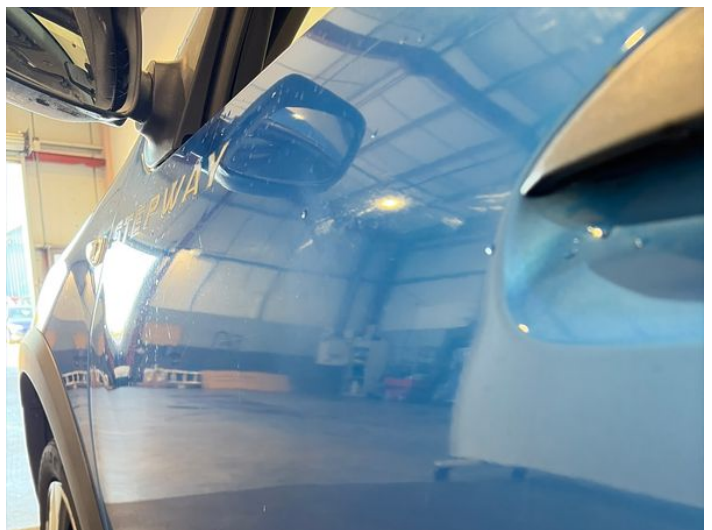
8: Door nsf  
Dented  
Over 30mm

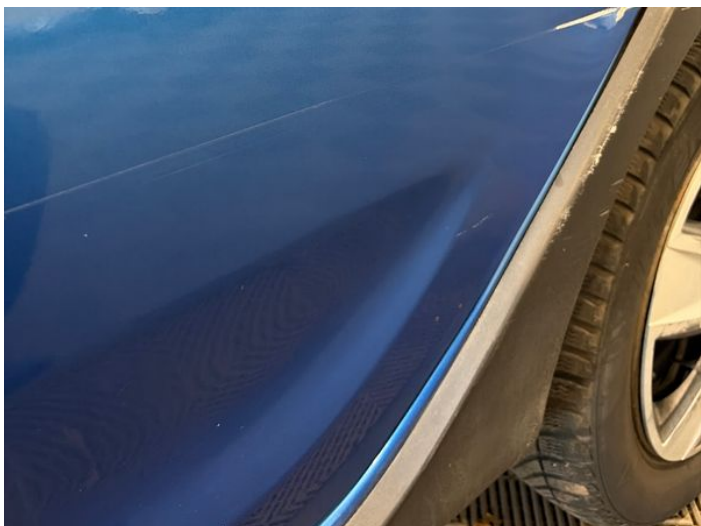
9: Door nsr  
Dented  
With Paint Damage

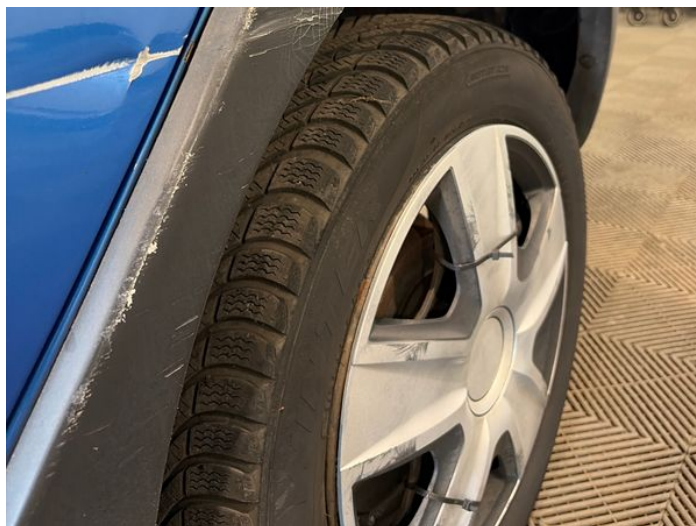
10: Qtr Panel Arch Extension ns  
Scuffed (Unpainted)  
Over 100mm

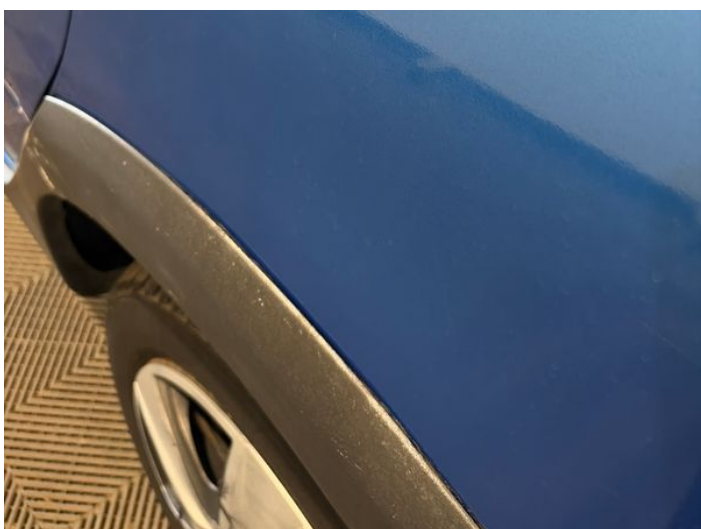
11: Qtr Panel nsr  
Poor Previous Repair  
Rippled UpTo 30%

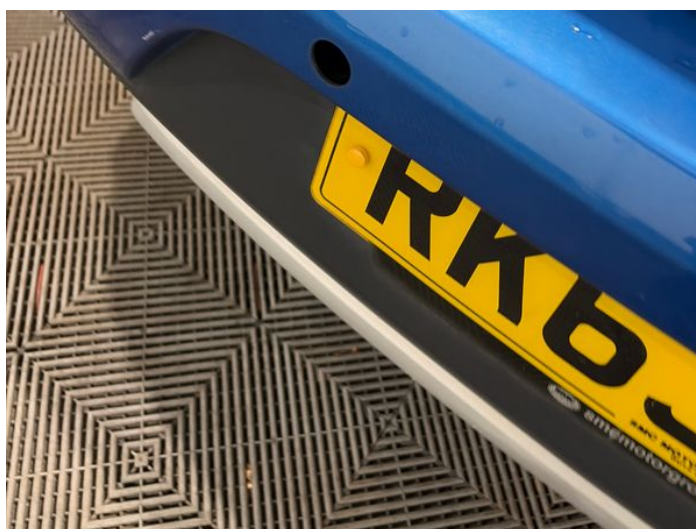
12: Parking Sensor Rear  
Missing  
Replace

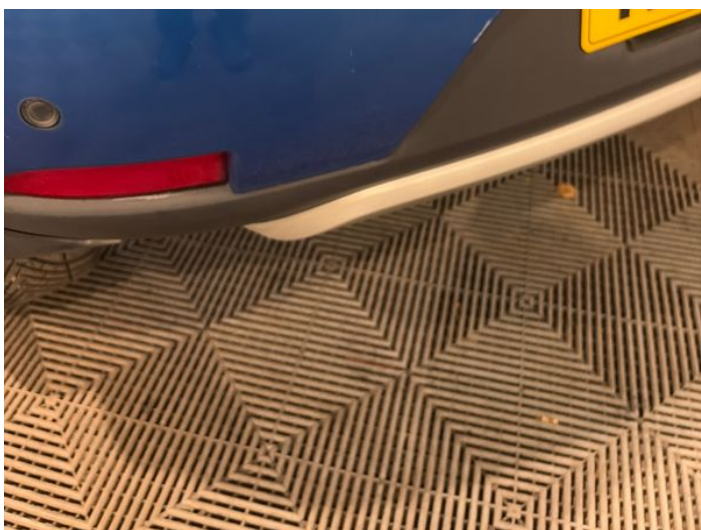
13: Bumper Rear  
Scratched  
25 to 100mm Thru Paint

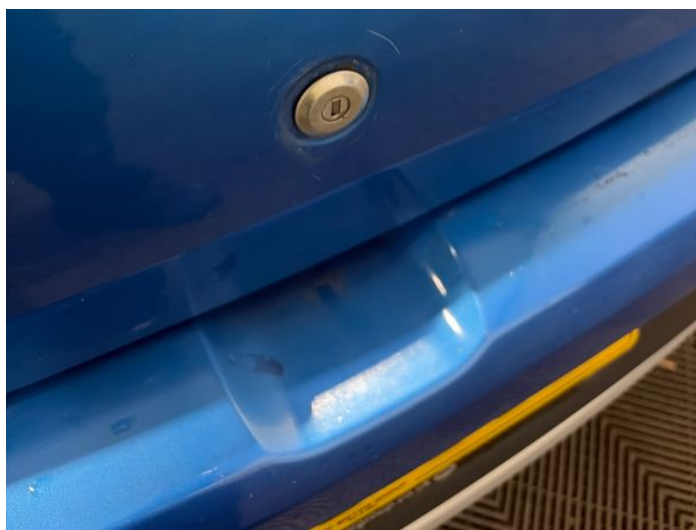
14: Tailgate  
Scratched  
UpTo 25mm Thru Paint

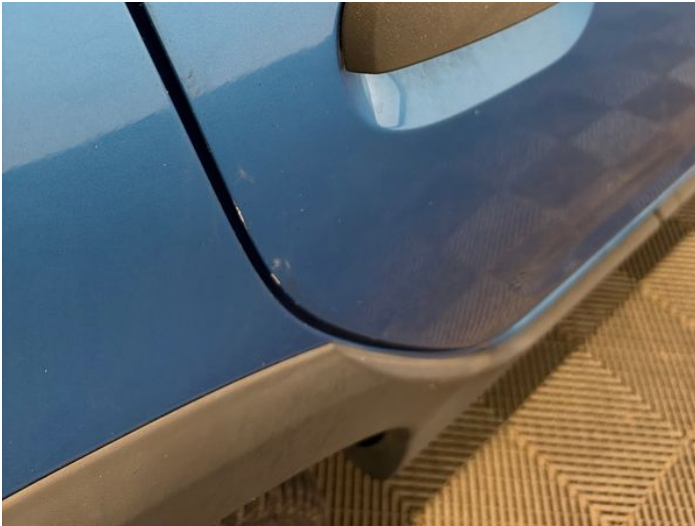
15: Door osr  
Dented  
With Paint Damage

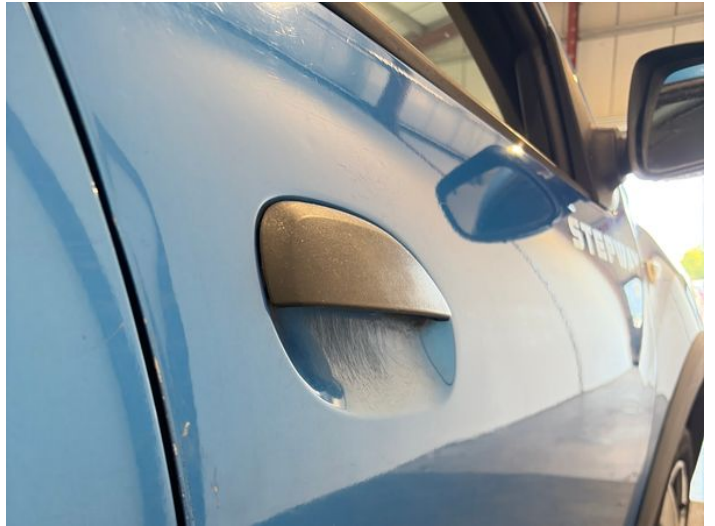
16: Door osf  
Dented  
With Paint Damage

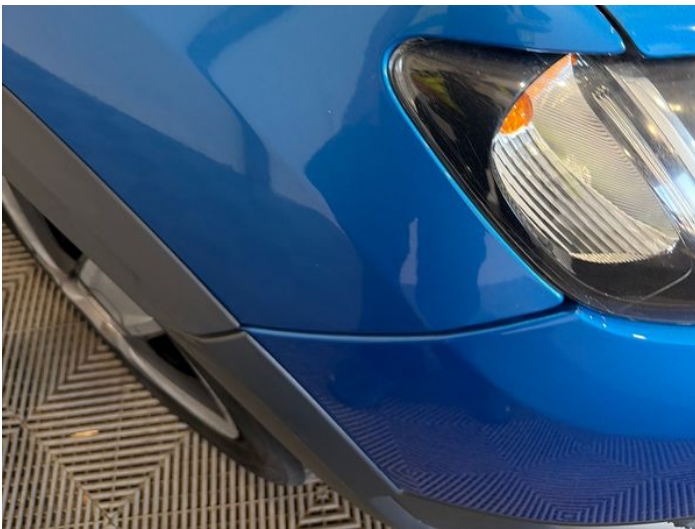
17: Wing osf  
Chipped  
1 To 5

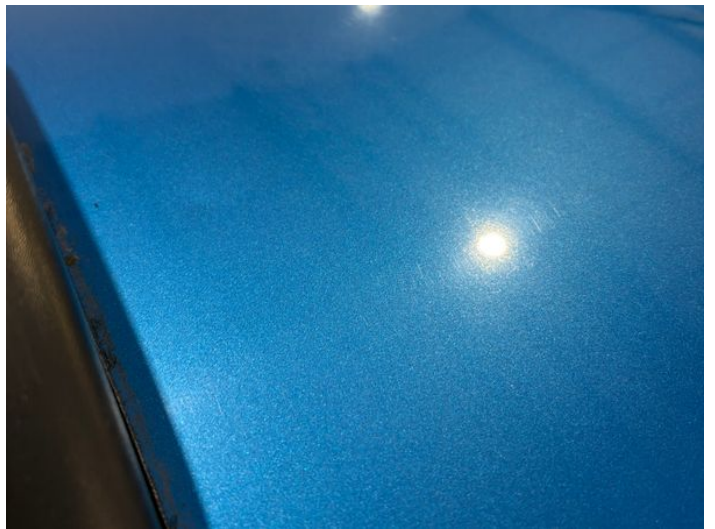
18: Roof  
Dented  
Between 10mm + 30mm

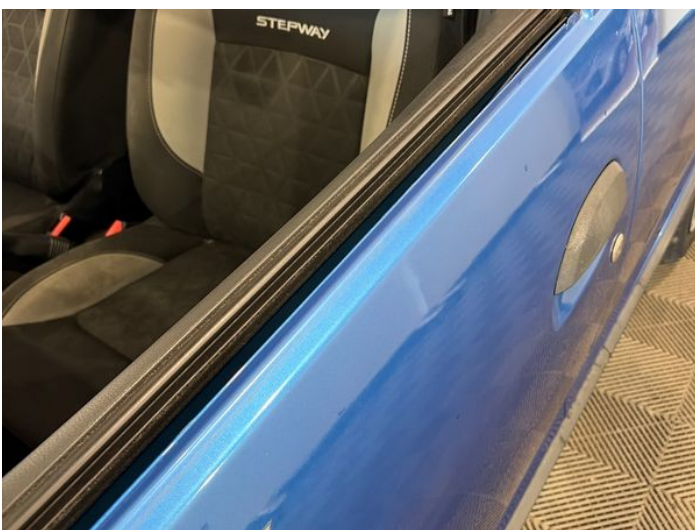
19: Aperture Seal nsf  
Missing  
Replace
