# VEHICLE INSPECTION REPORT

**TGZ3705**

## Vauxhall Grandland X 1.2 Turbo SRi Nav 5dr

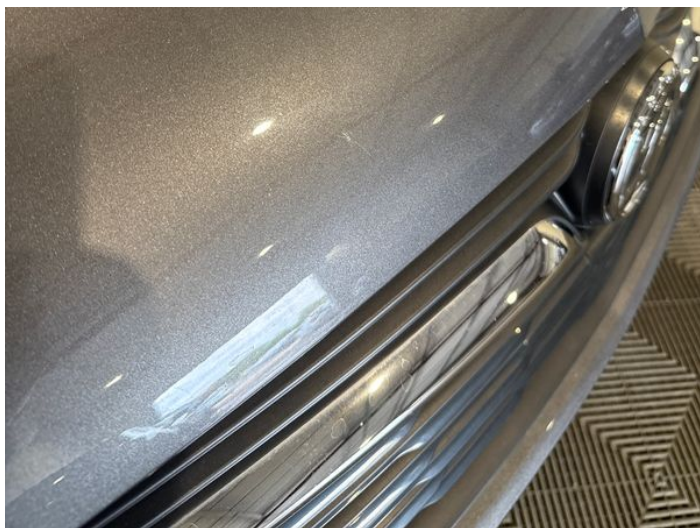
1: Bonnet  
Chipped  
1 To 5

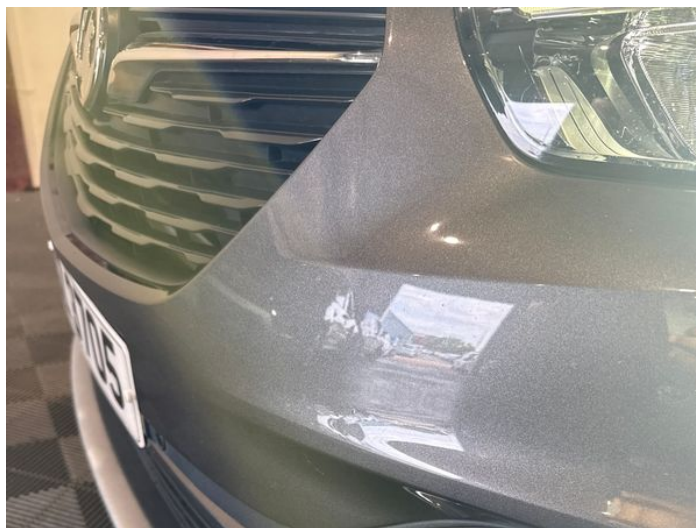
2: Bumper Front  
Chipped  
1 To 5

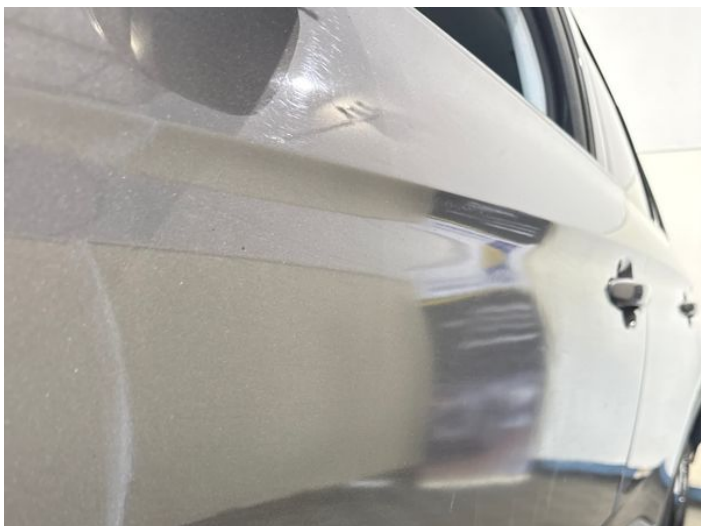
3: Door nsf  
Poor Previous Repair  
Rippled Up To 30%

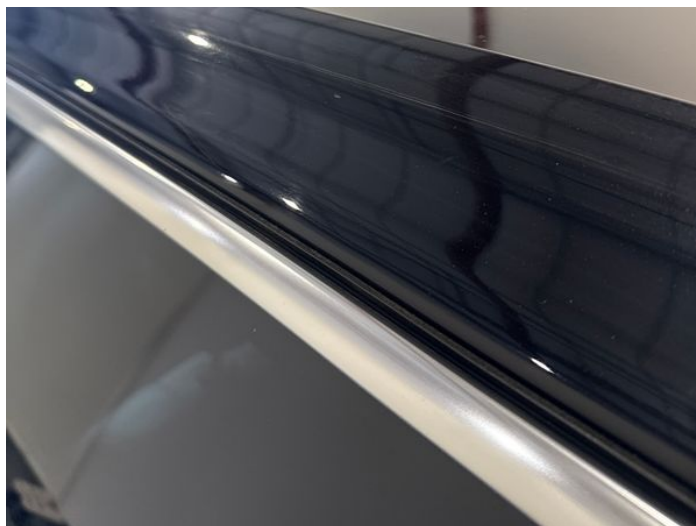
4: B Post ns  
Scratched  
Over 25mm Thru Paint

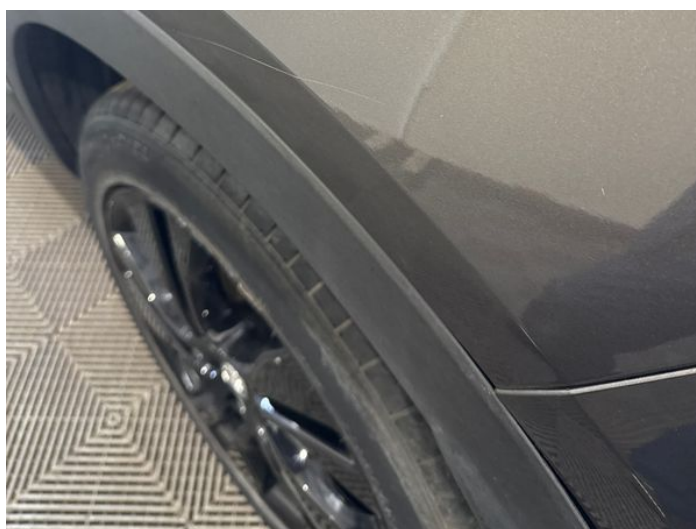
6: Qtr Panel nsr  
Scratched  
Over 25mm Thru Paint

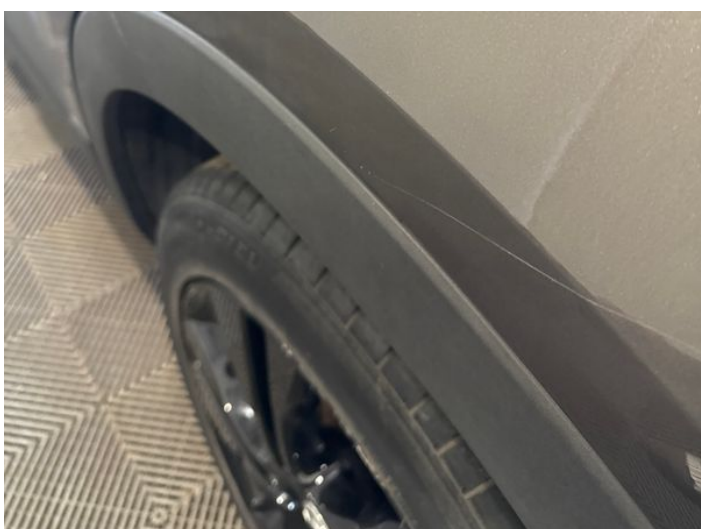
7: Qtr Panel nsr  
Dented  
Between 10mm + 30mm

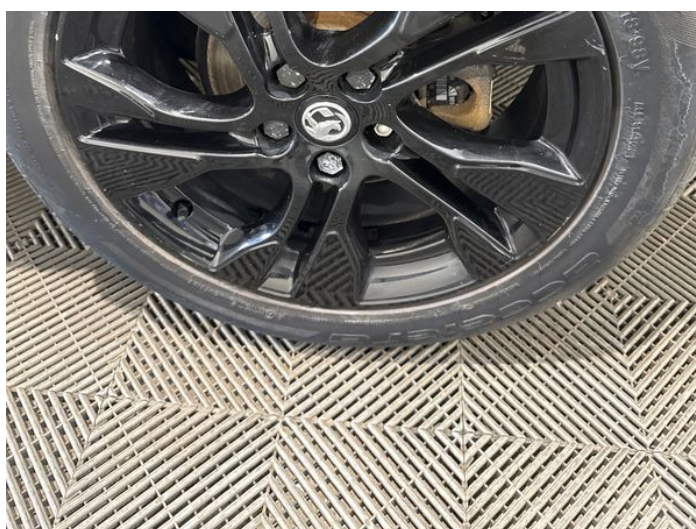
8: Wheel nsr  
Scratched  
Over 50mm

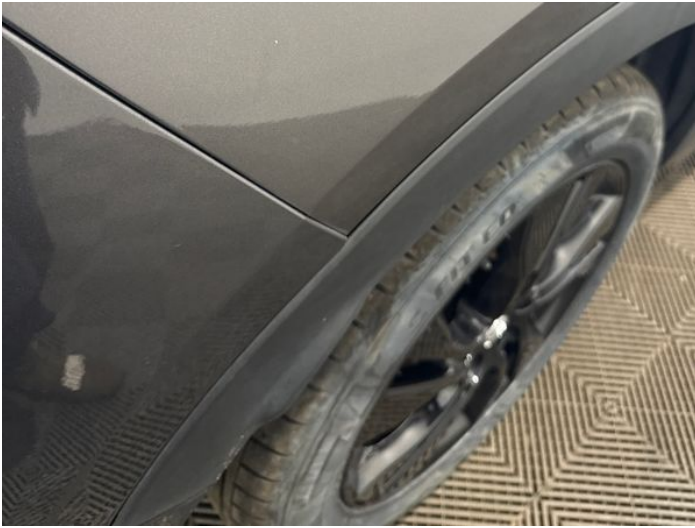
9: Qtr Panel osr  
Chipped  
1 To 5

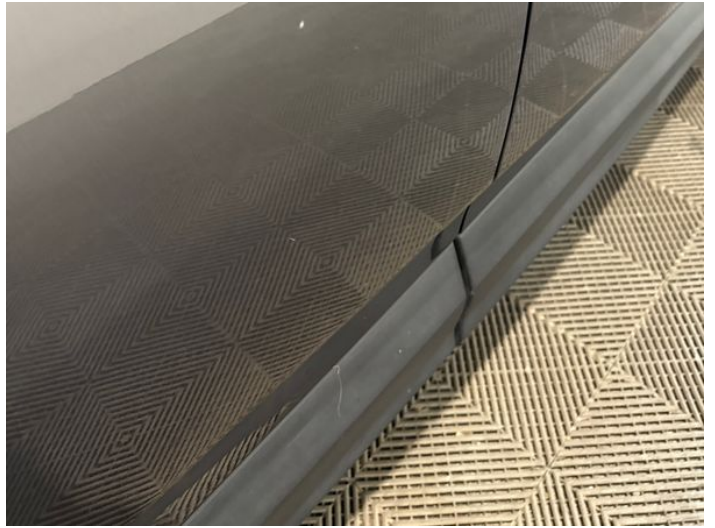
10: Door osr  
Dented  
Between 10mm + 30mm

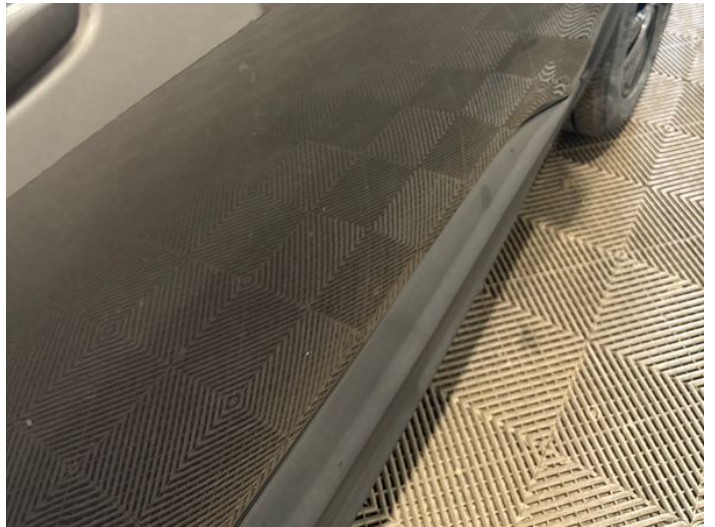
12: Door osf  
Dented  
2 Or Less UpTo 10mm

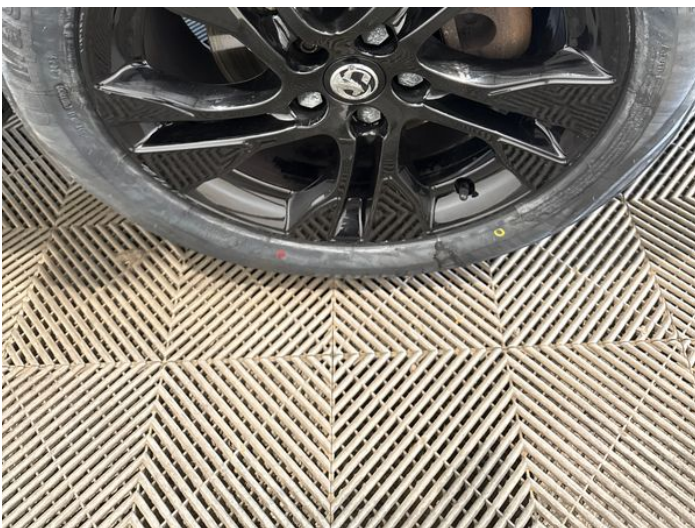
13: Wheel osf  
Scratched  
Over 50mm

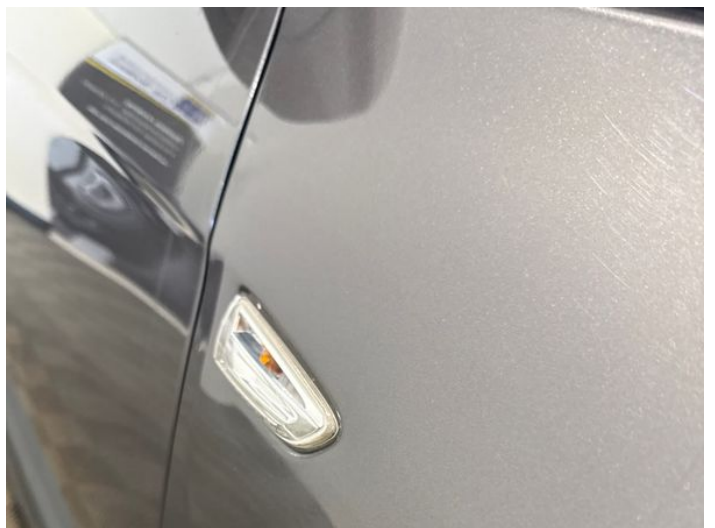
14: Wing osf  
Dented  
Over 30mm

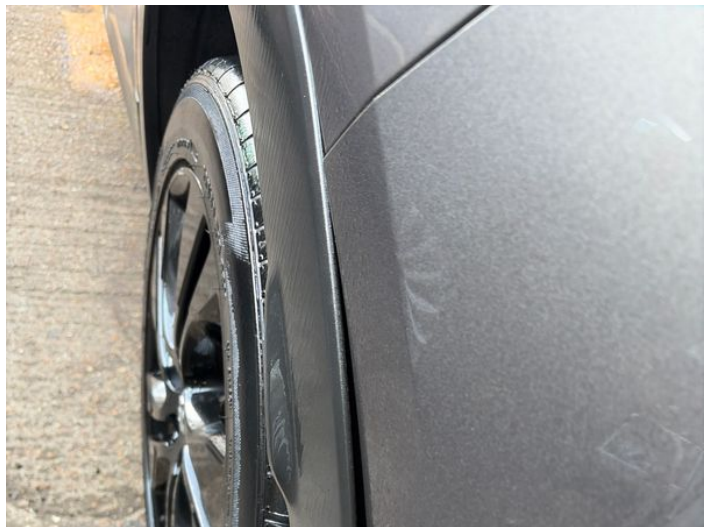
16: Qtr Panel Arch Extension ns  
Broken  
Replace
