# VEHICLE INSPECTION REPORT

**AY67VGJ**

## Peugeot 2008 1.2 PureTech Allure 5dr

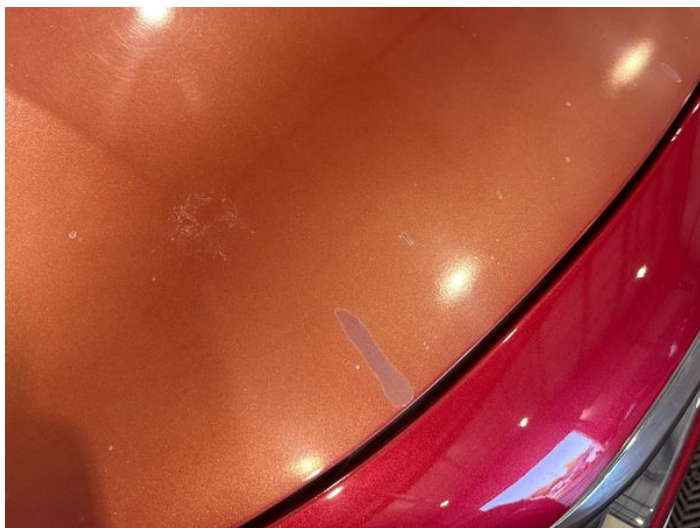
1: Bonnet  
Poor Previous Repair  
Paint Flake

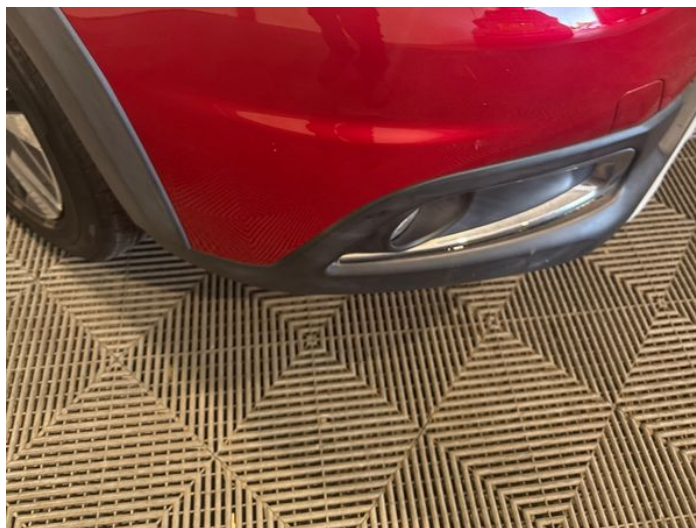
2: Bumper Front  
Scratched  
25 to 100mm Thru Paint

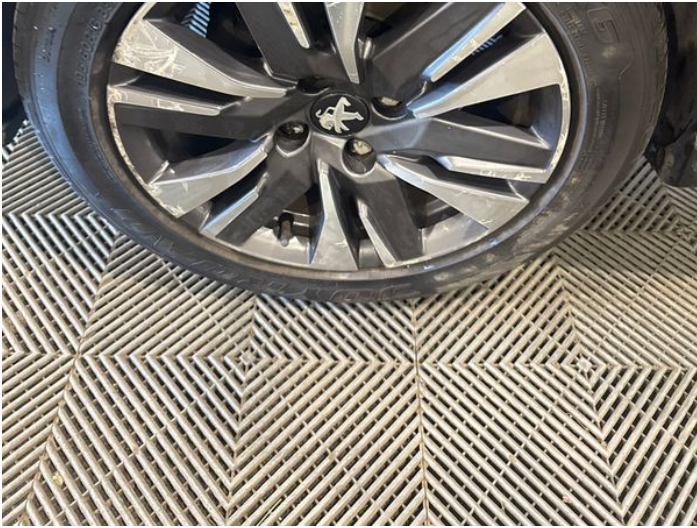
3: Wheel nsf  
Scratched  
Over 50mm

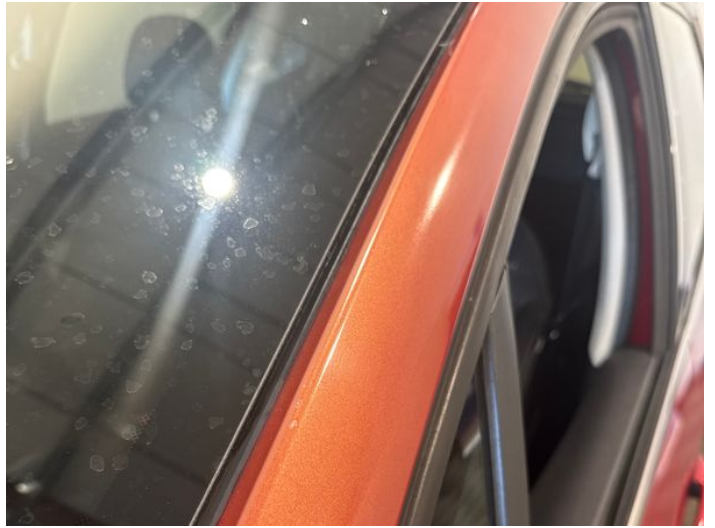
4: A Post ns  
Poor Previous Repair  
Paint Flake

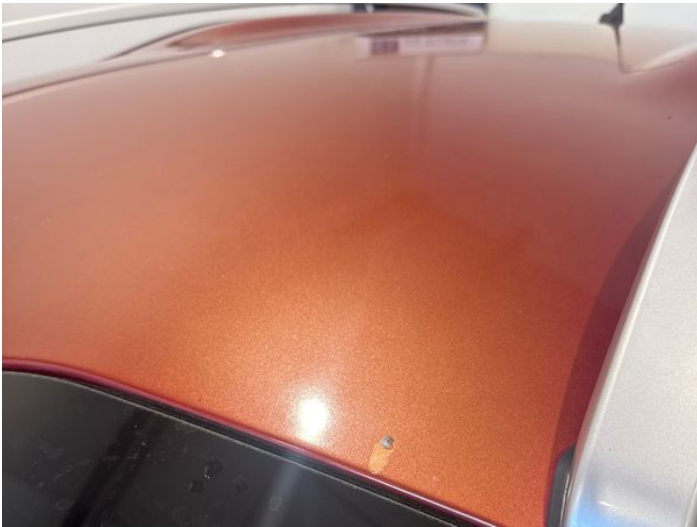
5: Roof  
Poor Previous Repair  
Paint Flake

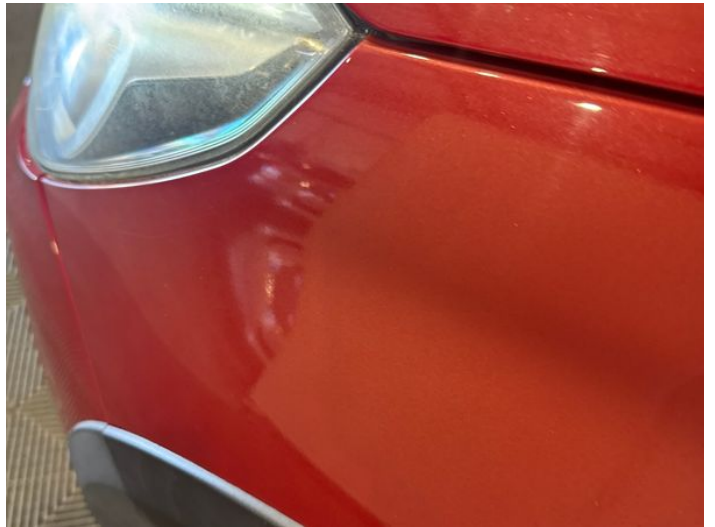
6: Wing nsf  
Chipped  
1 To 5

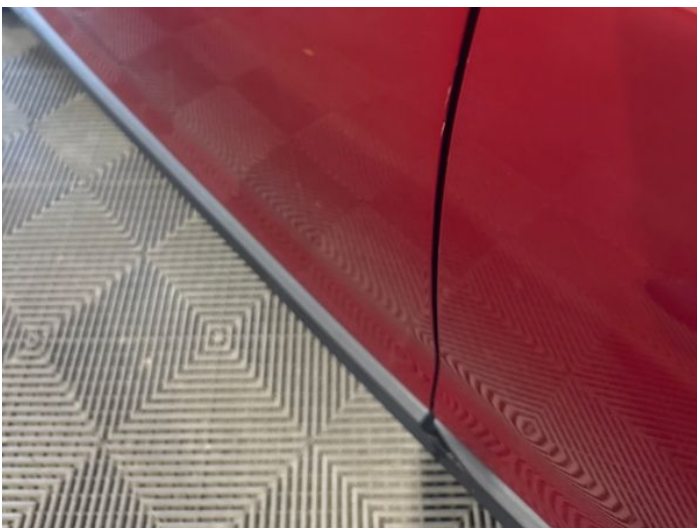
7: Door nsf  
Chipped  
Edge Chip

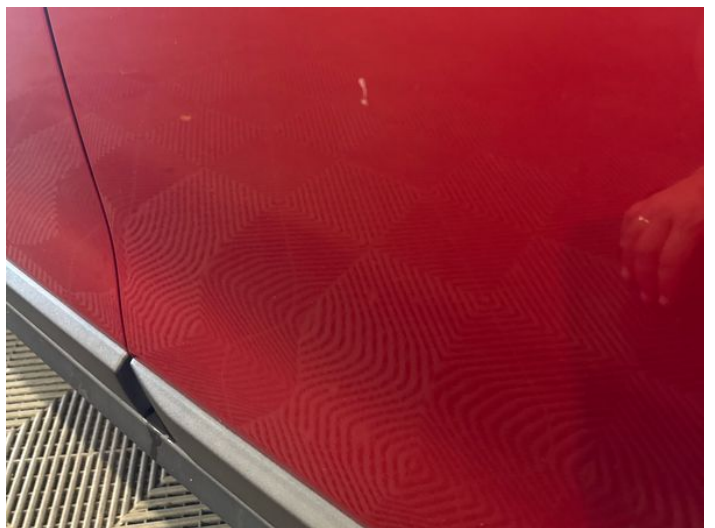
8: Door nsr  
Scratched  
Over 25mm Thru Paint

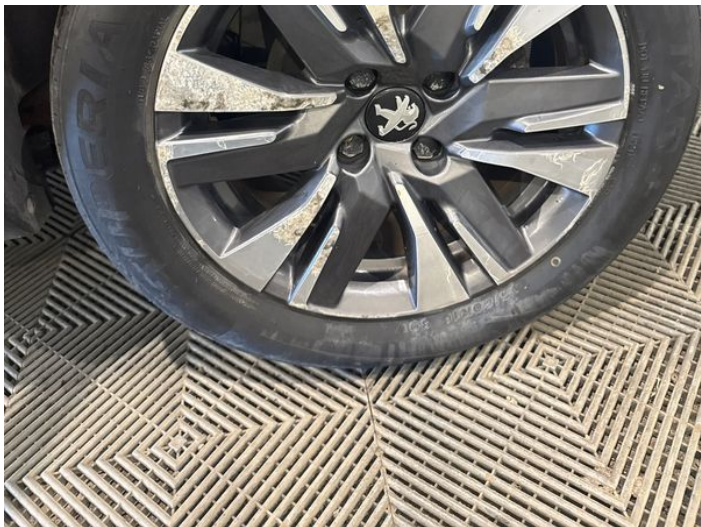
9: Wheel nsr  
Scratched  
Over 50mm

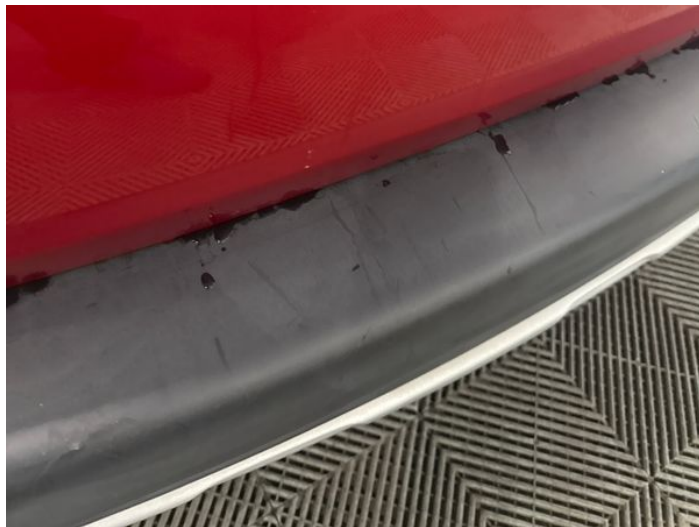
10: Tailgate  
Chipped  
1 To 5

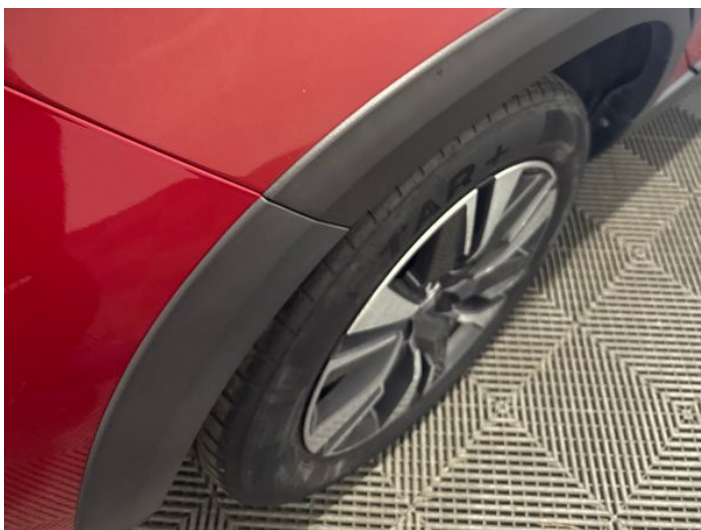
11: Qtr Panel osr  
Chipped  
1 To 5

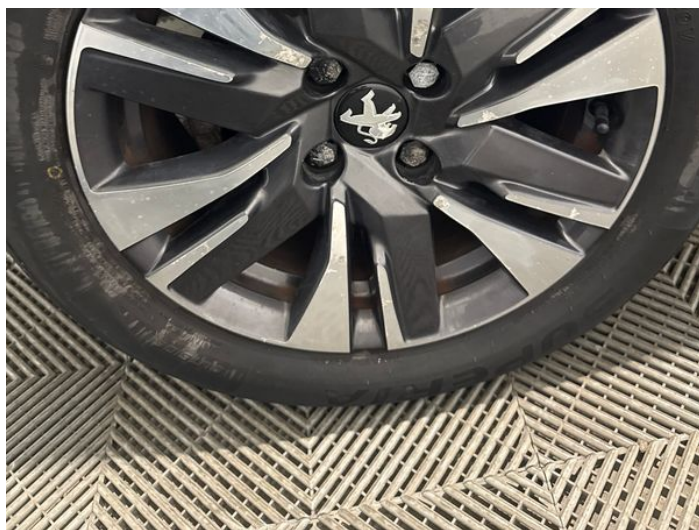
12: Wheel osr  
Corroded  
Light

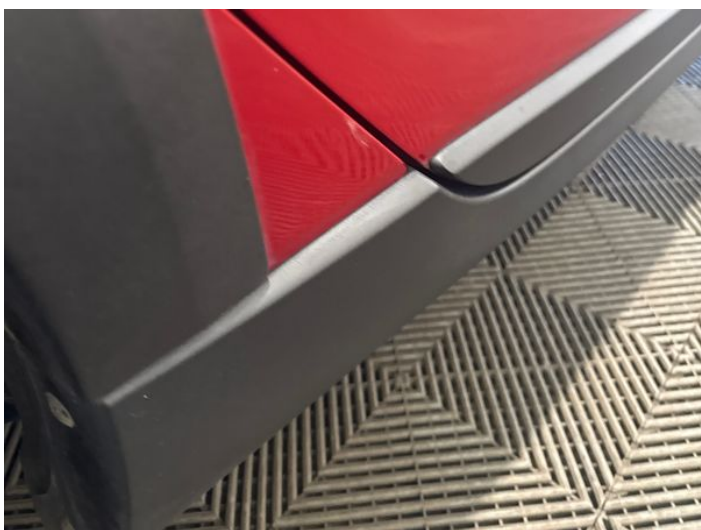
13: Door osr  
Scratched  
UpTo 25mm Thru Paint

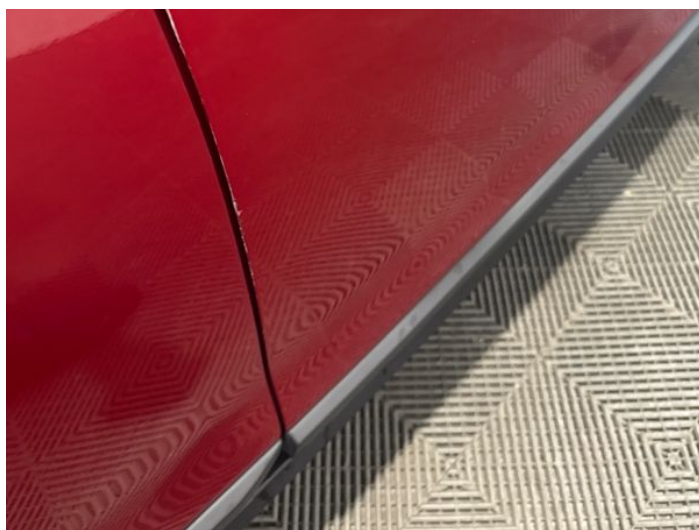
14: Door osf  
Chipped  
Edge Chip

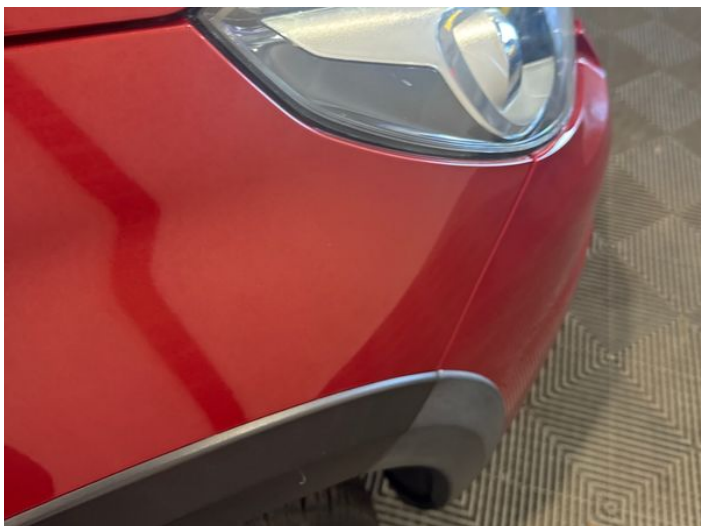
15: Wing osf  
Chipped  
1 To 5

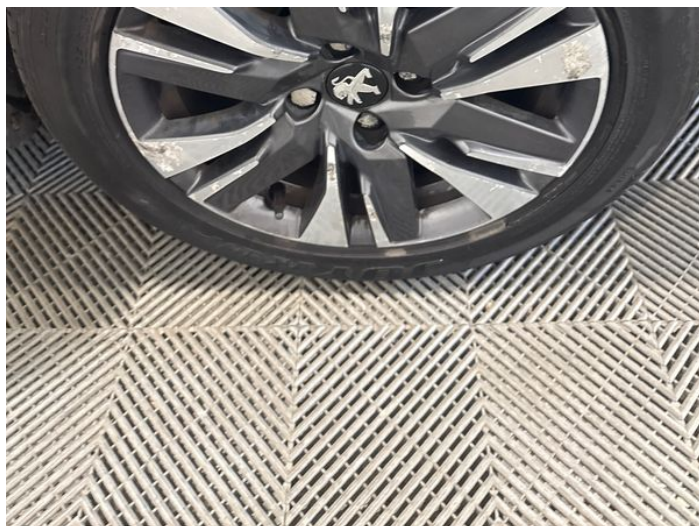
16: Wheel osf  
Scratched  
Over 50mm

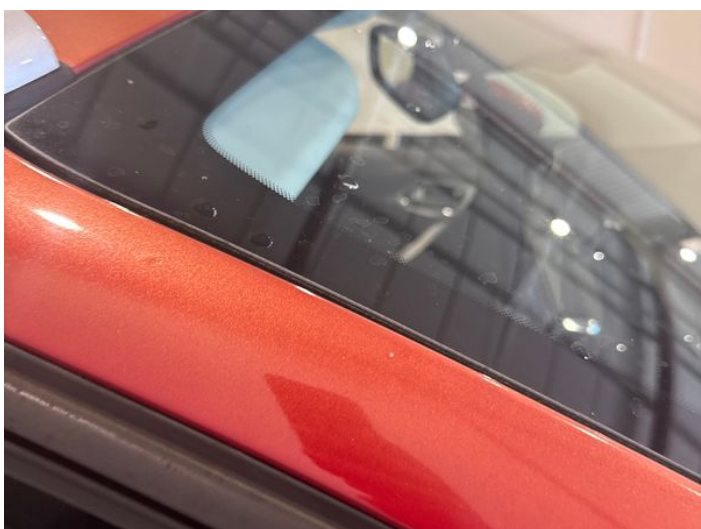
17: A Post os  
Chipped  
1 To 5
