# VEHICLE INSPECTION REPORT

**GX71VPV**

## Jaguar F-Pace 2.0 P400e R-Dynamic S 5dr Auto AWD

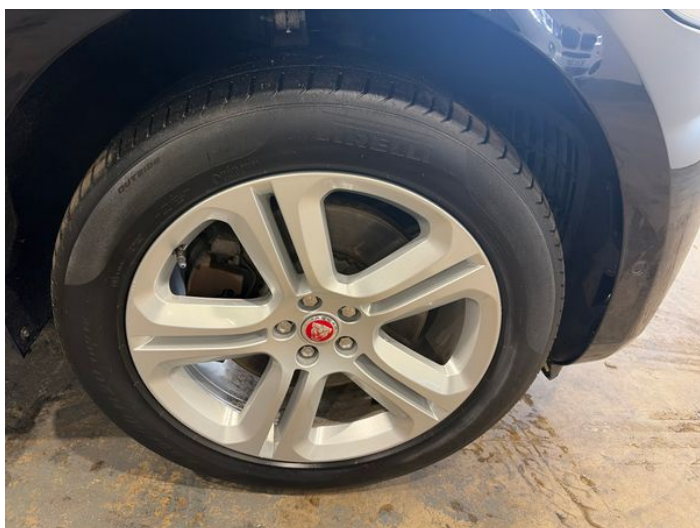
1: Wheel osf  
Scratched  
Up To 50mm

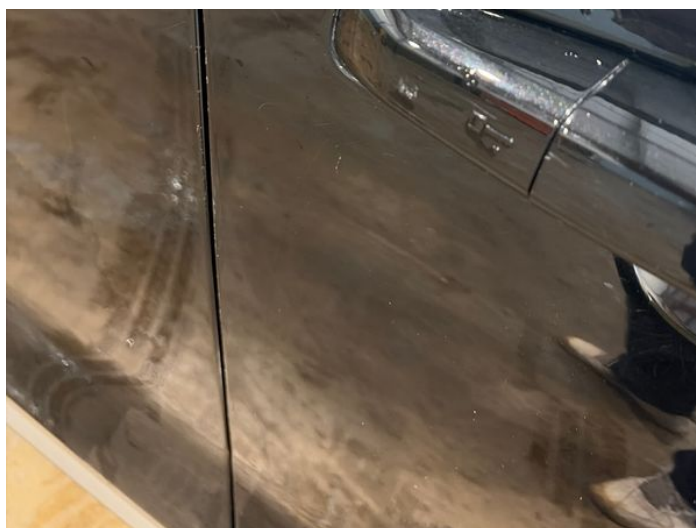
2: Door osf  
Chipped  
1 To 5

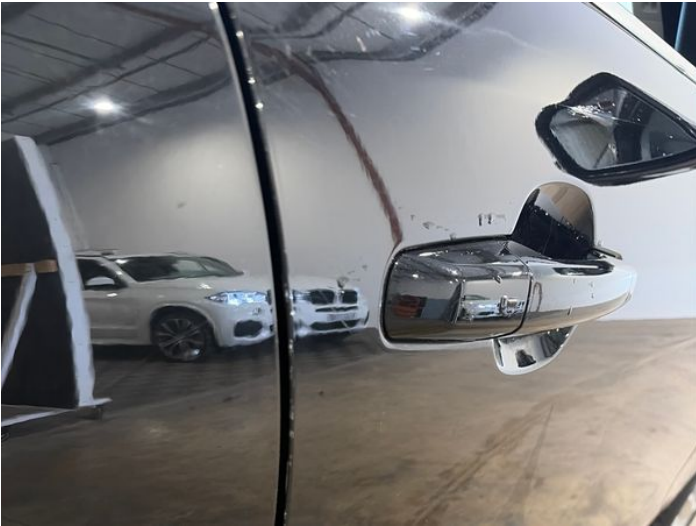
3: Door osf  
Chipped  
Edge Chip

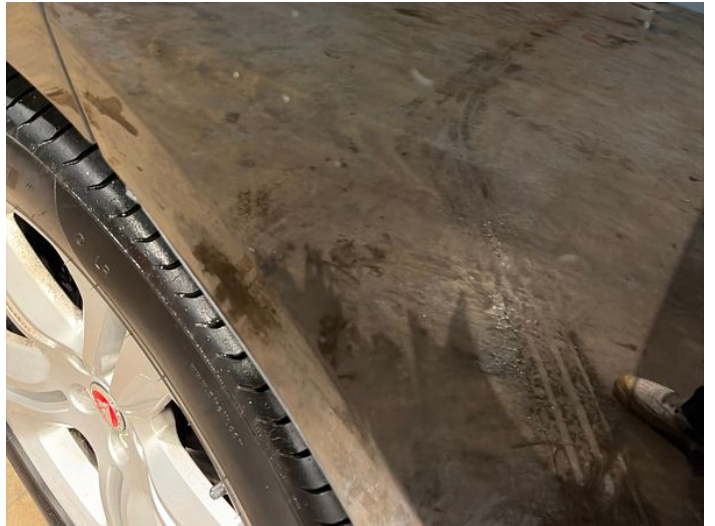
4: Door osr  
Chipped  
1 To 5

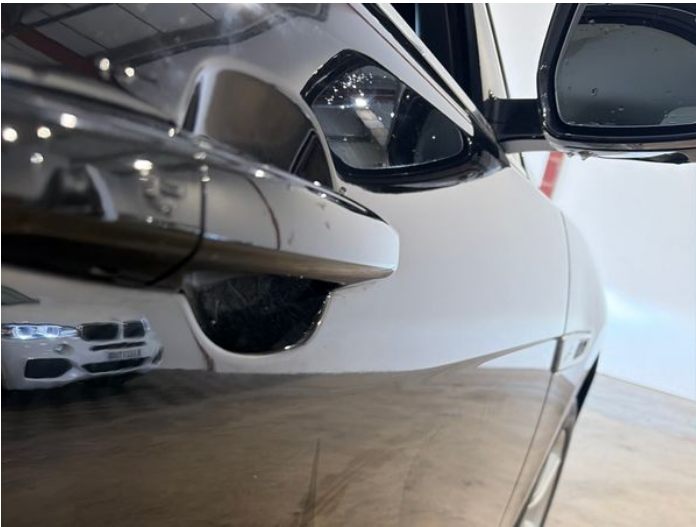
5: Door osf  
Dented  
2 Or Less UpTo 10mm

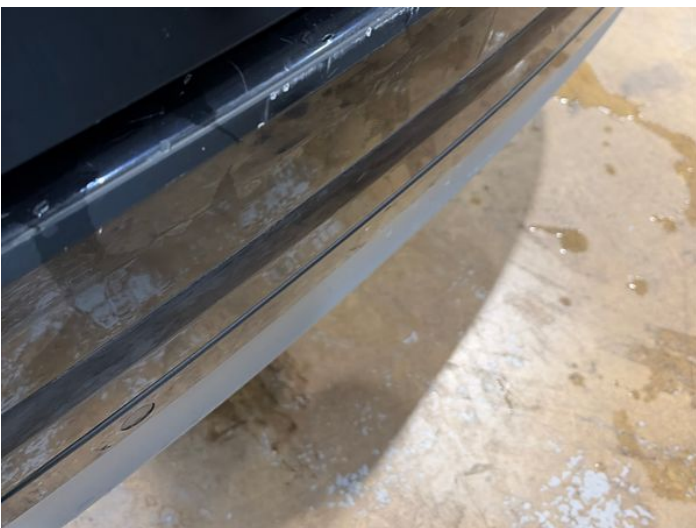
7: Bumper Rear  
Chipped  
Multiple Chips

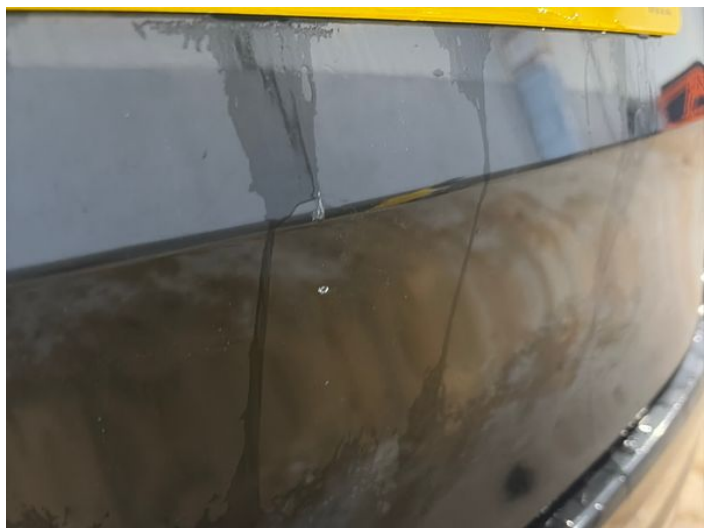
8: Tailgate  
Poor Previous Repair  
Poor Paint

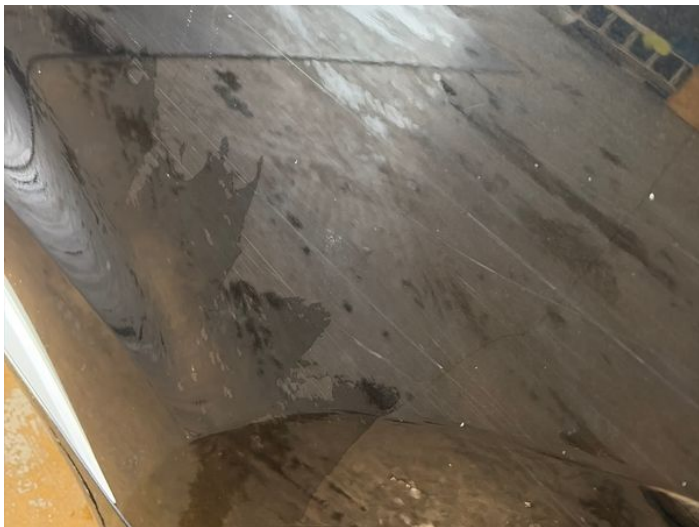
9: Door nsr  
Scratched  
Over 25mm Thru Paint

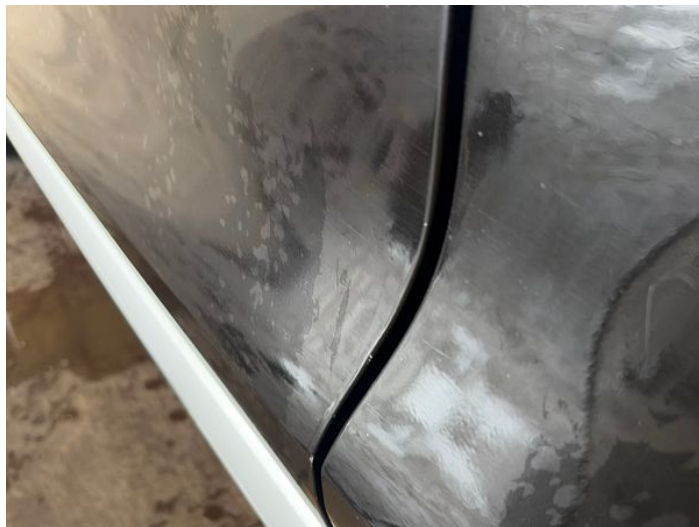
10: Door nsf  
Chipped  
Edge Chip

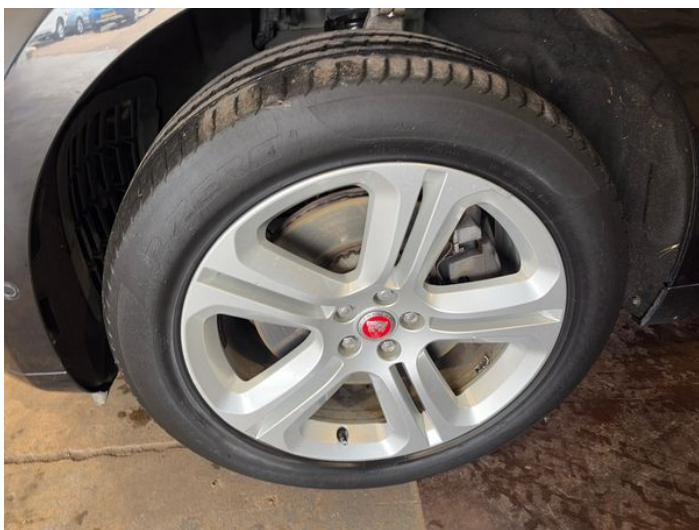
11: Wheel nsf  
Scratched  
Over 50mm

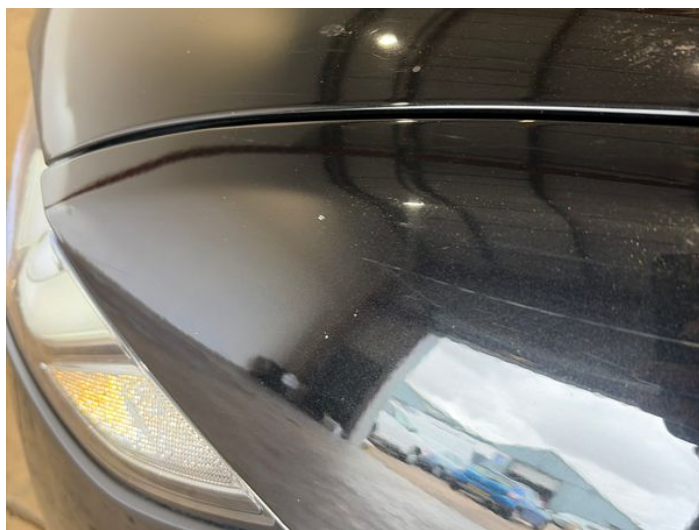
12: Wing nsf  
Chipped  
1 To 5

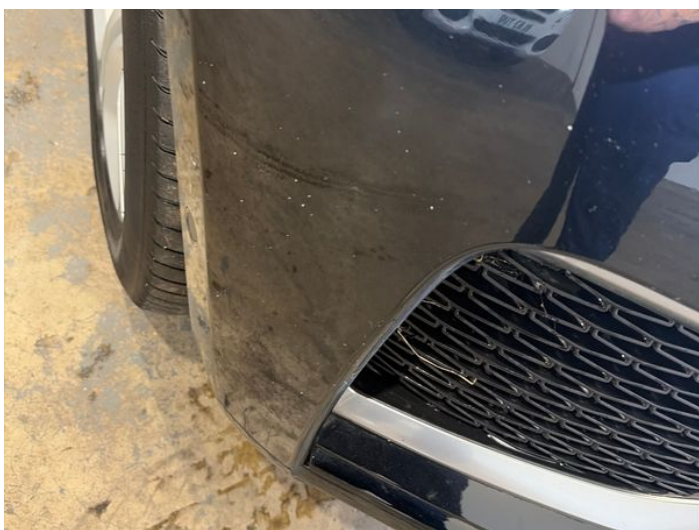
13: Bumper Front  
Chipped  
Multiple Chips

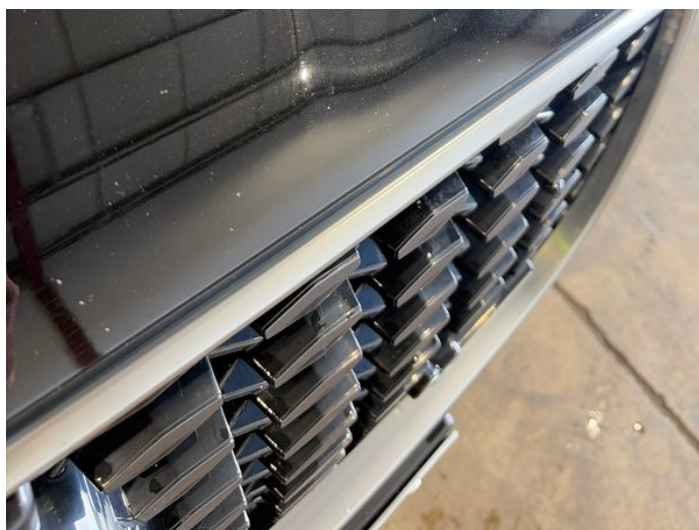
14: Bonnet  
Chipped  
1 To 5

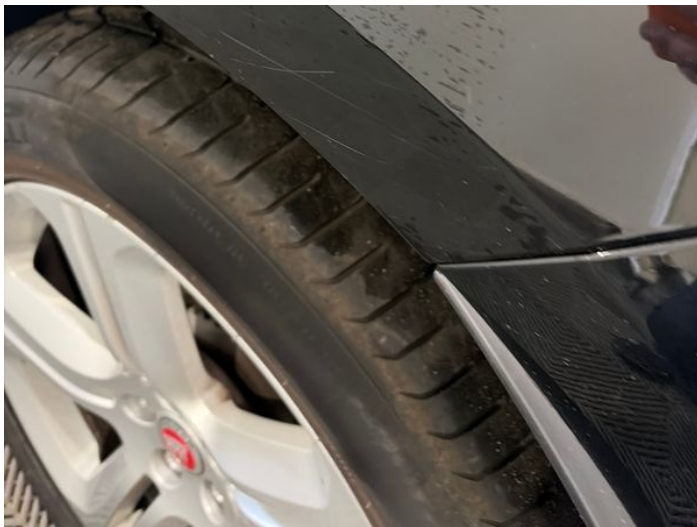
15: Qtr Panel nsr  
Scratched  
Over 25mm Thru Paint

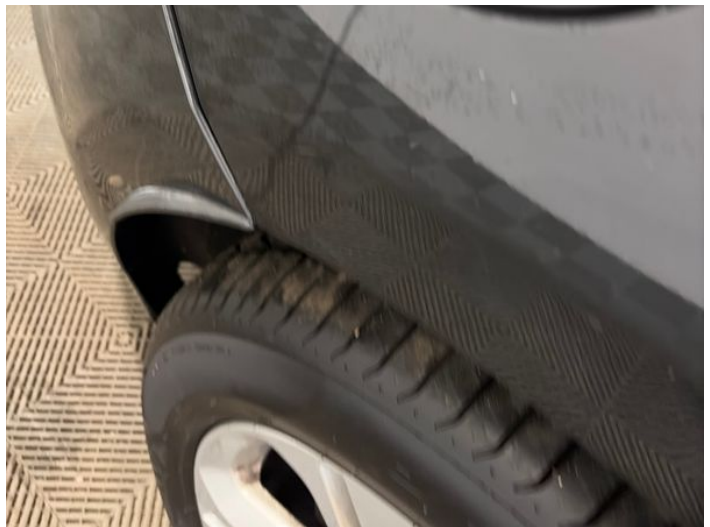
16: Qtr Panel osr  
Scratched  
UpTo 25mm Thru Paint
