# VEHICLE INSPECTION REPORT

OY12FBJ

## Vauxhall Astra 1.6i 16V Excite 5dr

nama  
GRADE  
4

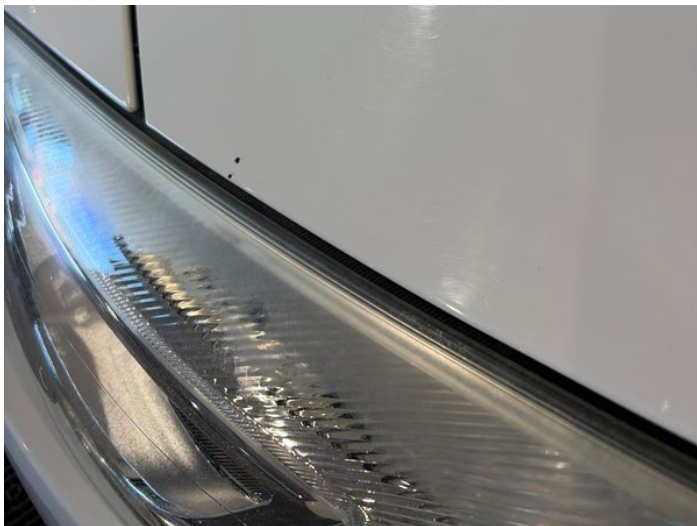
1: Bonnet  
Chipped  
1 To 5

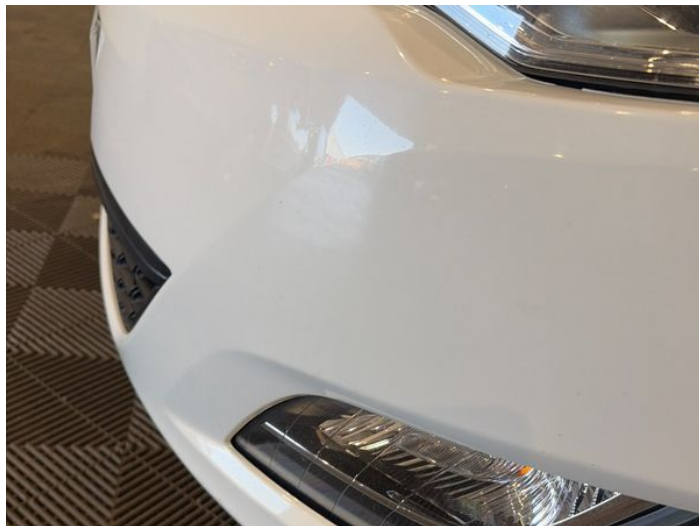
2: Bumper Front  
Chipped  
1 To 5

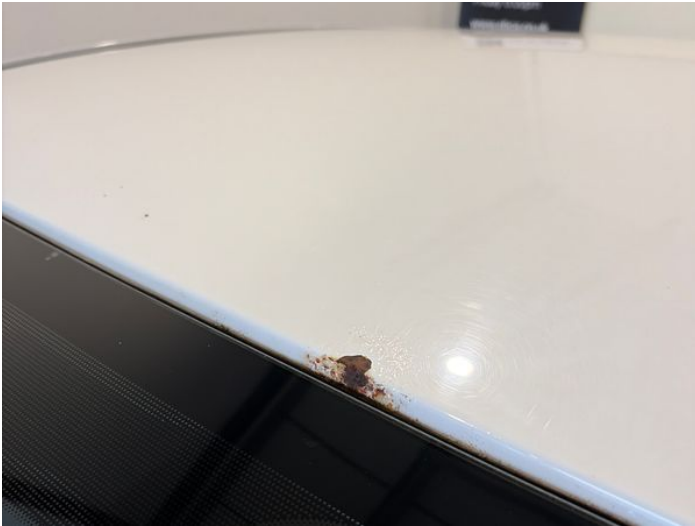
3: Roof  
Rusted  
Over 5mm

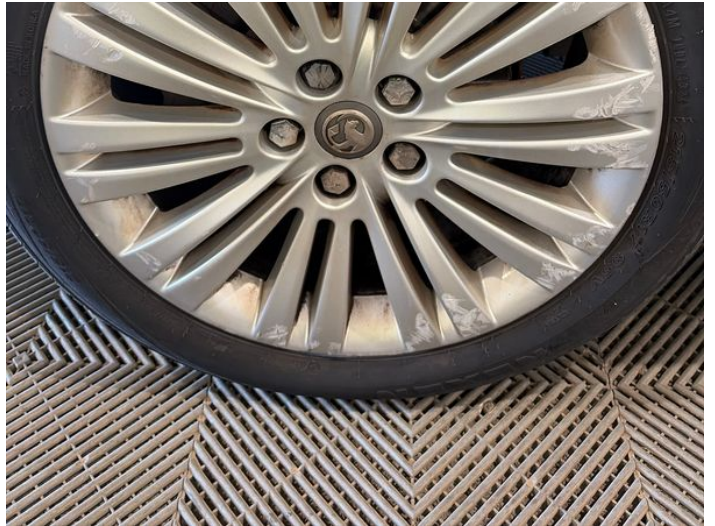
4: Wheel nsf  
Scratched  
Over 50mm

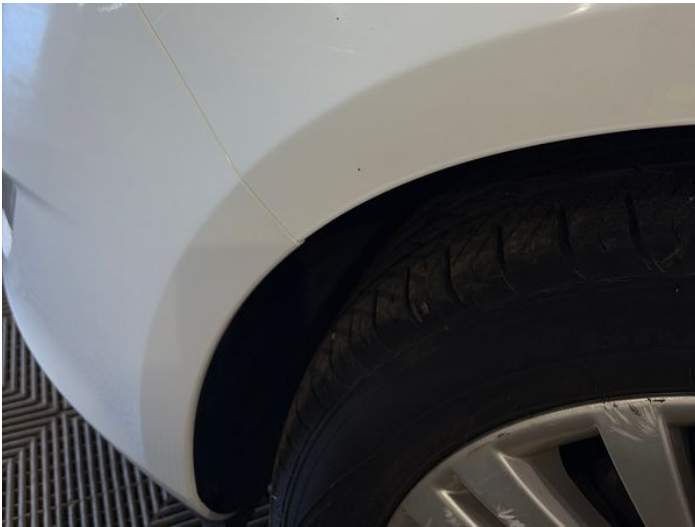
5: Wing nsf  
Chipped  
1 To 5

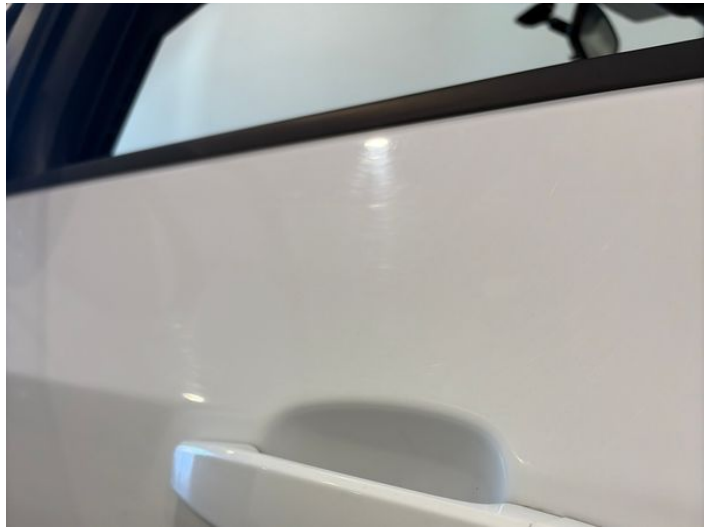
6: Handle Outer nsf  
Scratched (Painted)  
UpTo 25mm Thru Paint

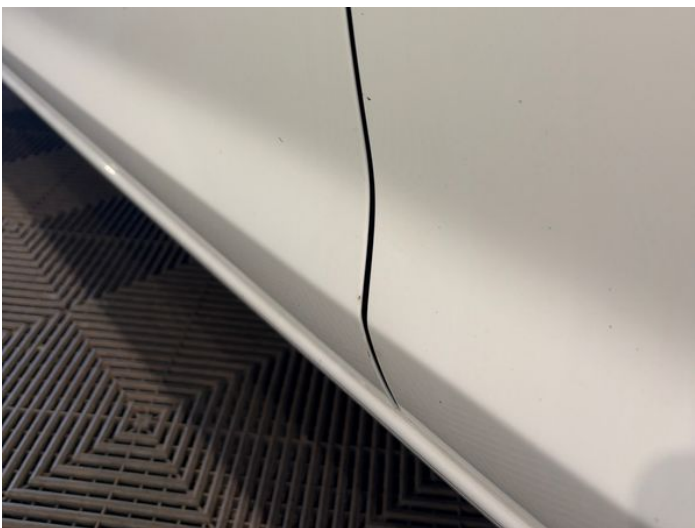
7: Door nsf  
Chipped  
1 To 5

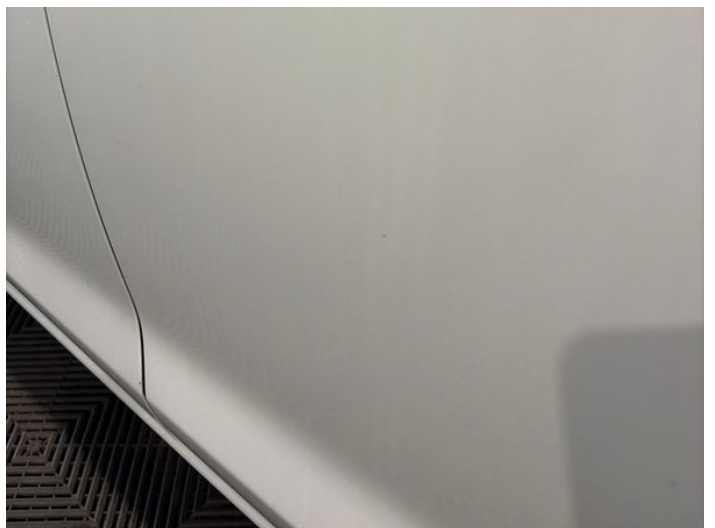
8: Door nsr  
Chipped  
1 To 5

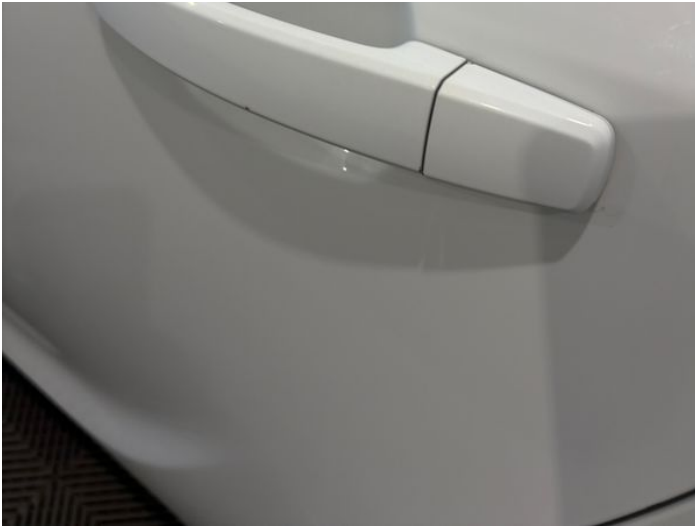
9: Handle Outer nsr  
Scratched (Painted)  
UpTo 25mm Thru Paint

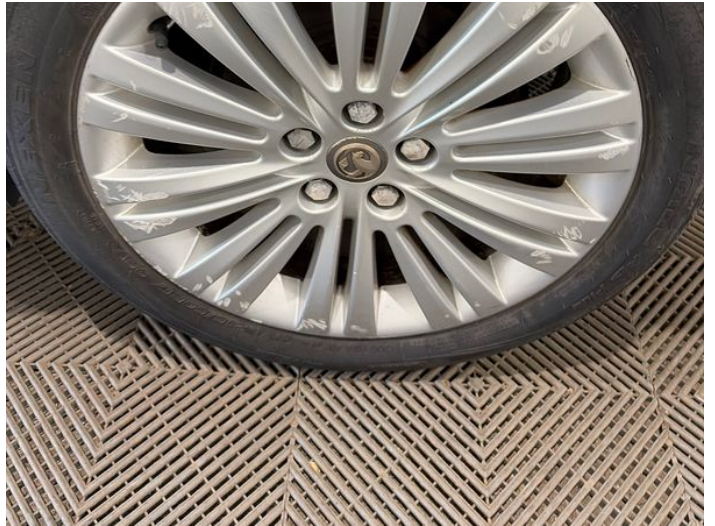
10: Wheel nsr  
Scratched  
Over 50mm

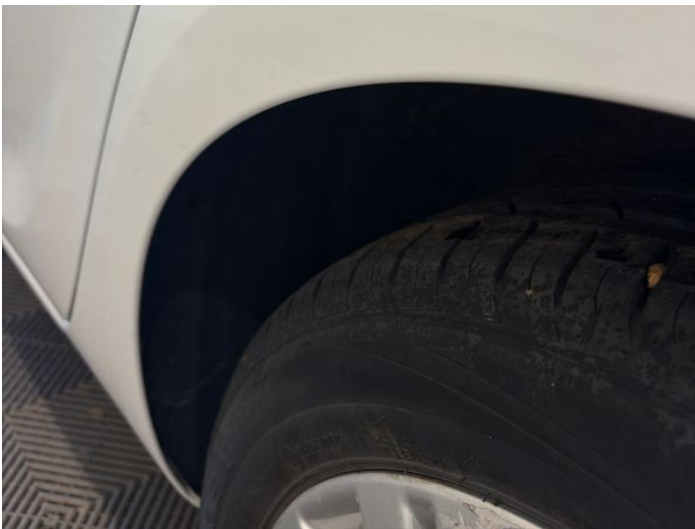
11: Qtr Panel nsr  
Dented  
Between 10mm + 30mm

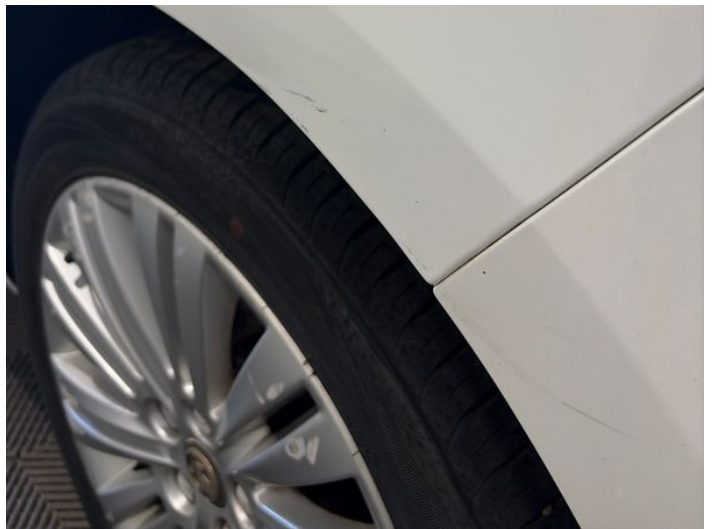
12: Qtr Panel nsr  
Scratched  
UpTo 25mm Thru Paint

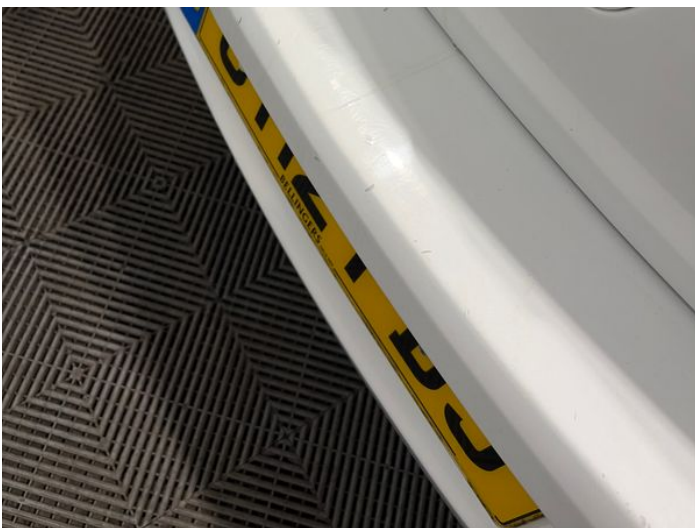
13: Bumper Rear  
Scratched  
Over 100mm Thru Paint

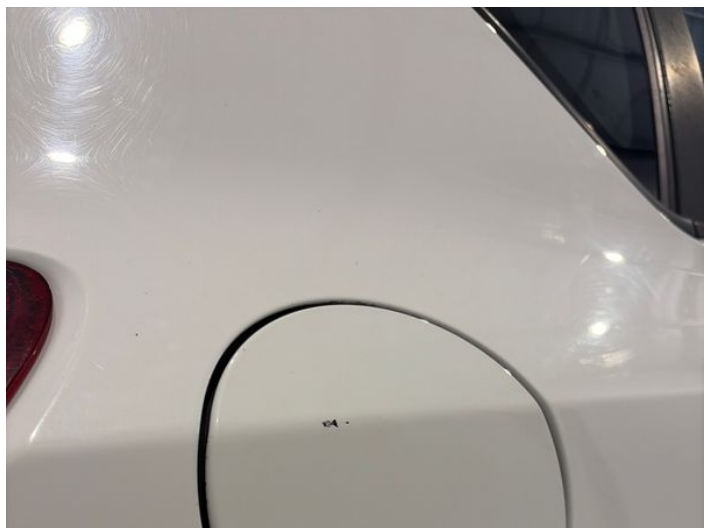
14: Qtr Panel osr  
Scratched  
UpTo 25mm Thru Paint

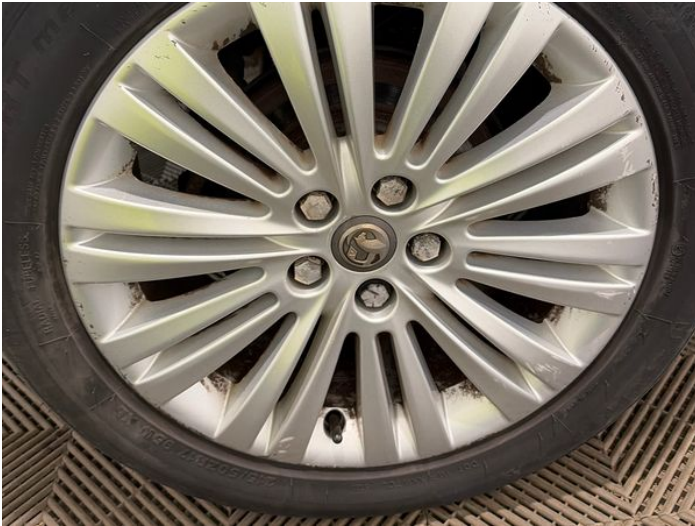
15: Wheel osr  
Scratched  
Over 50mm

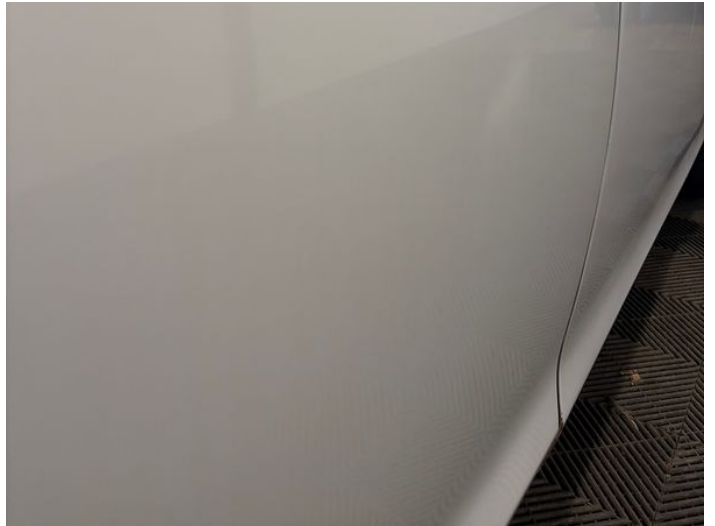
16: Door osr  
Dented  
Between 10mm + 30mm

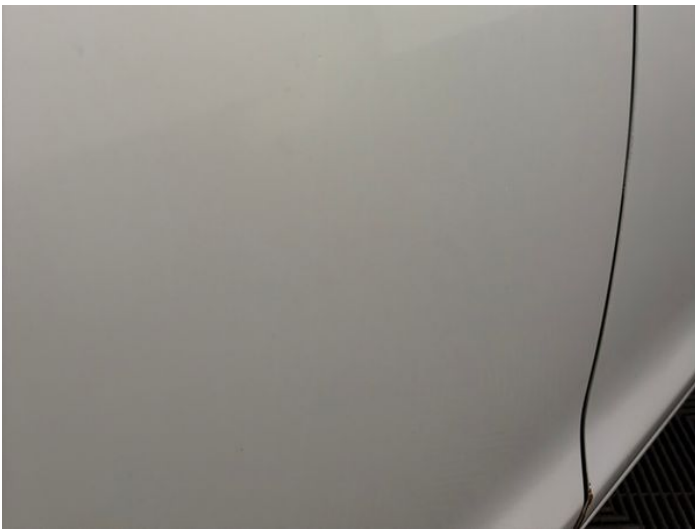
17: Door osr  
Chipped  
1 To 5

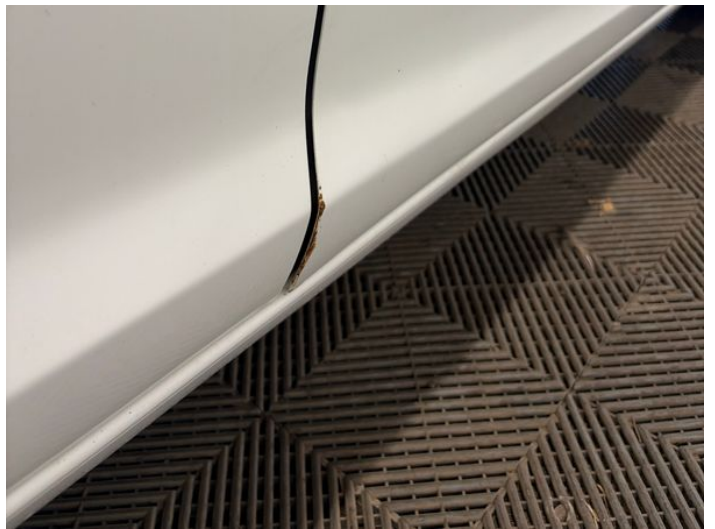
18: Door osf  
Scratched  
Rusted

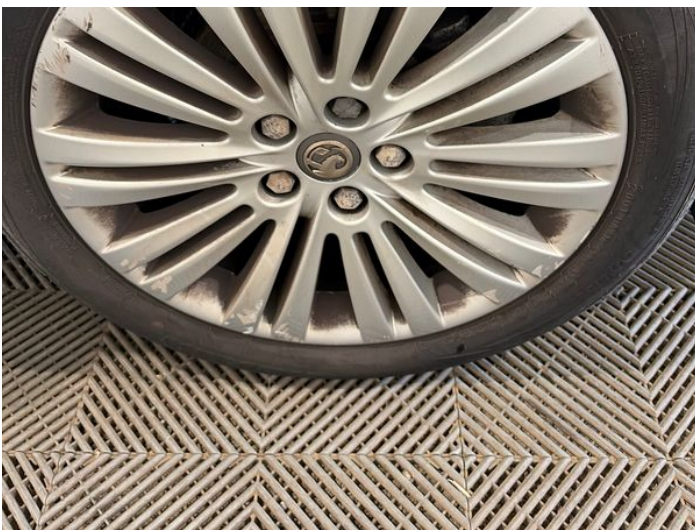
19: Wheel osf  
Scratched  
Over 50mm

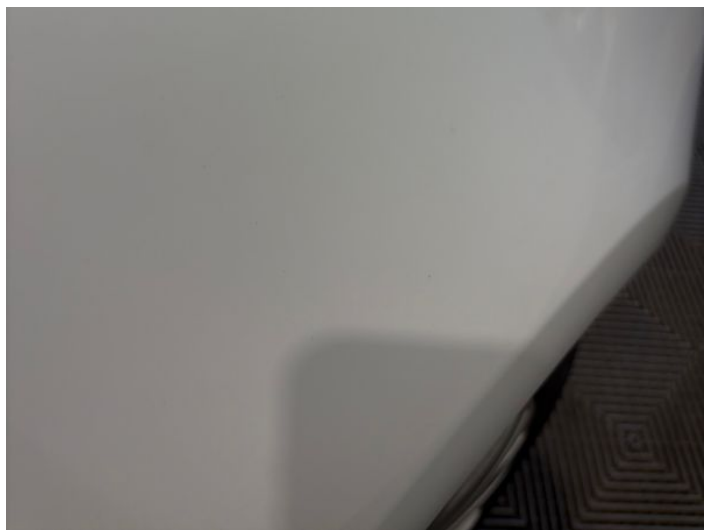
20: Wing osf  
Poor Previous Repair  
Paint Flake

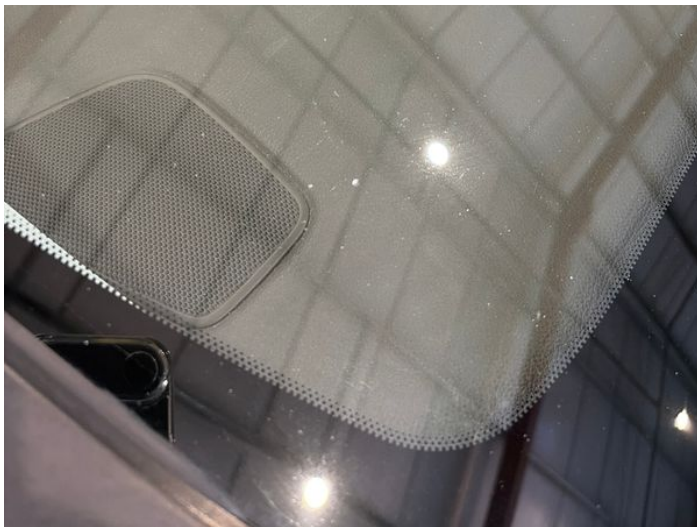
21: Screen Front  
Cracked  
Replace

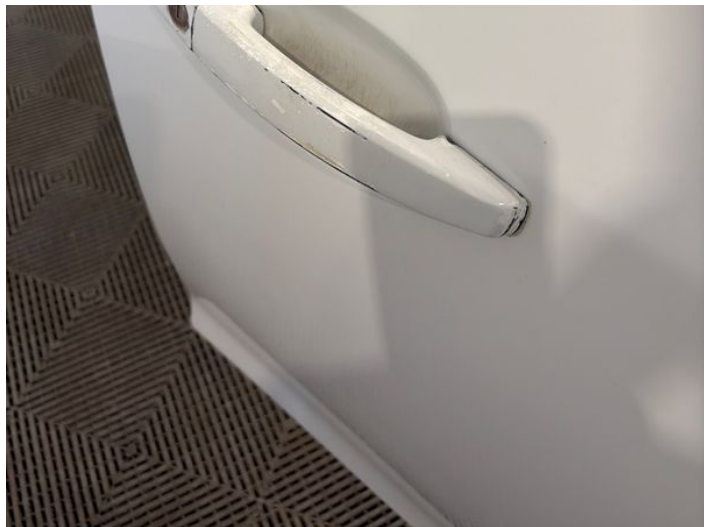
22: Handle Outer osf  
Scratched (Painted)  
Over 25mm Thru Paint
