# VEHICLE INSPECTION REPORT

**PO14WDS**

## Nissan Juke 1.6 Tekna 5dr CVT

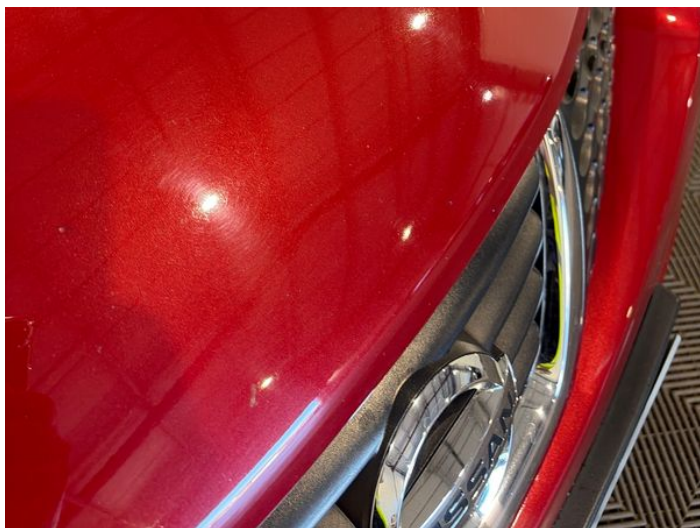
1: Bonnet  
Chipped  
1 To 5

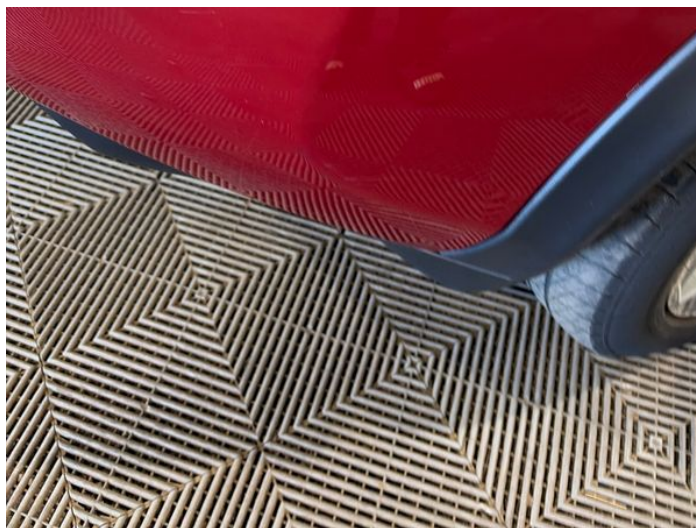
2: Bumper Front  
Scratched  
25 to 100mm Thru Paint

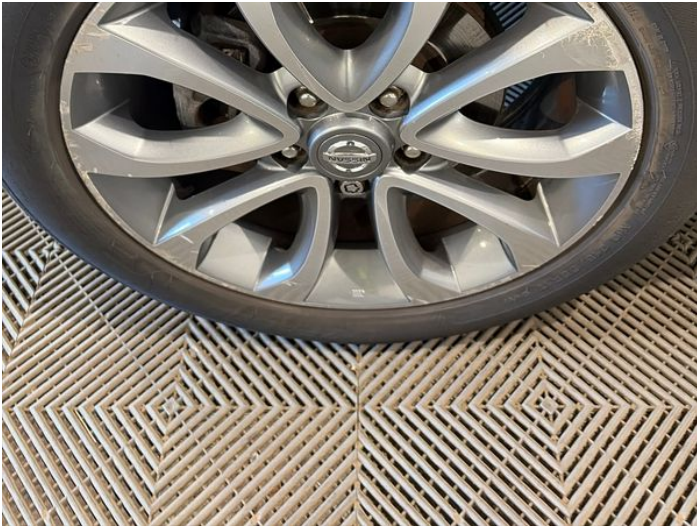
3: Wheel nsf  
Scratched  
Over 50mm

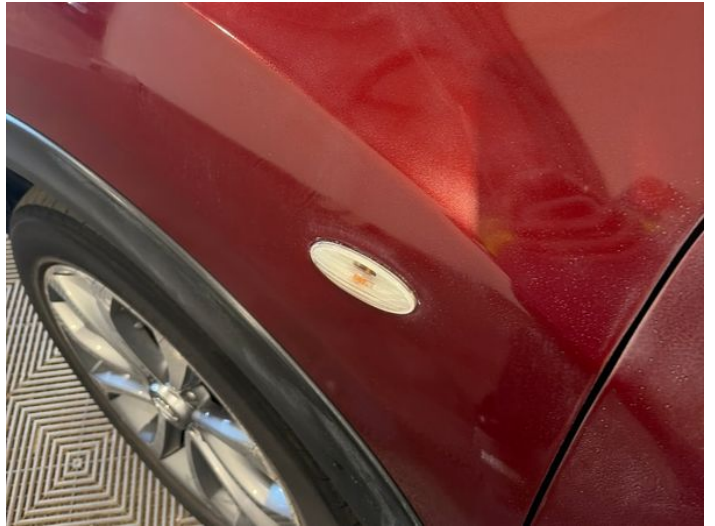
4: Wing nsf  
Poor Previous Repair  
Poor Paint

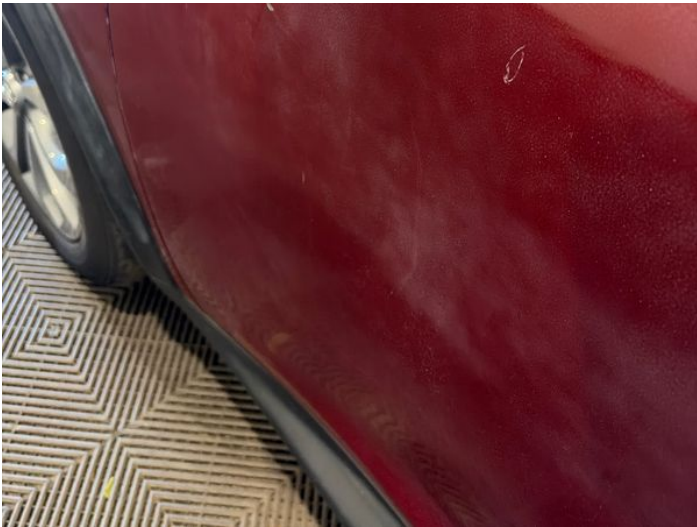
5: Door nsf  
Poor Previous Repair  
Rippled UpTo 30%

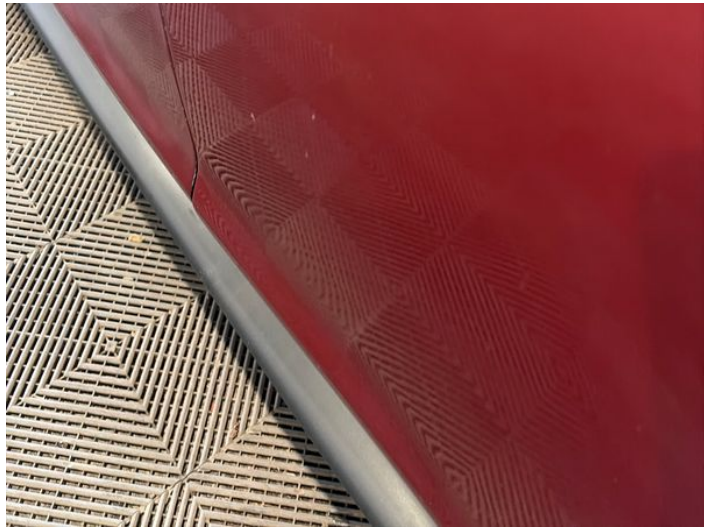
6: Door nsr  
Chipped  
Multiple Chips

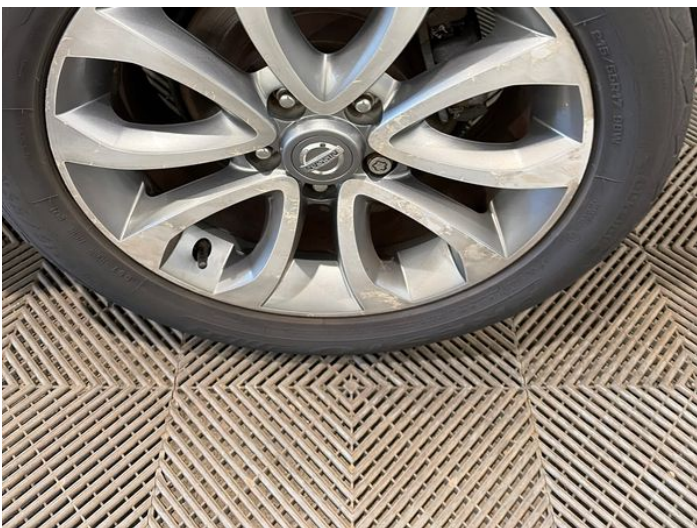
7: Wheel nsr  
Scratched  
Over 50mm

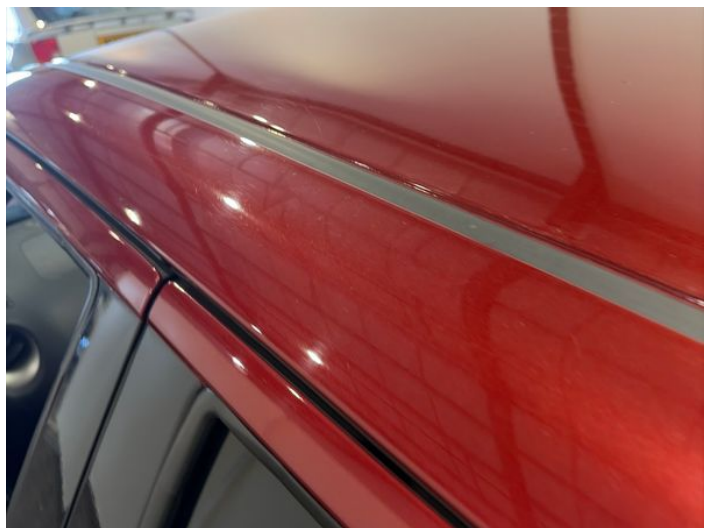
8: B Post ns  
Dented  
Between 10mm + 30mm

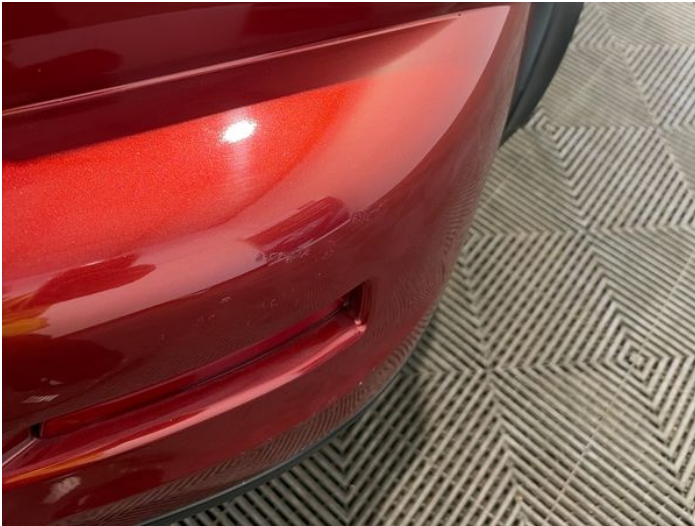
9: Bumper Rear  
Scratched  
25 to 100mm Thru Paint

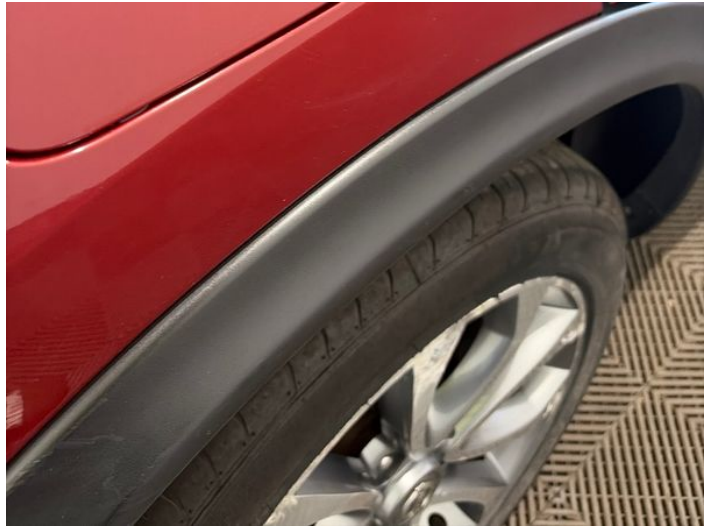
10: Qtr Panel osr  
Scratched  
UpTo 25mm Thru Paint

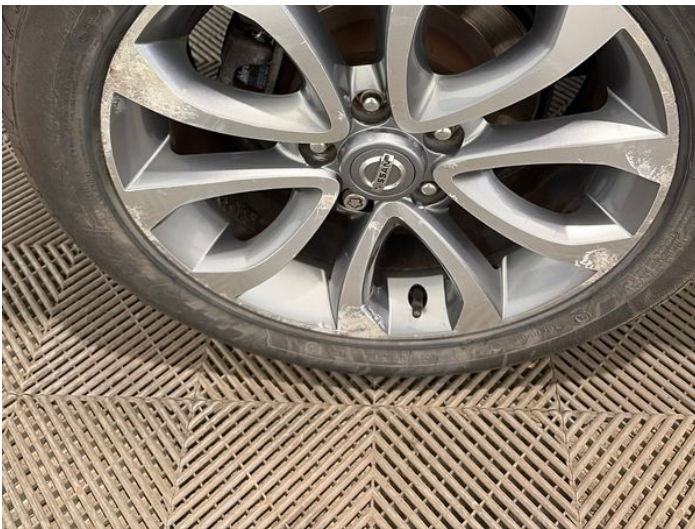
11: Wheel osr  
Scratched  
Over 50mm

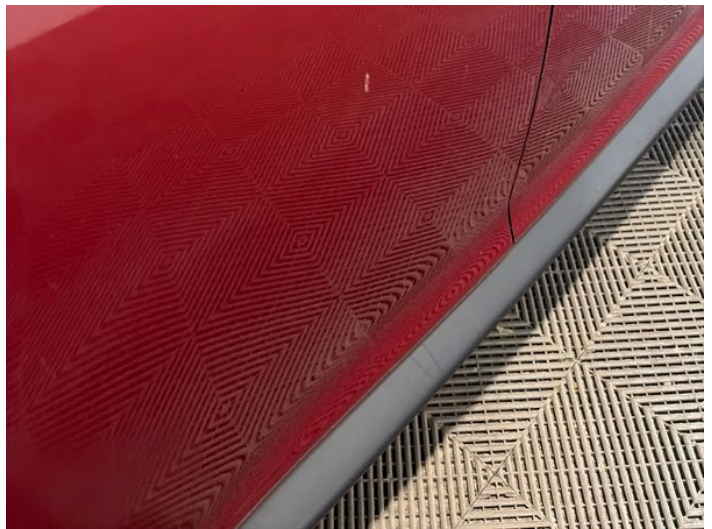
12: Door osr  
Chipped  
Multiple Chips

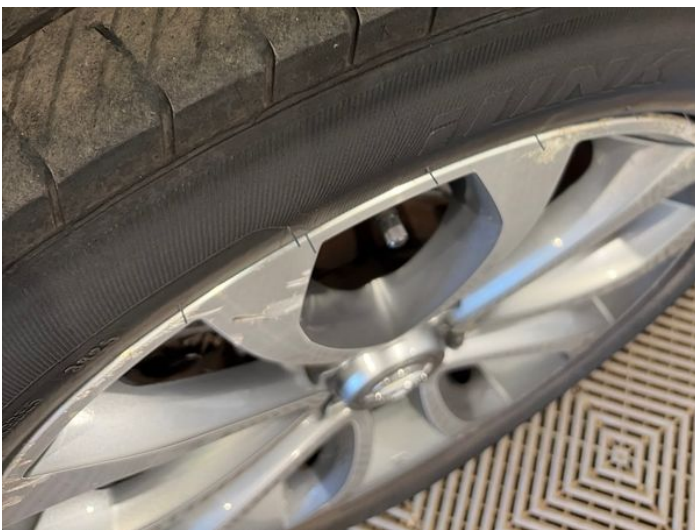
| NSF | BUDGET | Damaged |

13: Tyre nsf  
Damaged  
Replace

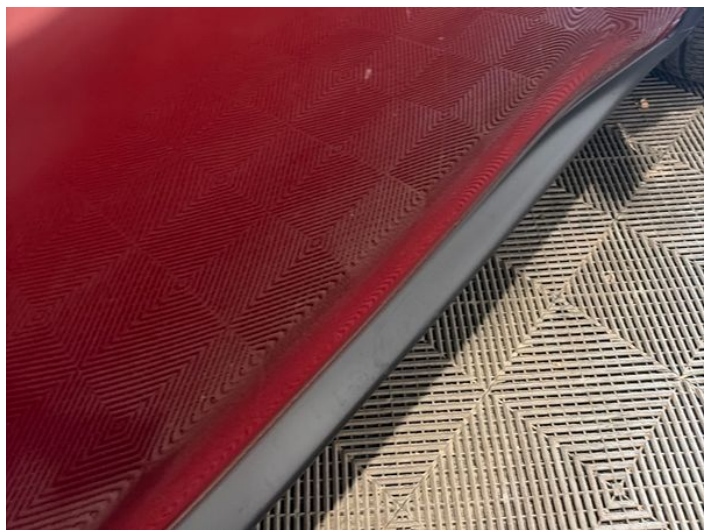
14: Door osf  
Scratched  
Over 25mm Thru Paint

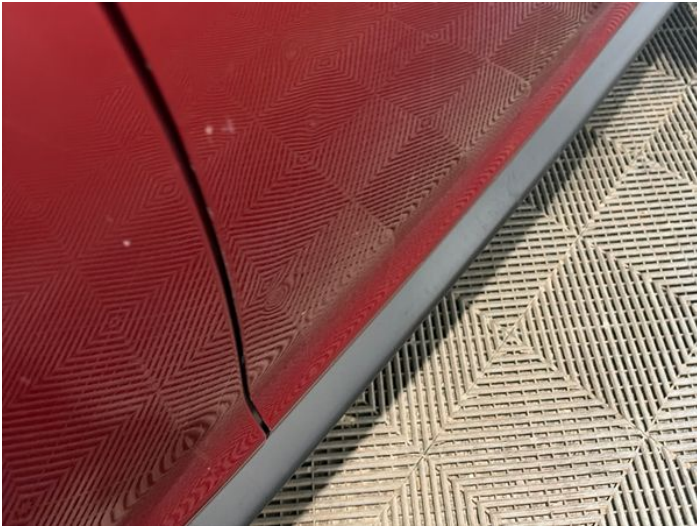
15: Door osf  
Dented  
Between 10mm + 30mm

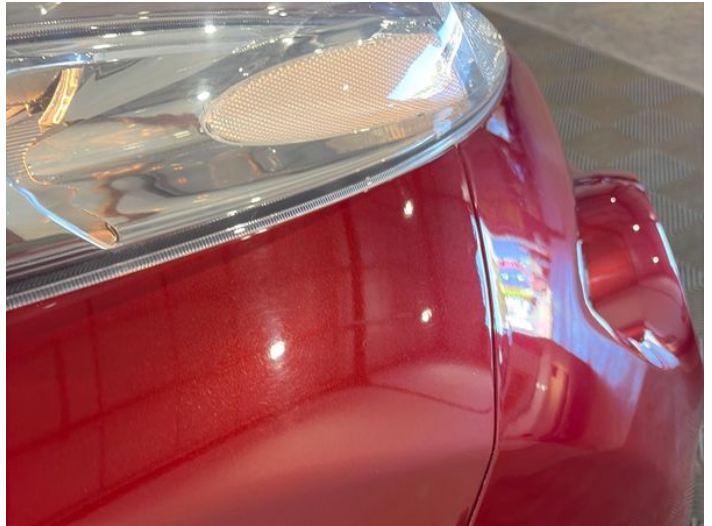
16: Wing osf  
Chipped  
1 To 5

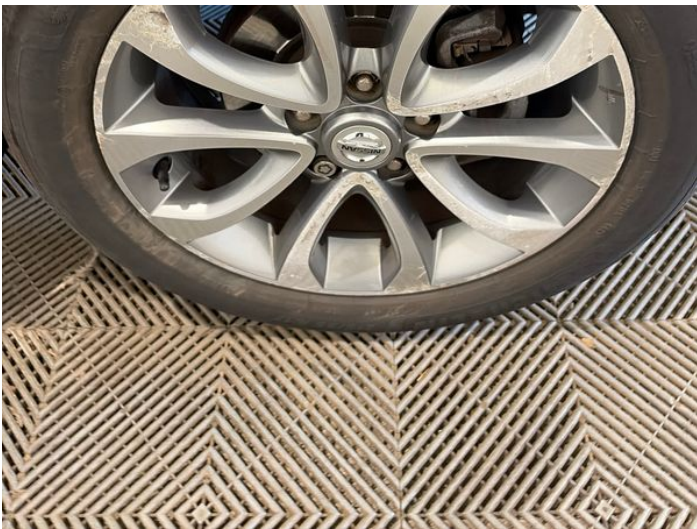
17: Wheel osf  
Scratched  
Over 50mm

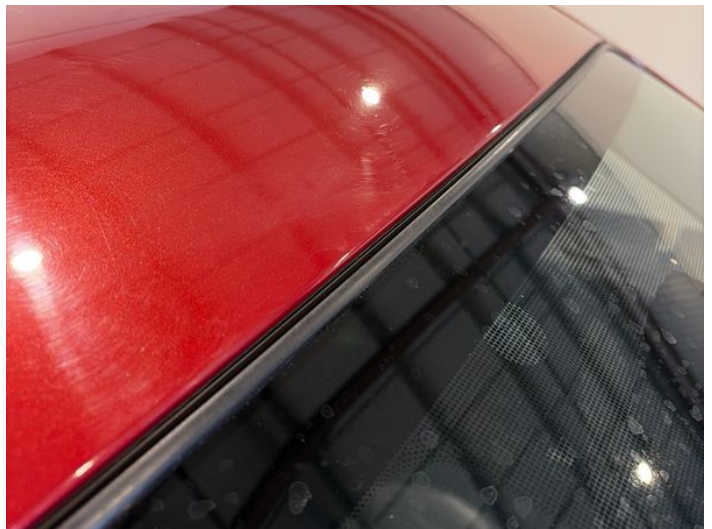
18: Roof  
Scratched  
UpTo 25mm Thru Paint
