# VEHICLE INSPECTION REPORT

**GU57XSN**

## Citroen Xsara Picasso 2.0i 16V Exclusive 5dr Auto

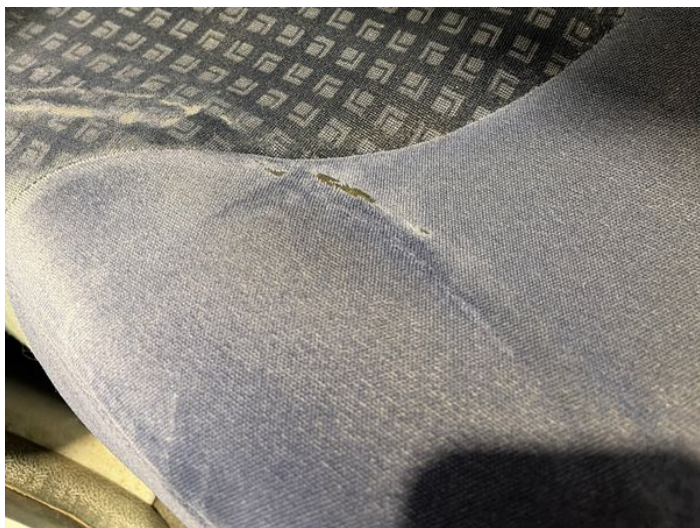
1: Seat Base Cover osf  
Scuffed  
Over 25mm

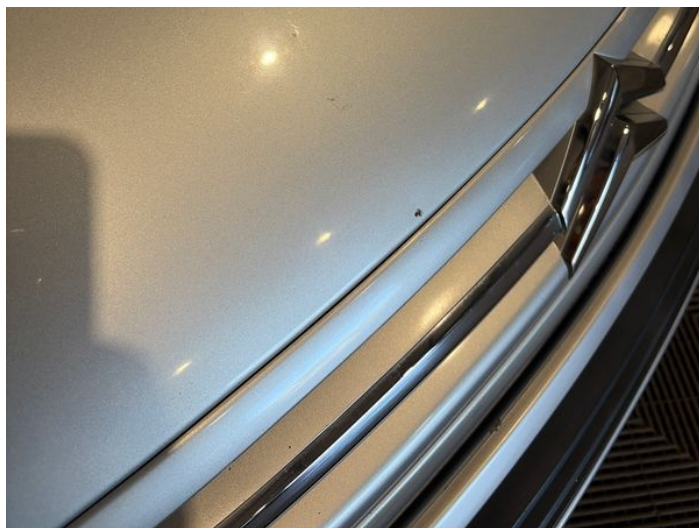
2: Bonnet  
Chipped  
1 To 5

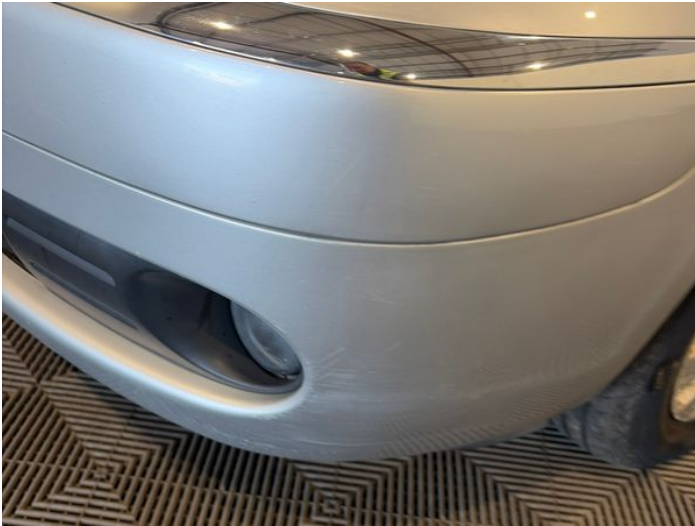
3: Bumper Front  
Scratched  
Over 100mm Thru Paint

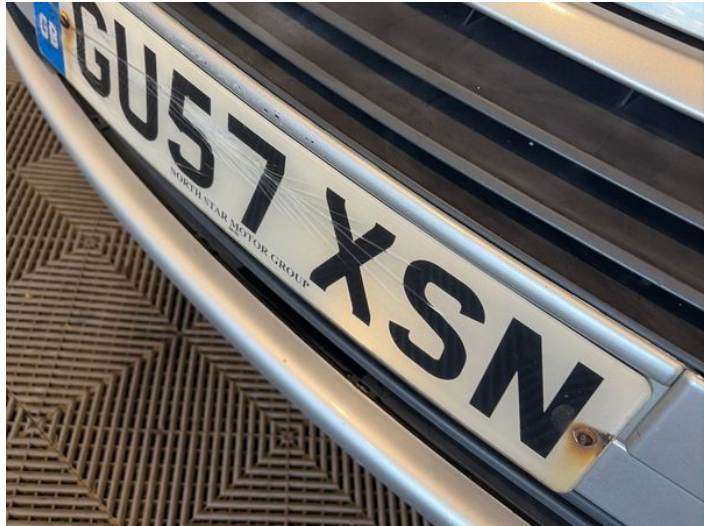
4: Number Plate Front  
Broken  
Replace

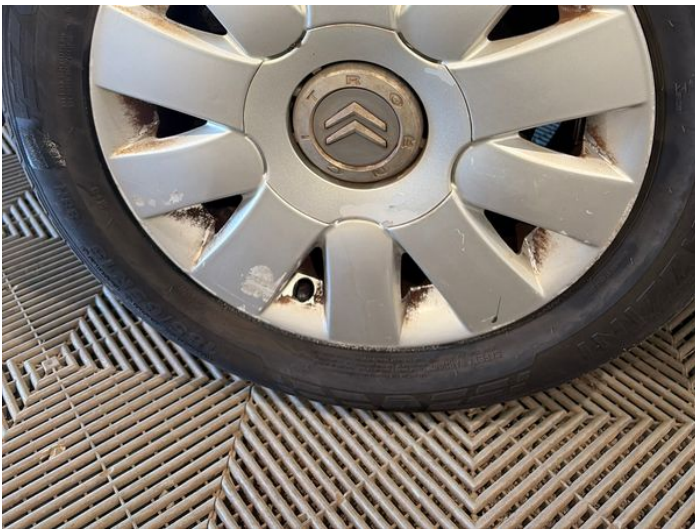
5: Wheel nsf  
Scratched  
Over 50mm

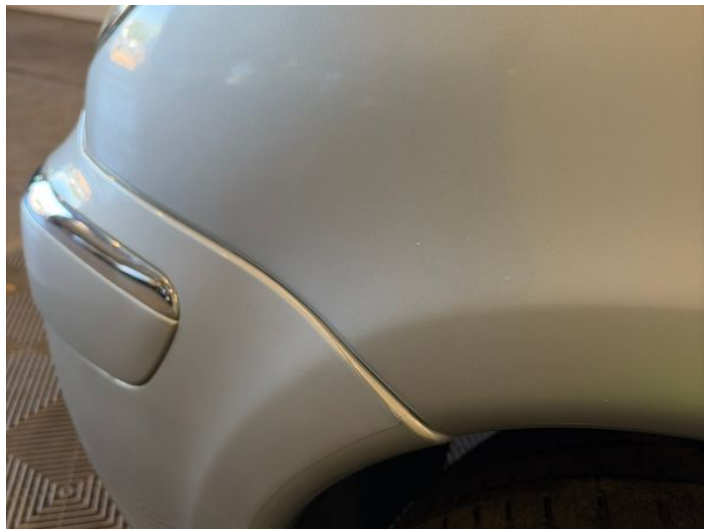
6: Wing nsf  
Poor Previous Repair  
Poor Paint

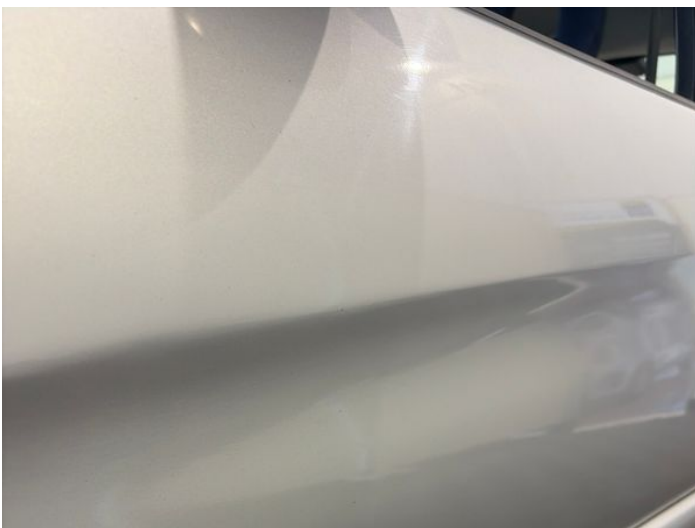
7: Door nsf  
Poor Previous Repair  
Poor Paint

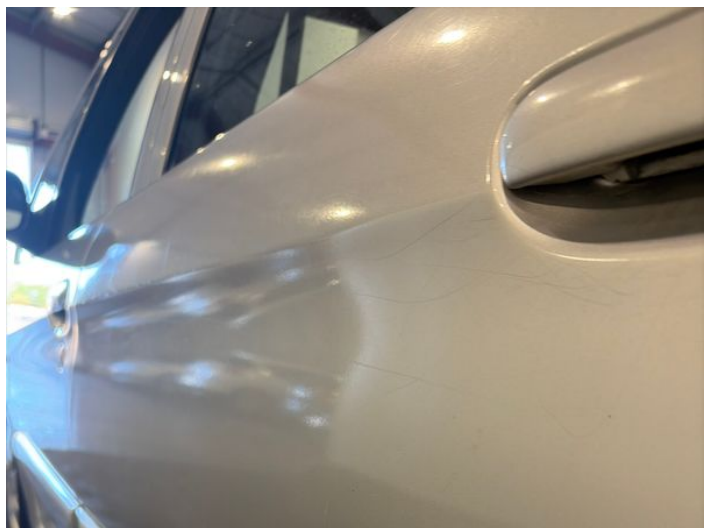
8: Door nsr  
Poor Previous Repair  
Rippled UpTo 30%

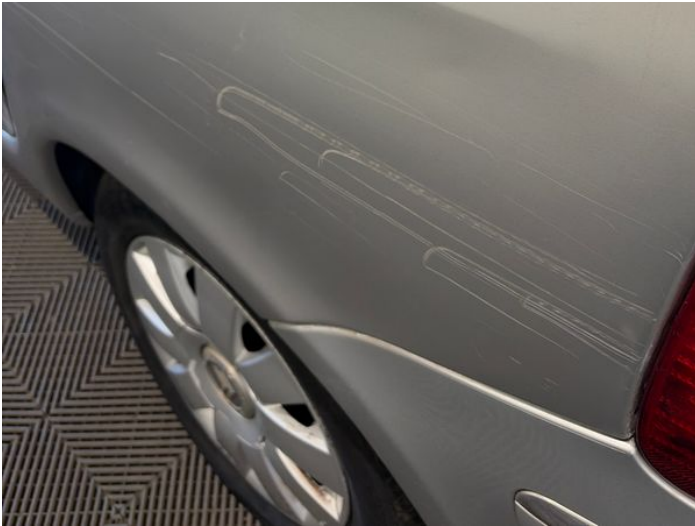
9: Qtr Panel nsr  
Dented  
With Paint Damage

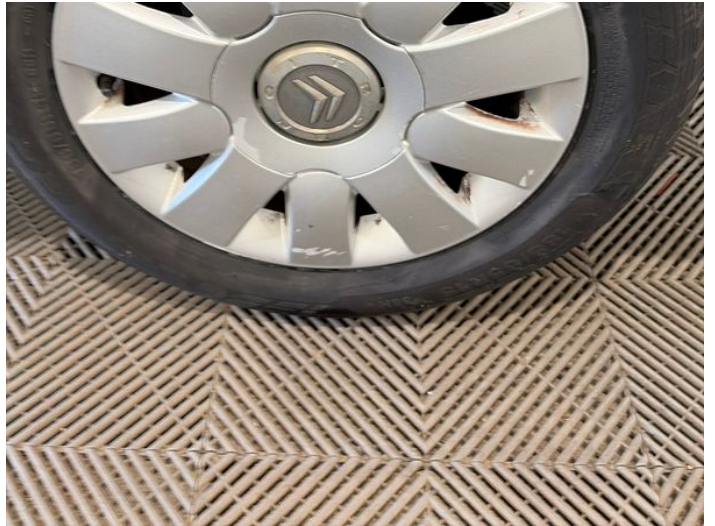
10: Wheel nsr  
Scratched  
Over 50mm

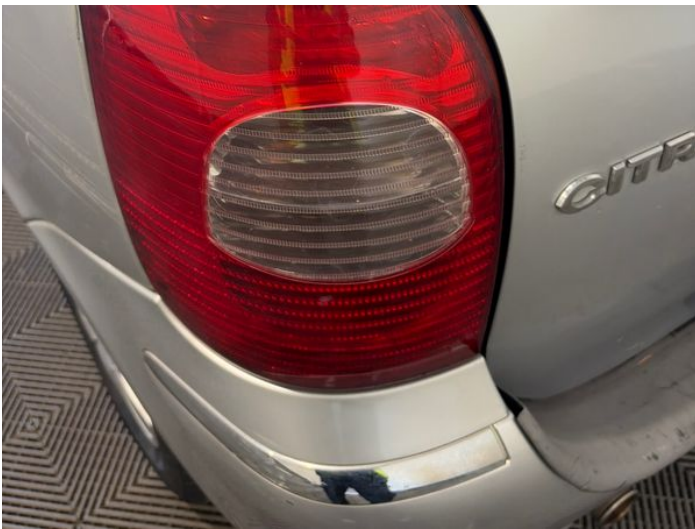
11: Lamp nsr  
Broken  
Replace

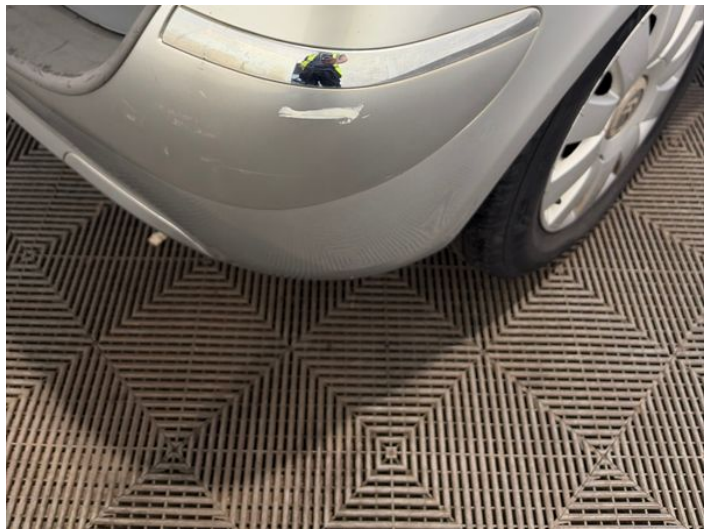
12: Bumper Rear  
Scratched  
Over 100mm Thru Paint

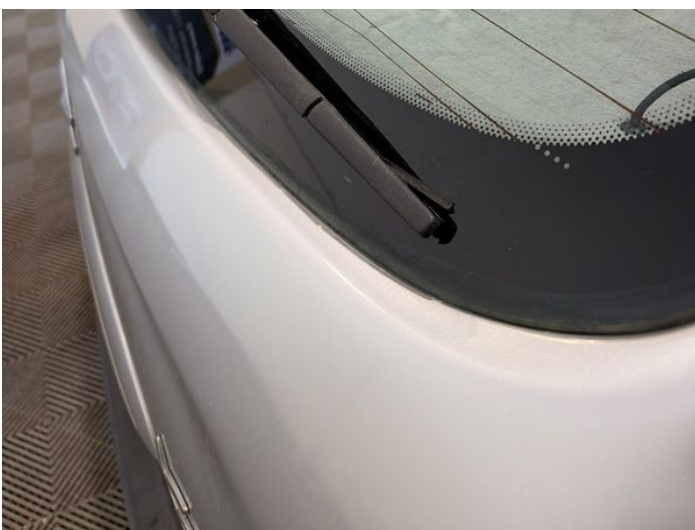
13: Wiper Rear  
Broken  
Replace

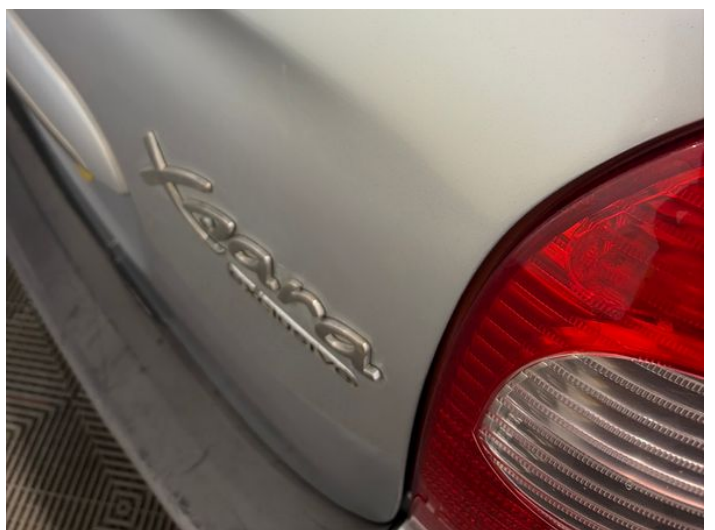
14: Tailgate  
Scratched  
Over 25mm Thru Paint

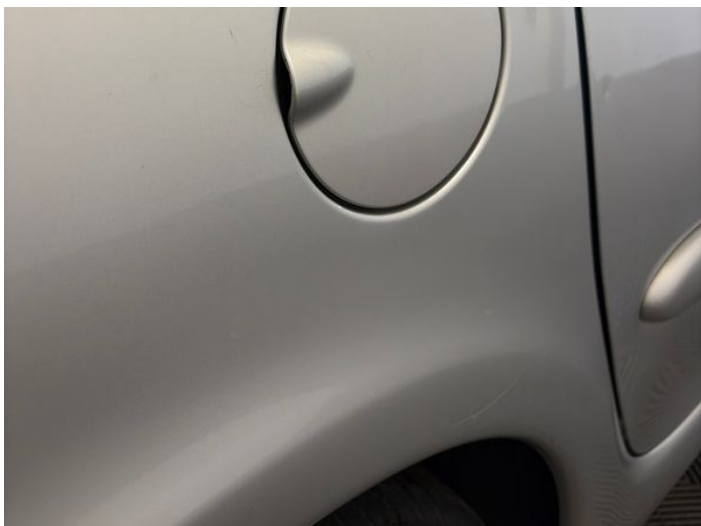
15: Qtr Panel osr  
Dented  
With Paint Damage

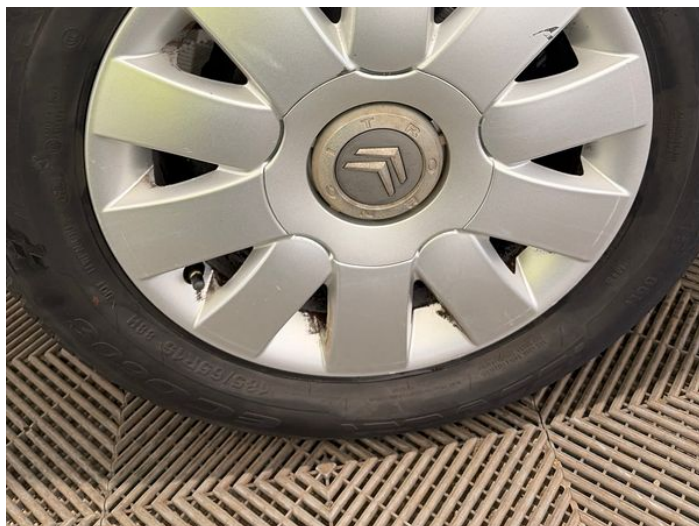
16: Wheel osr  
Scratched  
Over 50mm

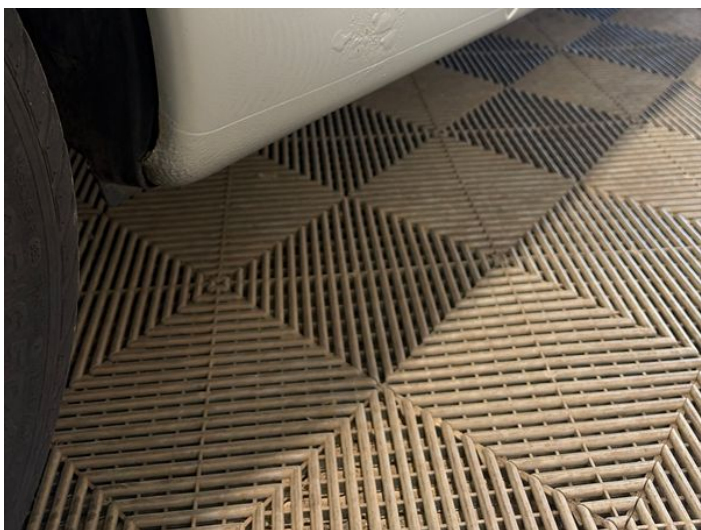
17: Sill os  
Rusted  
Over 5mm

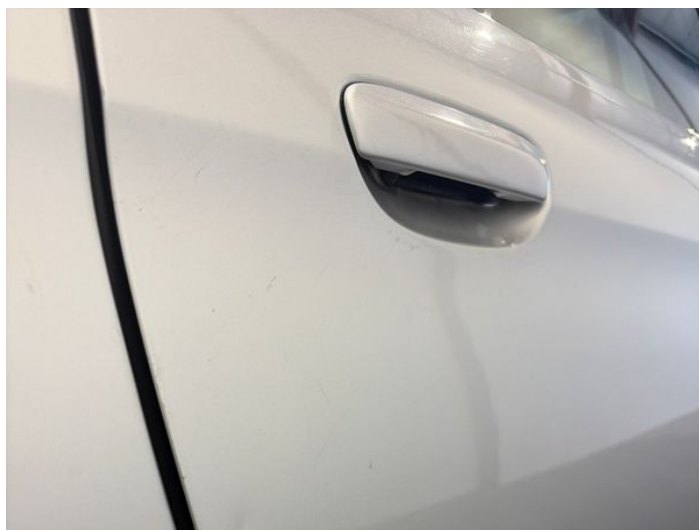
18: Door osr  
Dented  
Between 10mm + 30mm

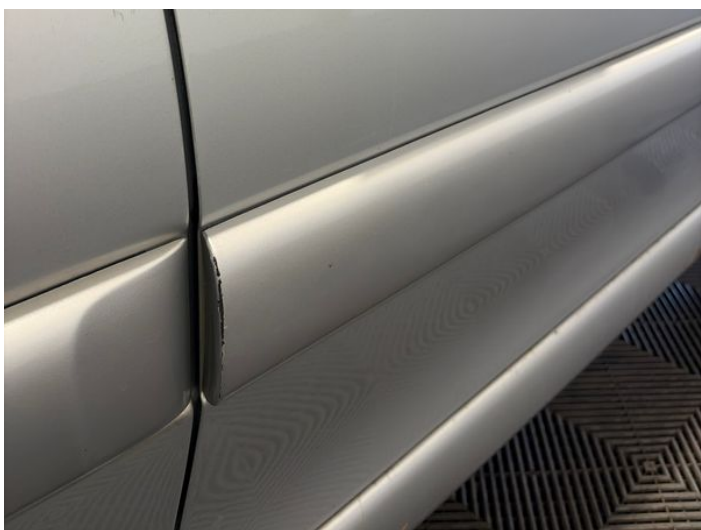
19: Door osf  
Scratched  
Over 25mm Thru Paint

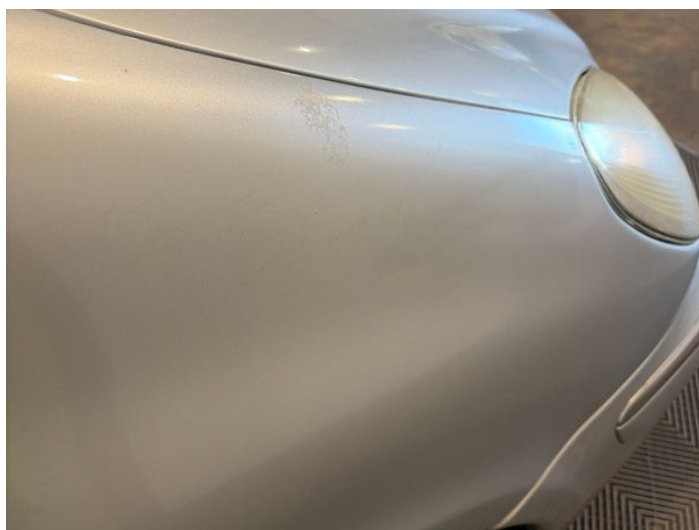
20: Wing osf  
Scratched  
Over 25mm Thru Paint

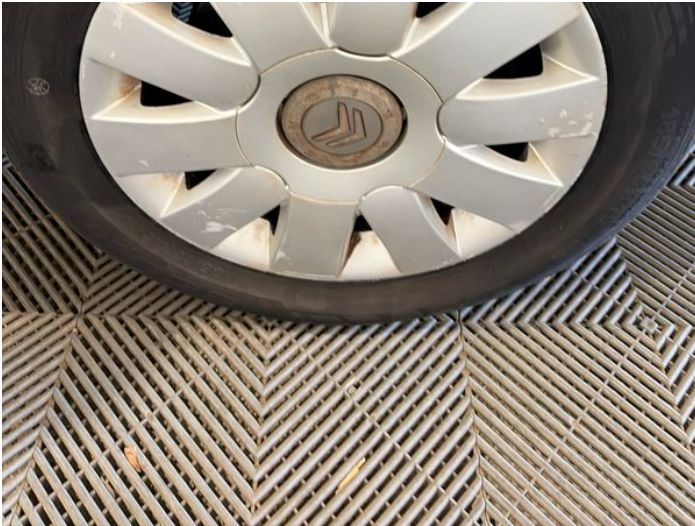
21: Wheel osf  
Scratched  
Over 50mm

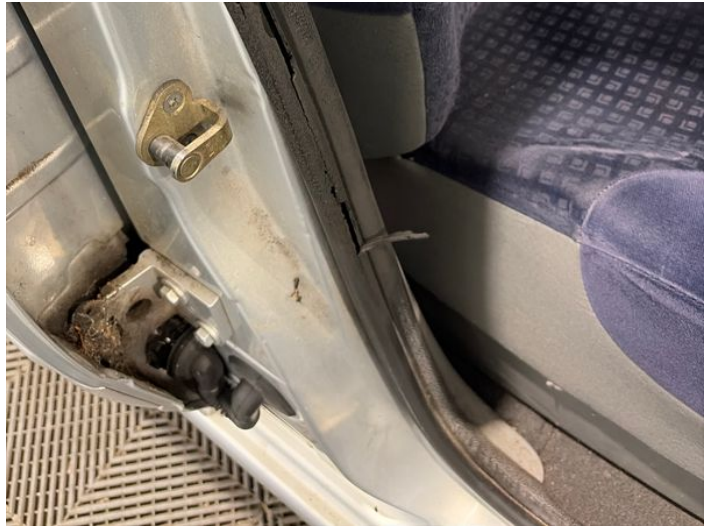
22: Aperture Seal osf  
Broken  
Replace

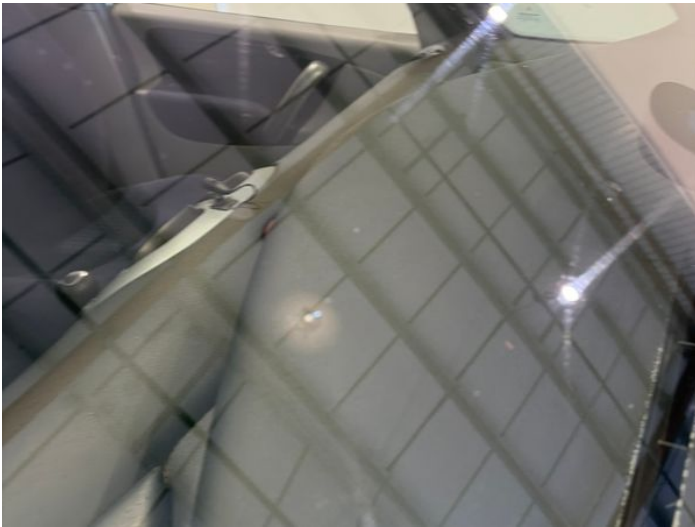
23: Screen Front  
Cracked  
Replace

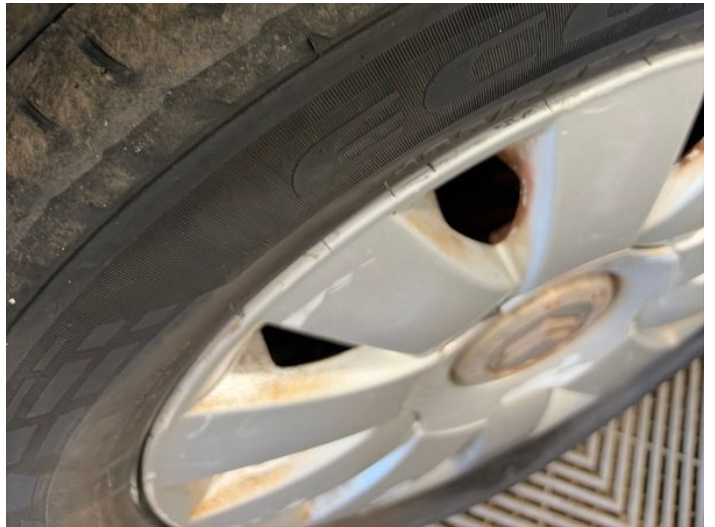
| NSF | MAZZINI | Damaged |

24: Tyre nsf  
Damaged  
Replace

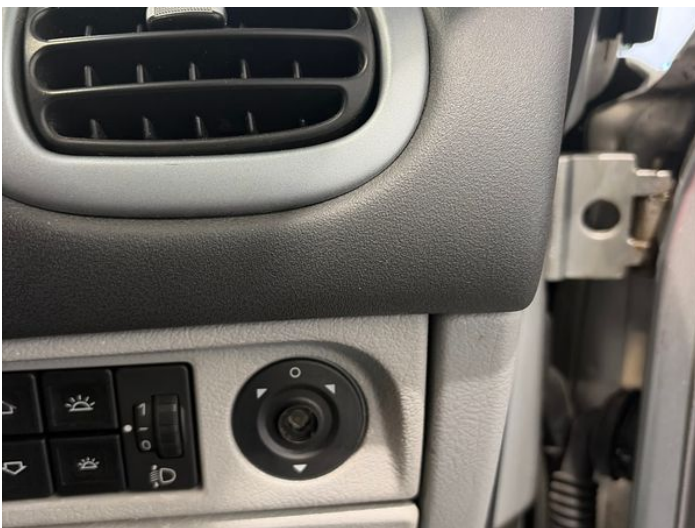
25: Switches And Controls  
Broken  
Replace
