## VEHICLE INSPECTION REPORT

**YA57BXD**

### BMW 3 Series 330i M Sport 2dr Auto

Cat: S Incident History

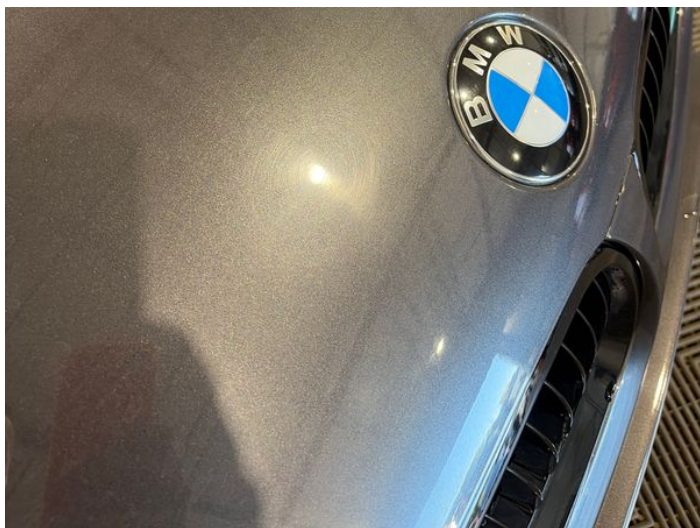
1: Bonnet  
Chipped  
1 To 5

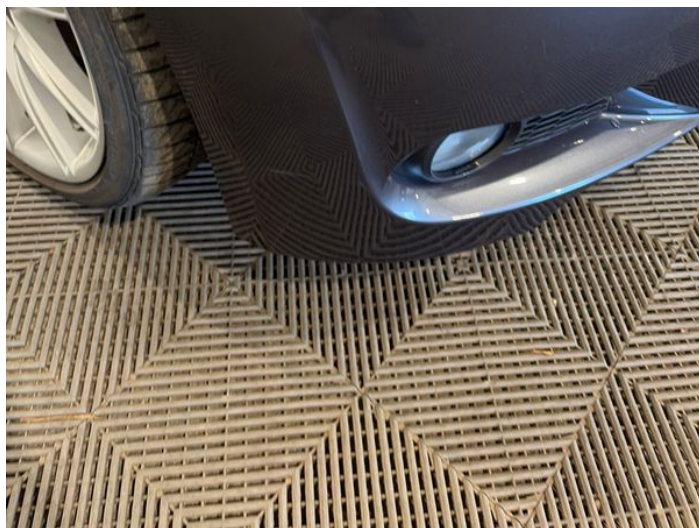
2: Bumper Front  
Scratched  
25 to 100mm Thru Paint

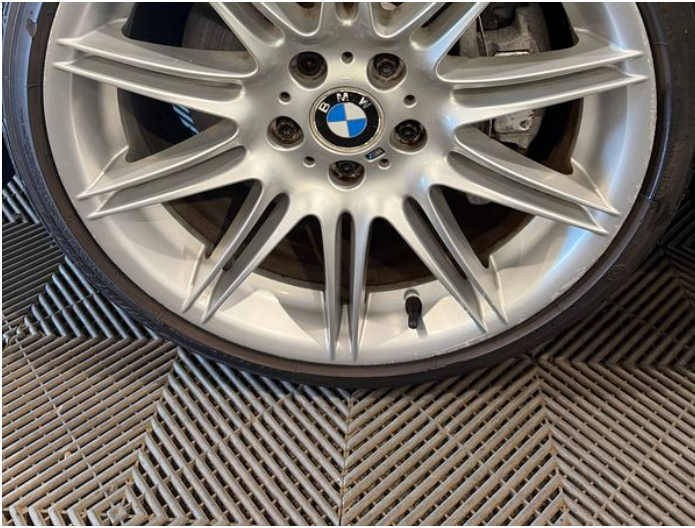
3: Wheel nsf  
Scratched  
Over 50mm

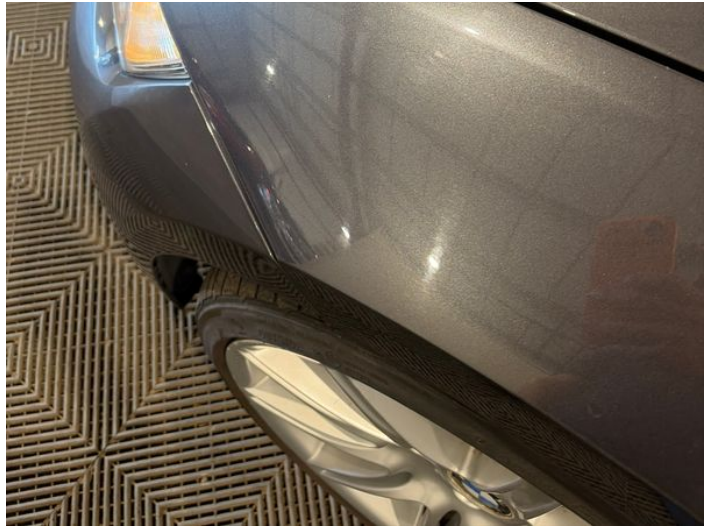
4: Wing nsf  
Chipped  
1 To 5

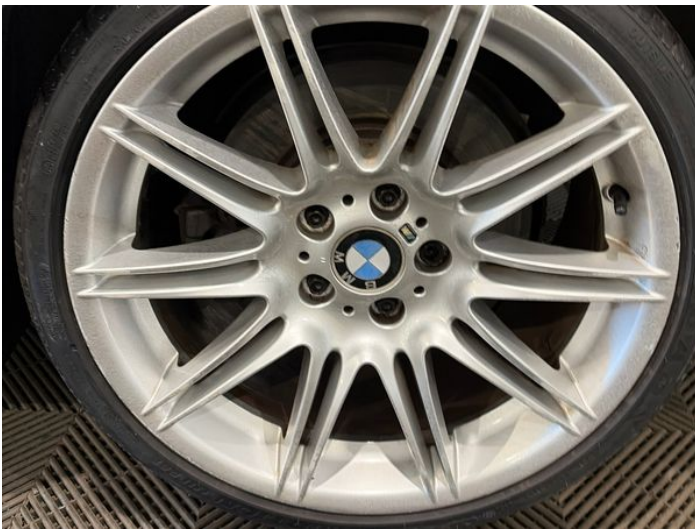
5: Wheel nsr  
Scratched  
Over 50mm

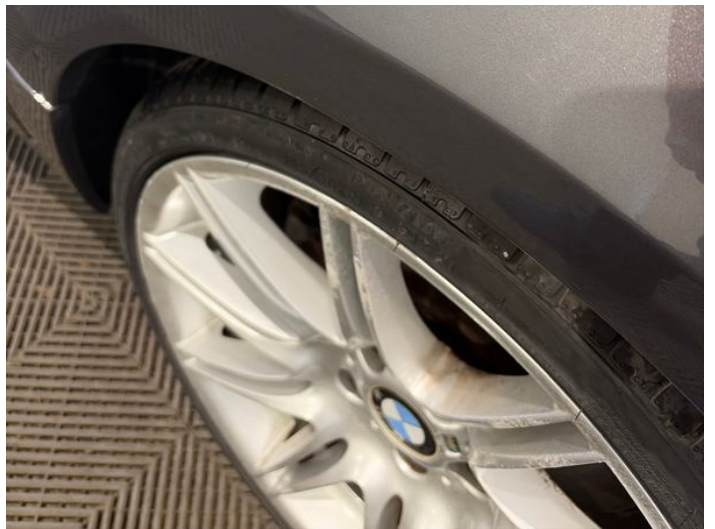
6: Qtr Panel nsr  
Scratched  
Over 25mm Thru Paint

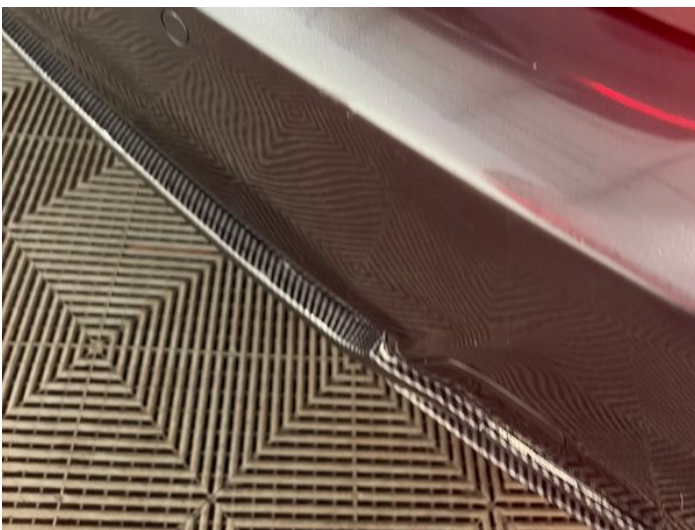
7: Bumper Rear  
Dented  
Between 10mm + 30mm

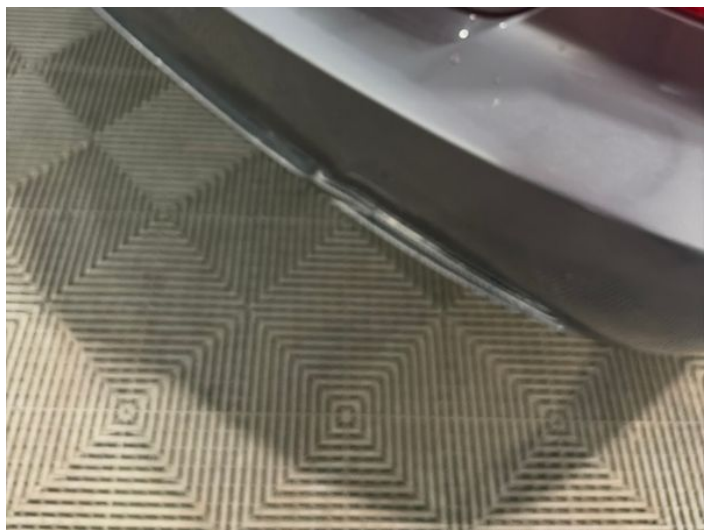
8: Bumper Rear  
Poor Previous Repair  
Poor Paint

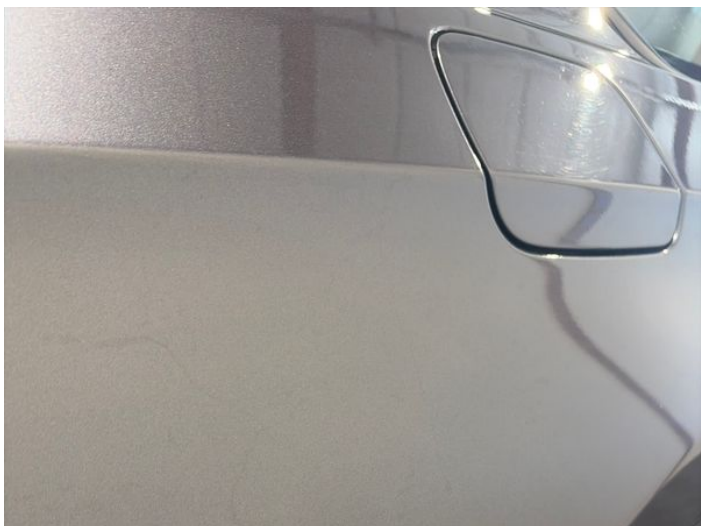
9: Qtr Panel osr  
Poor Previous Repair  
Poor Paint

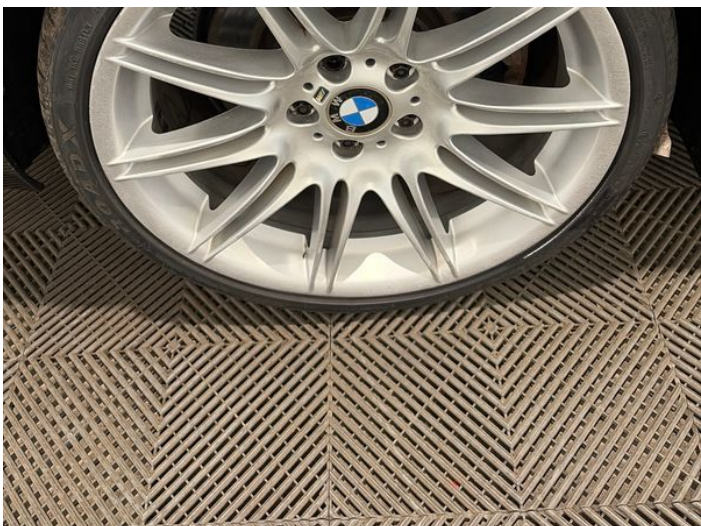
10: Wheel osr  
Scratched  
Over 50mm

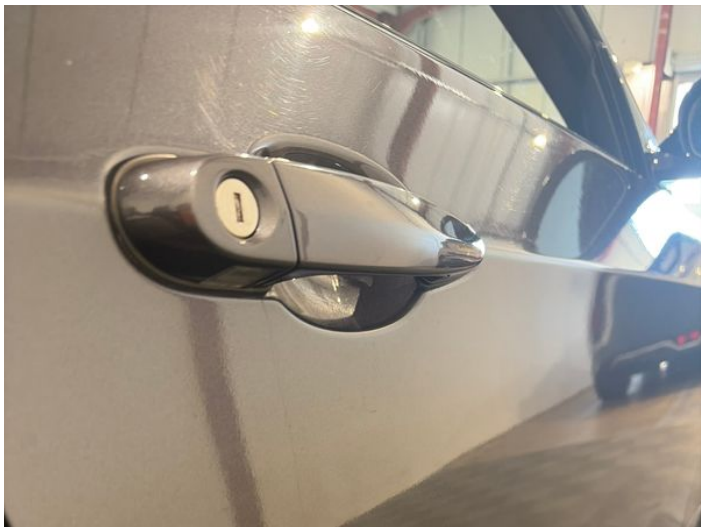
11: Door osf  
Poor Previous Repair  
Poor Paint

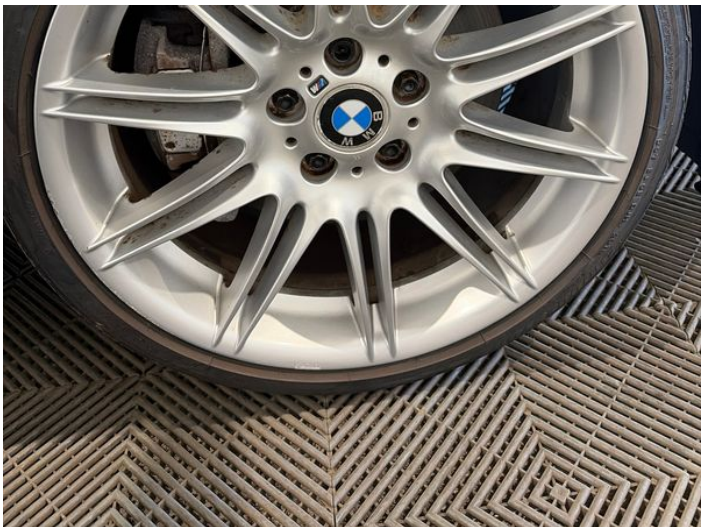
12: Wheel osf  
Scratched  
Over 50mm
