## VEHICLE INSPECTION REPORT

**ST17NFM**

### Nissan Qashqai 1.2 DiG-T Tekna [Non-Panoramic] 5dr

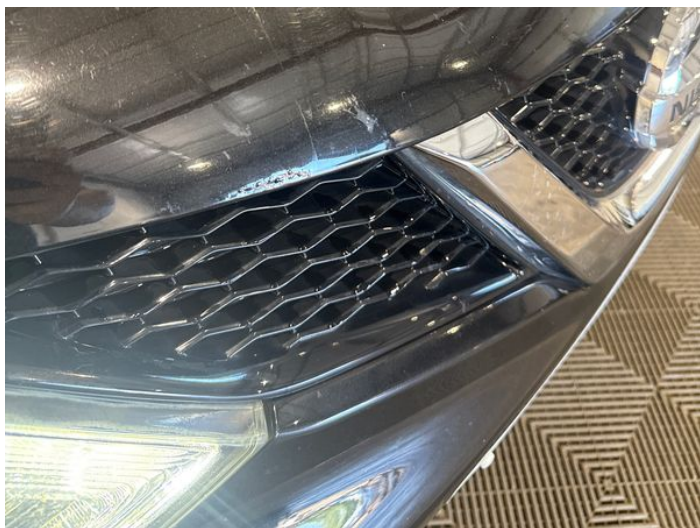
1: Bonnet  
Dented  
With Paint Damage

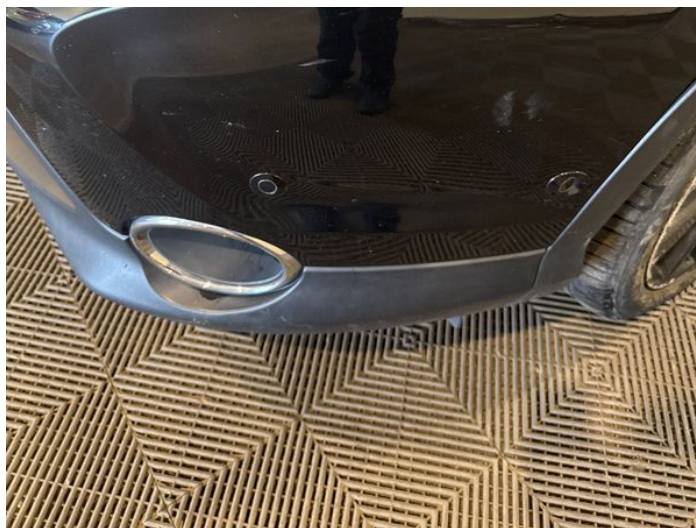
2: Bumper Front  
Scratched  
25 to 100mm Thru Paint

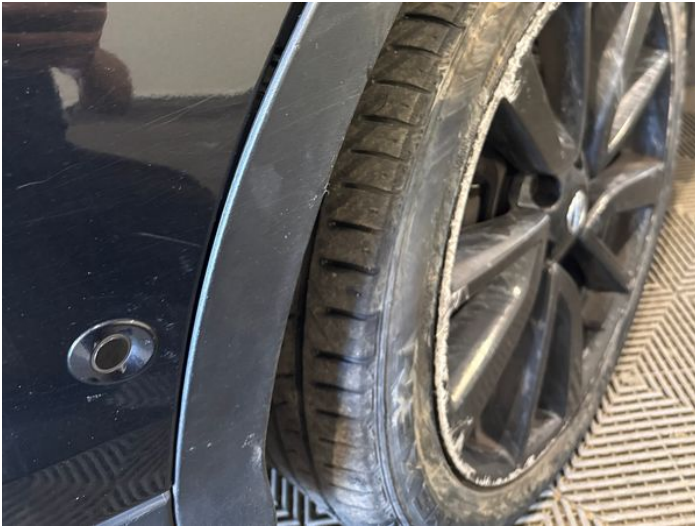
3: Wing Front Arch Extension ns  
Scuffed (Unpainted)  
Over 100mm

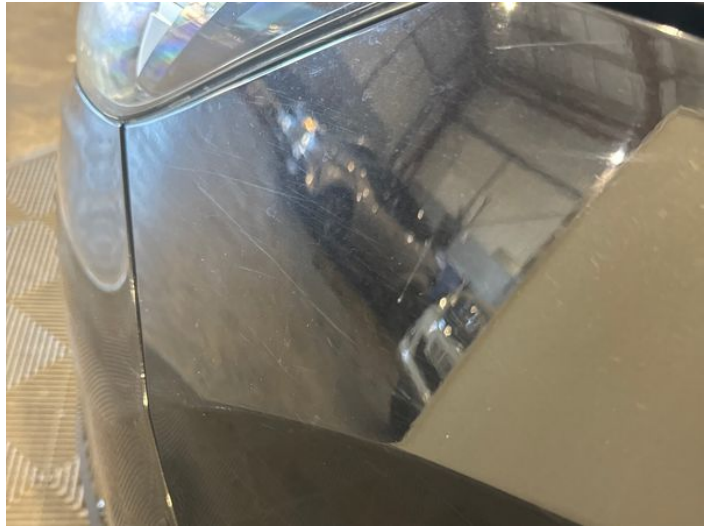
4: Wing nsf  
Scratched  
UpTo 25mm Thru Paint

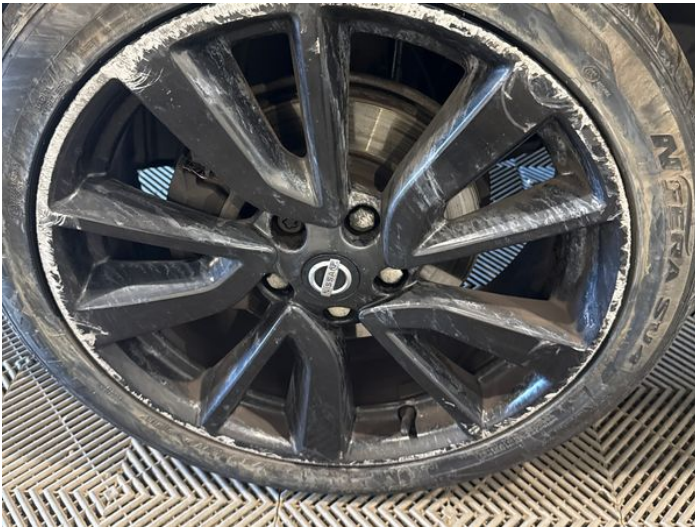
5: Wheel nsf  
Scratched  
Over 50mm

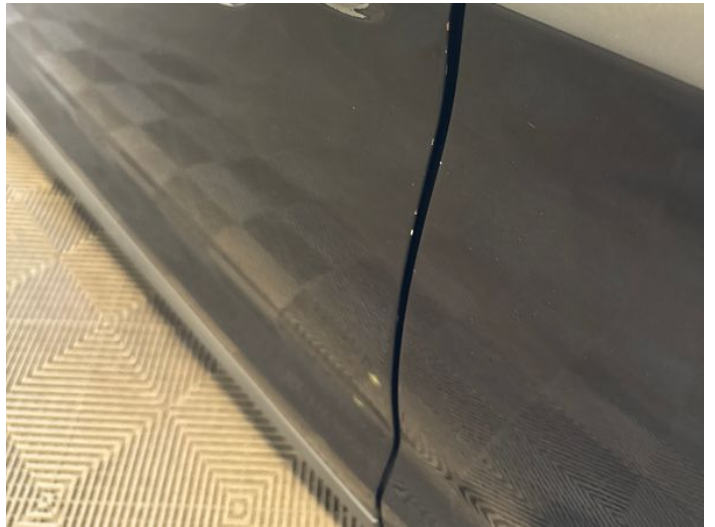
6: Door nsf  
Chipped  
Edge Chip

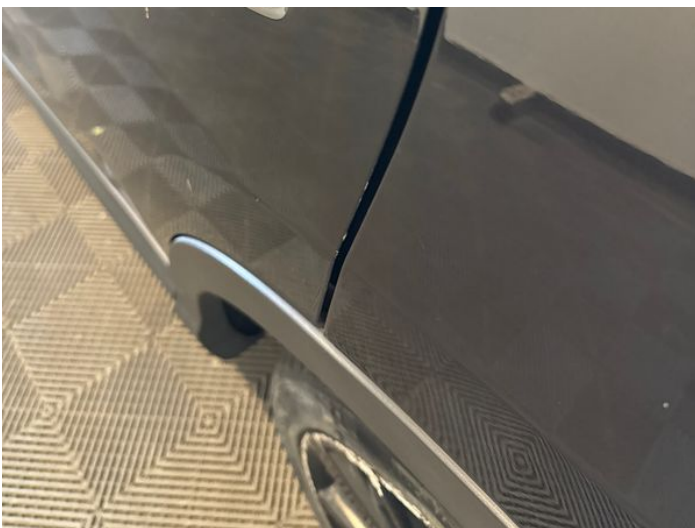
7: Door nsr  
Chipped  
Edge Chip

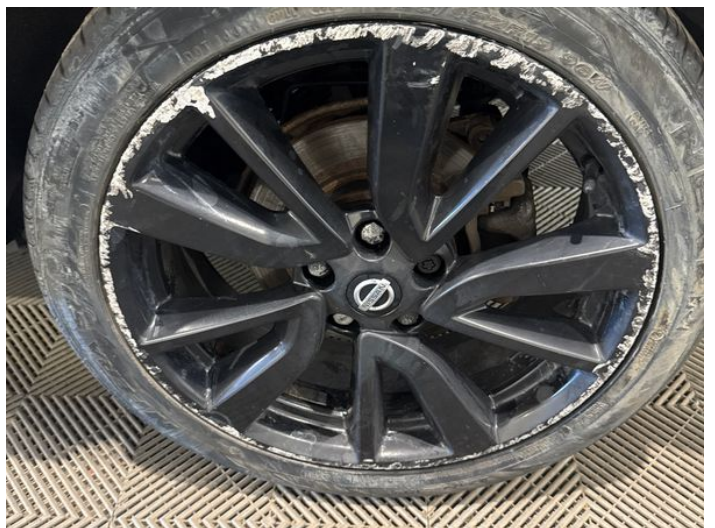
8: Wheel nsr  
Scratched  
Over 50mm

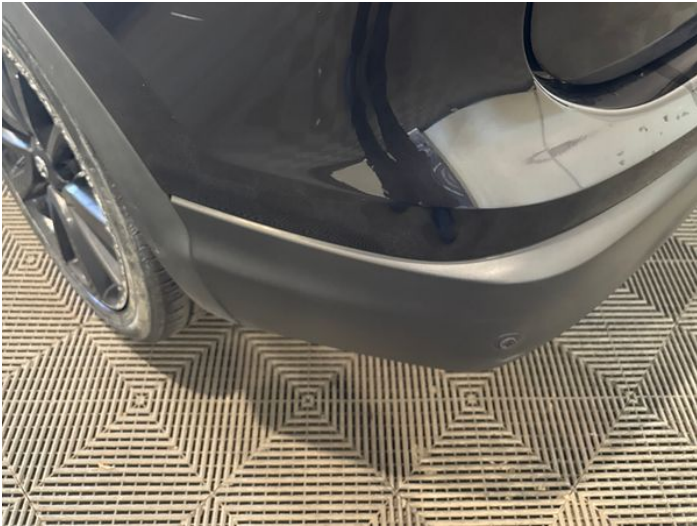
9: Bumper Rear  
Scratched  
25 to 100mm Thru Paint

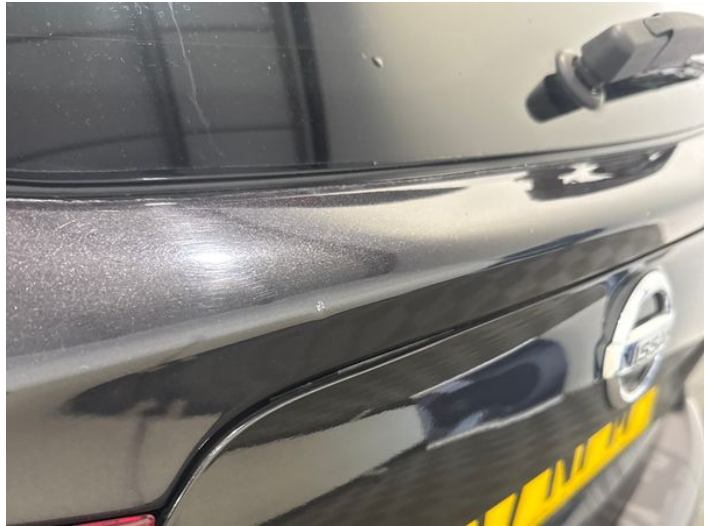
10: Tailgate  
Dented  
2 Or Less Up To 10mm

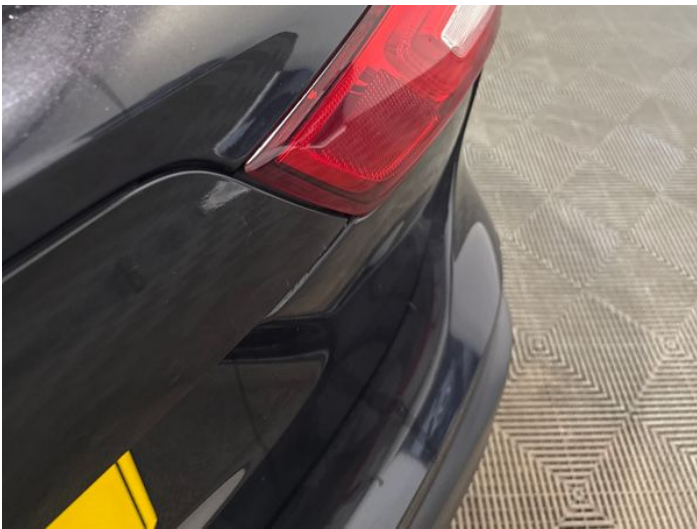
11: Tailgate  
Chipped  
1 To 5

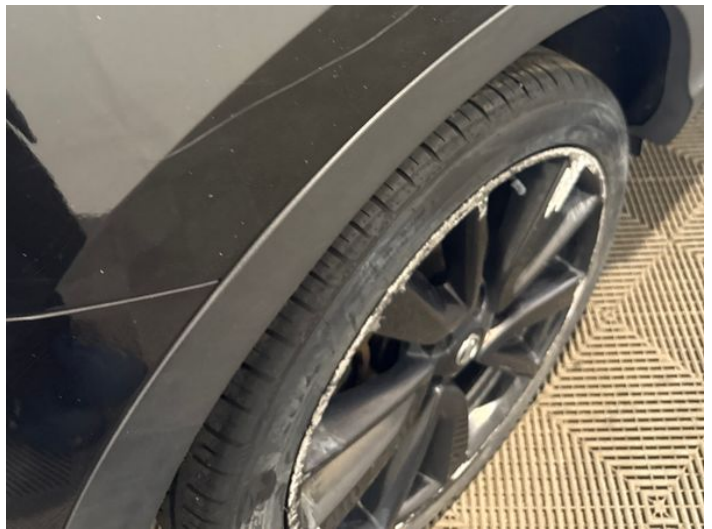
12: Qtr Panel osr  
Scratched  
Over 25mm Thru Paint

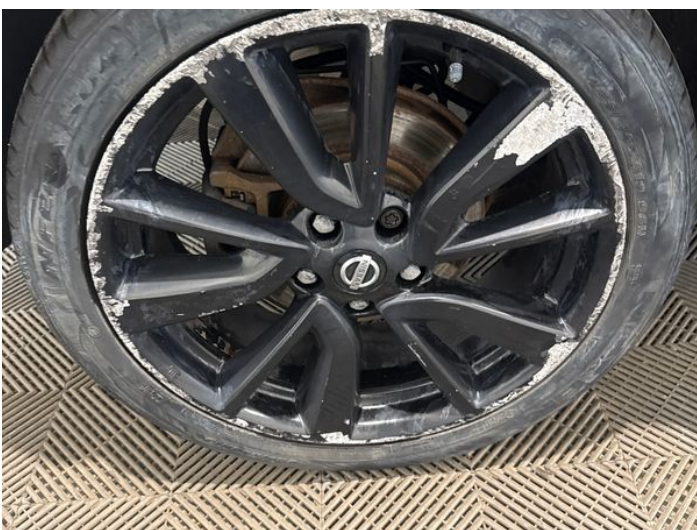
13: Wheel osr  
Scratched  
Over 50mm

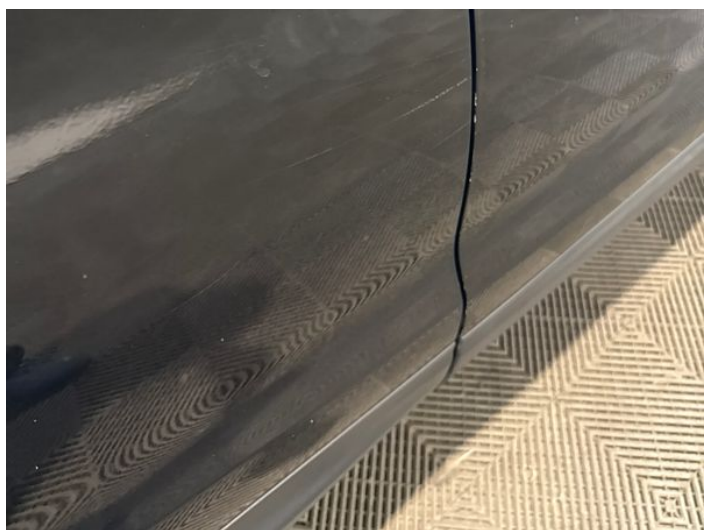
14: Door osr  
Scratched  
Over 25mm Thru Paint

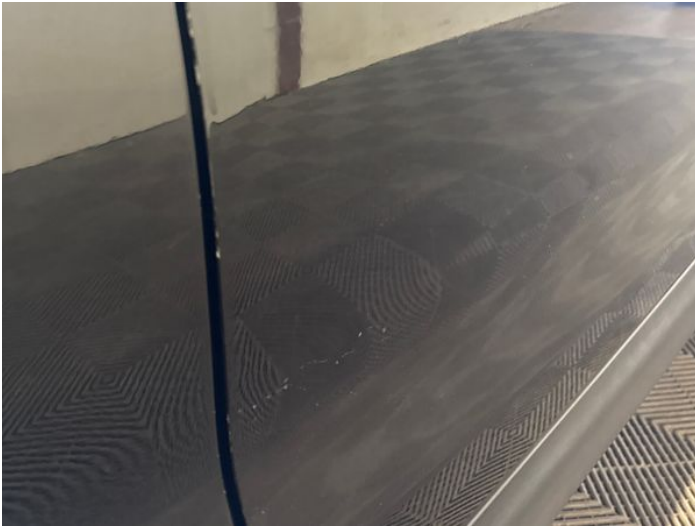
15: Door osf  
Dented  
Between 10mm + 30mm

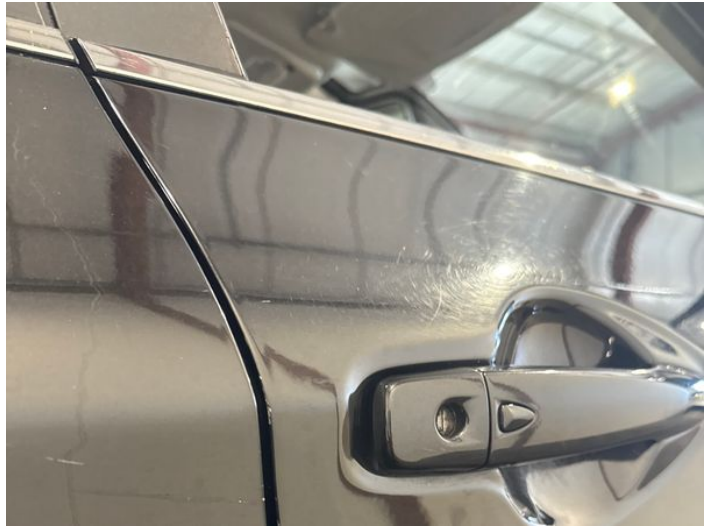
16: Door osf  
Chipped  
Edge Chip

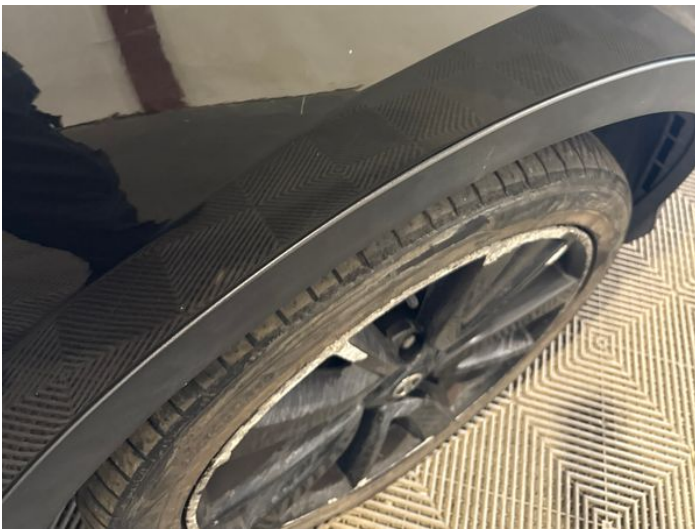
17: Wing osf  
Scratched  
UpTo 25mm Thru Paint

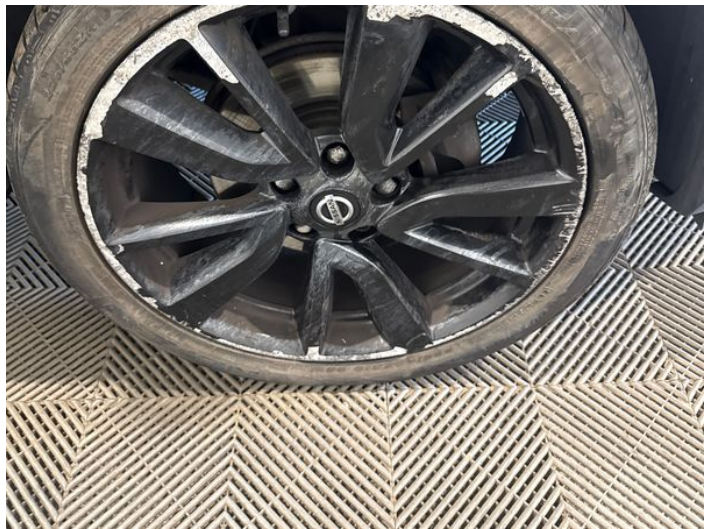
18: Wheel osf  
Scratched  
Over 50mm
